Broward Marine Fire Fort Lauderdale, Florida

This is Report 101 of the Major Fires Investigation Project conducted by Varley-Campbell & Associates, Inc. under contract EMW-94-C-4423 to the United States Fire Administration, Federal Emergency Management Agency.

BROWARD MARINE FIRE

SEPTEMBER 5, 1996

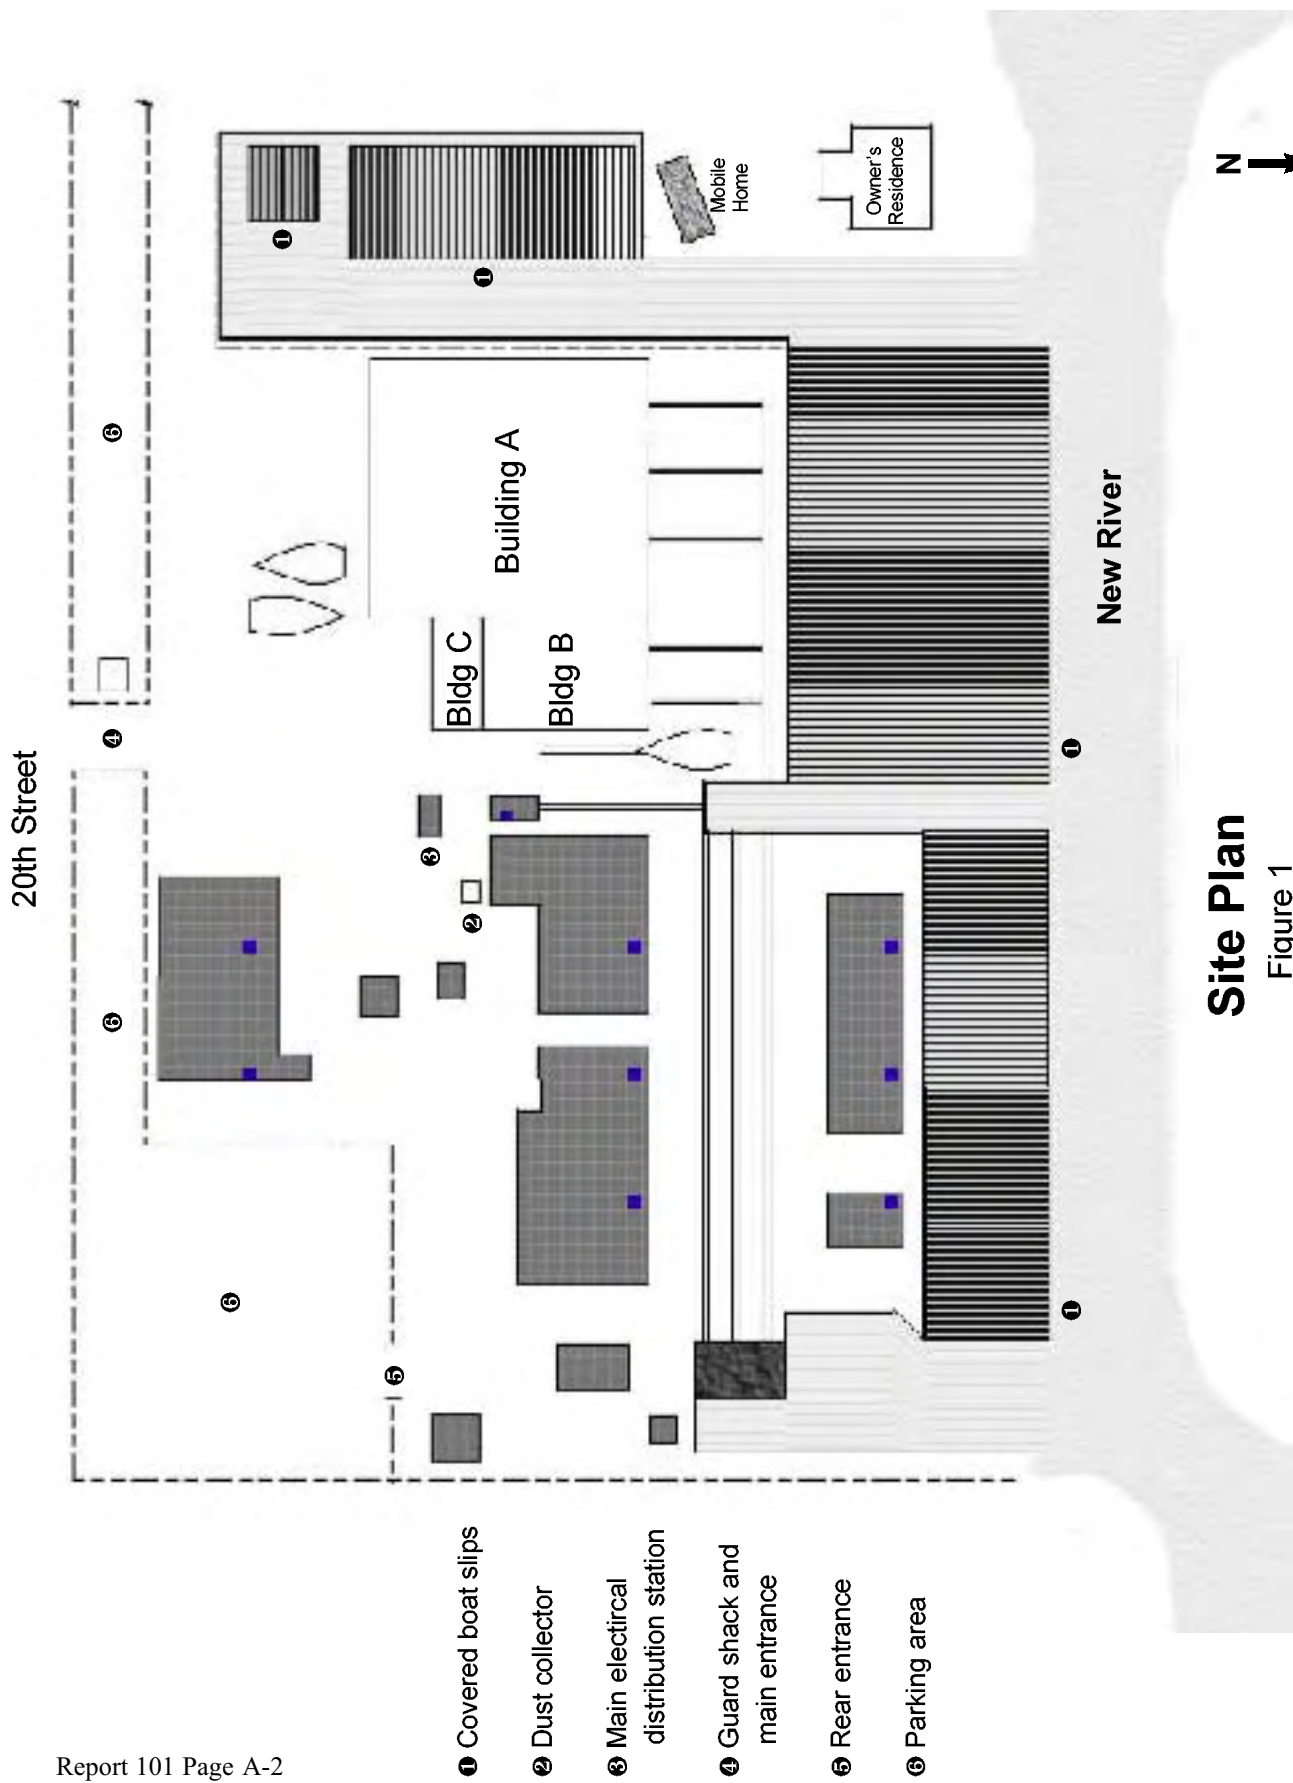
Site Plan
Figure 1

Area of Origin

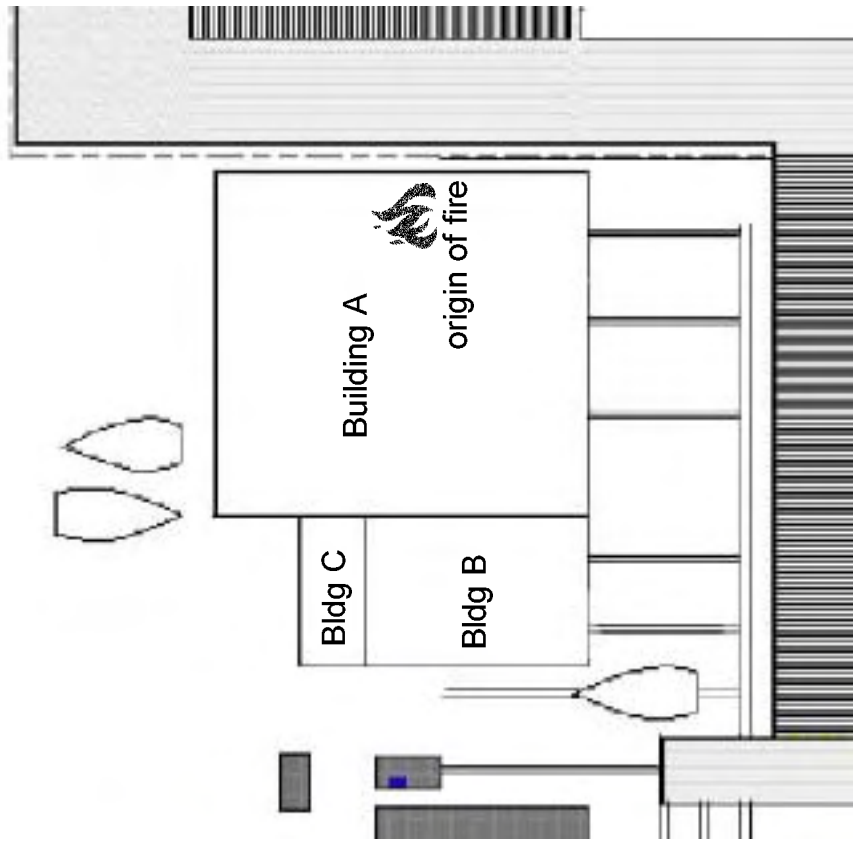
Figure 2

Area of Origin

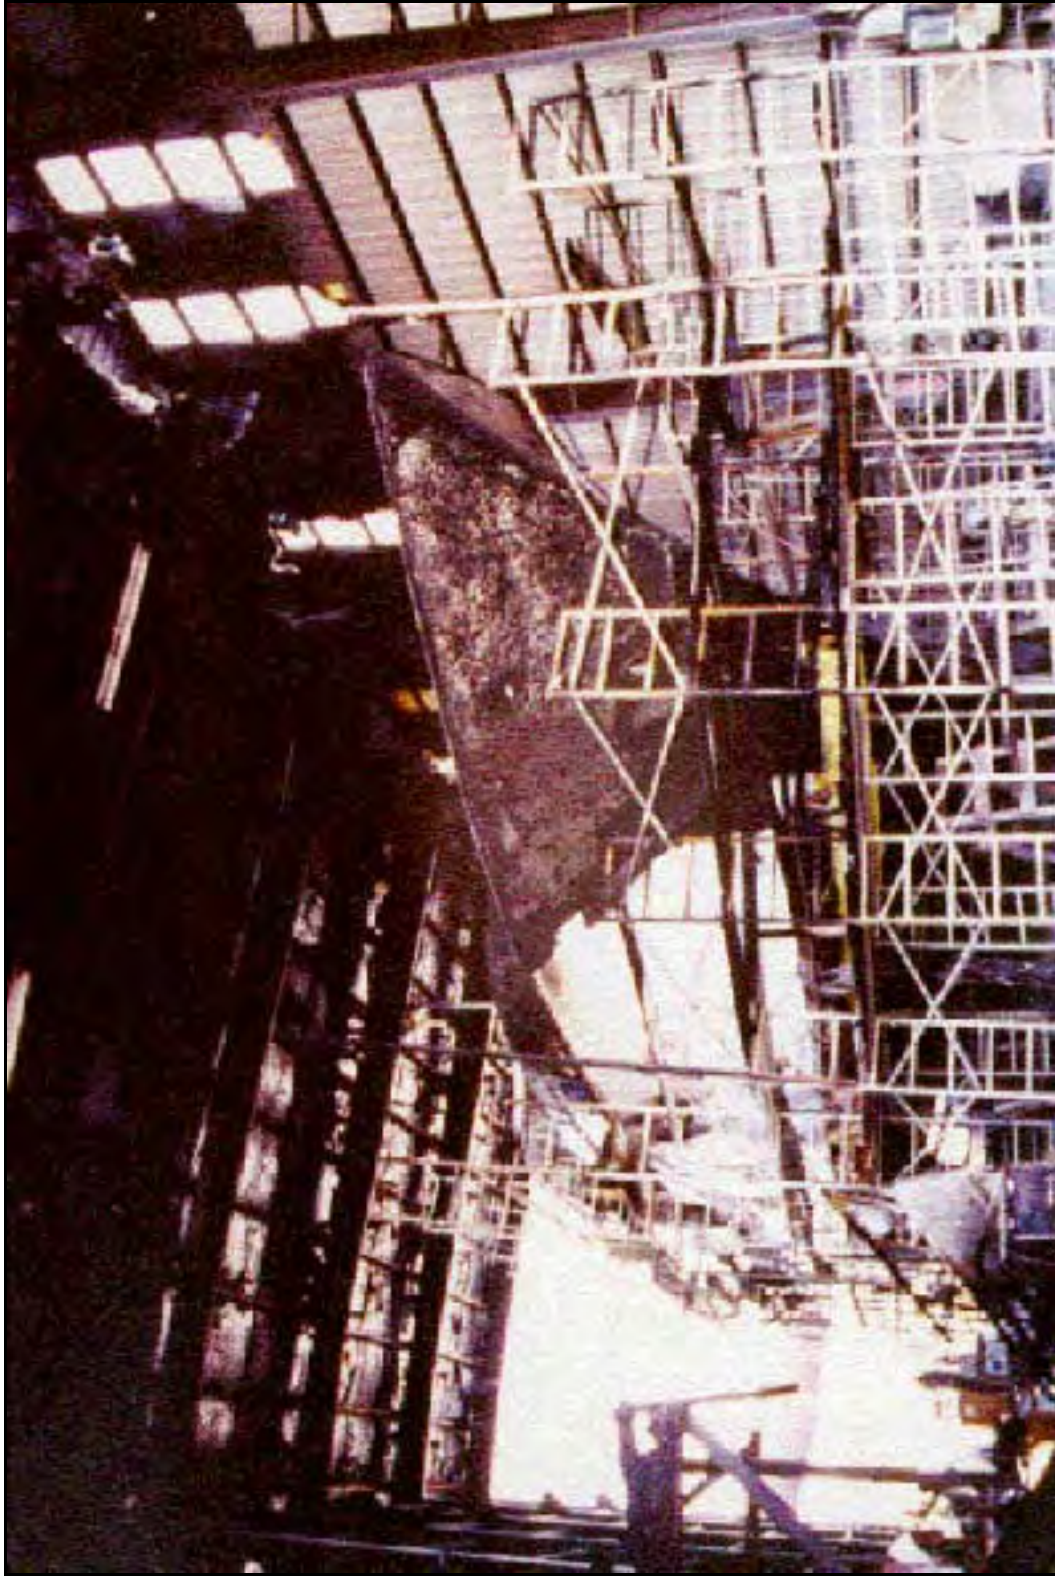
1. View of yacht under construction in Building B. Scaffolding constructed around the yacht hindered the firefighting efforts.

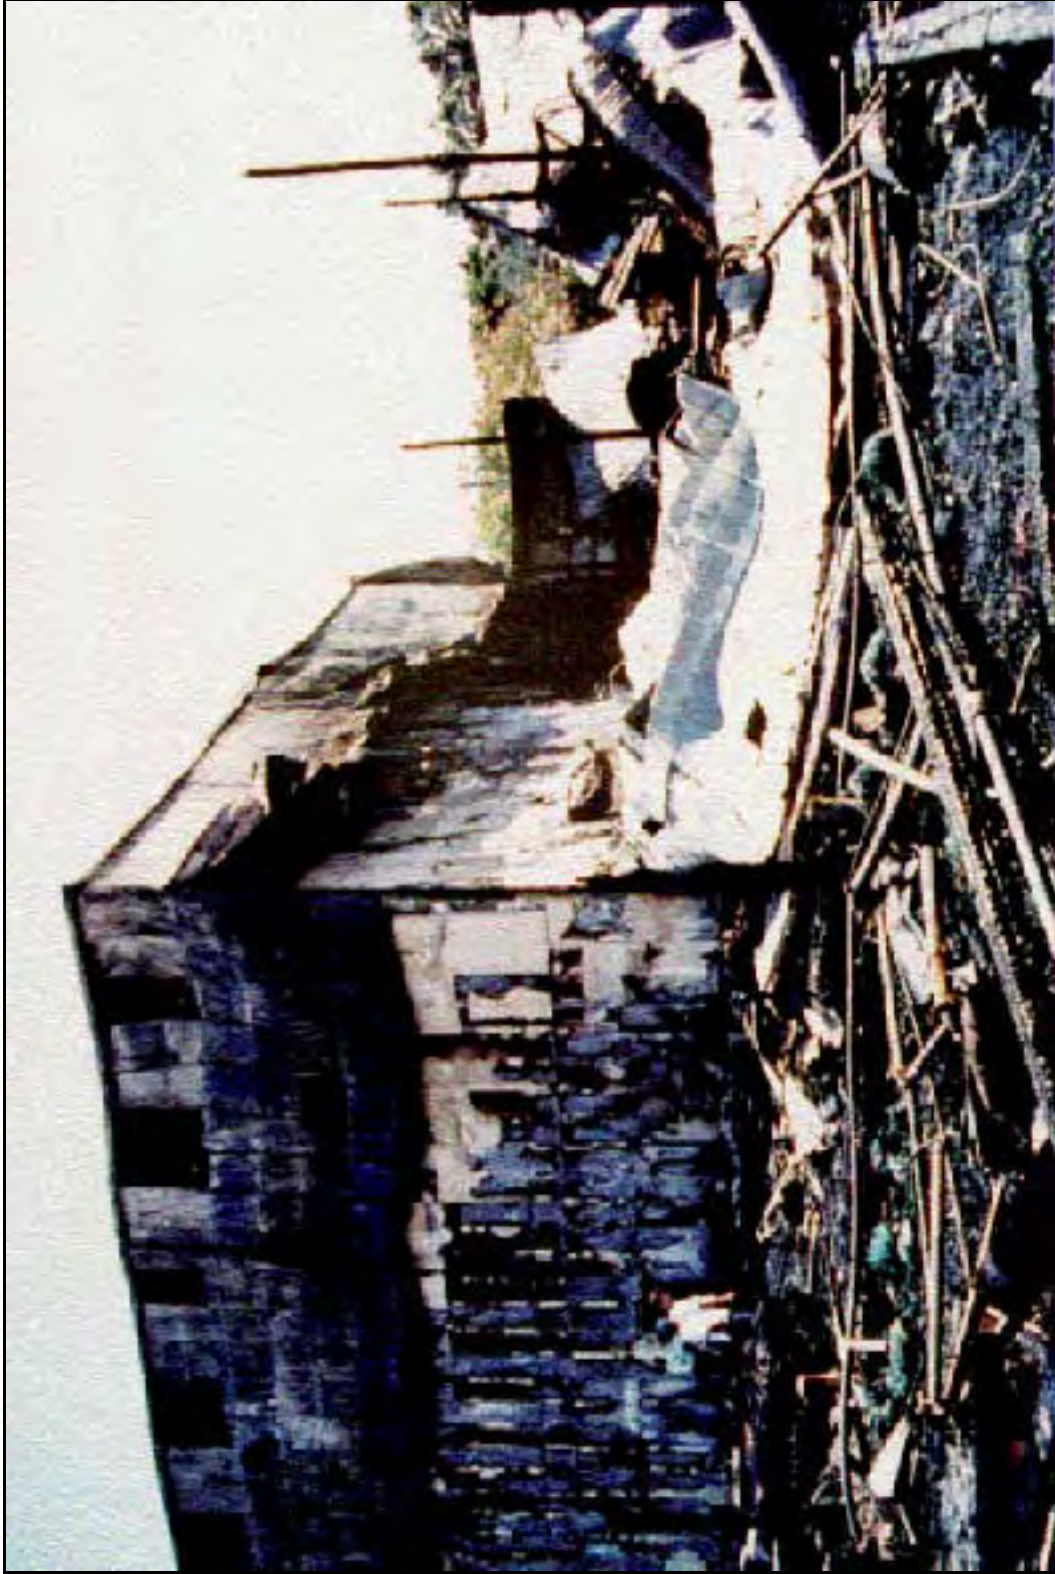
2. View looking east from Manufacturing Building (Building A) towards the destroyed Office Building (Building C).

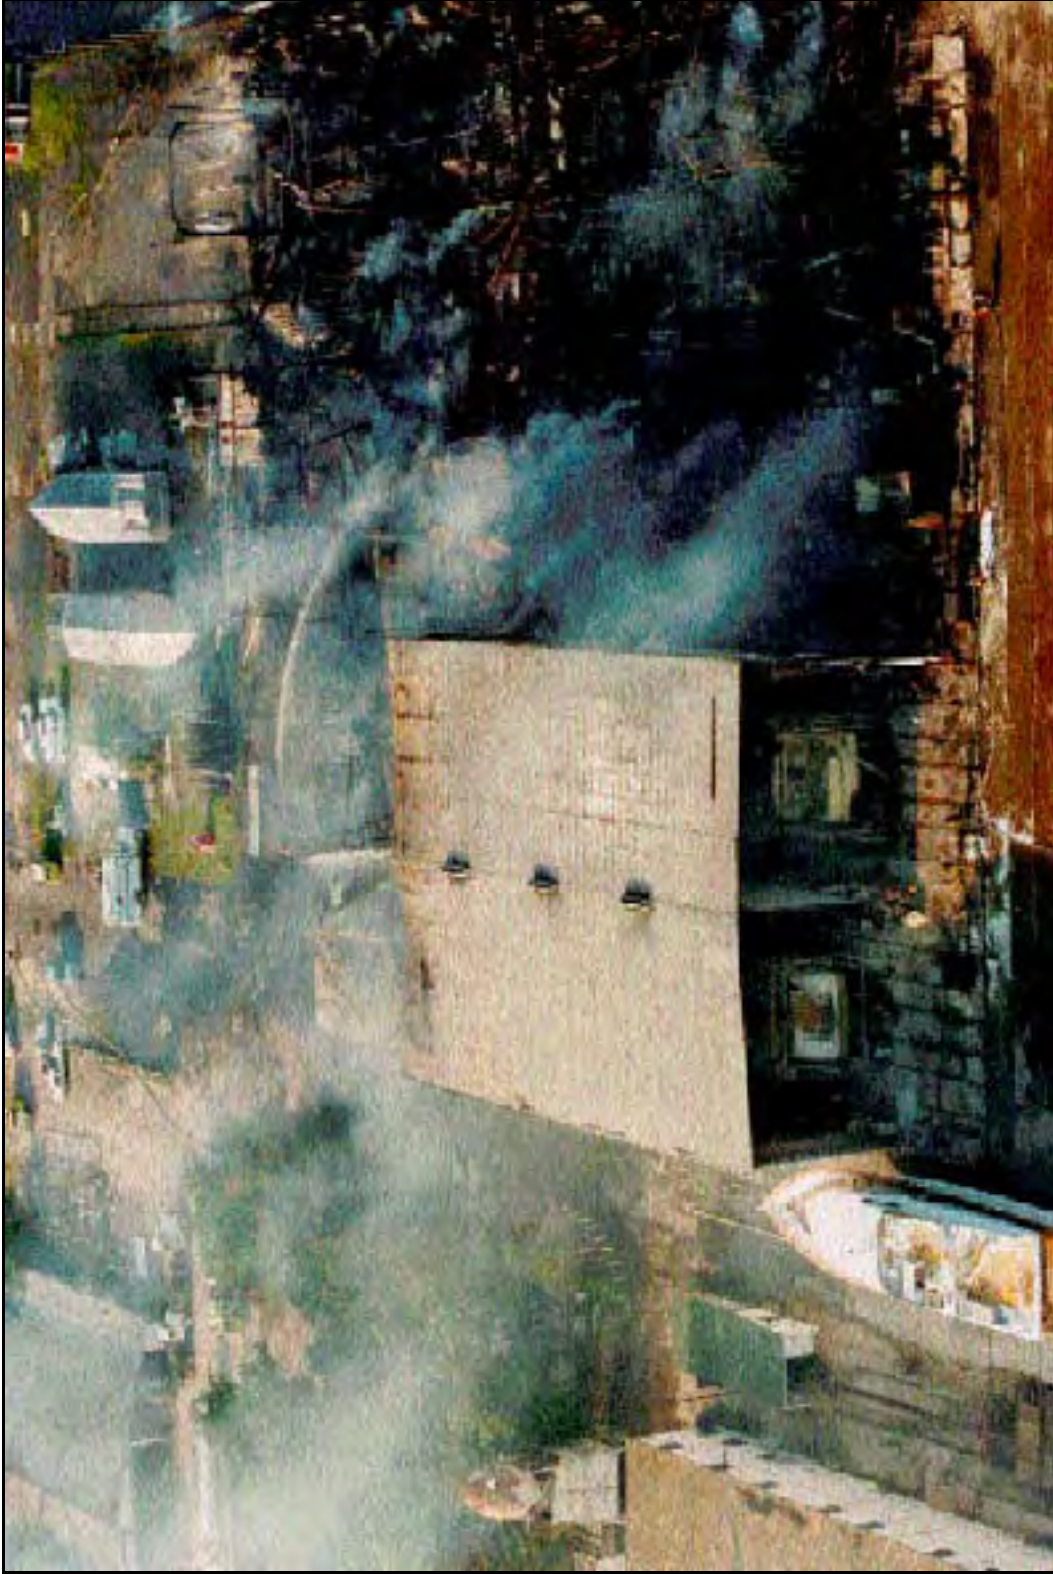
3. Aerial view of fire scene; the two boat hulls located at the top of the photograph are situated south of Building A.

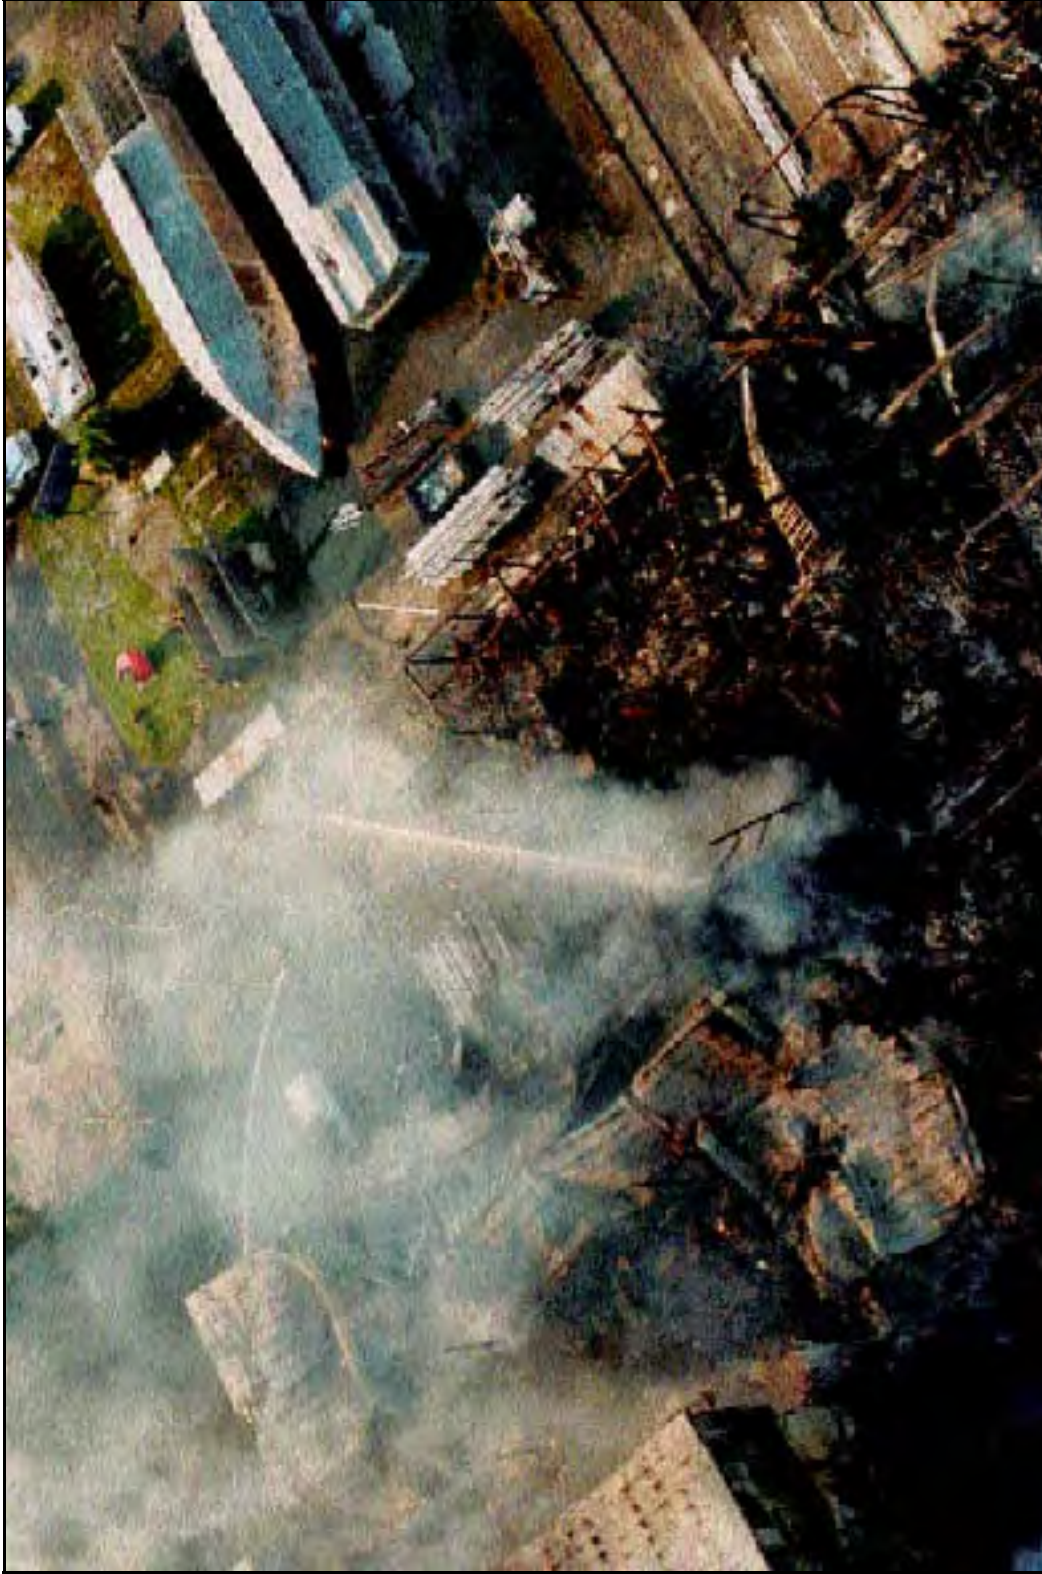
4. Aerial view of the south corner of the collapsed Manufacturing Building (Building A).

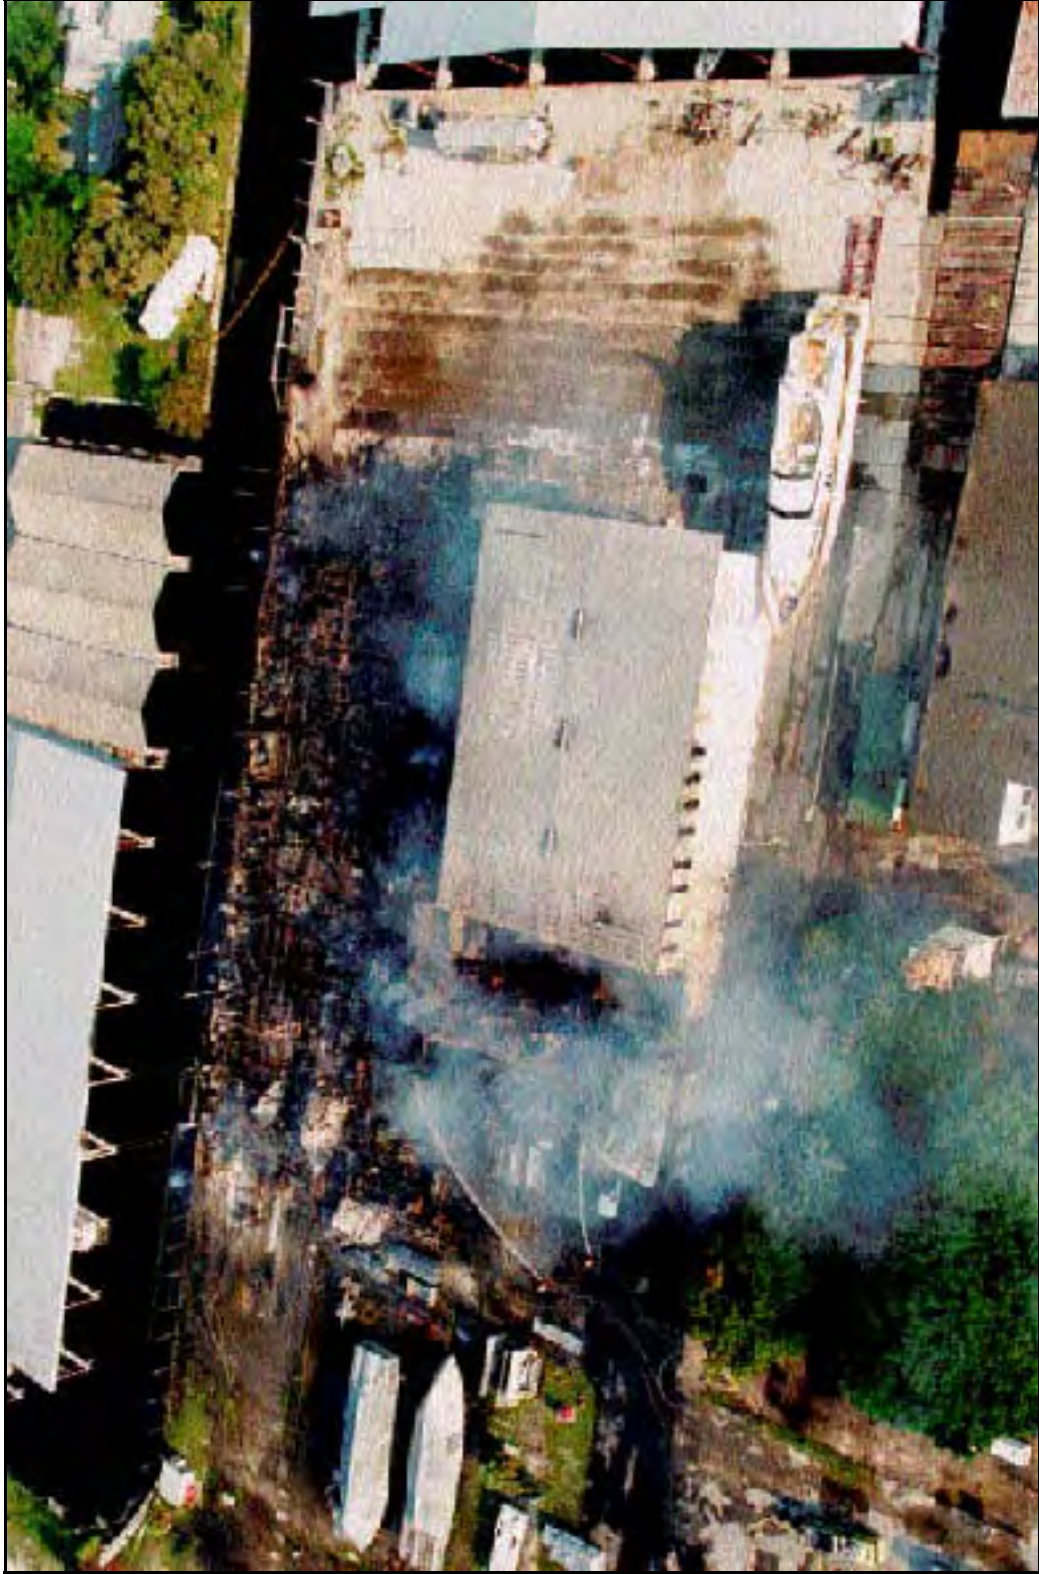
5. Aerial view of the fire scene, with the canal and neighboring covered boat slips (to the west) at top of photograph.
