## Old Buckingham Station Chesterfield, Virginia

# **Old Buckingham Station Chesterfield, Virginia**

**Investigated by Thomas H. Miller, P.E.**

This is Report 105 of the Major Fires Investigation Project conducted by Varley-Campbell & Associates, Inc. under contract EMW-94-C-4423 to the United States Fire Administration, Federal Emergency Management Agency.

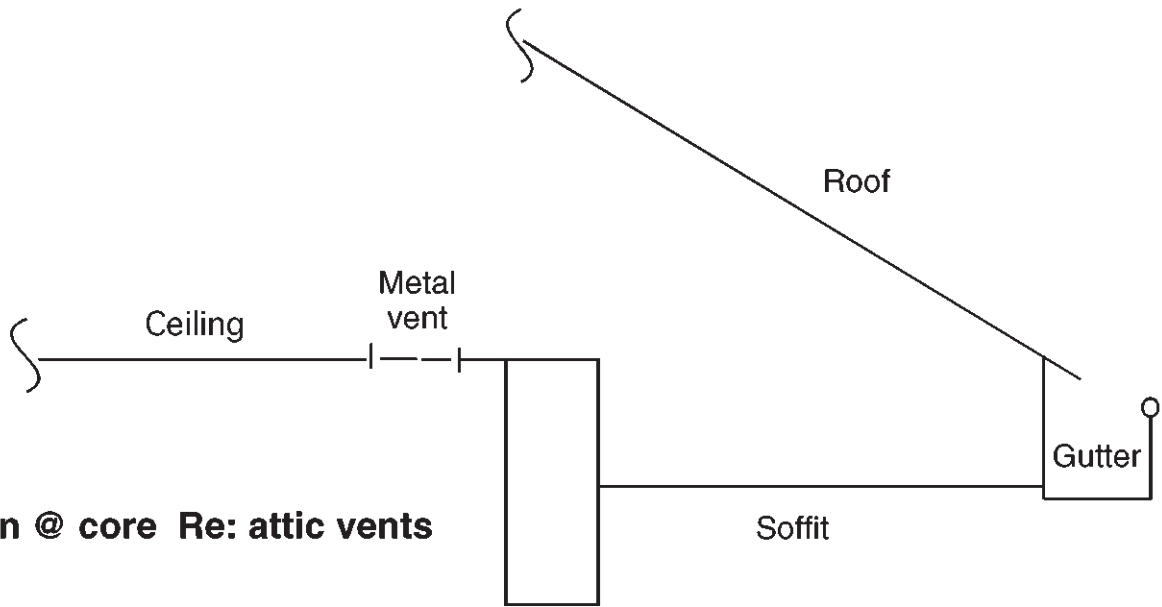
**Section @ core Re: attic vents**

The floors were 2x4 parallel cord trusses 18 to 24-inches deep supporting a plywood subfloor that was topped with a thin (about 1-inch) layer of lightweight concrete. Gypsum board ceilings were attached directly to the bottom cords of the truss. The roof was constructed of a chip board deck over peaked wood trusses made from 2x4 and 2x6 members. The truss span was approximately 40 feet with a peak height of 13.5 feet and an 8/12 pitch. The roof contained a ridge vent and continuous soffit vents were provided around the perimeter of the building. (See Appendix C for soffit vent details.)

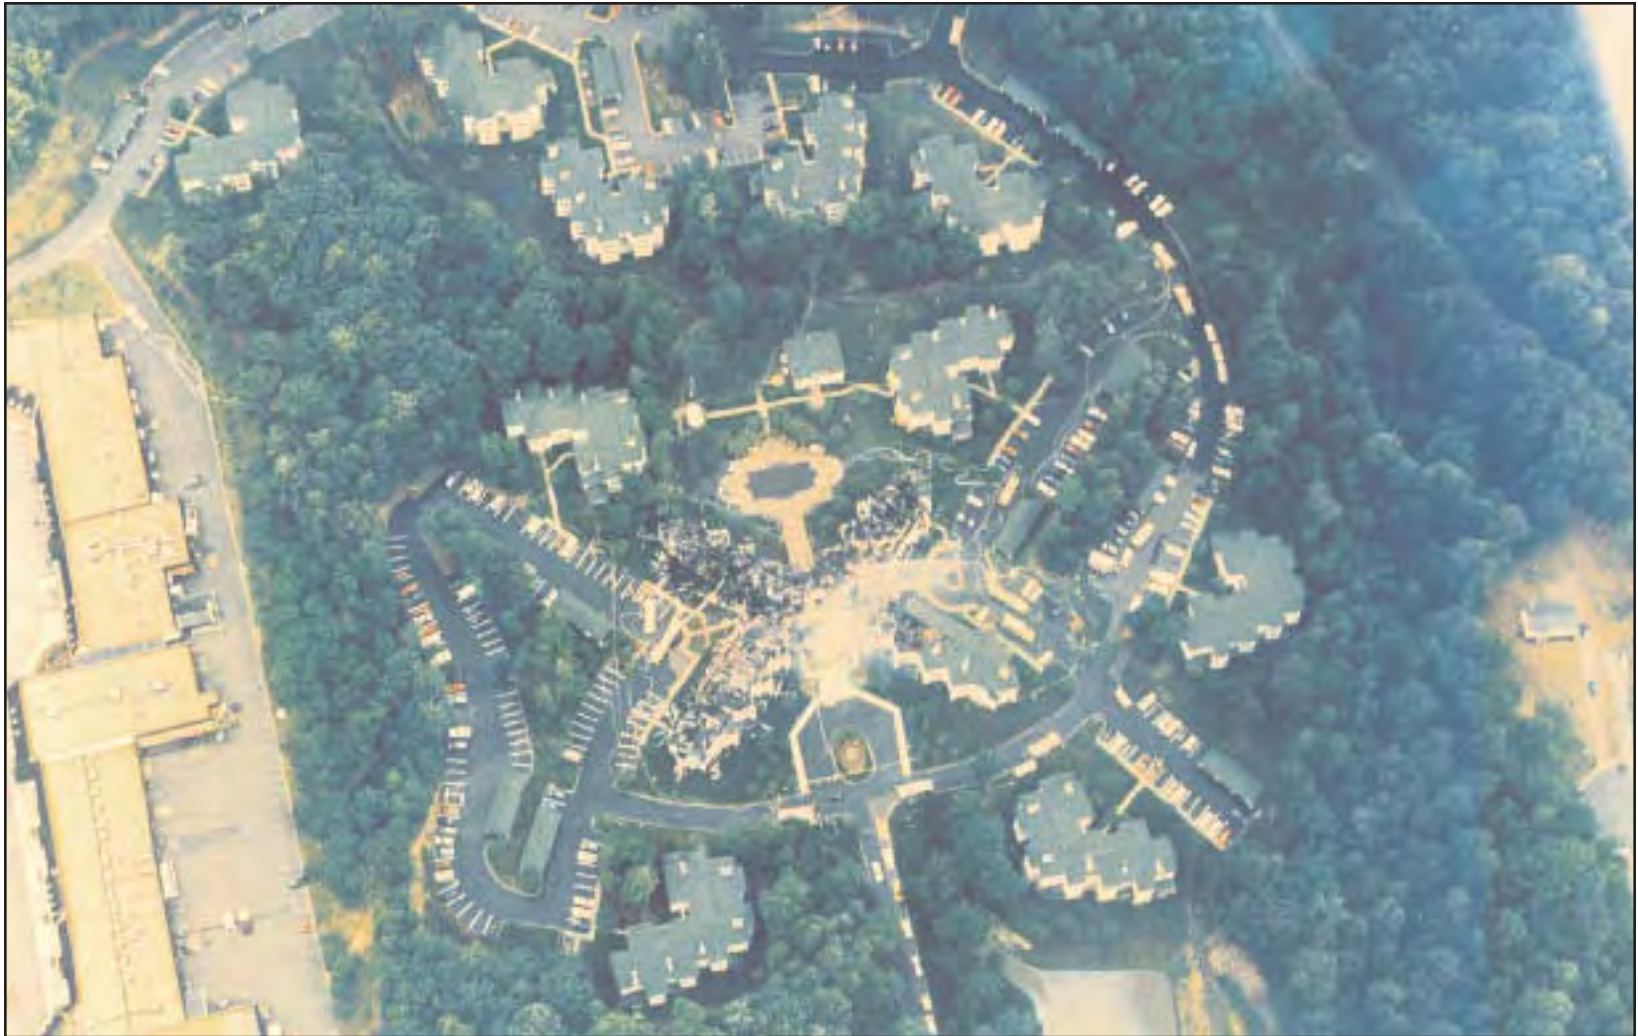
1. Site view of fire with north to the left. The shopping center and woods for the hand-stretched hose is on the left with Engine 73 still in position.

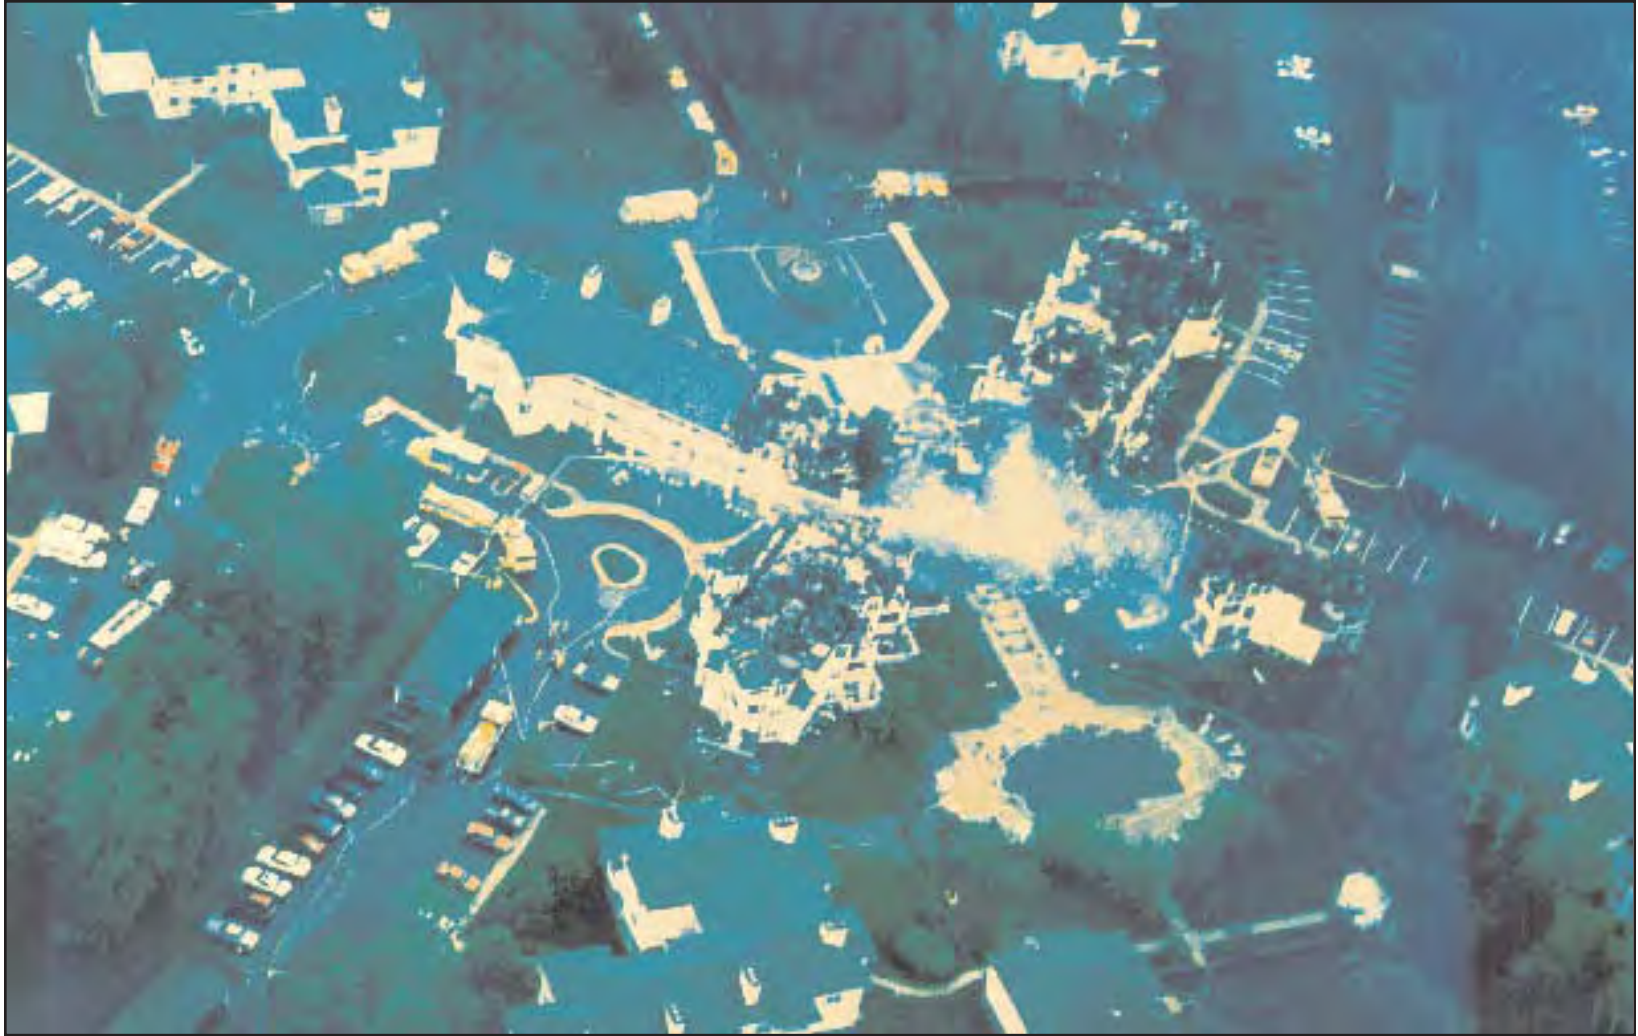
2. View of building with units still operating to complete extinguishment. North is to the left.

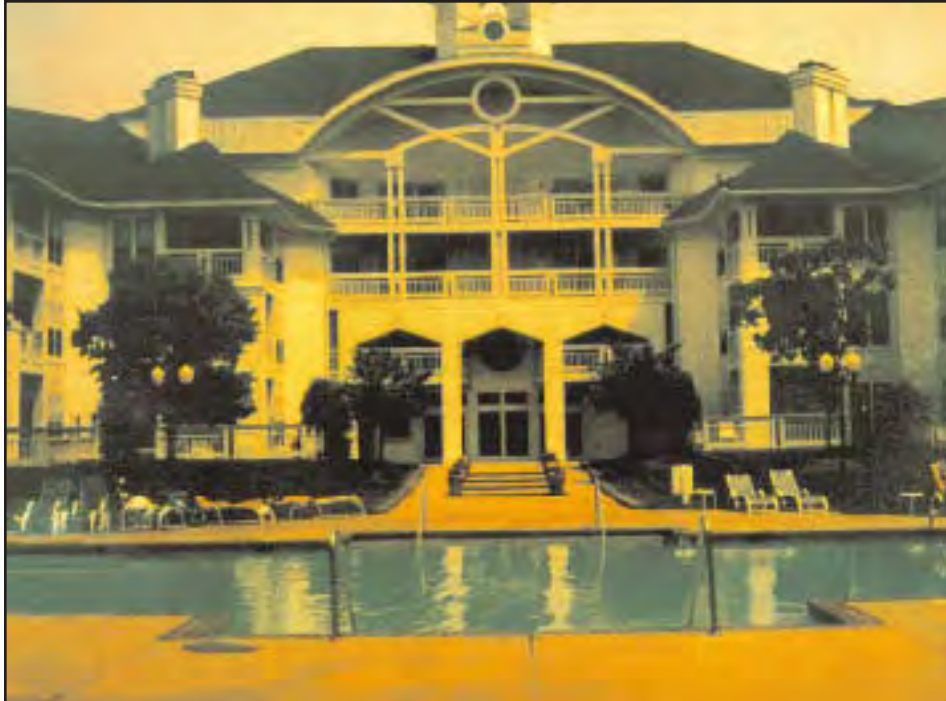
4. The rear or swimming pool side of the four story core building before the fire. The fire started on a second floor breezeway on the left side of this photograph.

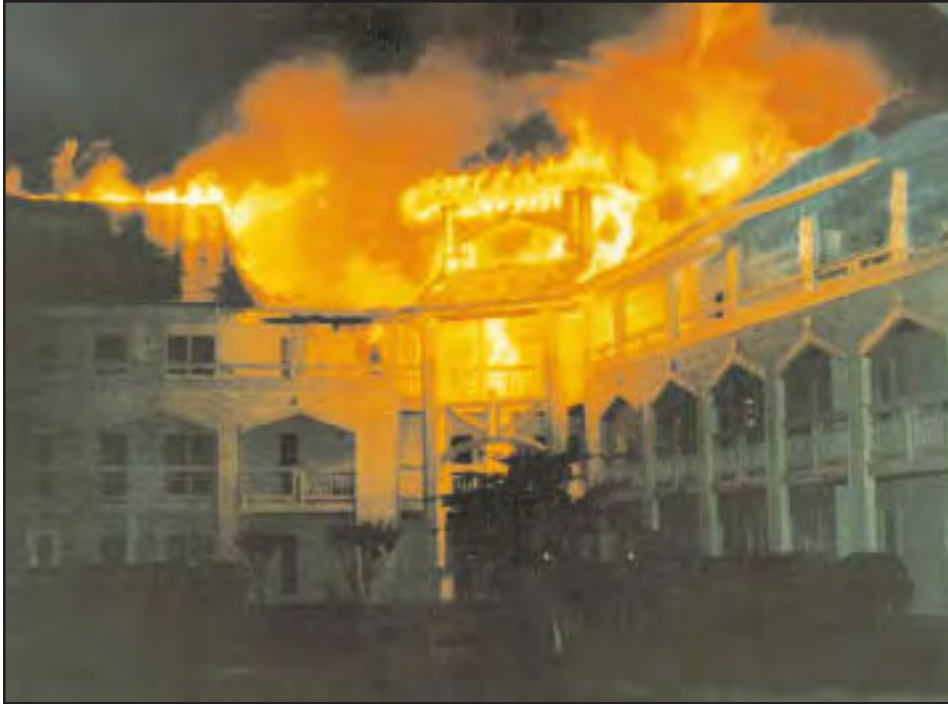
5. Fire involvement in Sector D (North side) as units were preparing to operate in this sector. The fire was well-established in the attic, third floor walkway, and fourth floor.

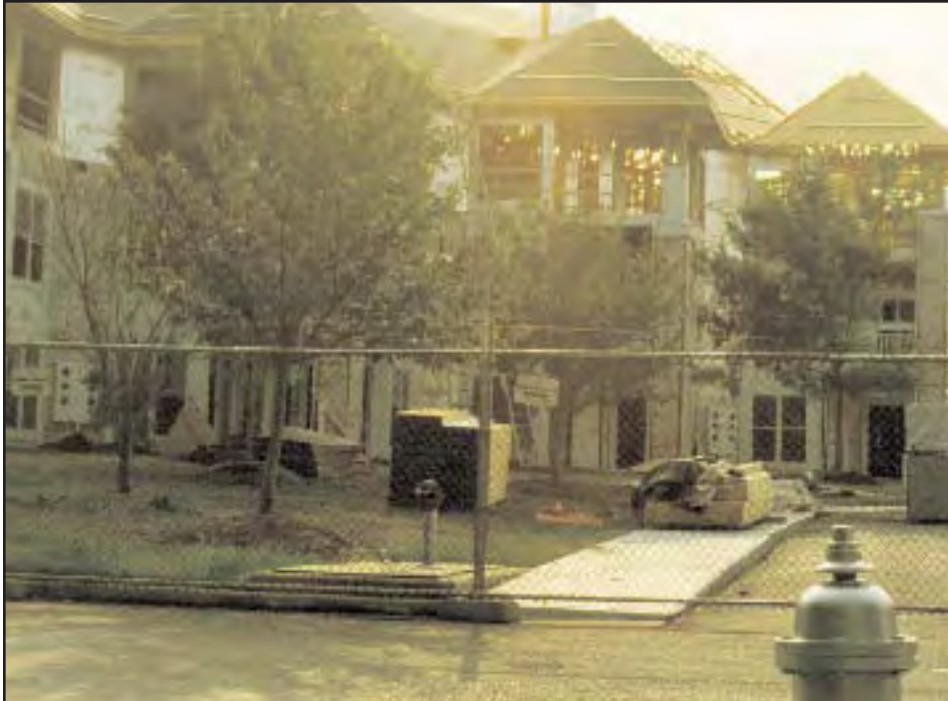
6. Fire hydrant and core siamese connection used by Engine 54 on arrival. Repairs and reconstruction are being made to the front wing; this side is the patio/balcony for each apartment.

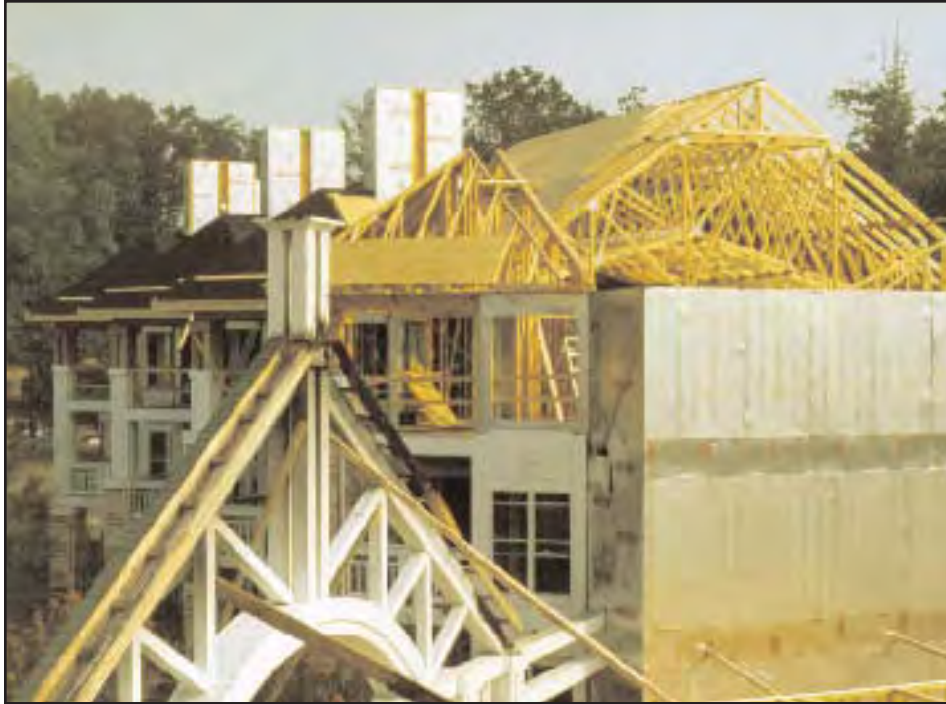
7. The remains of the front archway and the repairs and reconstruction underway for the wing in Photograph 6. The attic trusses and exterior sheathing materials are illustrated.

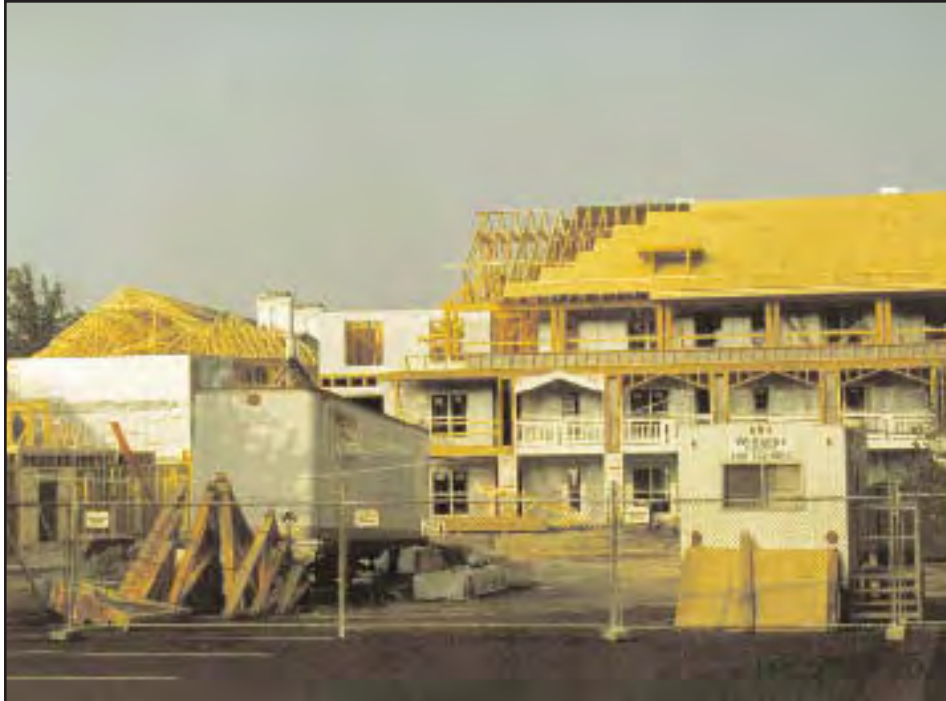
8. Reconstruction underway in Sector B, which is on the south side of the building. The exterior walkways were on this side of the wings.

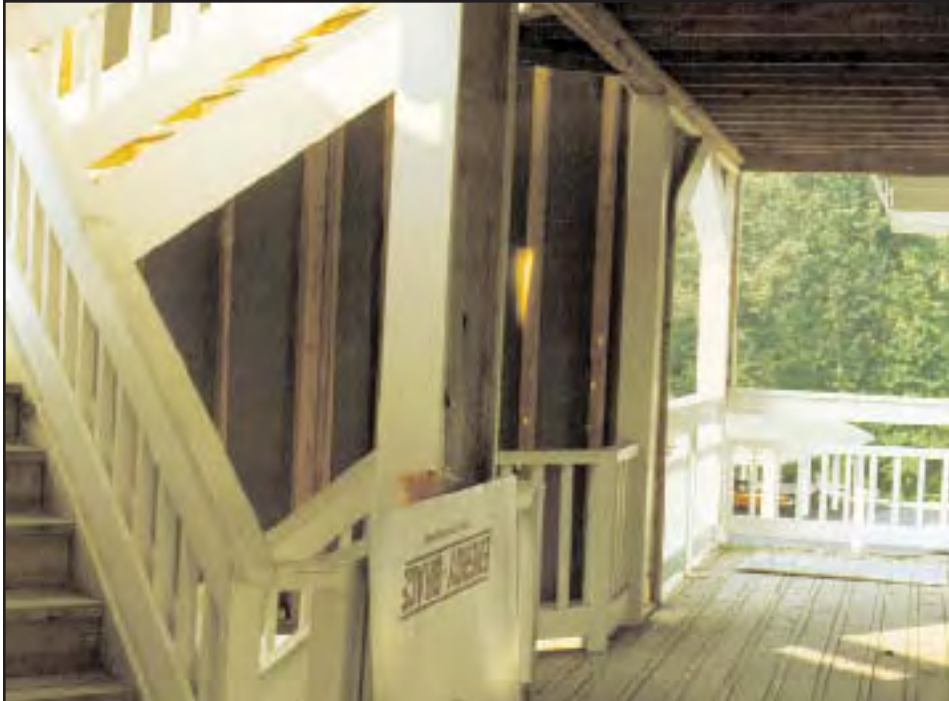
located at the core and the other at the ends of the wings (See Appendix C for diagram). The walkways were of wood construction and contained small gaps between the deck boards to permit water to drain through. With the exception of horizontal sidewall automatic sprinkler heads that were located near the two core stairways, the covered walkways were not protected by automatic sprinklers.

10. The stairway and exterior walkways used throughout the building. Note the gaps in the walkway to allow water to drain and the piece of thin exterior sheathing leaning against the stairway.

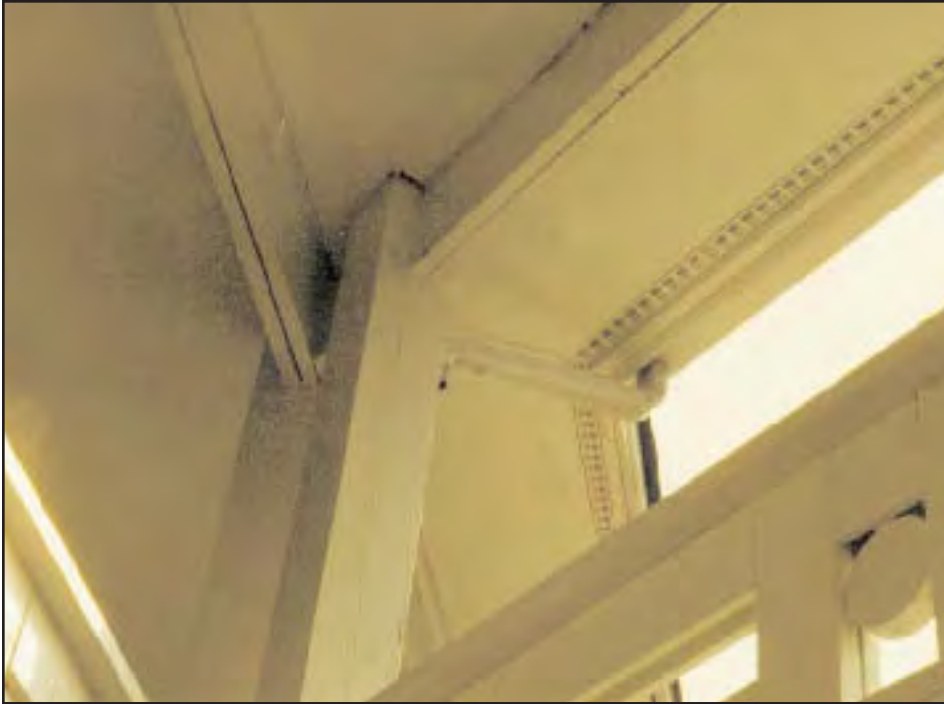
Ventilation Openings into Attic	Air vent openings at the building eaves permitted the fire to easily access the unprotected combustible attic space.
Fire Spread	The open combustible corridors and balconies and lightweight exterior wall finish supported rapid vertical and horizontal fire spread.

11. Typical eave line vents installed around the perimeter of the building. The fire is believed to have entered the attic through these vents.

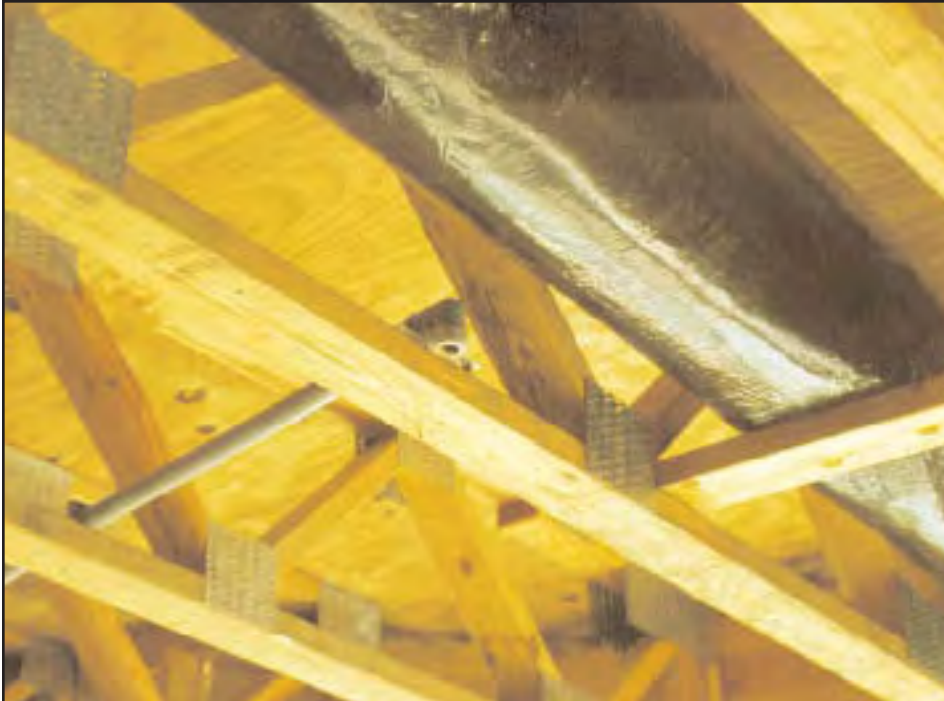
12. The parallel cord wood floor trusses used in the original construction and a polybutylene automatic sprinkler line.
