Sprinklered Records Storage Facility

Chicago, Illinois

**Sprinklered Records Storage Facility
Chicago, Illinois
October 29, 1996**

This is Report 106 of the Major Fires Investigation Project conducted by Varley-Campbell and Associates, Inc./TriData Corporation under contract EMW-94-4423 to the United States Fire Administration, Federal Emergency Management Agency.

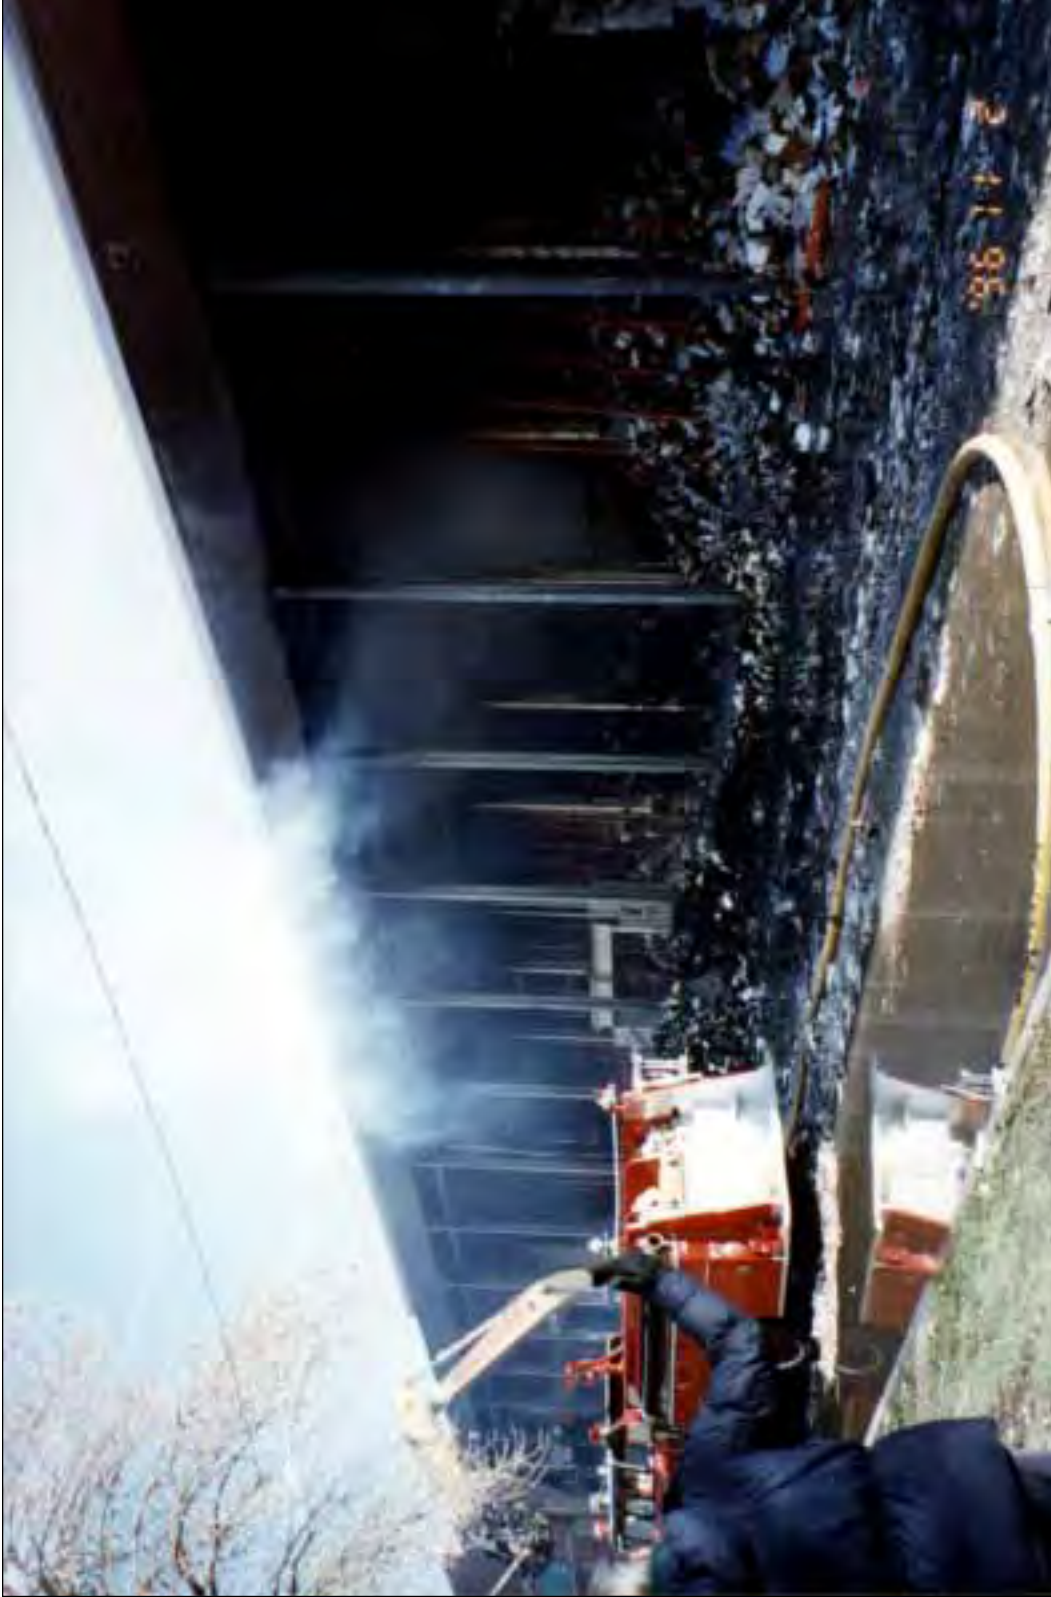
1. Knox Avenue and the front of Building III several days after the fire during overhaul. The west street curb line is at the bottom left corner.

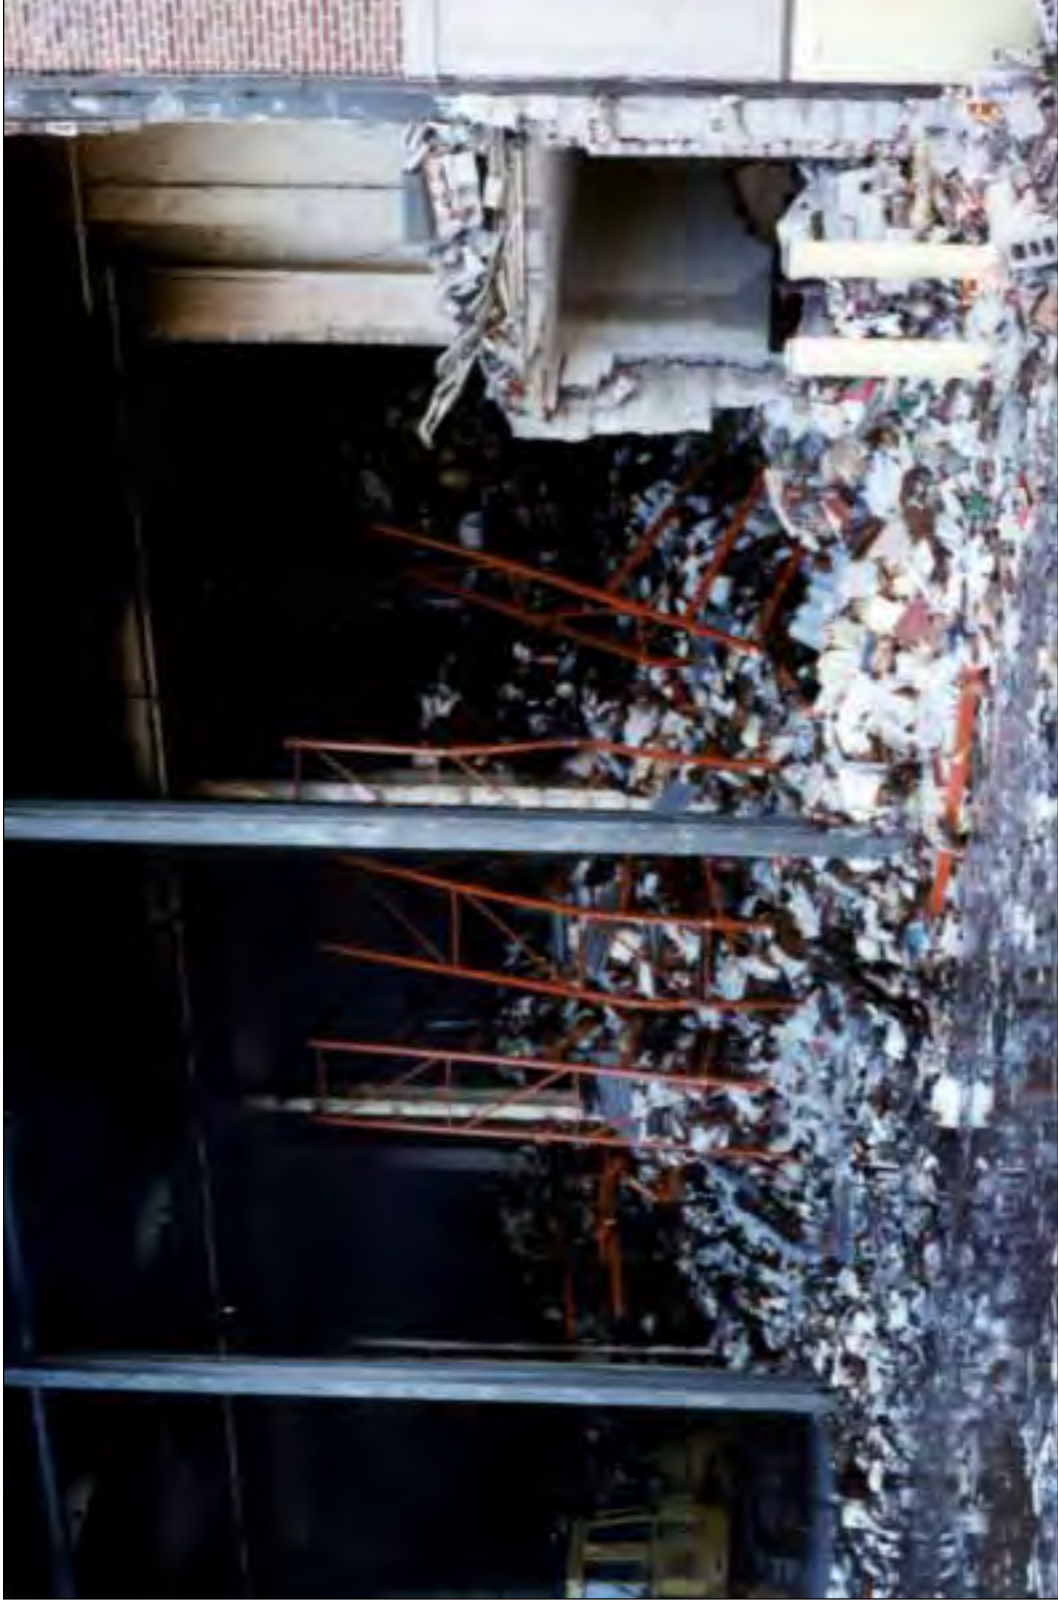
2. Typical of the rack collapse, record box failure, and documents filling the aisles. The brick-faced, hollow concrete block front wall was removed on the night of the fire.

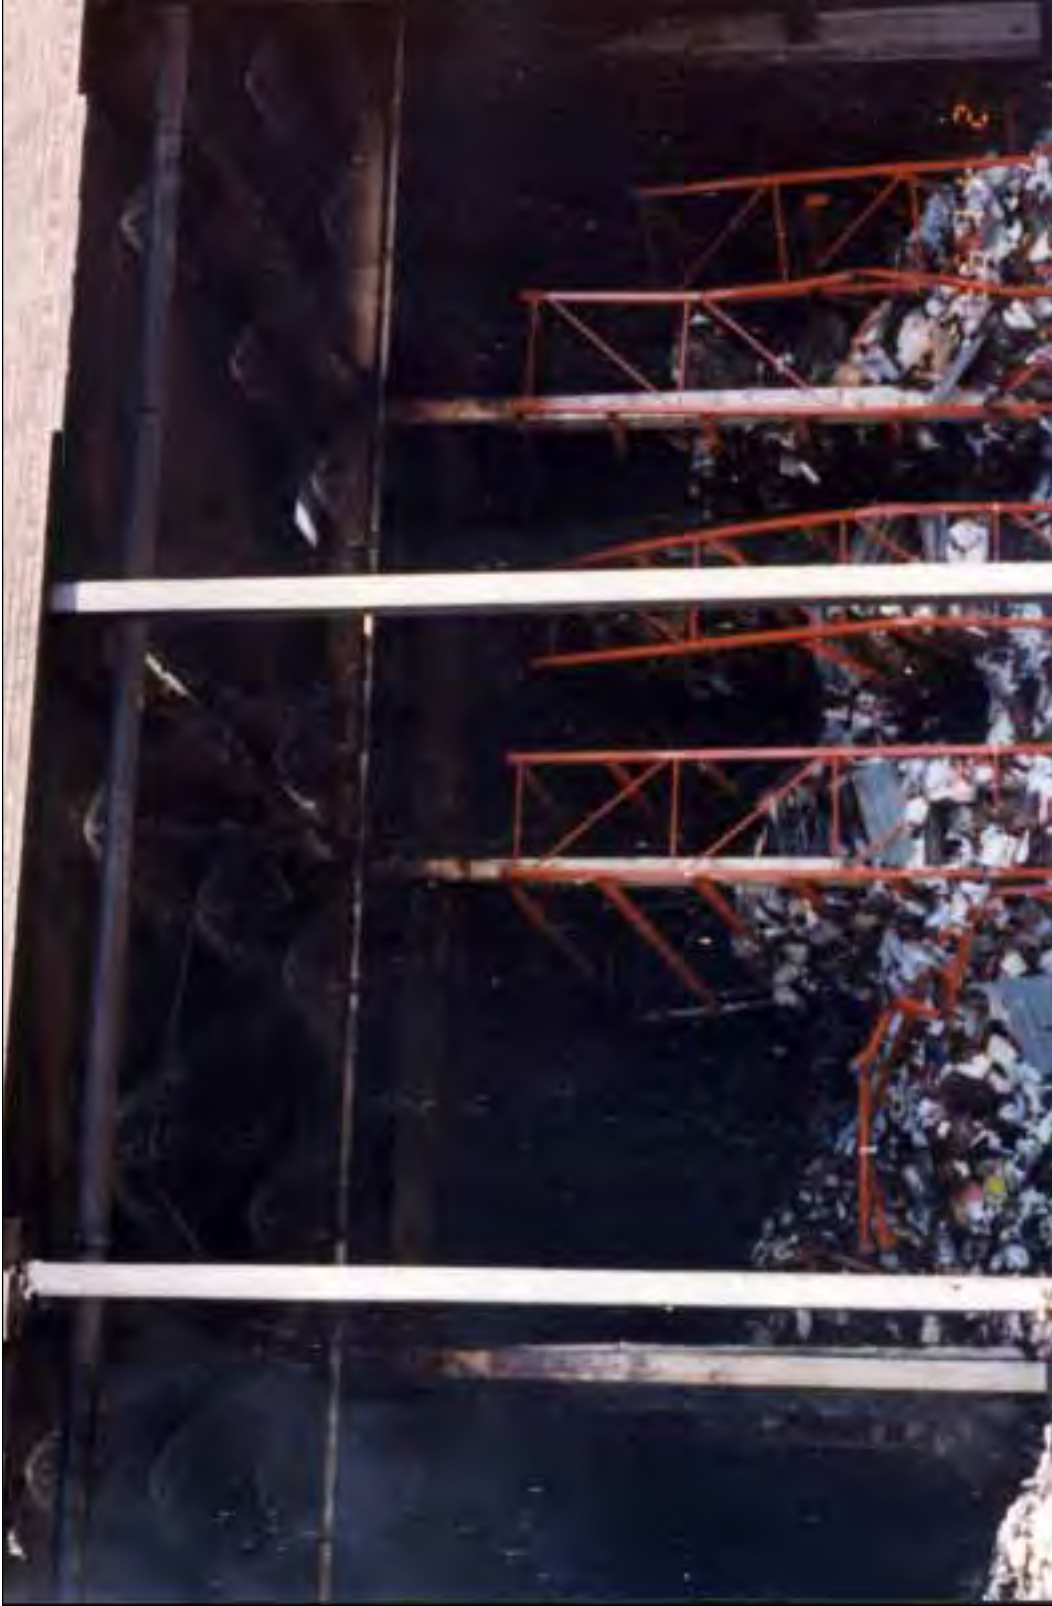
3. Racks and operating overhead automatic sprinklers near the northwest corner of Building III. Complete and partial collapse of the storage racks, shelves, and contents.

The automatic sprinklers installed at the ceiling were inadequate for the hazard and did not comply with NFPA Standards. Because of the solid shelves, it is likely that sprinklers should have been provided at each shelf level. The narrow aisles may have justified the use of automatic sprinklers along the rack face to slow the fire spread on the face and between racks.

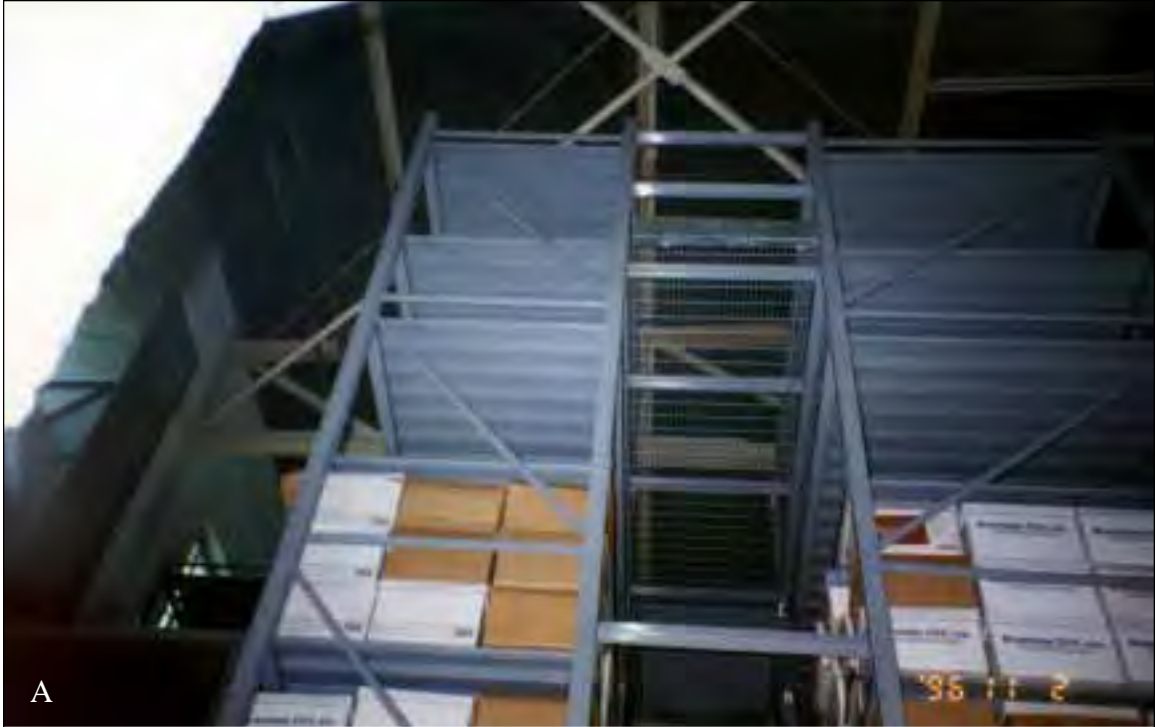
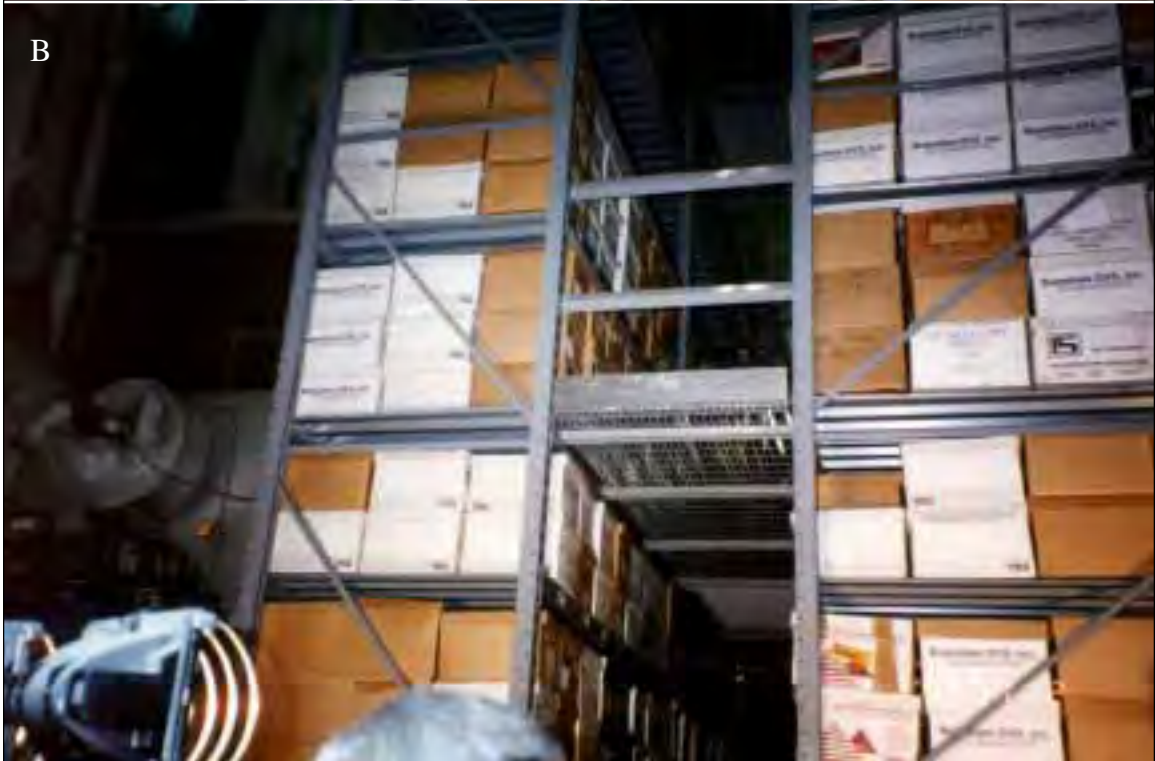
4. A and B. The shelving and records storage arrangement in the adjacent compartment to the east of the fire compartment. Taken from the floor, the two levels of elevated, grated walkways and the building's roof are depicted.

The use of tall racks with grated intermediate walkways is not recommended by NFPA No. 232A. Rather, full floors with fire resistance ratings are recommended to limit the extension of fire travel and to reduce the number of records subject to destruction or damage in a single fire. Where tall storage racks are used, cautions on fire detection, complete automatic sprinkler protection, and fire department preplanning are provided. Preplanning should include how to gain access to the racks, smoke and heat venting from the fire area, reaching the fire in the upper area, and fighting the fire at its source.

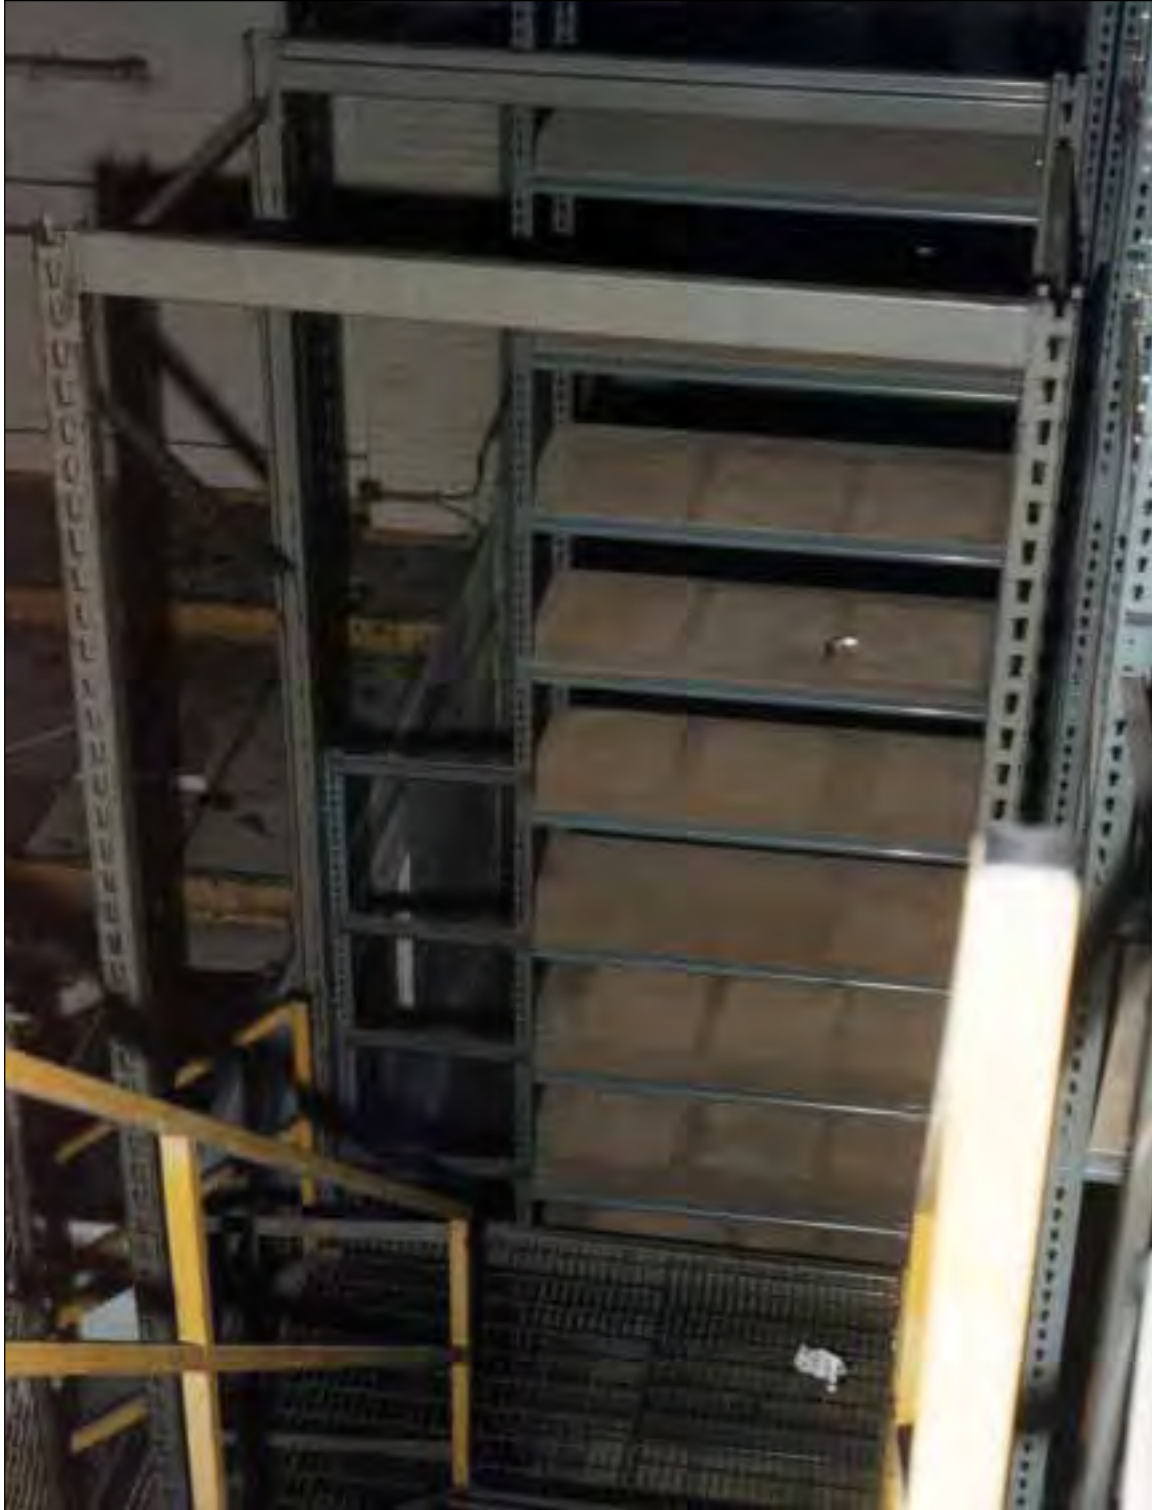
5. Looking down from the top walkway gives a different perspective to the storage arrangement in the adjacent compartment to the east. Note the solid shelves, unprotected steel racks, and typical access stairs.

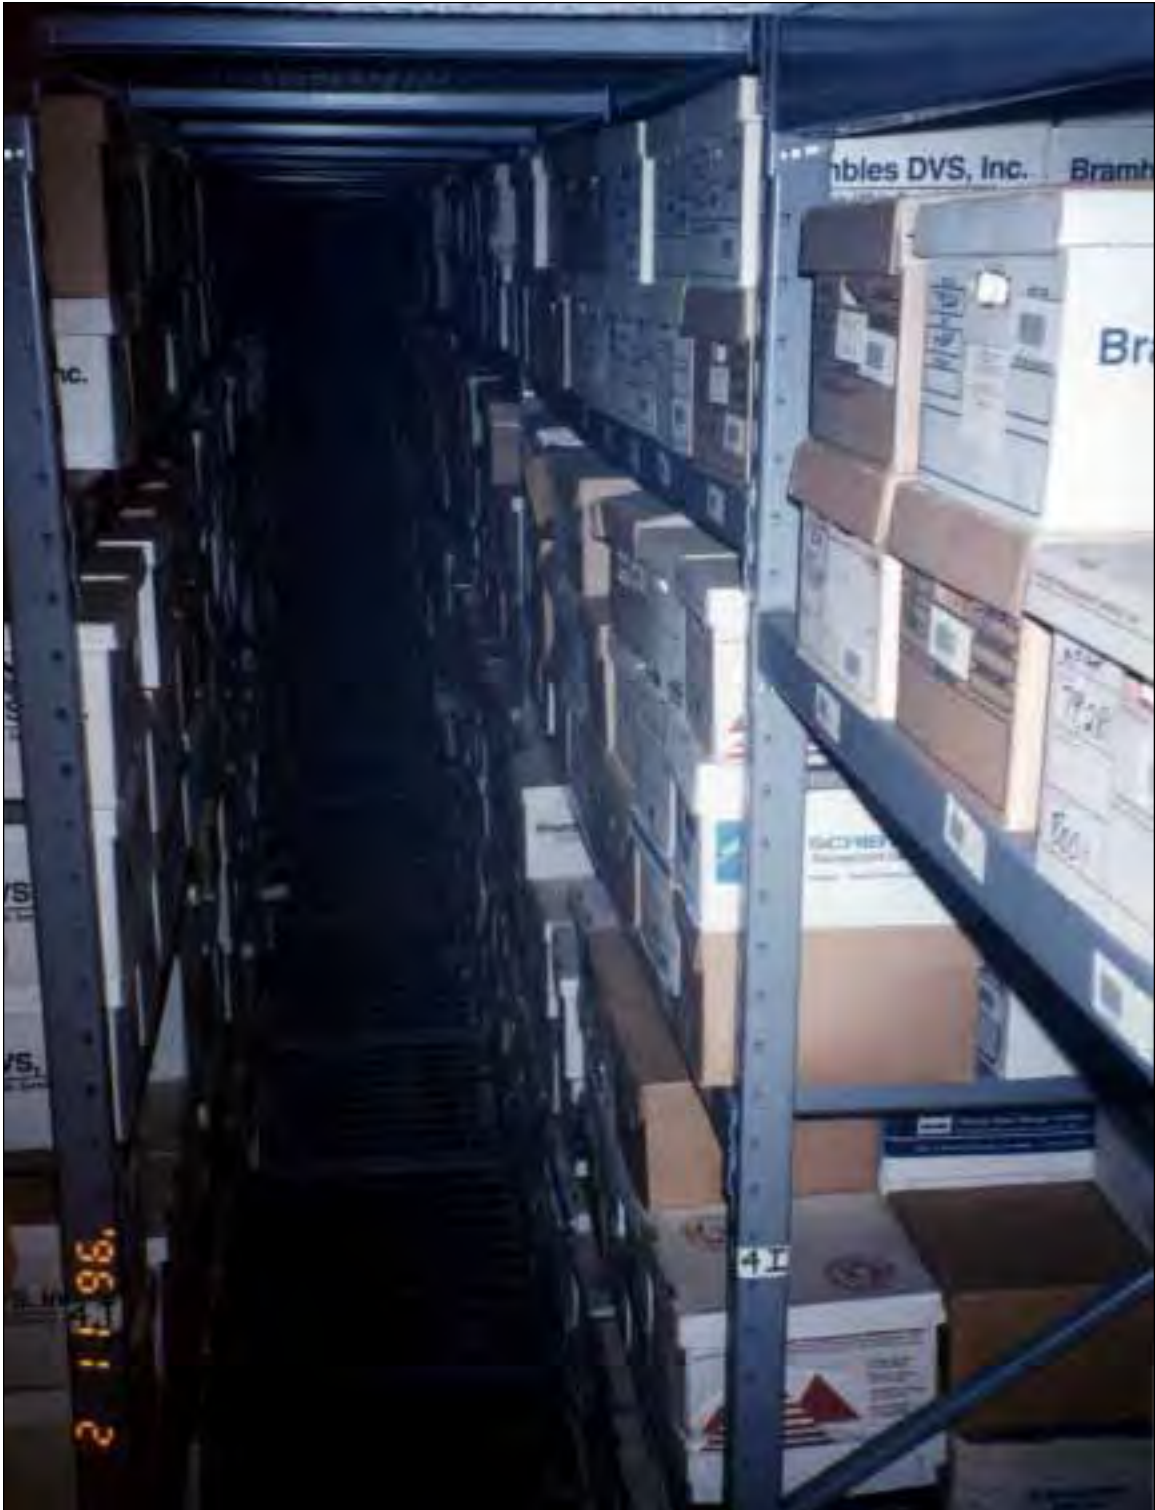
6. An intermediate level storage aisle with records boxes in place. The size and style of the storage boxes varied by section.

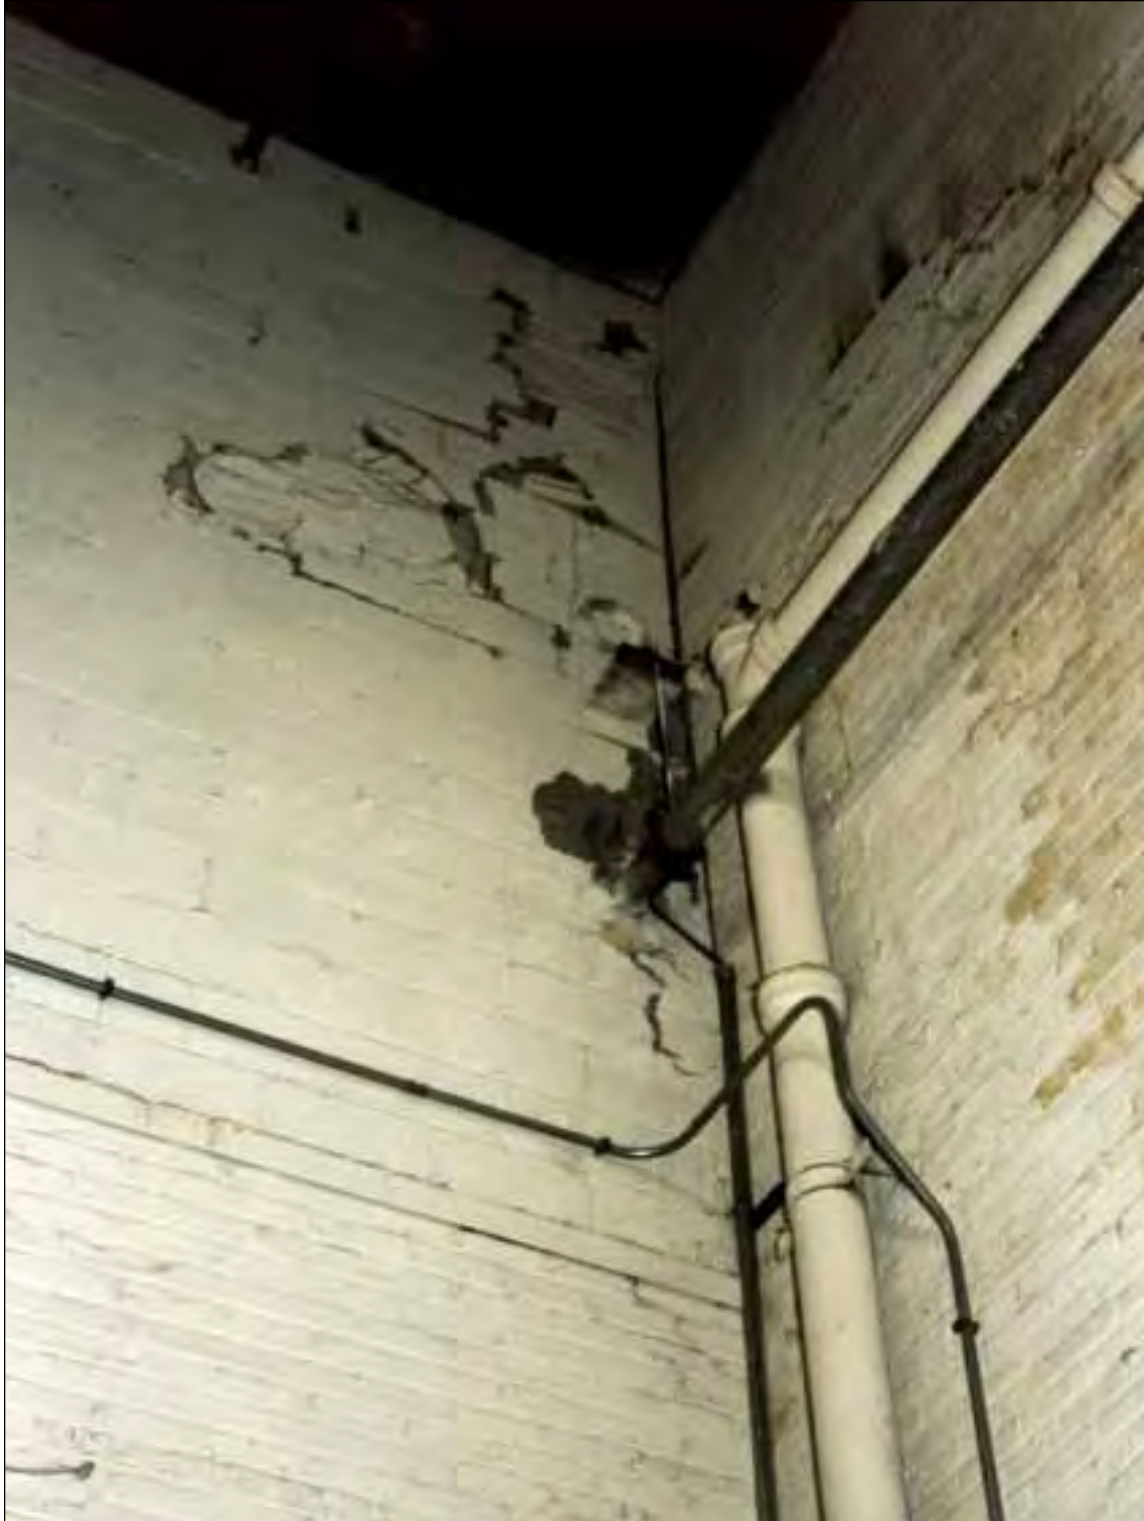
The adjacent building construction to the north was noncombustible with masonry walls and a gypsum roof deck on unprotected steel trusses, beams, and columns. The expansion of the fire area caused buckling in the steel trusses. In addition, the masonry separation wall was displaced and cracked in several locations. (See Photograph 7)

7. Masonary wall damage in Building II, north of the fire building, due to expansion of the fire wall between buildings. This corner is the southeast corner of Space 6.

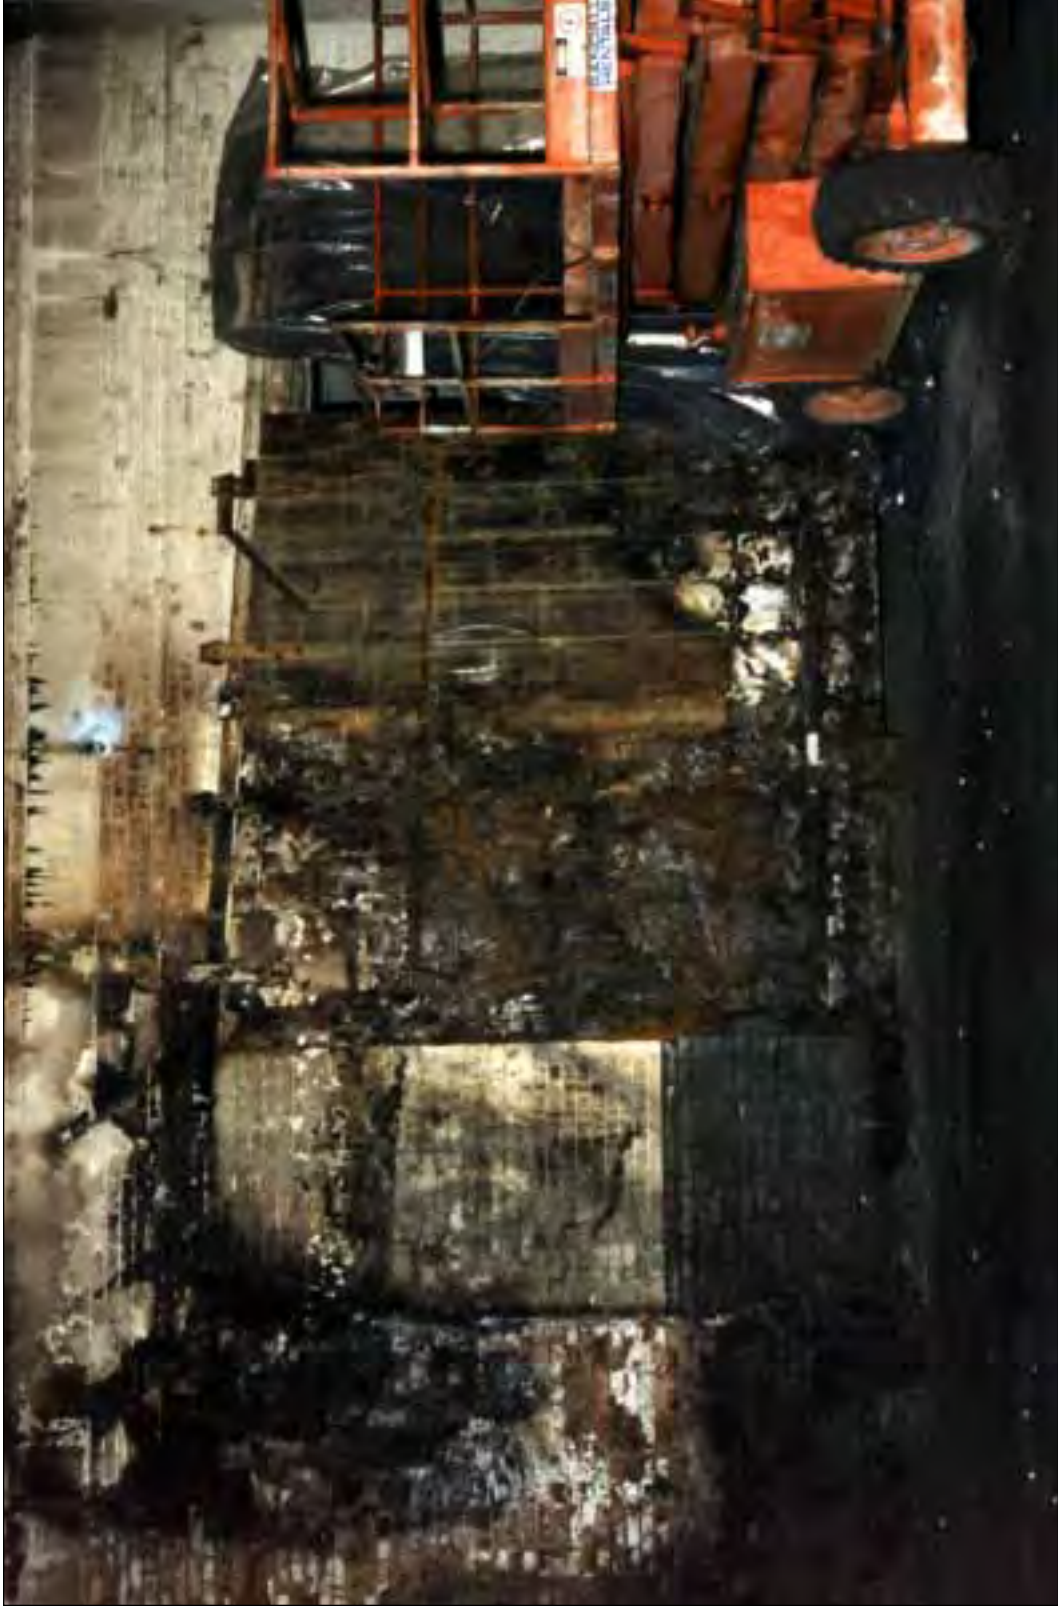
8. The fire side of the metal clad sliding fire door between Buildings III and IV. This door was supported by fire companies operating from the non-fire side of the door.

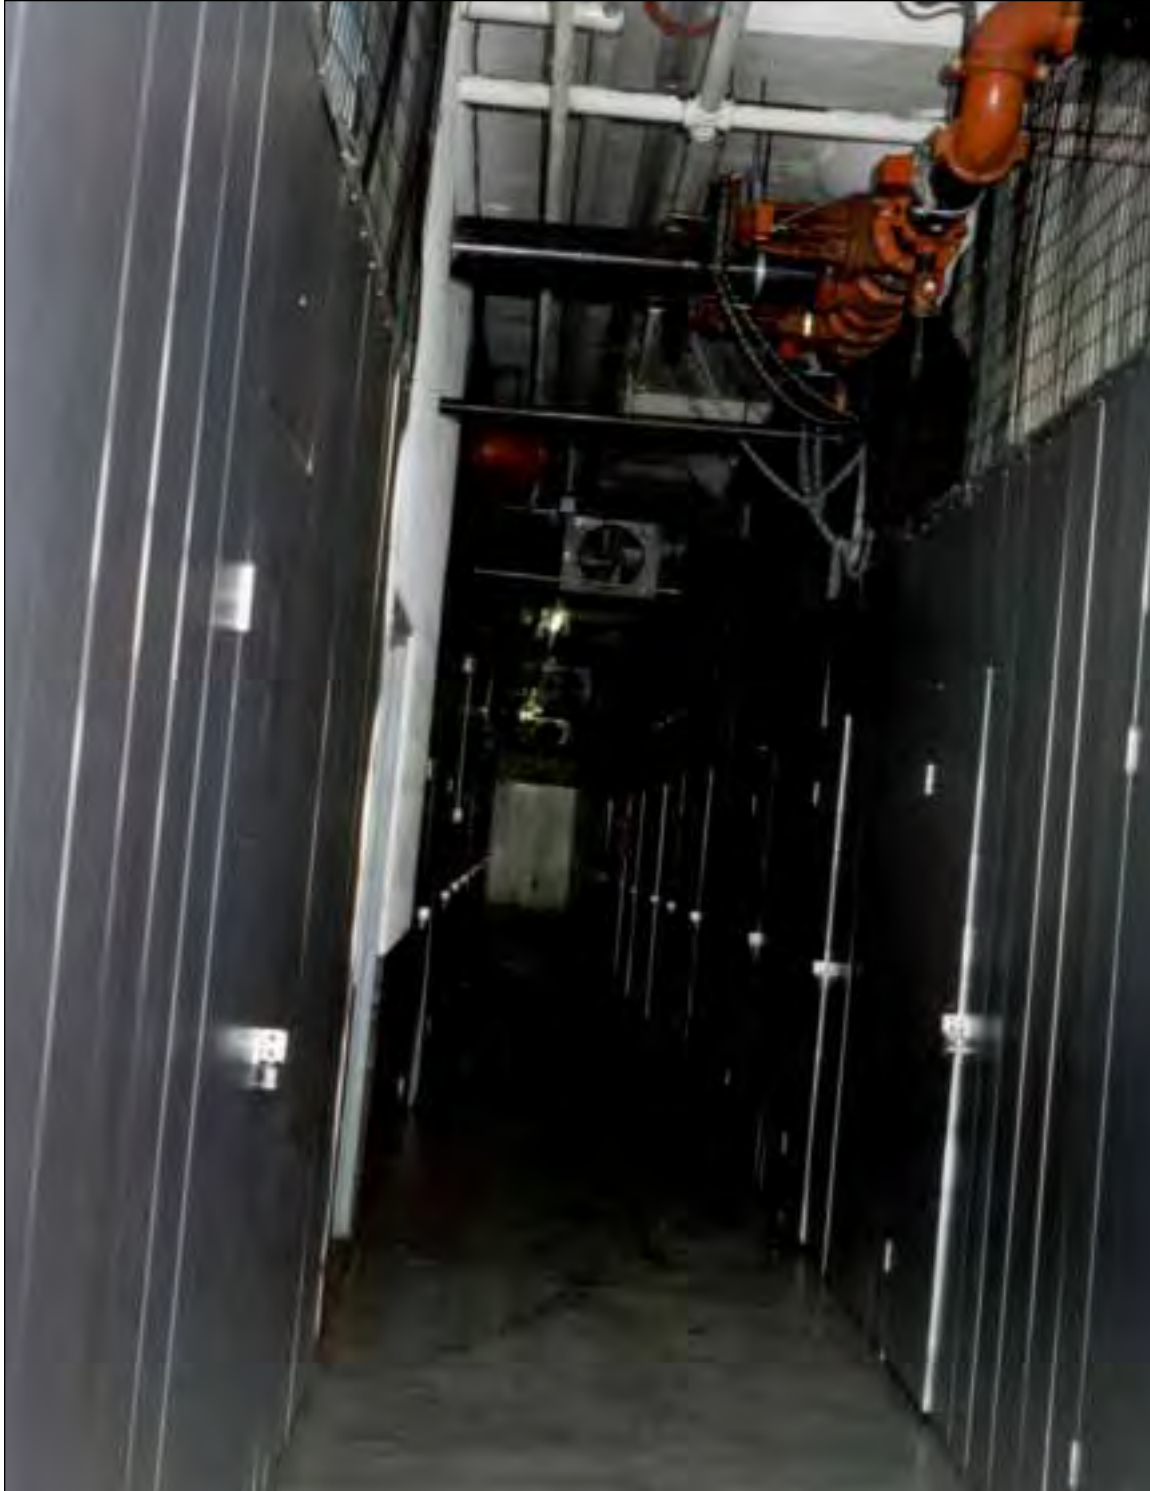
The storage "cubicles" on the second floor consisted of metal walls about eight feet high that were closed to the roof deck by heavy wire formed into about 3 inch by 3 inch squares. The access door to each unit was secured by a tenant provided lock. This arrangement provided security for each space yet did not necessarily interfere with the automatic sprinkler water distribution. Sprinkler heads were provided at the ceiling only and were spaced using an ordinary hazard schedule. There did not appear to be an attempt to locate an individual sprinkler head within each storage locker.

9. Typical public storage rooms or lockers located on the floor above the fire. Note the automatic sprinkler control valves and flow switch located at the ceiling level and the eight feet high solid walls topped by heavy wire mesh.

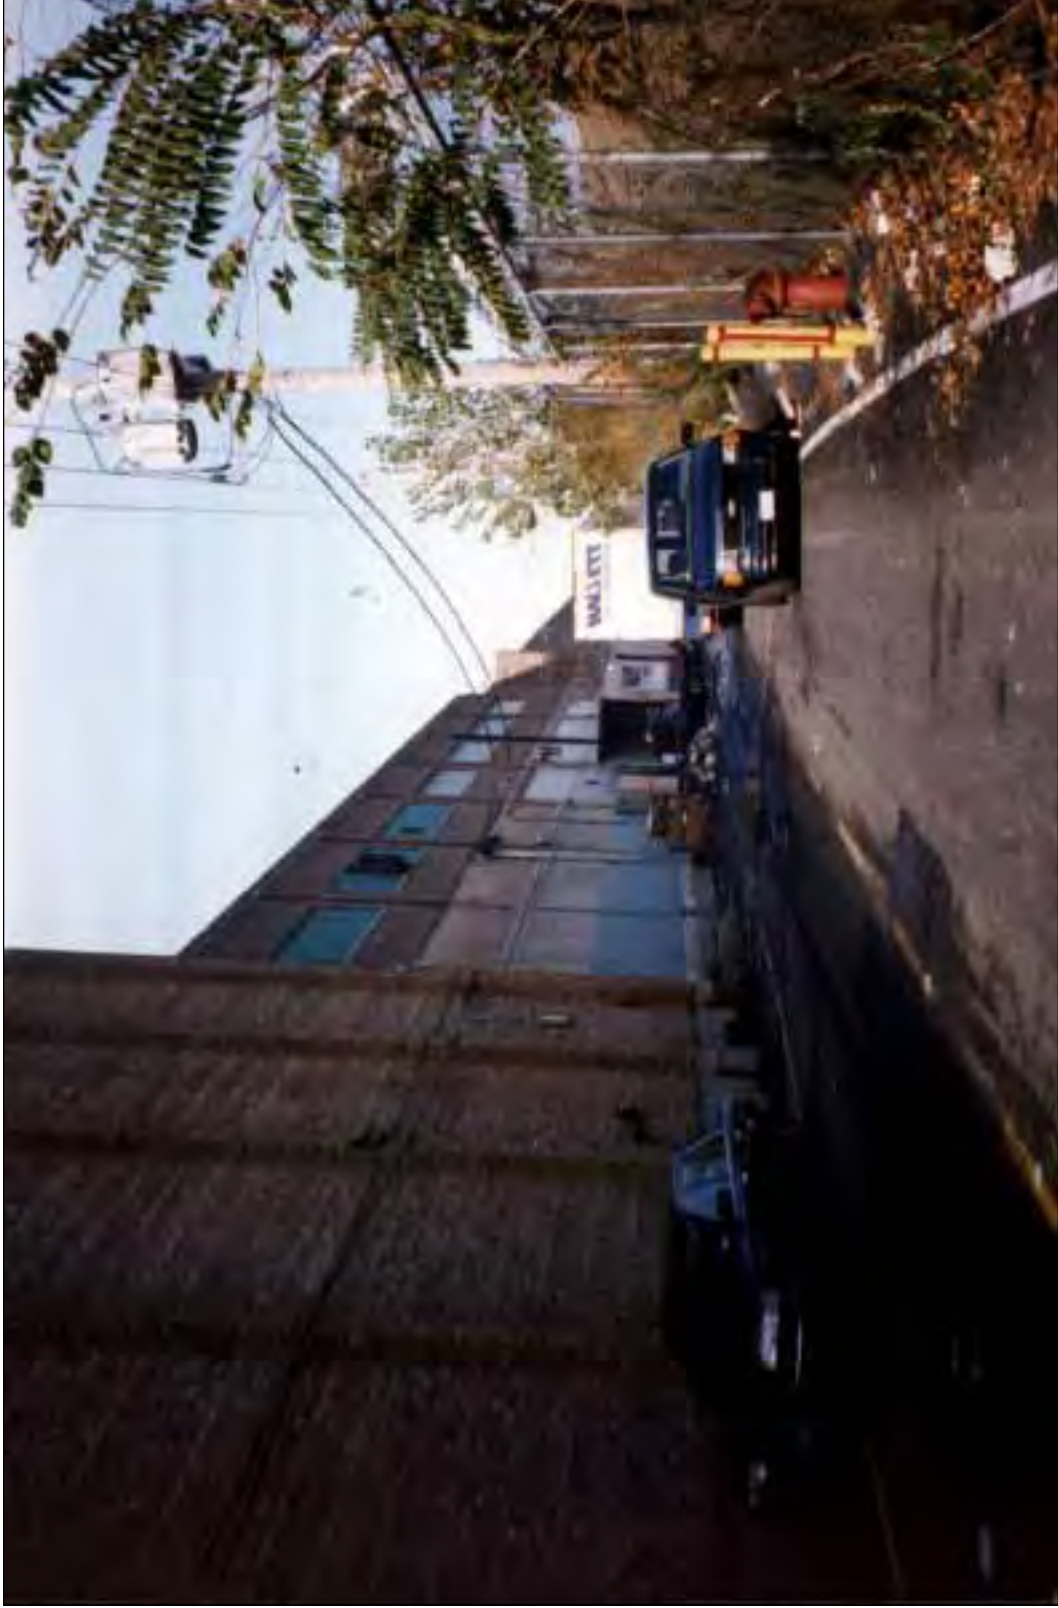
10. Hall Drive on the east side of the building looking to the north. The southeast corner of the fire building is just left of center.
