Manufacturing Mill Fire Methuen, Massachusetts

Manufacturing Mill Fire

Methuen, Massachusetts

December 11, 1995

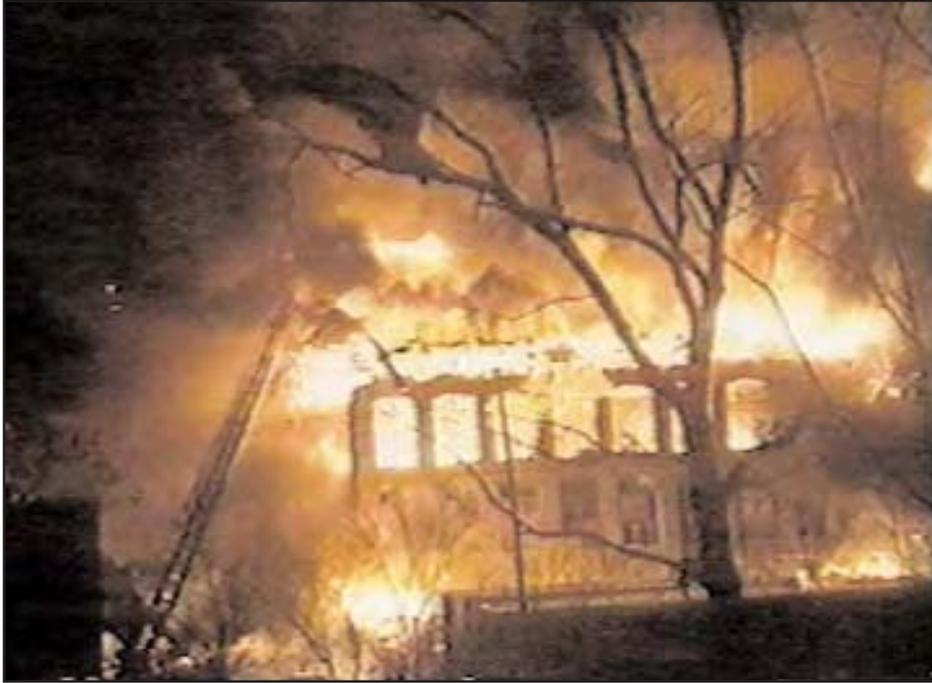
1. Ladder pipe operations near the northwest corner of the Monomac Building early in the fire. Vantage point was across the Spickett river.

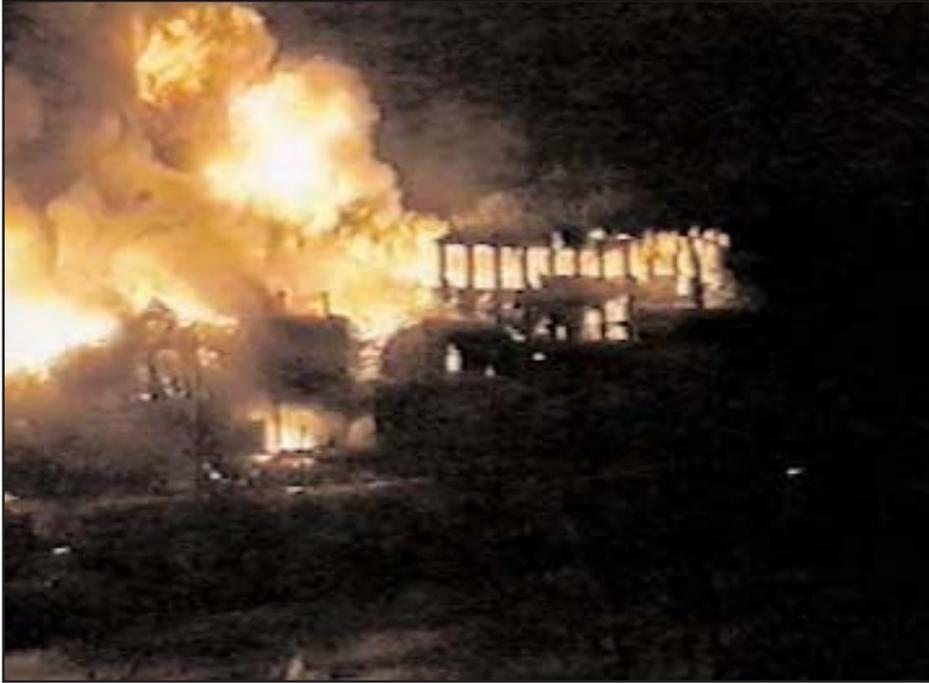
2. The fully involved west side of the Monomac Building; floors have collapsed as have some walls. Vantage point was across the Spickett River.

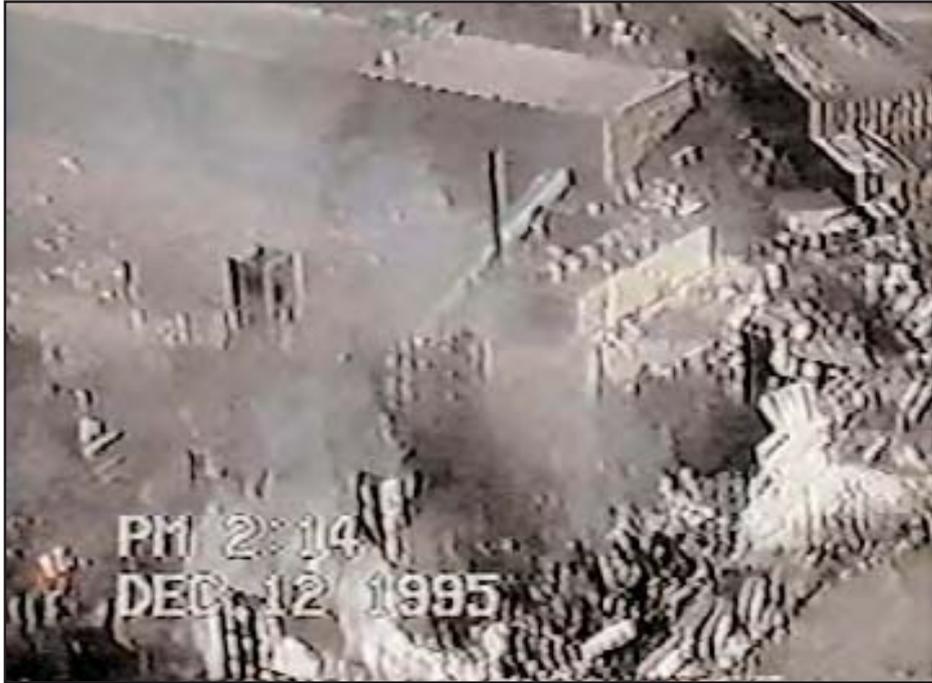
3. Ariel view of the fire scene early afternoon on December 12, 1995 looking southwest. The Mariner and Van Brodie Buildings are in the background.

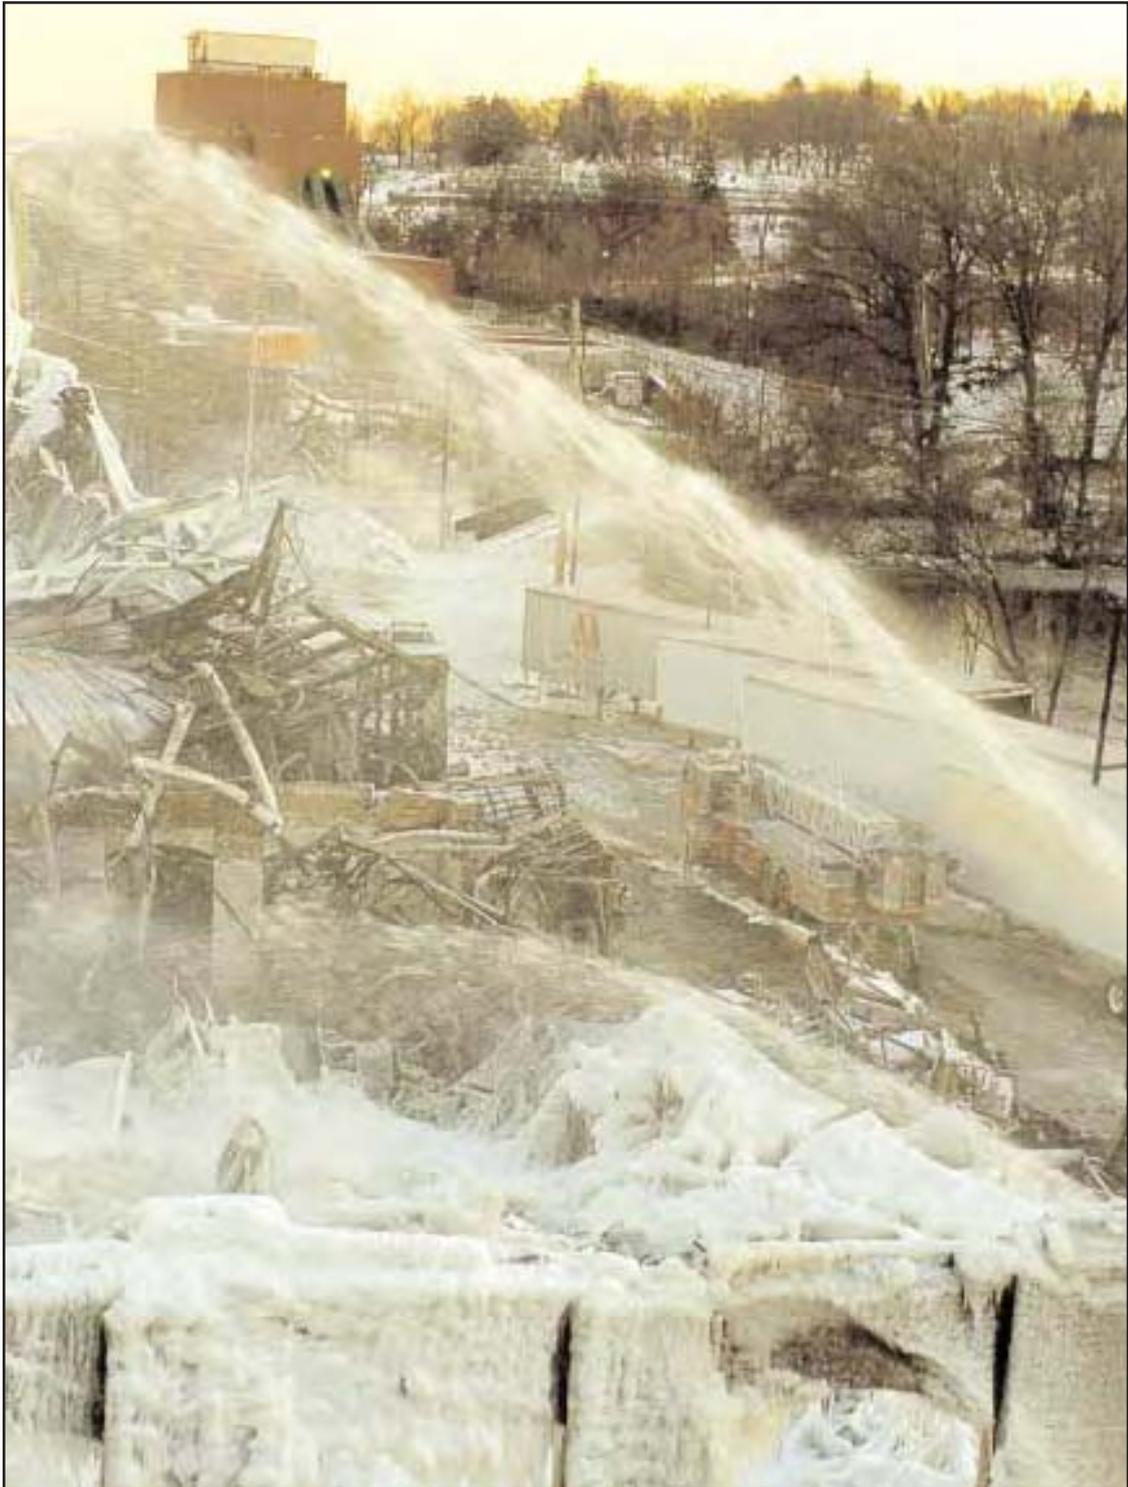
Mop-up operations on the west side of the site. The bridge over the Spickett River is in the background. Note the tight conditions and truck trailer parking.

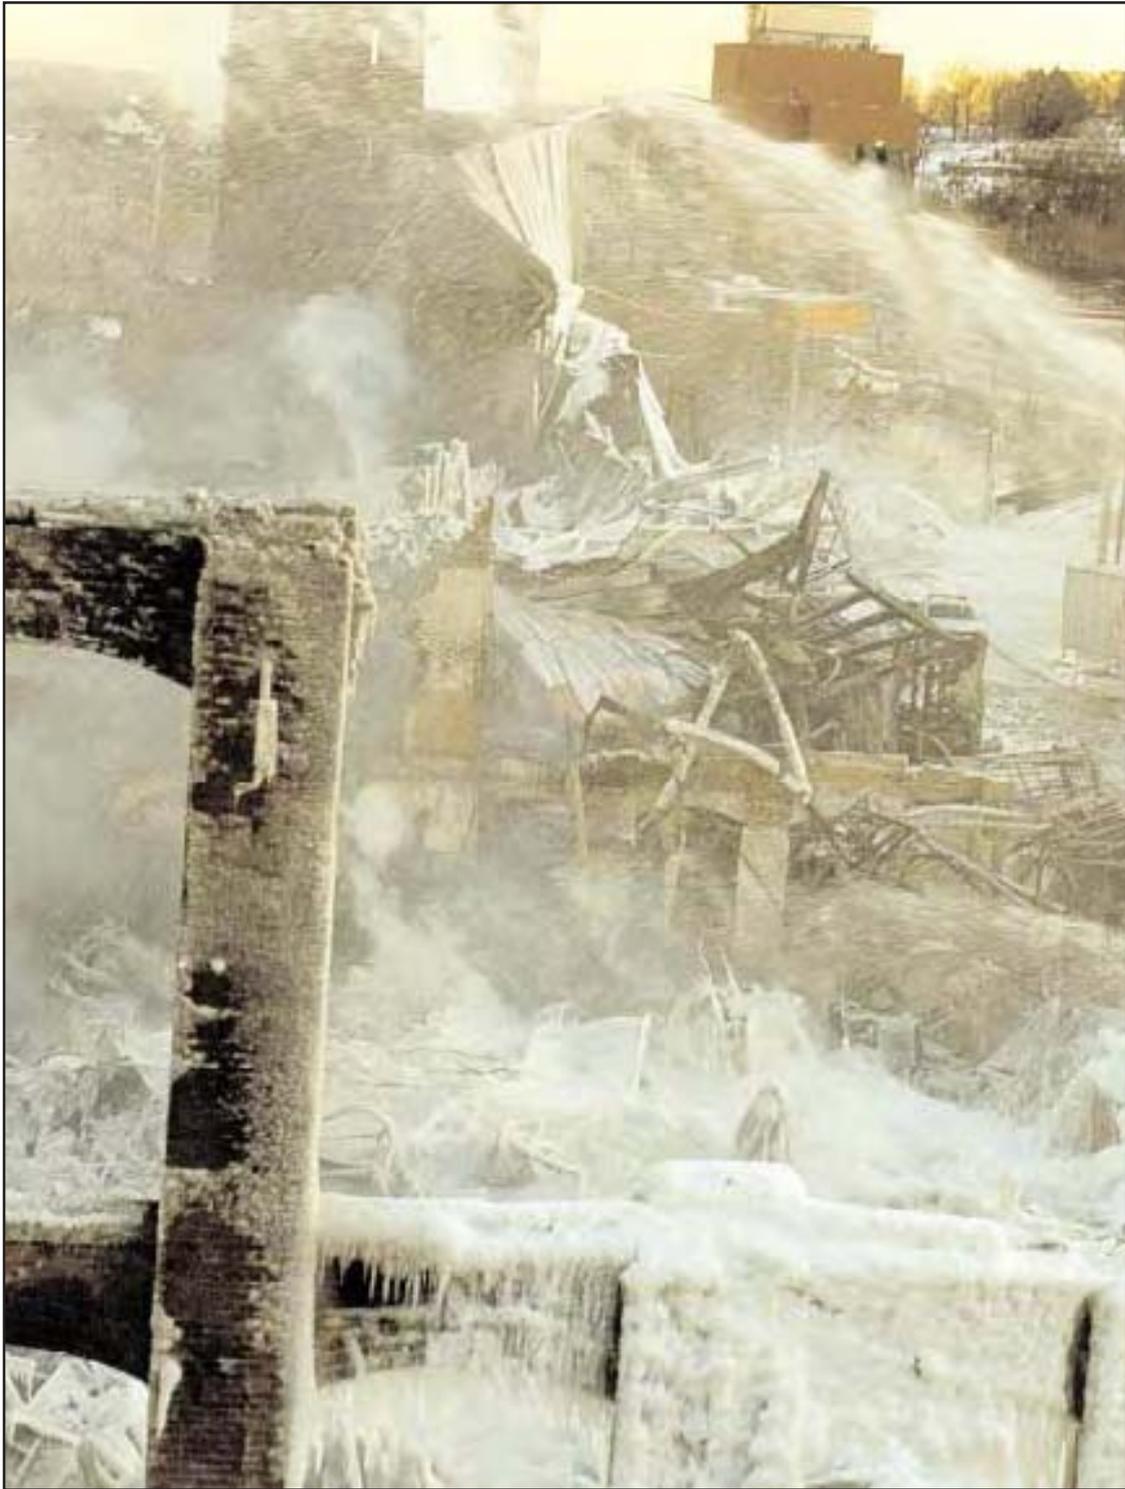
5. Remains of the Monomac Building looking to the south.

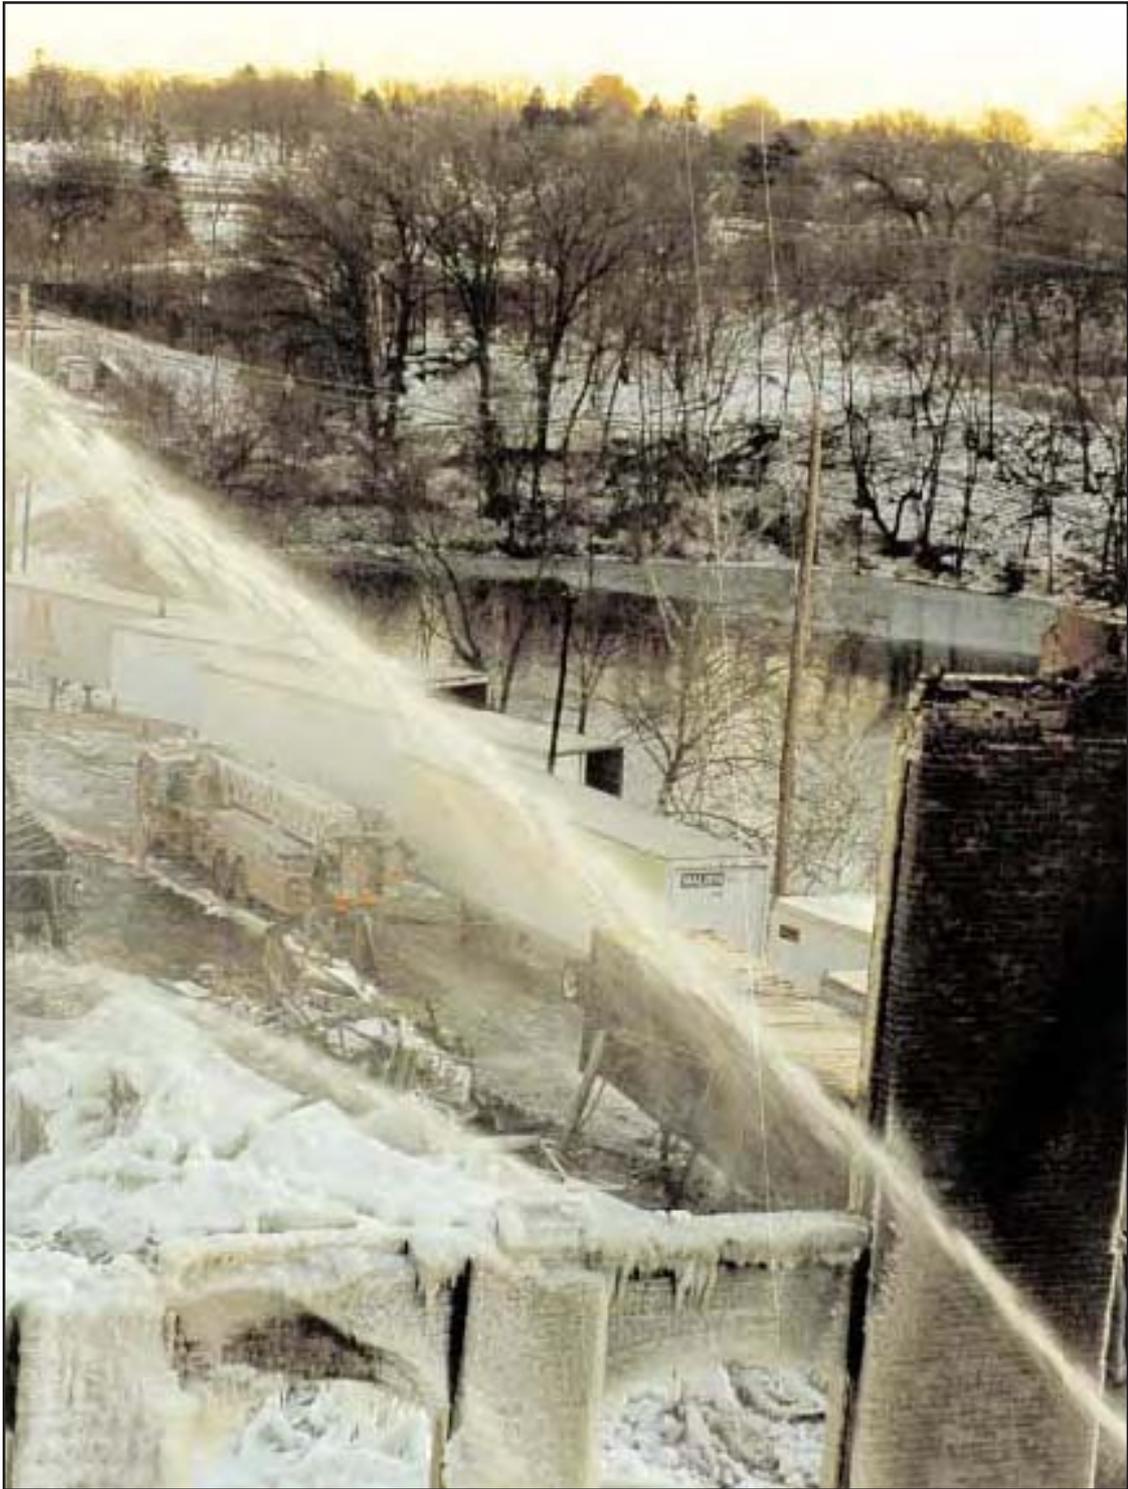
6. Conditions on the west side of the site with the truck trailers and the Spickett River.

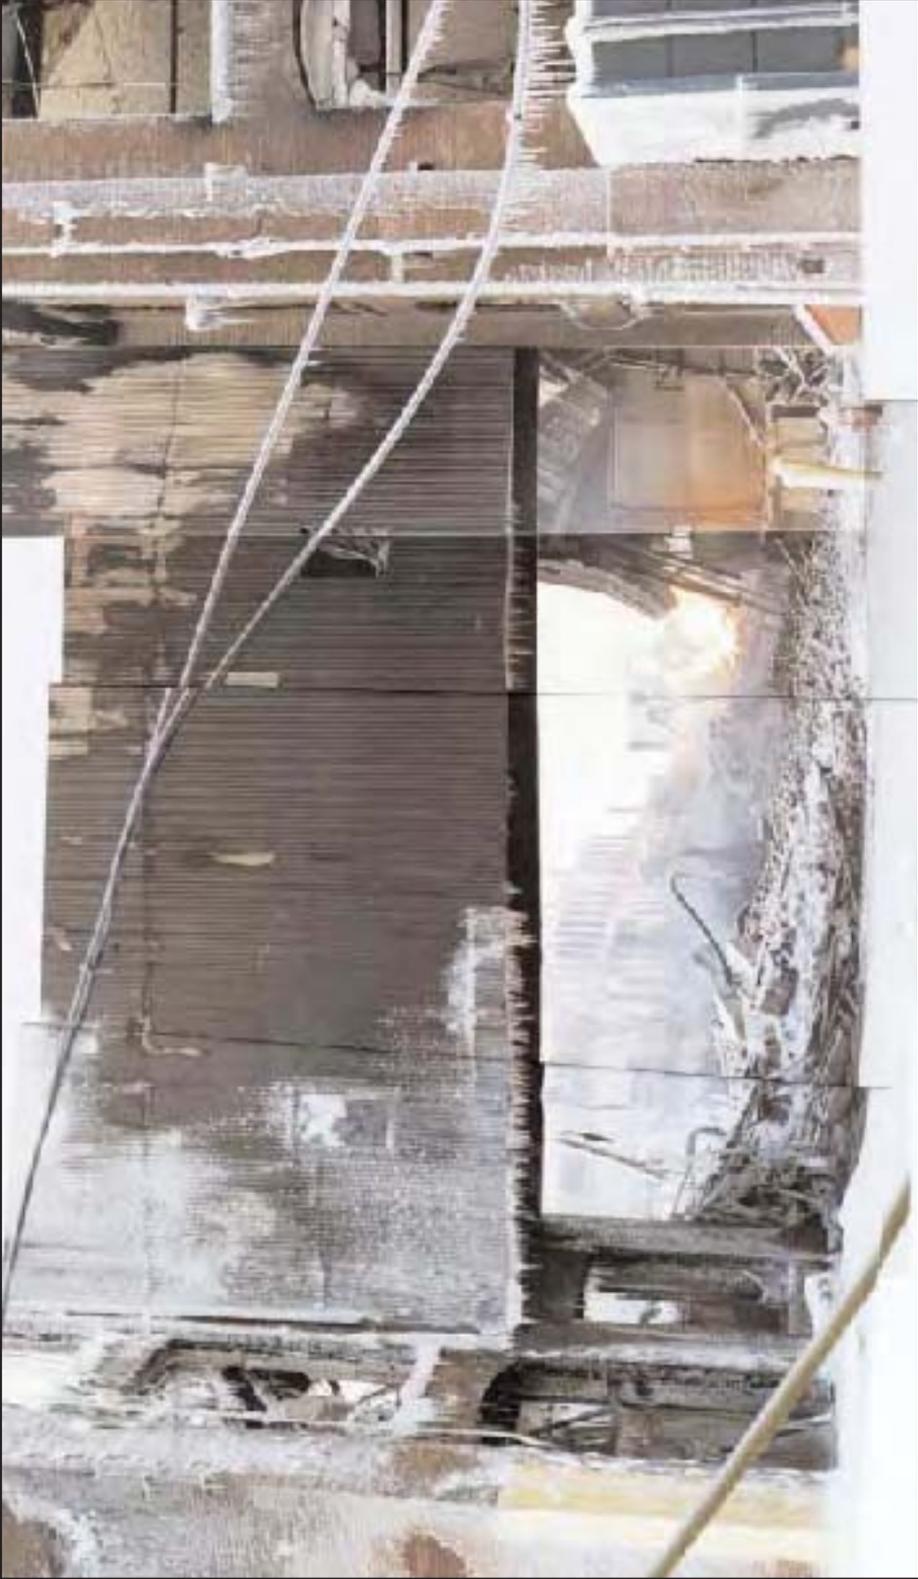
7. Composite of the overhead connecting bridge between the Monomac and Process buildings.

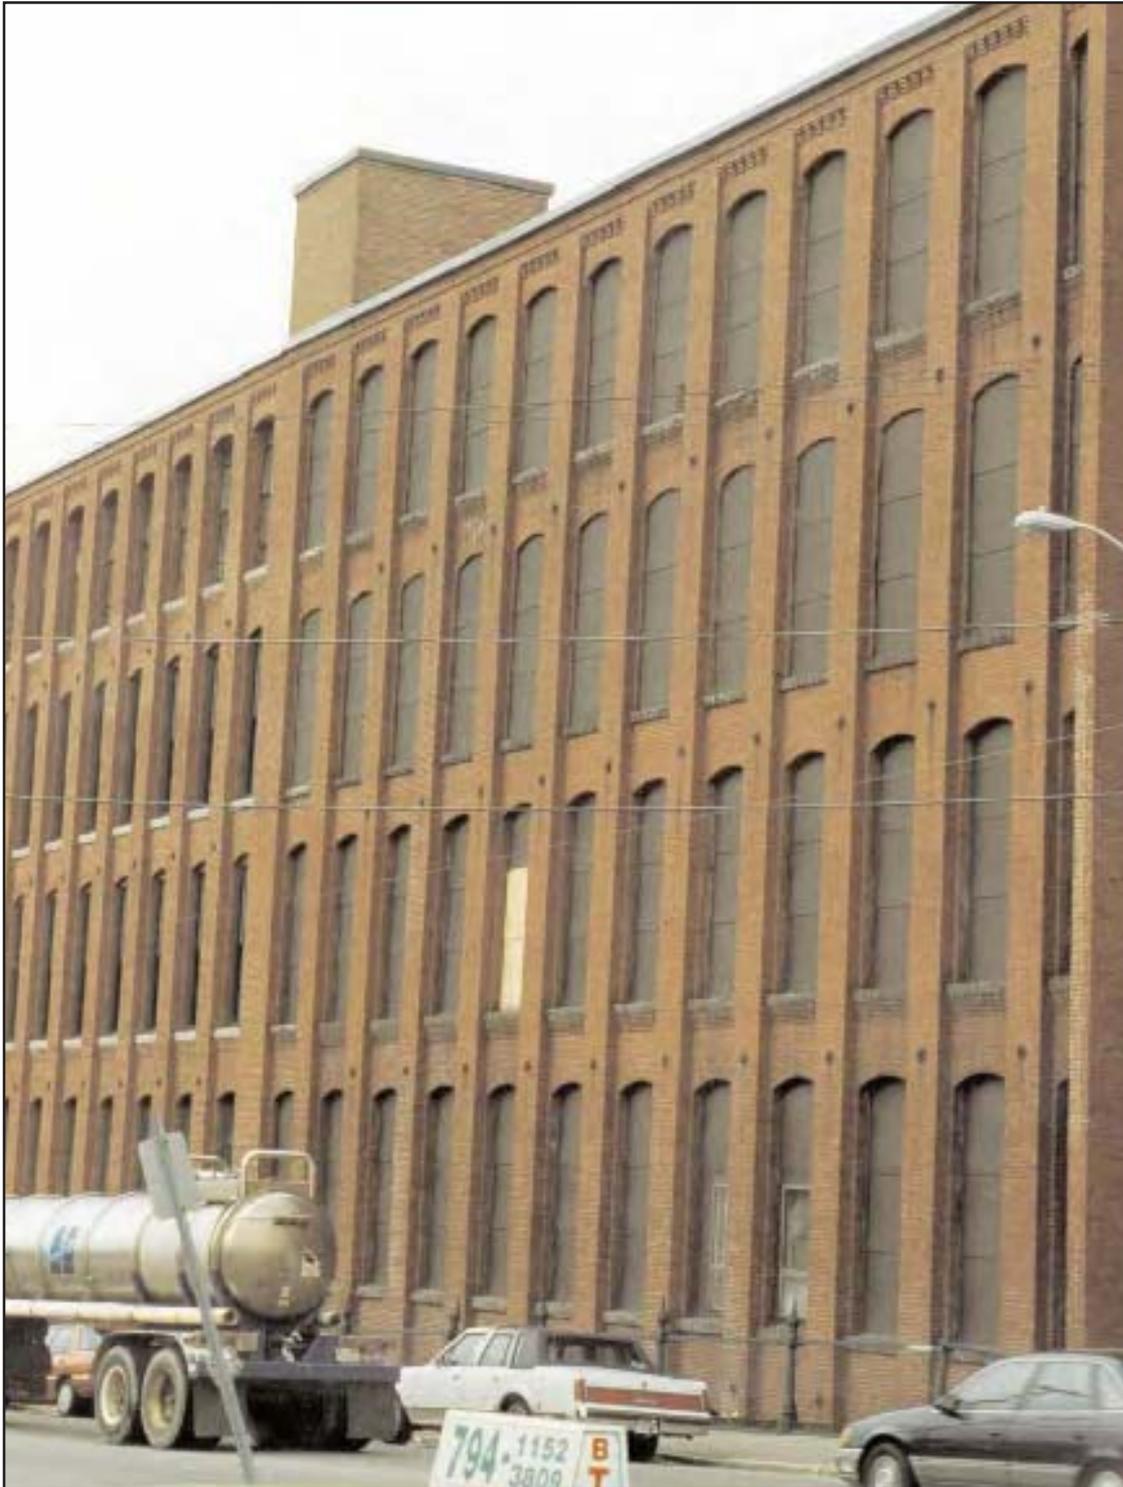
11. Windows once needed for natural light have been covered over, making visible fire location difficult. In addition, depending on the materials used, ventilation may be difficult.
