Kona Village Apartments Fire Bremerton, WA

November 13, 1997

This is Report 121 of the Major Fires Investigation Project conducted by Varley-Campbell and Associates, Inc./TriData Corporation under contract EME-97-CO-0506 to the United States Fire Administration, Federal Emergency Management Agency.

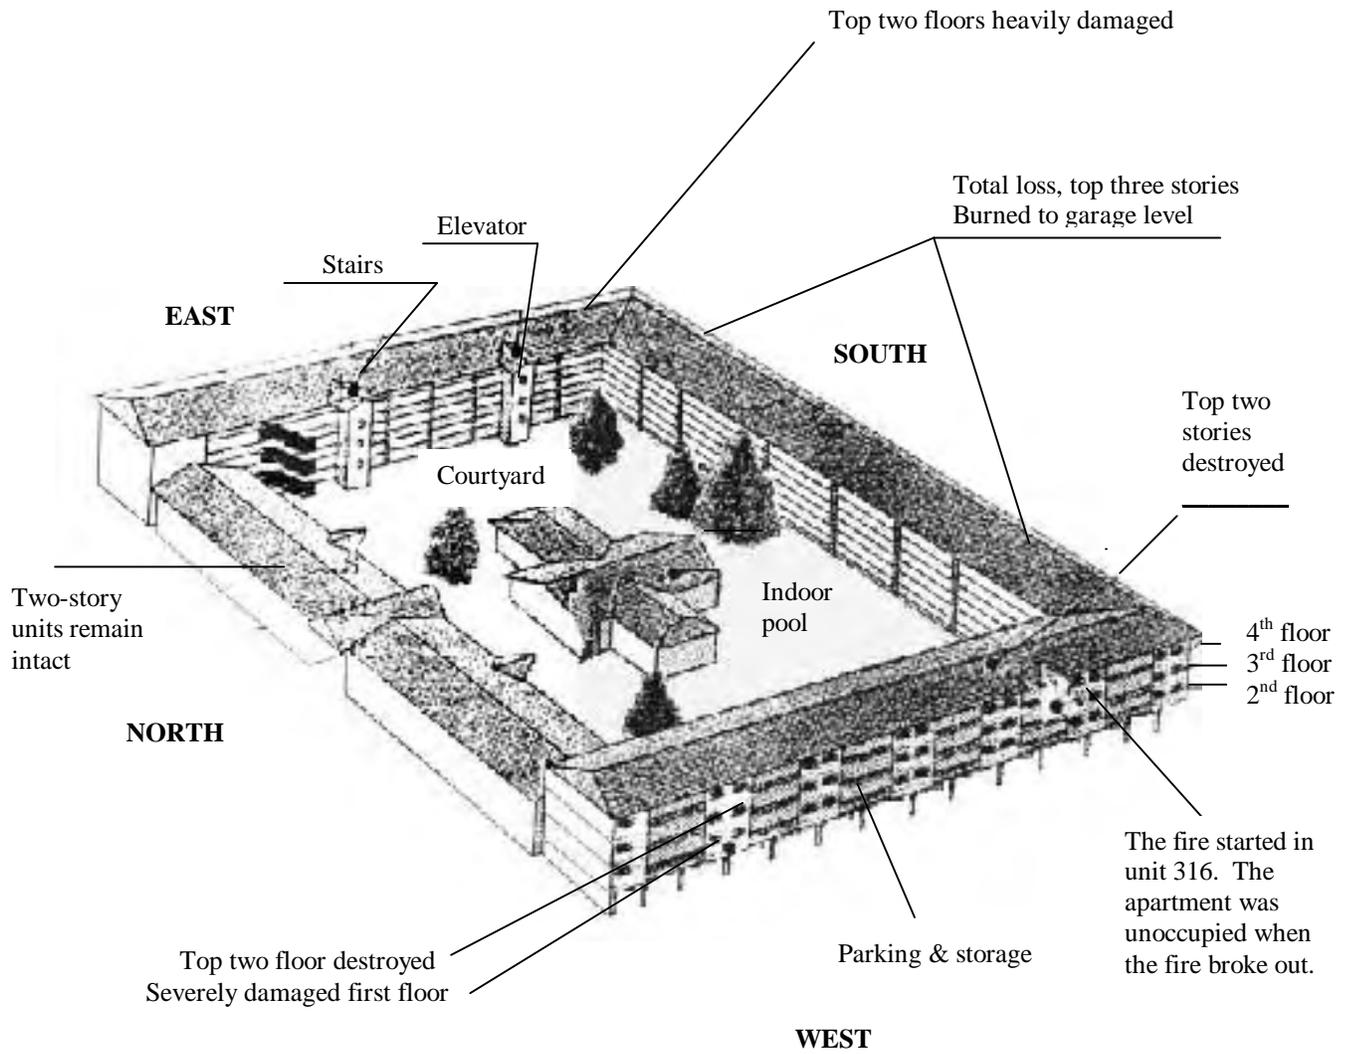
Diagram 1. Kona Village Complex

Diagram 1 shows the features of the Kona Village complex. Note the U-shaped construction of three living floors built over the parking/storage/utility floor. The north side is the two-story portion, which housed the rental office.

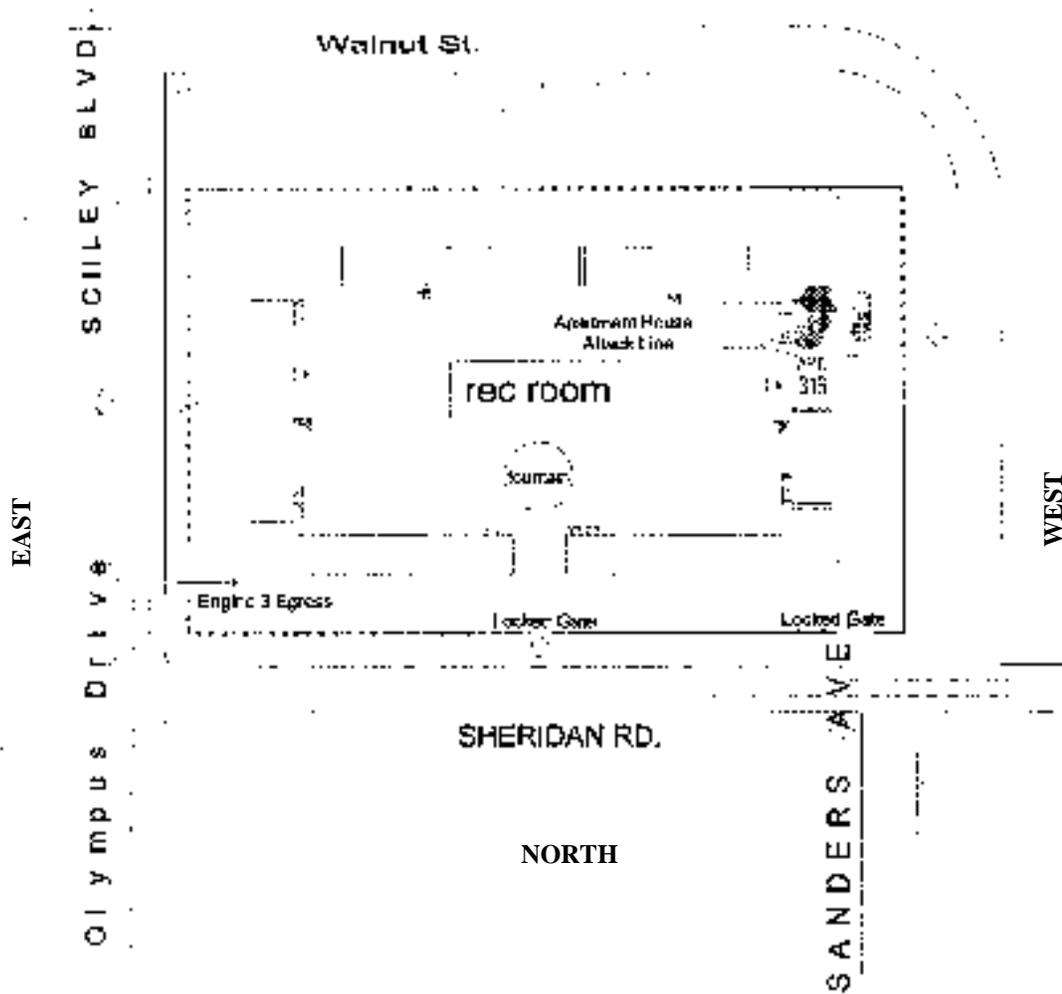
Diagram 2. Fire origin and first-in engine location

Diagram 2 indicates origin of fire and position of first arriving engine. Heavy smoke was evident of the west side and coming from the courtyard.

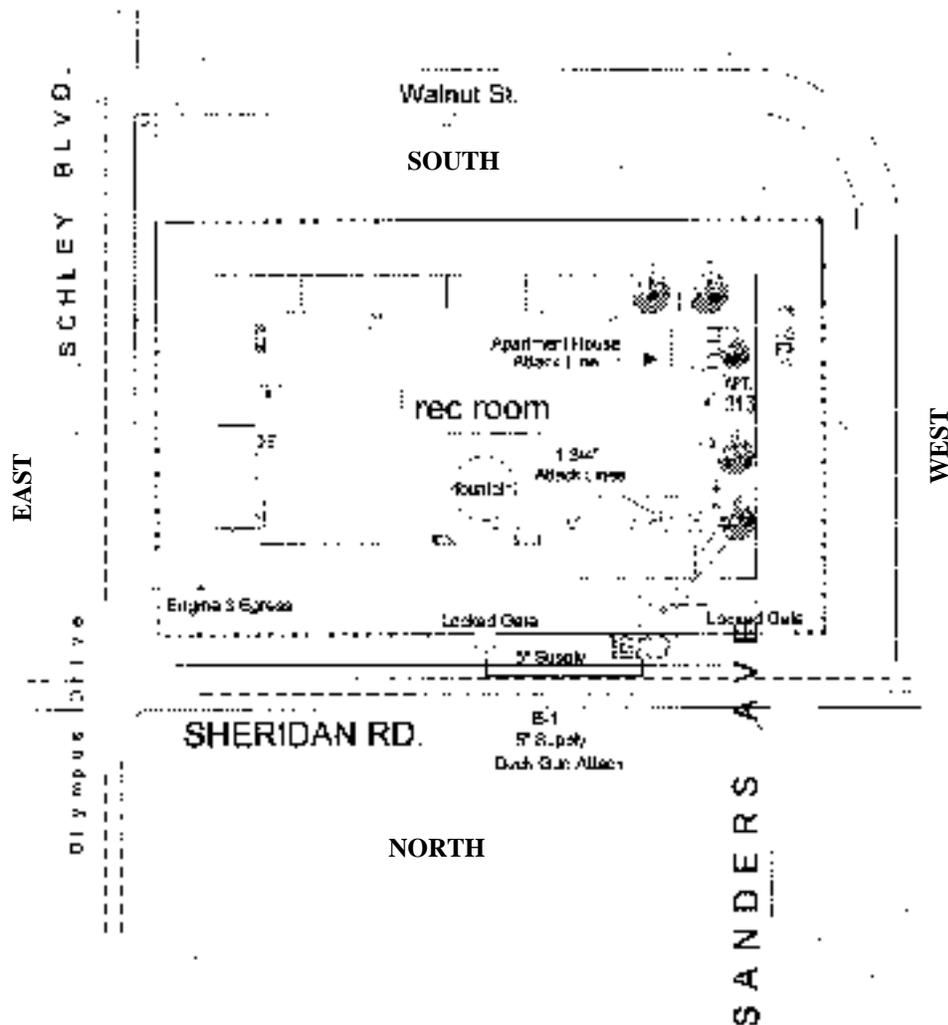
Diagram 3. Position of second engine and early fire travel

Diagram 3 indicates the position of second arriving engine (E-1) and extent of rapid fire travel. Conditions deteriorated from heavy smoke to heavy fire in a matter of seconds. E-1 hooked directly

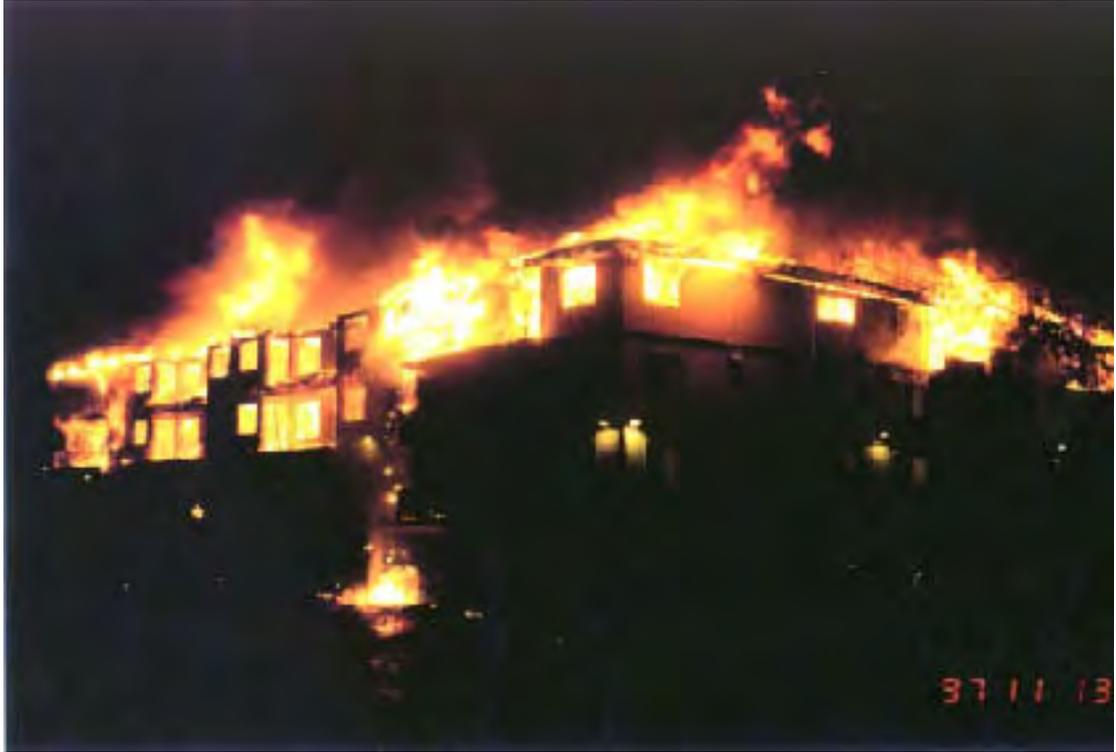
Photo 1 was taken at the southeast corner of building, shows fire conditions twenty minutes after dispatch.

The area of origin and location of the fatalities is at the left in the photo. The fire has extended horizontally through the attic area and dropped down via pipe chases and utility shafts.

Photo 1. Extreme fire conditions at the southeast corner

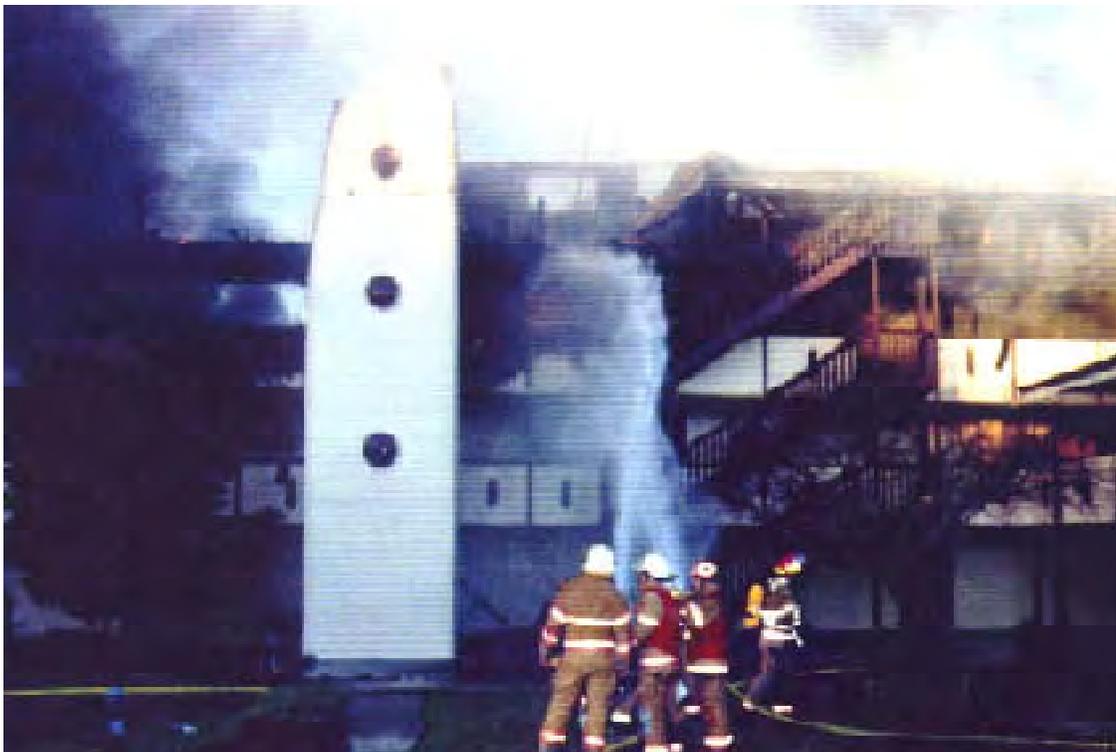
Photo 2 shows interior courtyard operations. Crews are deploying a portable monitor and multiple handlines to cutoff exterior fire extension. The two-story portion (north) is visible at the right. The enclosure to the left is the elevator. The apartment of origin is to the upper left.

Photo 2. Interior operations in courtyard, west wing

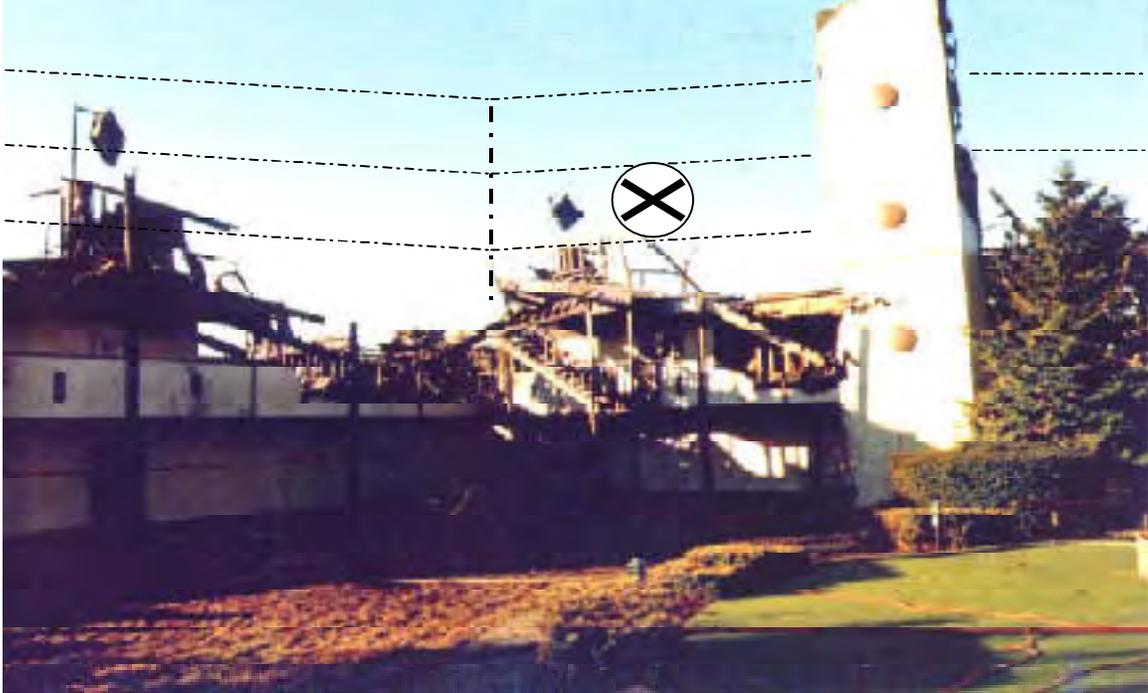
*Photo 3. The view from the interior courtyard toward the SW corner.
The X approximates the apartment of origin. Note the hose cabinets and piping still standing*

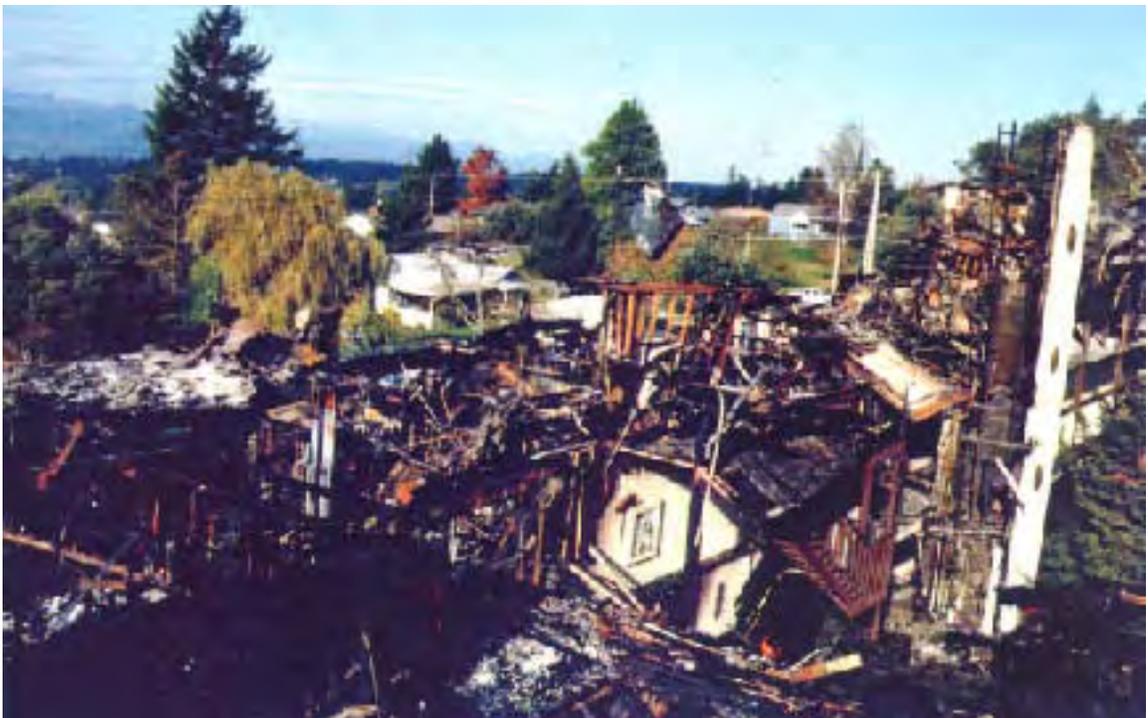
*Photo 4. An elevated view of the west wing looking in a NW direction.
The apartment of origin is at the center left*

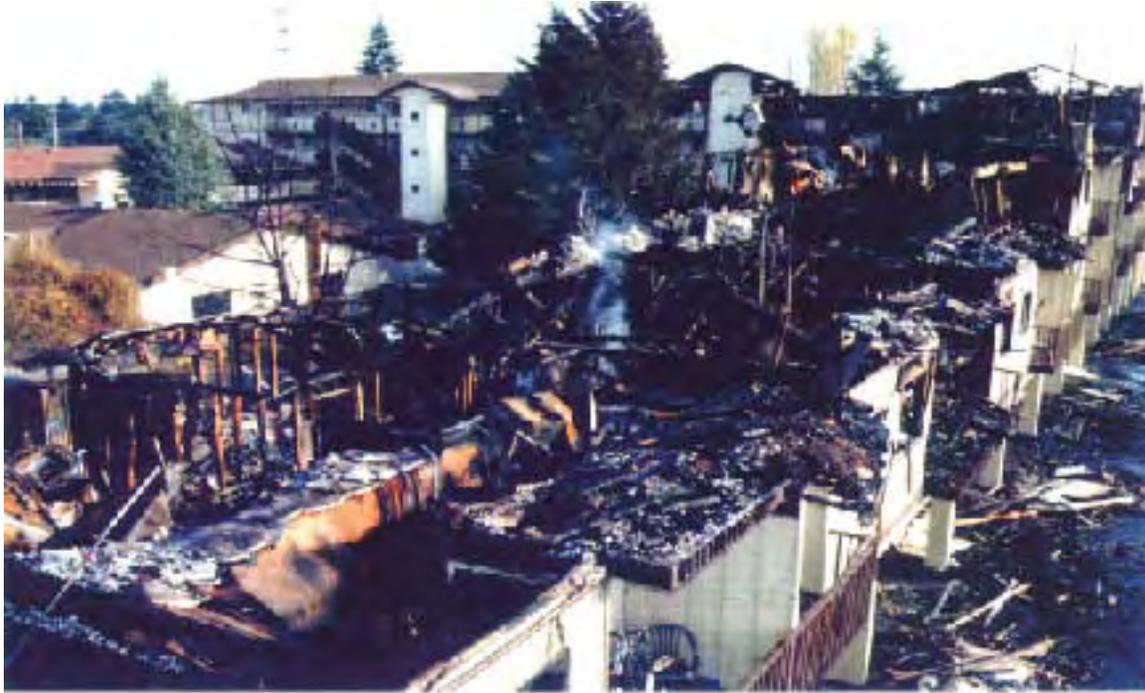
The south block was totally destroyed by fire, the west block was 60% destroyed, and the east block was about 30% destroyed. Overhaul continued for several days concurrent with the search for victims. The cause and origin investigation continued as well.

*Photo 5. An elevated view of the south wing toward the east wing.
The fire was stopped at the SE corner*
