INDUSTRIAL SILO FIRE AND EXPLOSION

Industrial Silo Fire and Explosion

This is Report 122 of the Major Fires Investigation Project conducted by Varley-Campbell and Associates, Inc./TriData Corporation under contract EME-97-CO-0506 to the United States Fire Administration, Federal Emergency Management Agency.

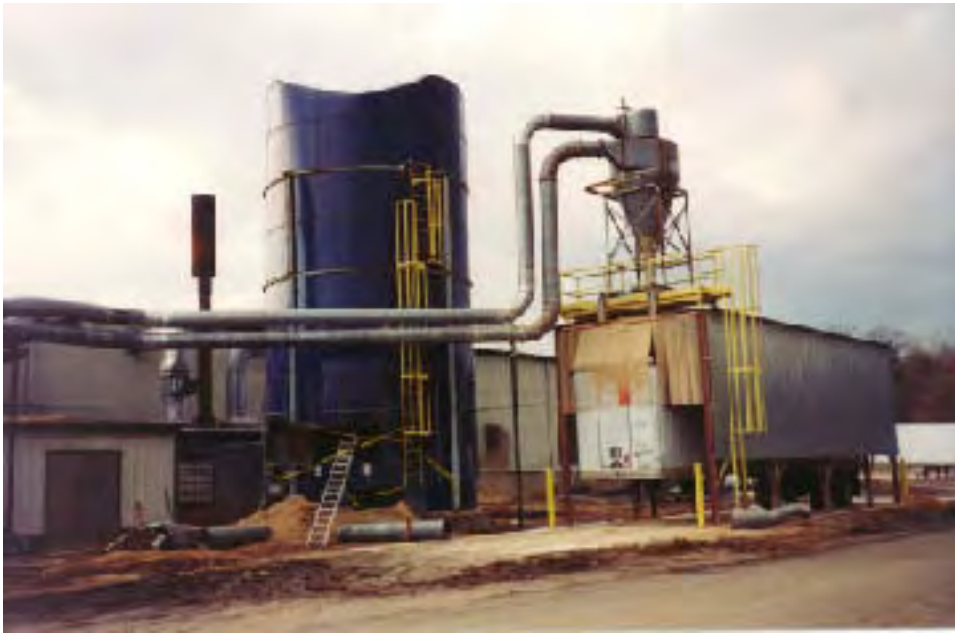
Photo #1 gives a perspective of the silo and its orientation to the building. The trailer shed to the right received wood waste via ducting and cyclone arrangement similar to that of the silo, for short-term storage in an open-box trailer and then disposal off site.

Photo 1. Silo with trailer shed to right and manufacturing facility in background

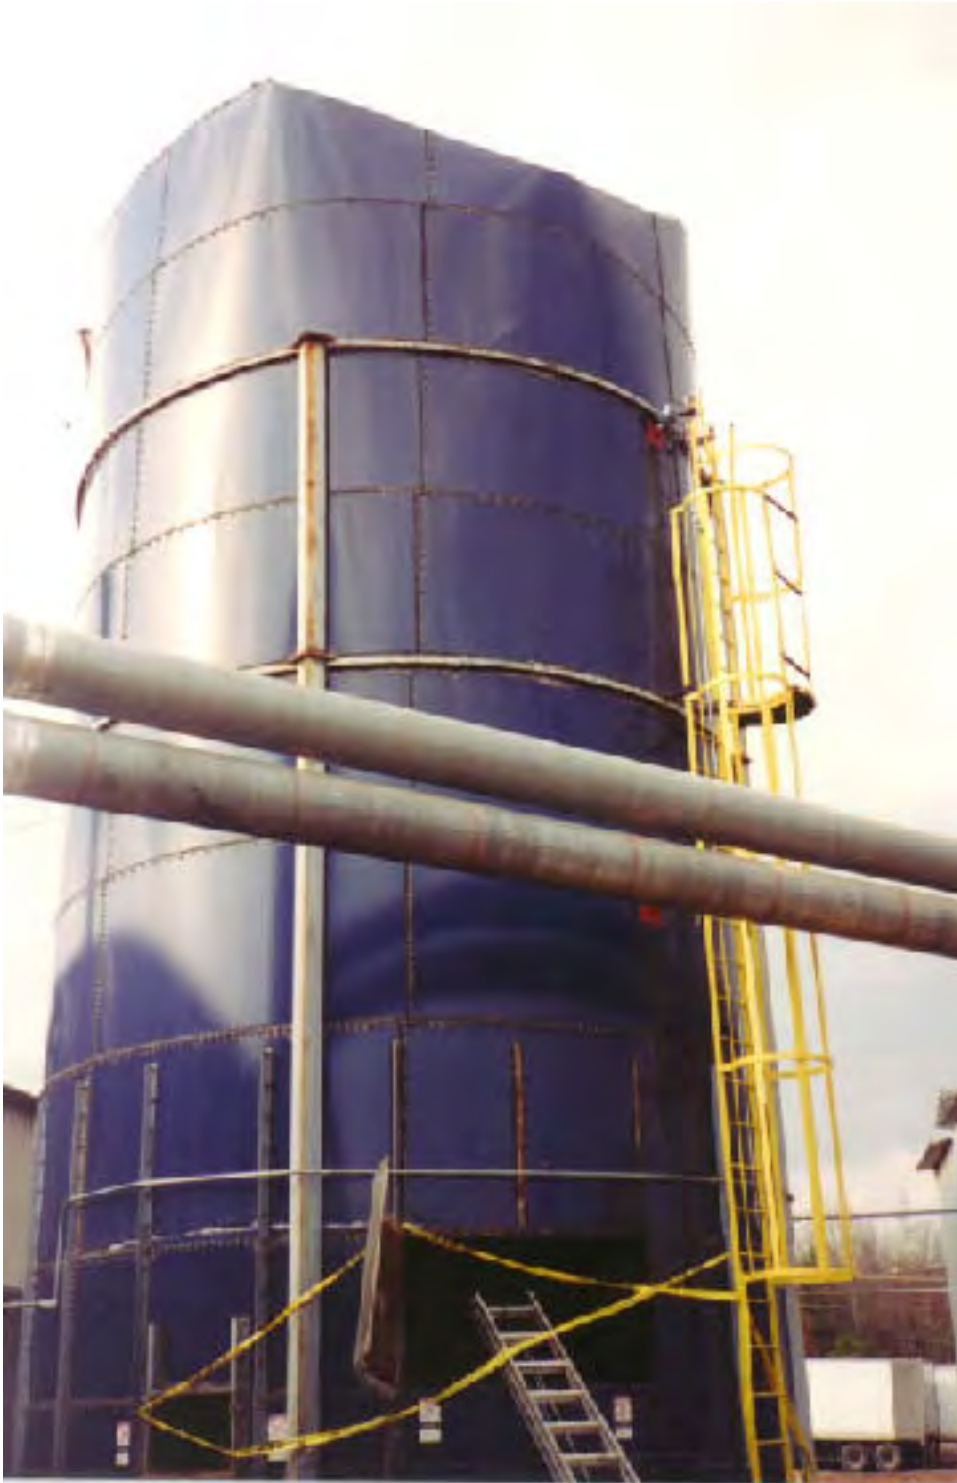
The Chief had moved all but essential personnel from around the base of the silo area as the crew commenced to remove the plates. As they worked on removing the last bolt of the 3 x 4 plate, one of the firefighters at the plate area noticed water flowing out along with burning ashes in the air space above. He then described a sucking and gurgling sound that was followed by a loud, low order explosion. The firefighters on the roof recalled the same type of inrush of air at their position followed by a dull thump and the roar of the main explosion. (Photo #2 shows access plate in relation to silo, photo #3 is a closer view of the access plate area).

Photo 2. Access plate, origin of explosion

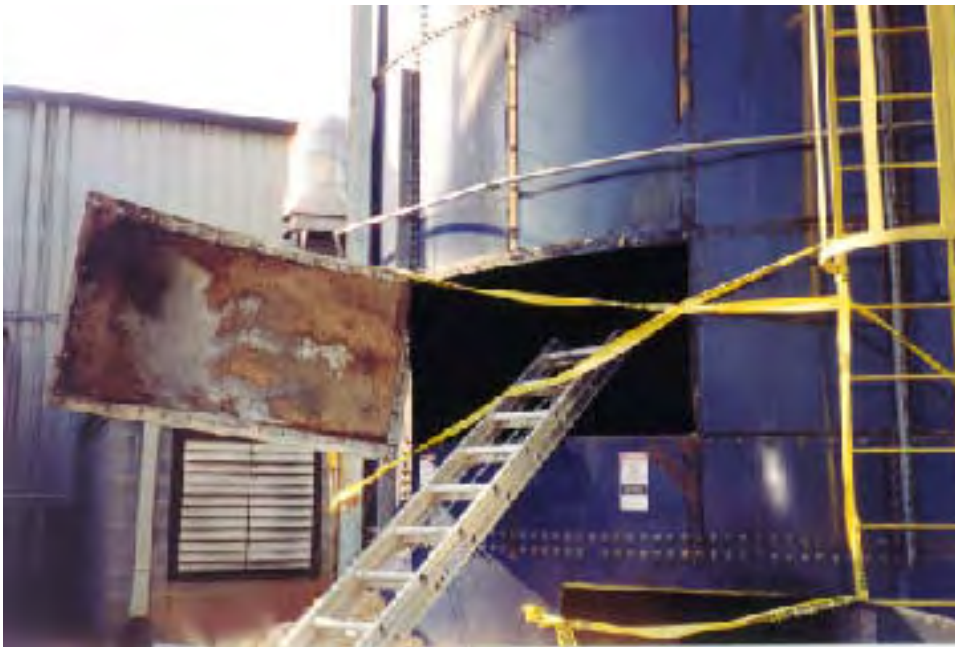
Photo 3. Access plate; area of origin of explosion

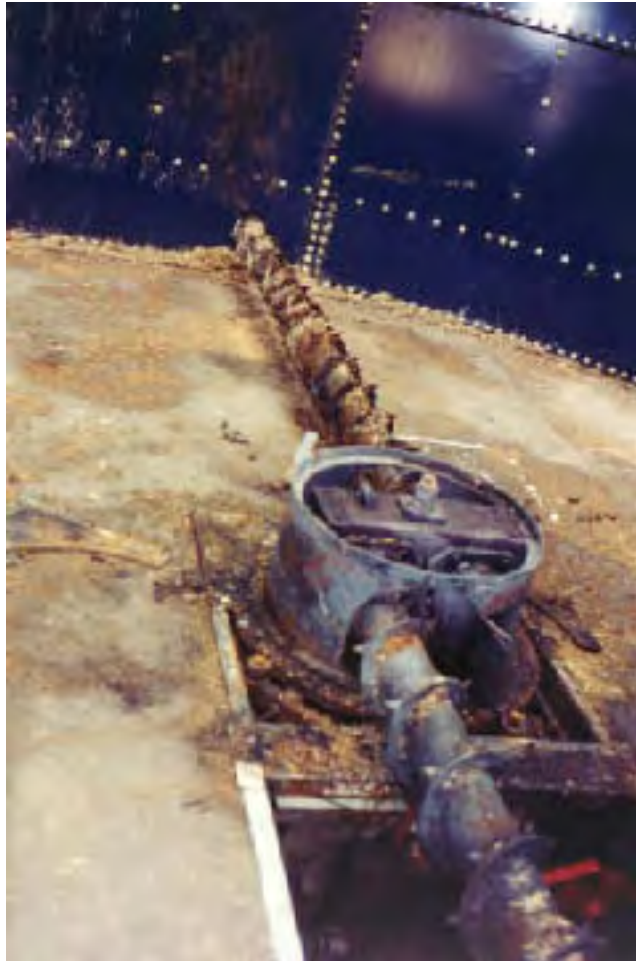
The observation indicated a large void area (approximately 12-foot x 16 foot x 10 foot) at the bottom of the silo radiating from the screw auger area. One of the "fingers" (Photo #4) of burned material ran to the direction of the access panel that was the focal point of the explosion. The direction of the burned void indicated fire travel in the direction of the screw auger to the compromised areas of the silo shell: the access panels. (Photos #5 and #6). Despite the application of several thousand gallons of water, **apparently no water penetrated to sufficient depth to reach the burning wood material.**

Photo 4. View of auger inside silo; fire burned along the auger shafts to access panels

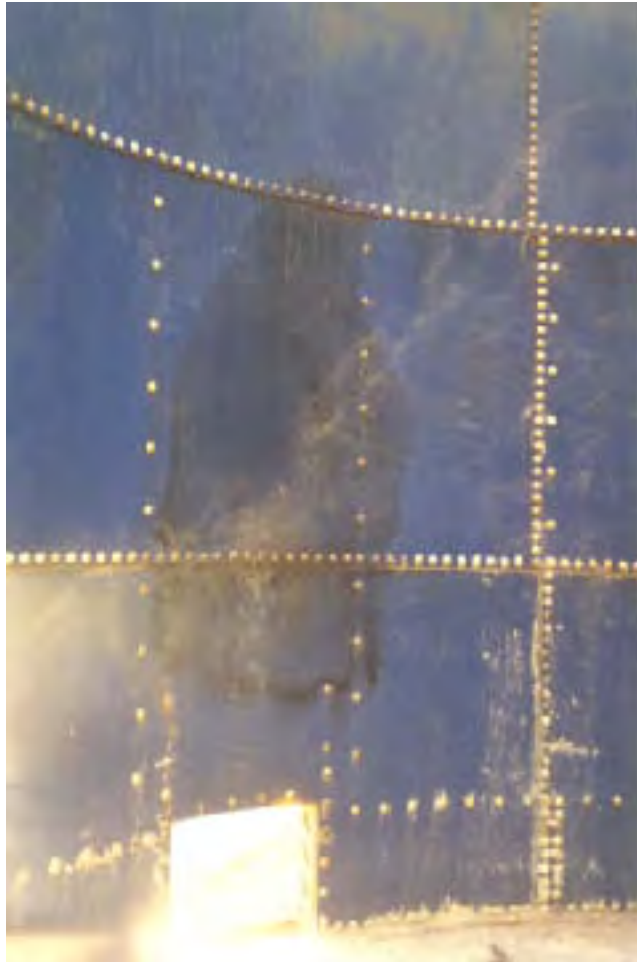
*Photo 5. Smaller access panel indicating burning in stack above 2'x2' access panel
(panel removed for post-fire investigation)*

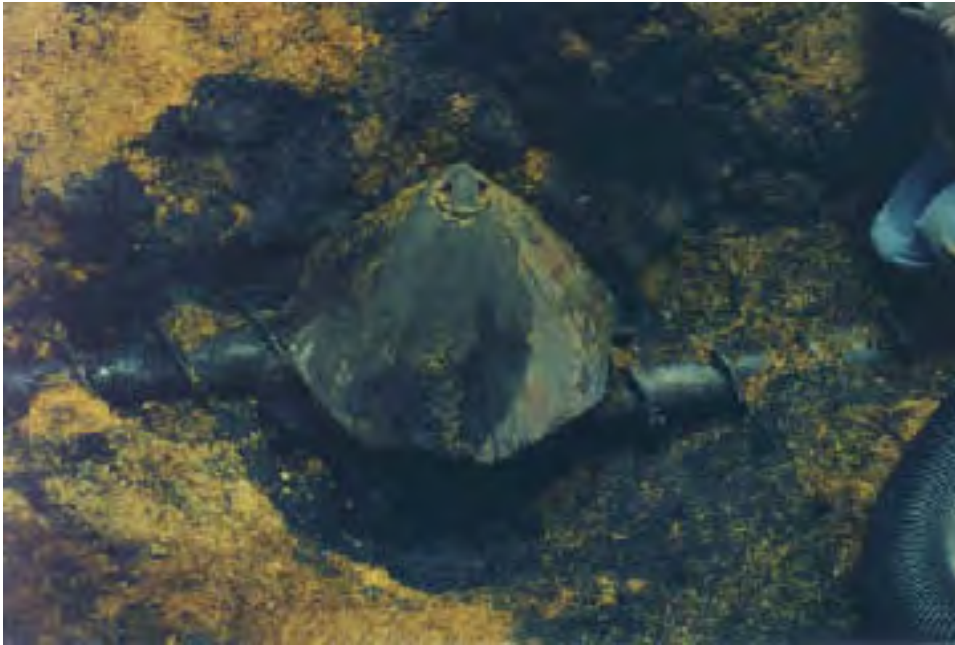
Photo 6. Auger gear box, covered by a shield suspected origin of fire

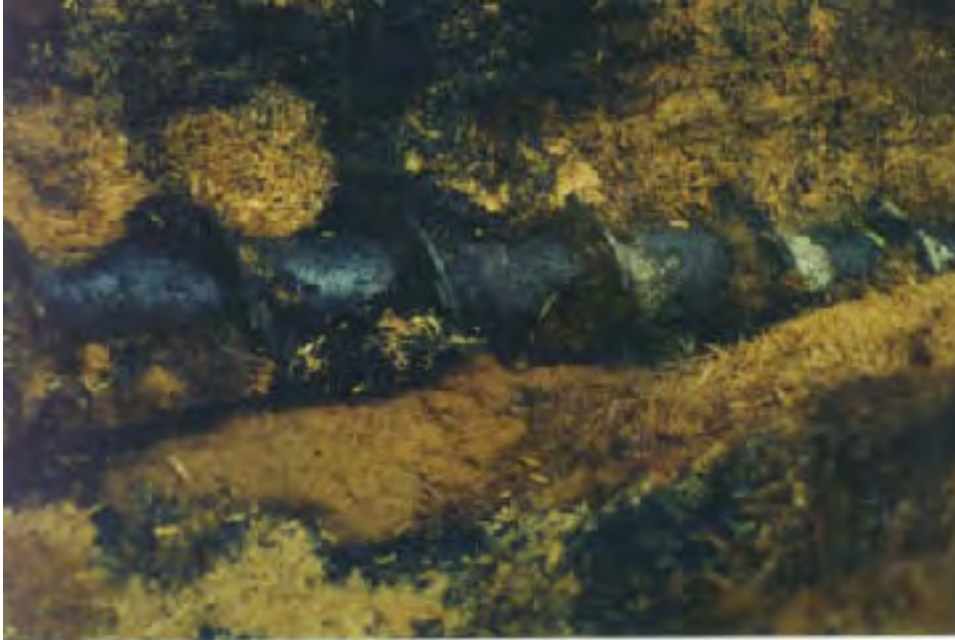
The fire marshal determined that the fire started when the gear box seized — burning the belt of the drive unit. The actual fire origin was deemed to have come from the plant side rather than from inside the silo. The day of fire origin was estimated to have been Tuesday or Wednesday. It was surmised that the fire burned void areas out of the sawdust over the auger. The fire also burned from the center toward the bolt holes in the access plates. (Photo #7).

Photo 7. Fire travel along auger shaft

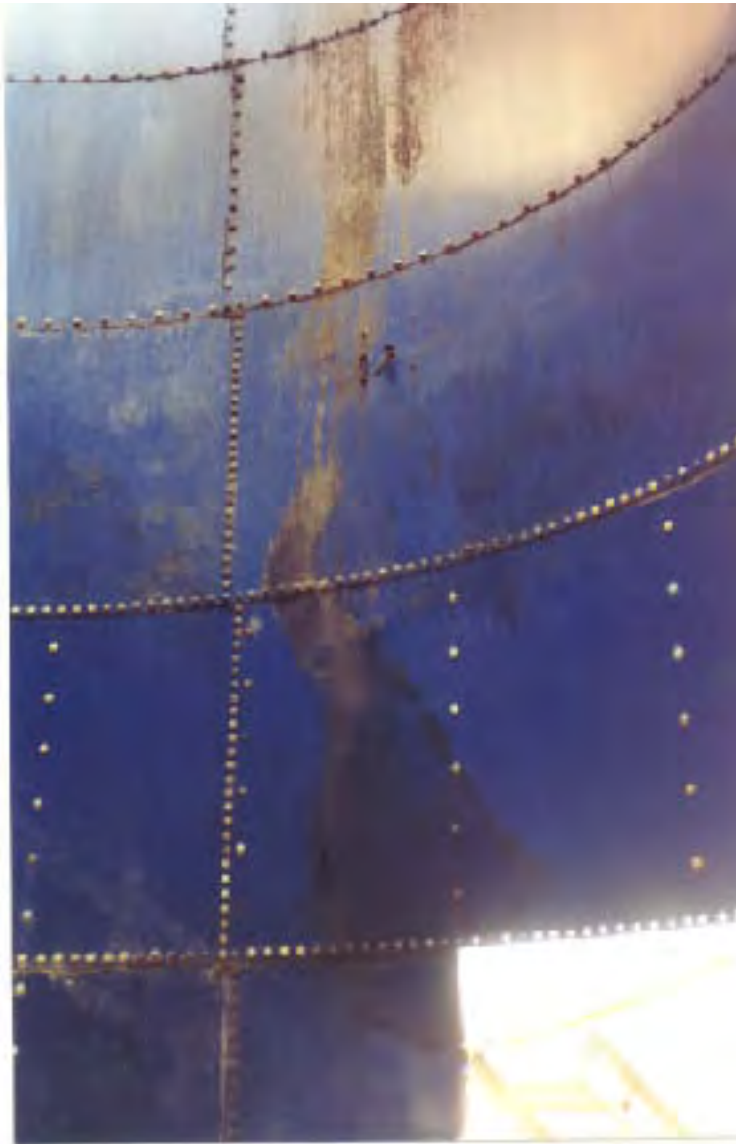
The explosion occurred when the 3'x4' side panel was removed, thus allowing oxygen to enter the burning area. (Photo #8). Because of the compromise of the integrity of the shell by the bolts and access plate, a minute source of oxygen-bearing air permitted the fire to burn in finger-like fashion from the source in the gearbox to the silo wall. This was an area of deep-seated, incomplete combustion, which needed only a source of oxygen to ignite explosively. This is consistent with backdraft-like explosions that have occurred in agricultural product silos. The sawdust also entrained dust to combine with the rapid oxidation of the backdraft to produce the energy sufficient to damage the silo and injure the firefighters. The water applied in the extinguishment attempts apparently either ran off the surface or was absorbed and acted as a tamper over the burned out voids in the wood waste.

Photo 8. View from inside silo showing burned-out areas in relation to access panel (origin of explosion)
