Explosion Mechanism Advisory Group report

Buncefield Major Incident Investigation Board

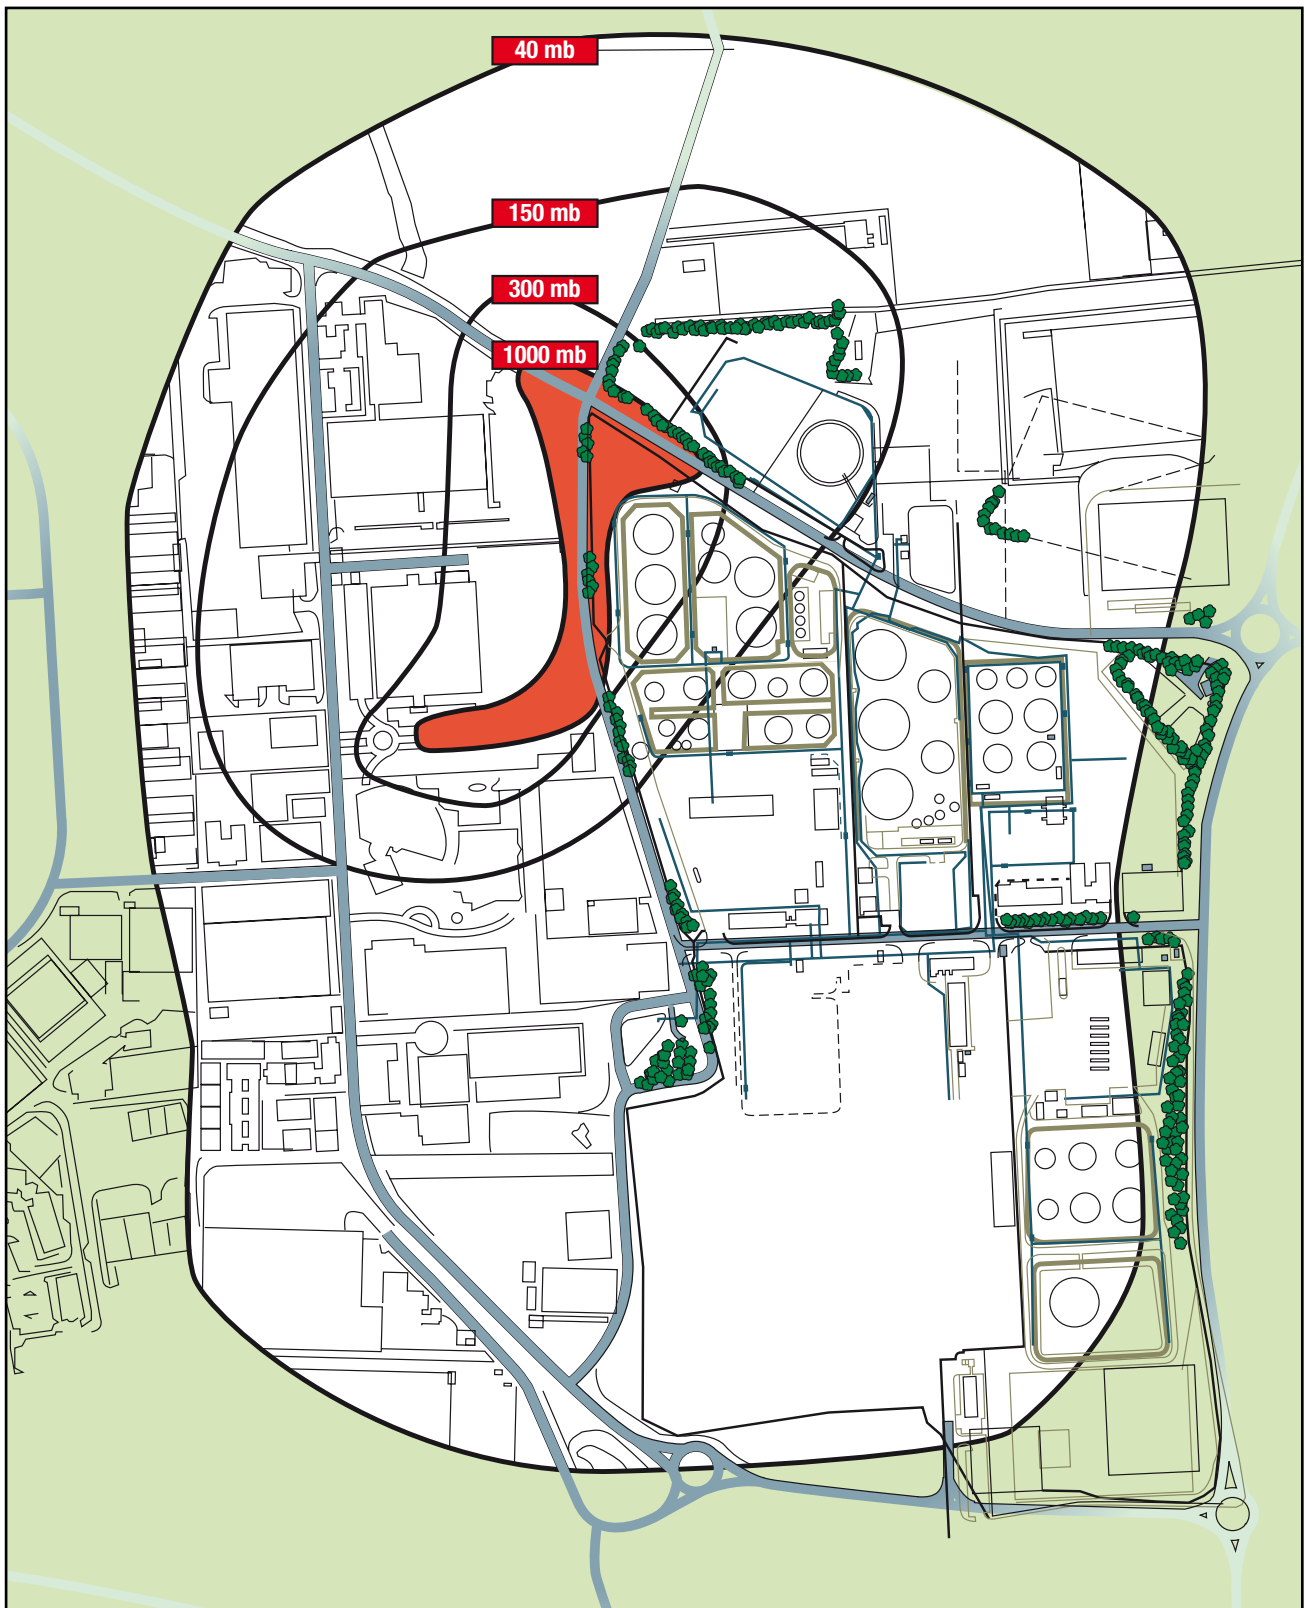
- An attempt has been made to summarise over-pressures on the map in Figure 1, with overlaid isobars of 1000, 300, 150 and 40 mbar. Regions with pressures above 1000 mbar are shown shaded.

Figure 1 Map of the area around the Buncefield site showing approximate over-pressure isobars. These are based on the distribution of damage caused to buildings (including the pump house and the emergency generator cabin), tanks and vehicles as recorded by the primary investigation team. Inevitably, there are large error bars, particularly associated with the 1000 mb contour. It was noted that the damage to vehicles across the car park was remarkably uniform, but there is no information available on over-pressures that are required to cause such damage. The red shading corresponds to an area in which there were convenient markers that provided strong forensic evidence that the over-pressure was greater than 1000 mb. This does not preclude the possibility that such over-pressures were achieved beyond this area.

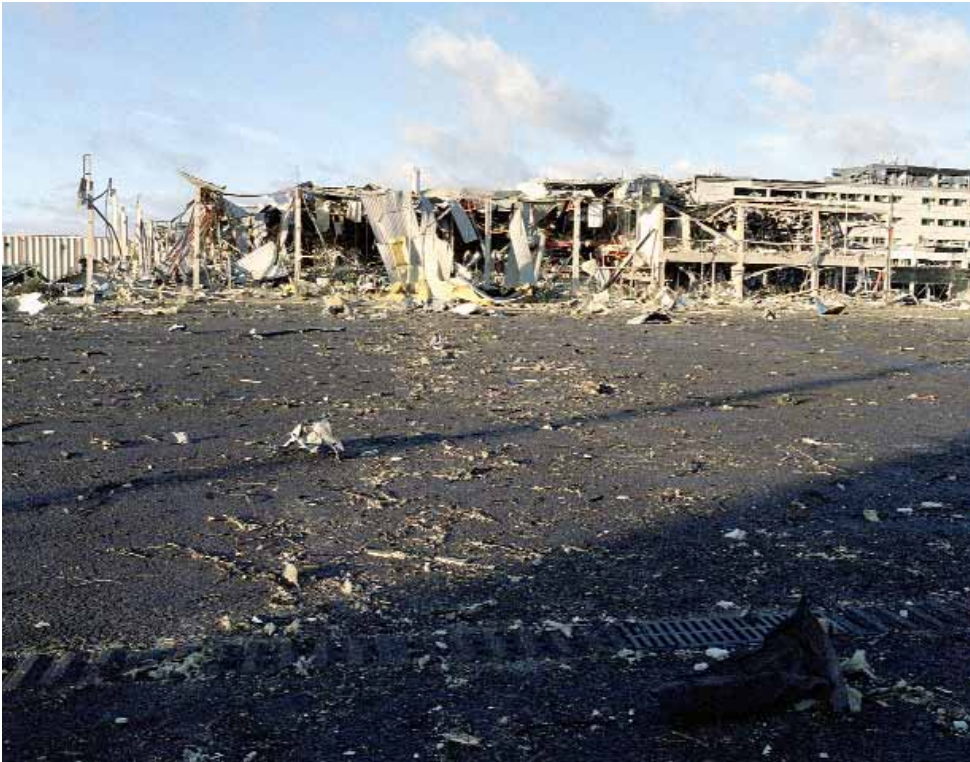
Figure 4 Fuji building looking north-west from the boundary with the Hertfordshire Oil Storage Ltd (HOSL) site

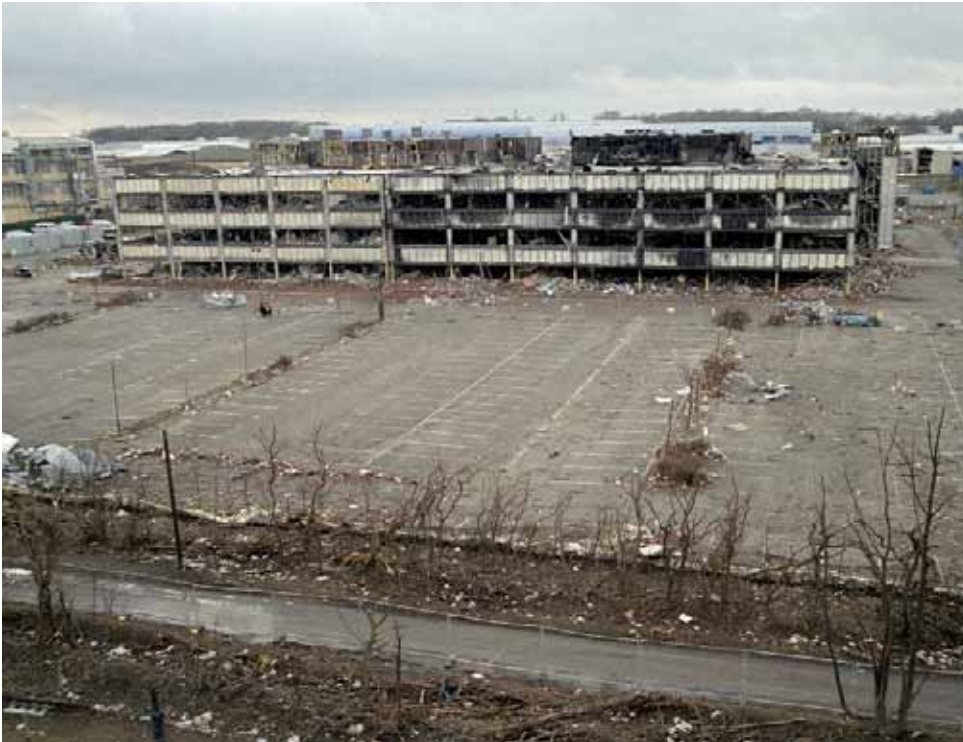
Figure 8 Looking west into Northgate building car park, from the position of Tank 912 (HOSL West)

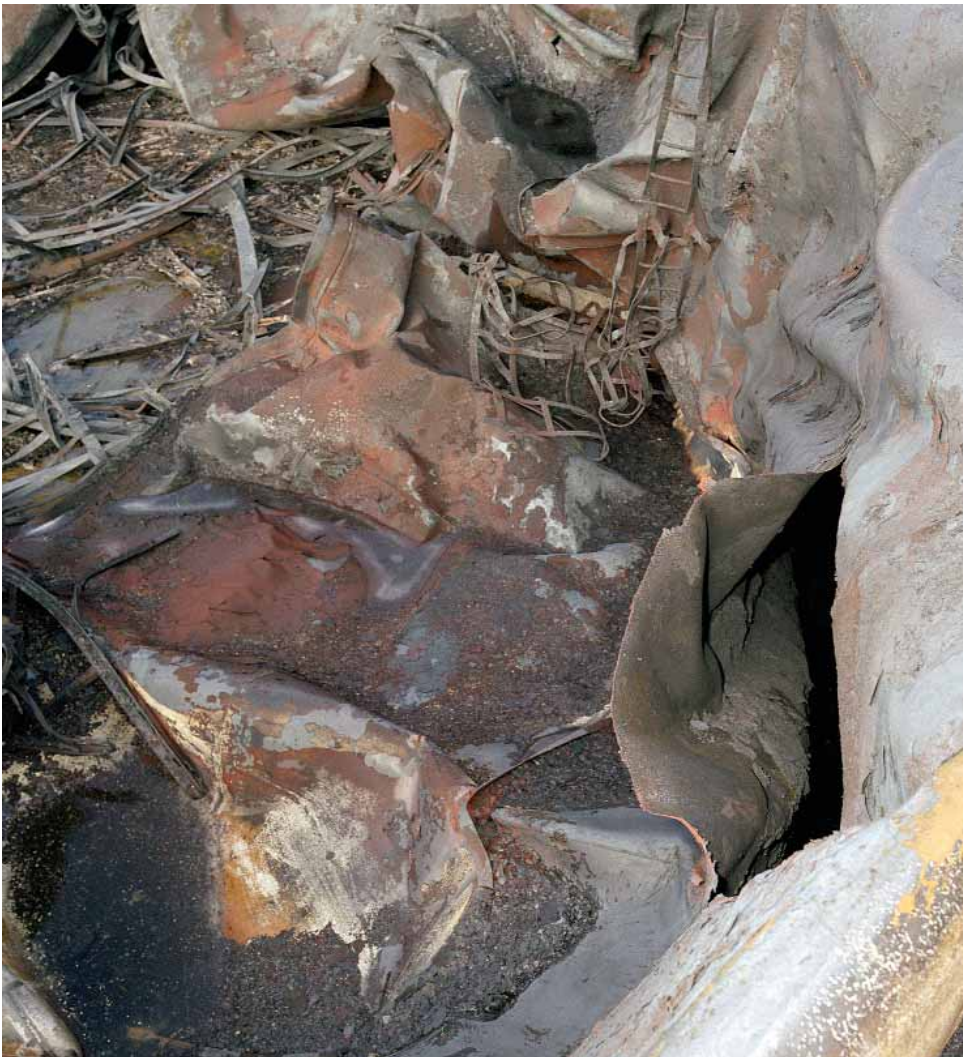
Figure 9 View into Tank 912

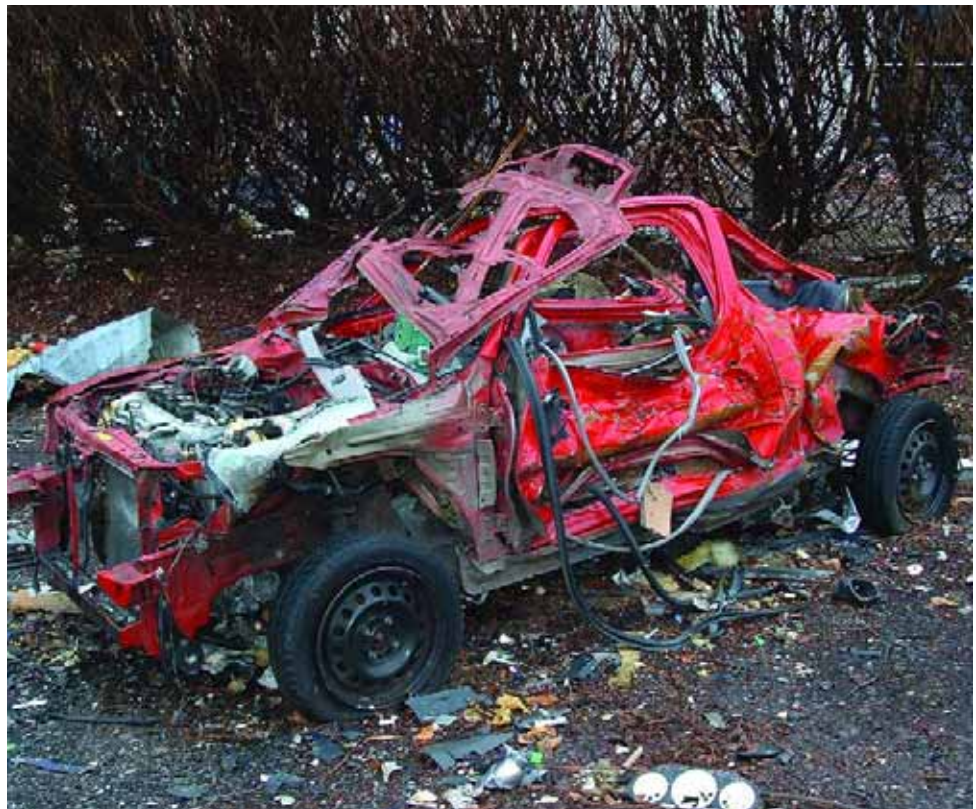
Figure 22 Damaged car located at the south end of the Fuji building car park, adjacent to the hedge with the Northgate building car park
