Shell Gas (LPG) Safety Alert No. 1

Road Tanker BLEVE, Greece

The following report is based on information gathered by Panagiotis Haritopoulos, Shell Gas Greece.

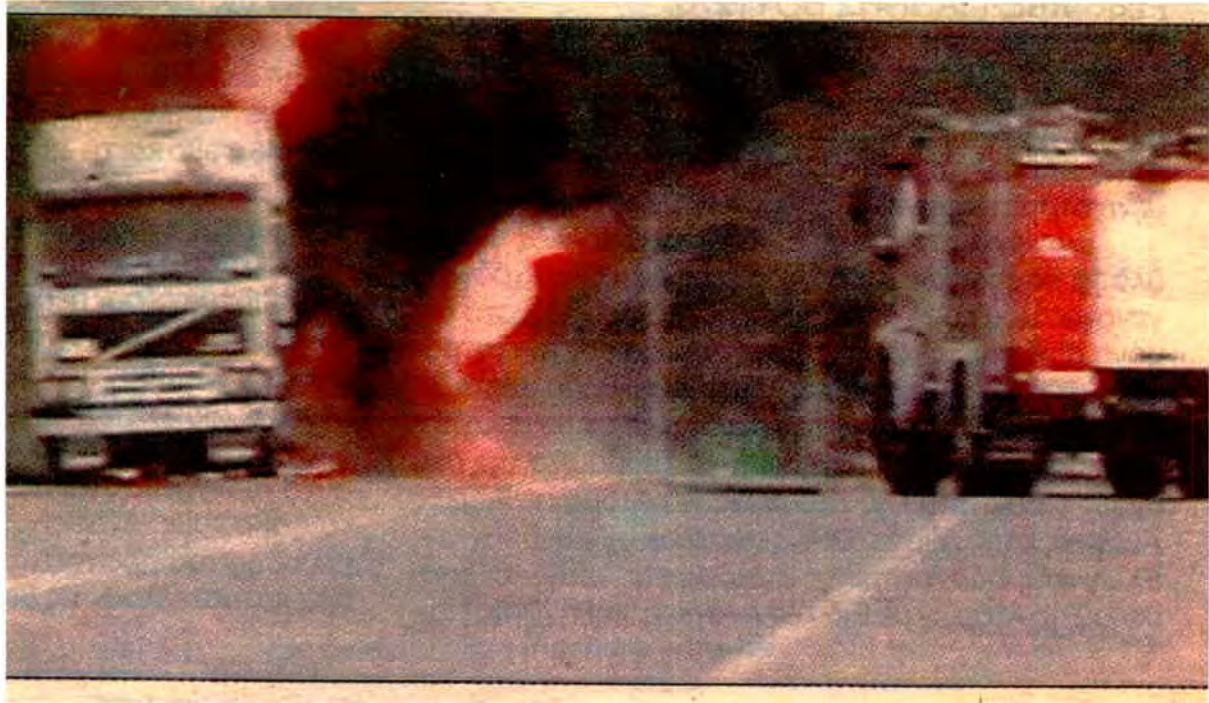
At 16:20 hours, the tanker was stopped on a two lane highway (with no barrier) by a police road patrol. The driver stopped the tanker half way off the road with its warning lights switched on. Shortly after, a van travelling in the same direction (reported to be speeding) hit the back of the tanker. The van driver was killed instantly and the van caught fire.

The fire from the van moved to the tanker, engulfing the LPG tank - the LPG pump, meter, inlet and outlet couplings and associated pipework were all situated in a metal compartment at the rear end of the vehicle and it is thought likely that the fire was supported by leaking LPG.

Three photos of the accident are attached. One was taken 15 seconds before the BLEVE. The other two show the scene afterwards.

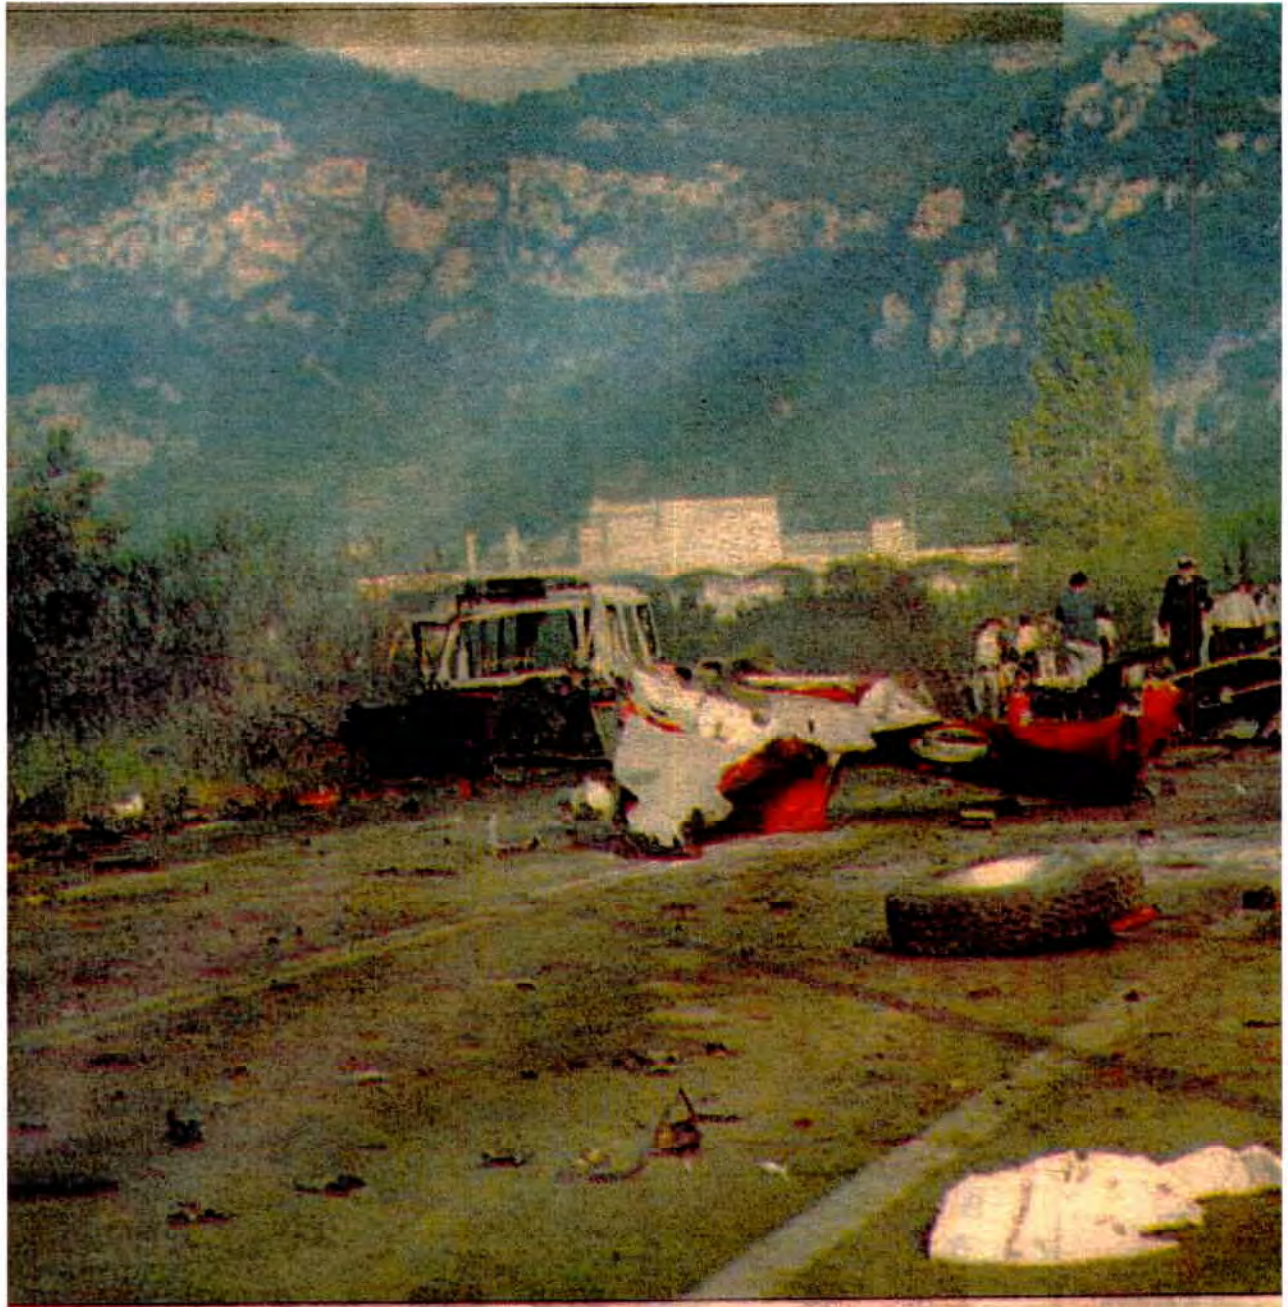
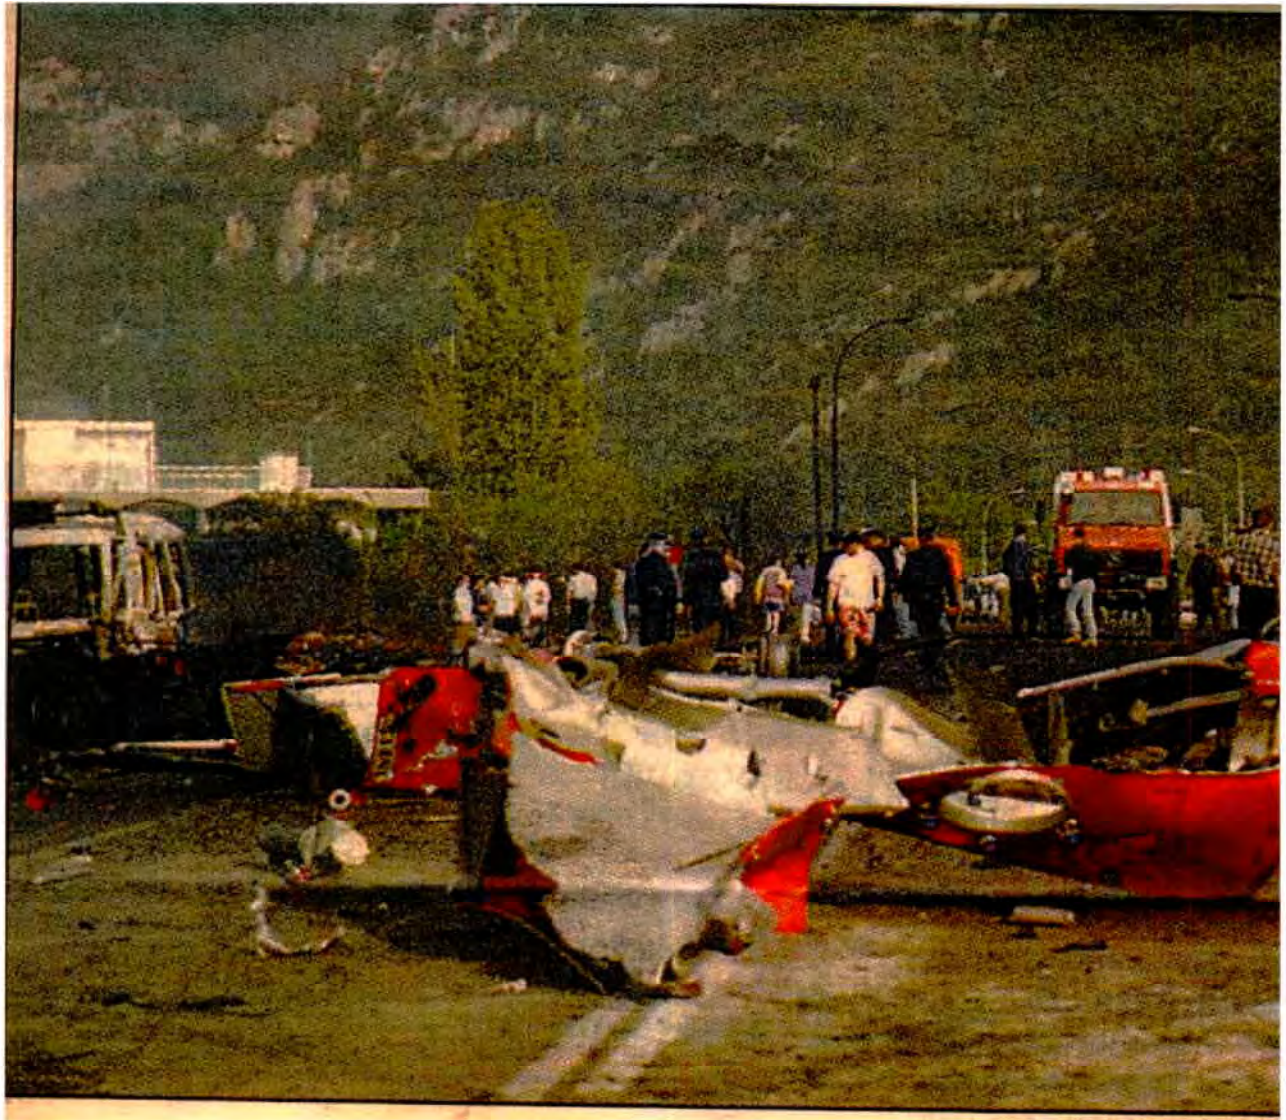
Eye witnesses report a 100 metre radius fire ball which ascended 150 metres into the sky. Large drops of burning liquid LPG were dropping from the sky at a distance over 300 - 400 metres away from the explosion. The tank lorry and the fire engine totally disintegrated. Large vehicle parts were projected 200 - 300 metres away (the engine of the fire truck was found 250 metres away). Smaller pieces of metal are reported to have been found at distances over 1 km away from the accident. The LPG tank was projected into a three storey building located 500 metres away, demolished its roof and landed in a field 200 - 300 metres further away (total 700 - 800 metres distance from the centre of explosion).

All three firemen who were close to the centre of the explosion were killed instantly. (Their bodies were found 70 metres away). The tanker driver, standing about 400 metres away, was killed by a piece of flying metal. Thirteen bystanders standing up to 300 metres away were injured and taken to hospital; injuries varied from second degree burns and multiple bone fractures to lighter burns, cuts and bruises. Buildings within a radius of 500 metres were damaged.
