Observers' Report

Fire at the chemical industries in Memmingen, Germany

Swedish Rescue Services Agency

This report has been prepared by
Ulf Andersson, Jörgen Persson, Matts Pålsson

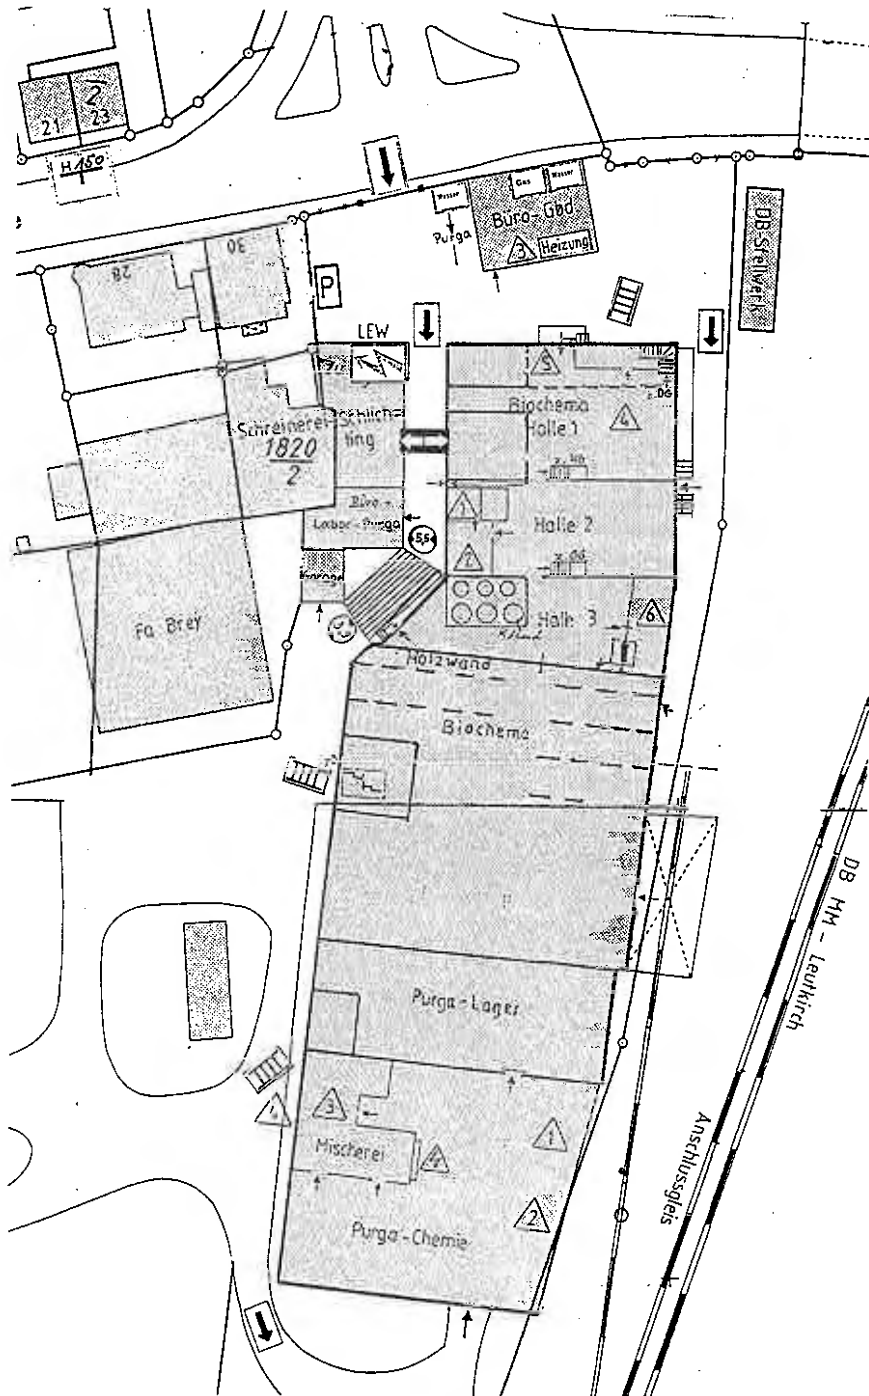
Each section (the two chemical industries and the warehouse) is separated by fire resistant partitioning and is classed in accordance with EI-60. The outer walls are built of brick and concrete. The supporting structures, horizontal, vertical and framework stabilising arrangements are made of unprotected steel and wood. The roof structure comprises wooden roof ridges and covered with tarred roofing felt. Some sections of the vacant warehouse have corrugated sheet metal roofing.

There is a fire resistant room, used as a chemical store, located in Biochema's premises along the east wall of the building.

On the west side of the building there is a covered loading dock. The superstructure is constructed entirely of wood and covered in tarred roofing felt. The superstructure connects the industrial premises with an adjacent building leased by Purga chemie.

Fig. 3: Plan of the building (part of the fire brigade's operations plan).

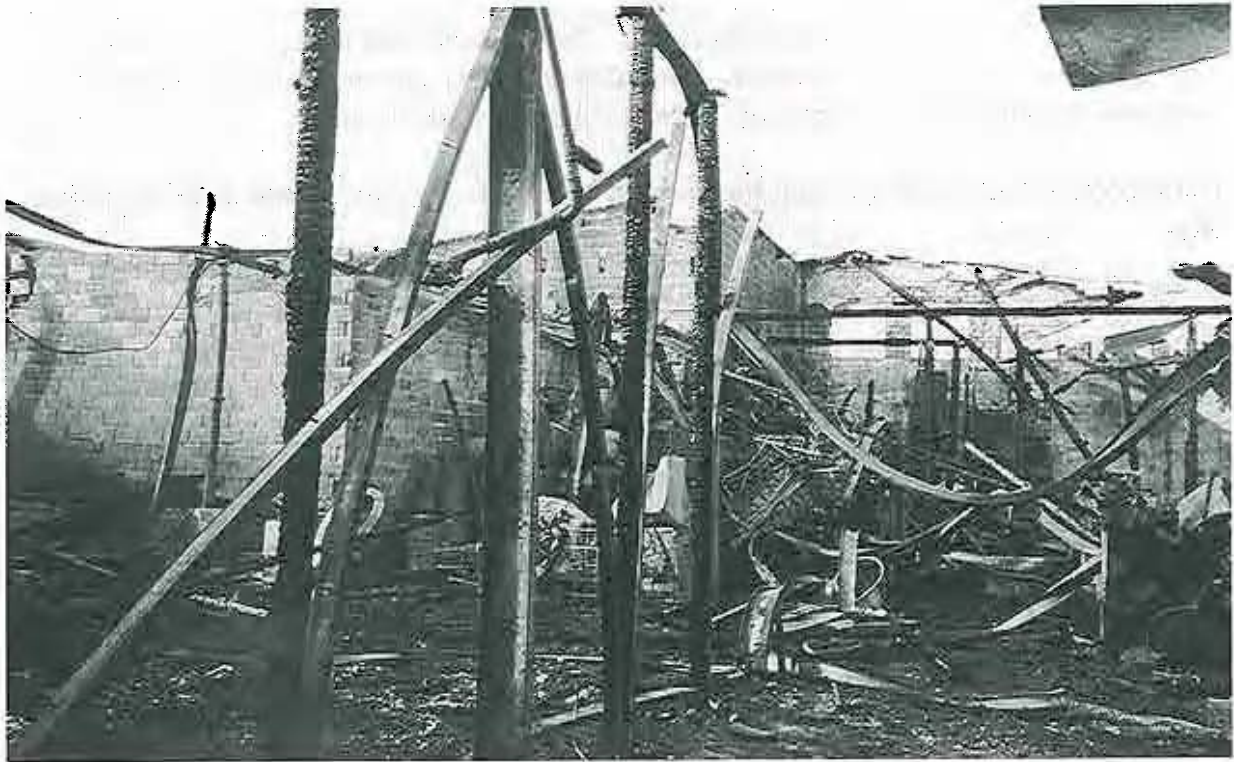
A 35-year-old man, who had formerly been employed at Biochema, broke into the premises. He started fires in at least three different places, including the vacant warehouse. The man suffered from pyromania and had been convicted of arson prior to this incident. It is likely that he did not use any kind of inflammable liquid but put combustible materials found in the premises into piles and ignited them. The man was later taken into custody and confessed the following day.

The fire in the Biochema premises and those adjacent was, by this time, fully developed and had burnt through the roof.

Fig. 4: The building in total ruin
