RAILROAD ACCIDENT REPORT

COLLISION INVOLVING THREE
CONSOLIDATED RAIL CORPORATION FREIGHT TRAINS
OPERATING IN FOG ON A DOUBLE MAIN TRACK
NEAR BRYAN, OHIO
JANUARY 17, 1999

**NTSB/RAR-01/01
PB2001-916301
Notation 7339A
Adopted May 9, 2001**

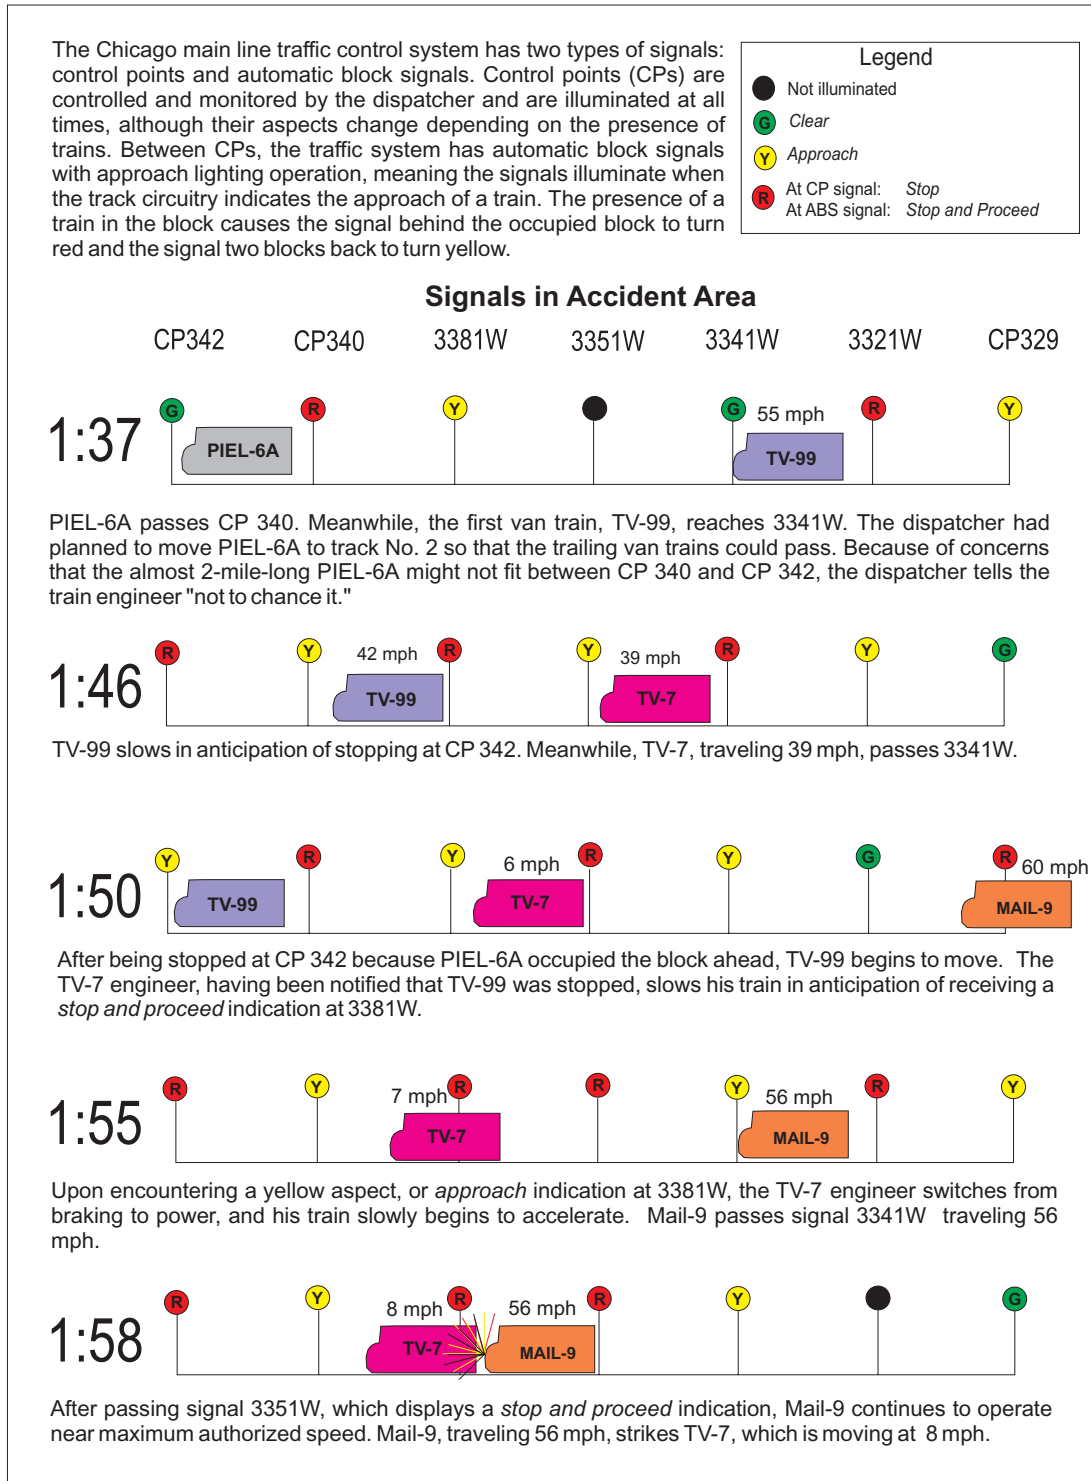
Figure 3. Progress of the trains during the 21 minutes before the accident. Clock times are at the left of the track layout.
