# National Transportation Safety Board

## Hazardous Materials Accident Brief

Accident No: DCA99MZ006  
Location: Whitehall, Michigan  
Date of Accident: June 4, 1999  
Time: 3:50 a.m. eastern standard time  
Carrier: Quality Carriers, Inc.  
Vehicles: MC-307 Cargo Tank  
Injured: 1 fatality and 1 injury  
Evacuated: 11 people from the plant  
Property Damage: In excess of \$411,000  
Materials Involved: Sodium hydrosulfide solution reacting with ferrous sulfate solution  
Type of Accident: Chemical reaction during cargo transfer

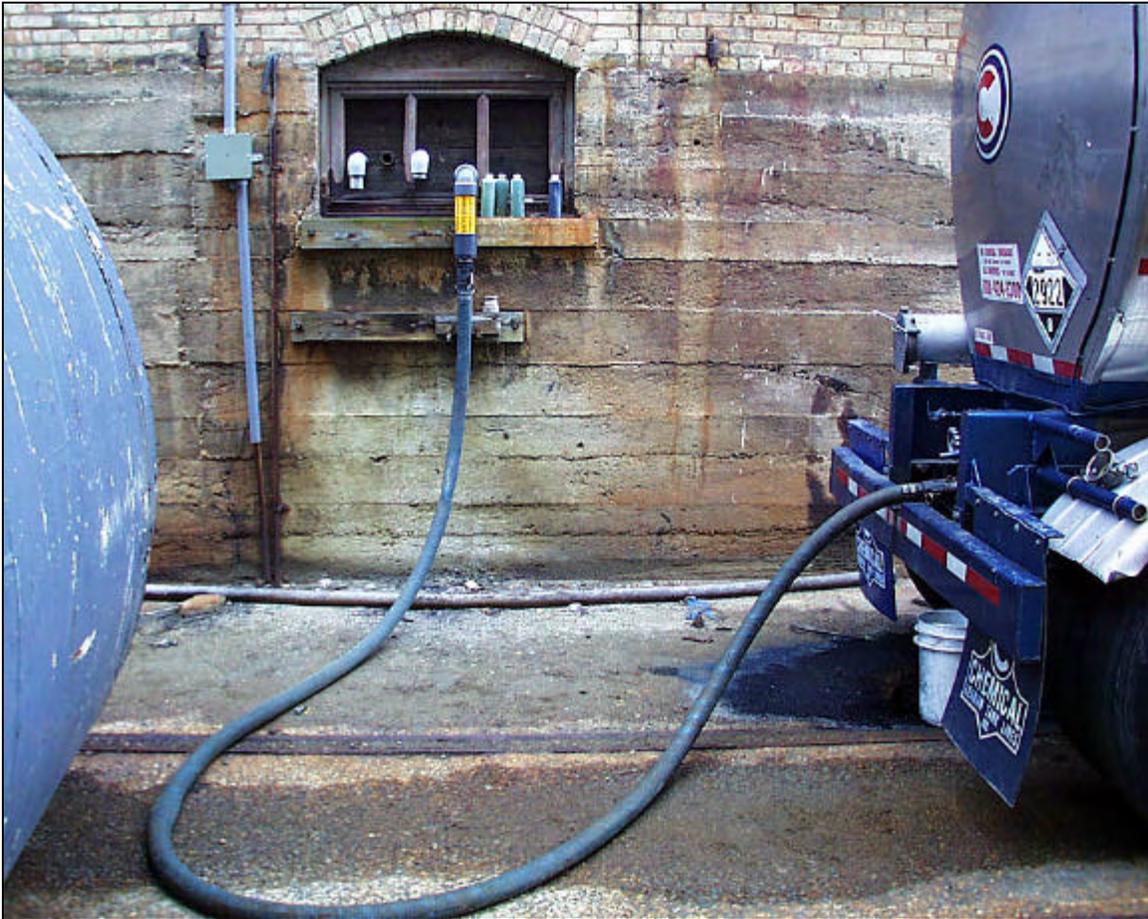
The shift supervisor showed the driver the ferrous sulfate connection (the only working transfer connection at that location) so he could deliver his product. (See figure 1.) The shift supervisor then unlocked a gate to allow the driver to bring his vehicle onto the plant property. The driver asked the supervisor to sign the shipping documents so he would not have to find the supervisor after the transfer was completed. According to the supervisor, he signed the paperwork without reading it and left the area. The signature block that the supervisor signed stated the following: “I have checked the documents for this shipment and verify that there is adequate storage room to receive this shipment and connection has been made to the proper storage facility.”

**Figure 1.** Postaccident view of the cargo tank (right) with transfer hose attached to the ferrous sulfate transfer coupler. The two pipes seen at the left of the ferrous sulfate coupling are no longer used and do not have couplers attached.

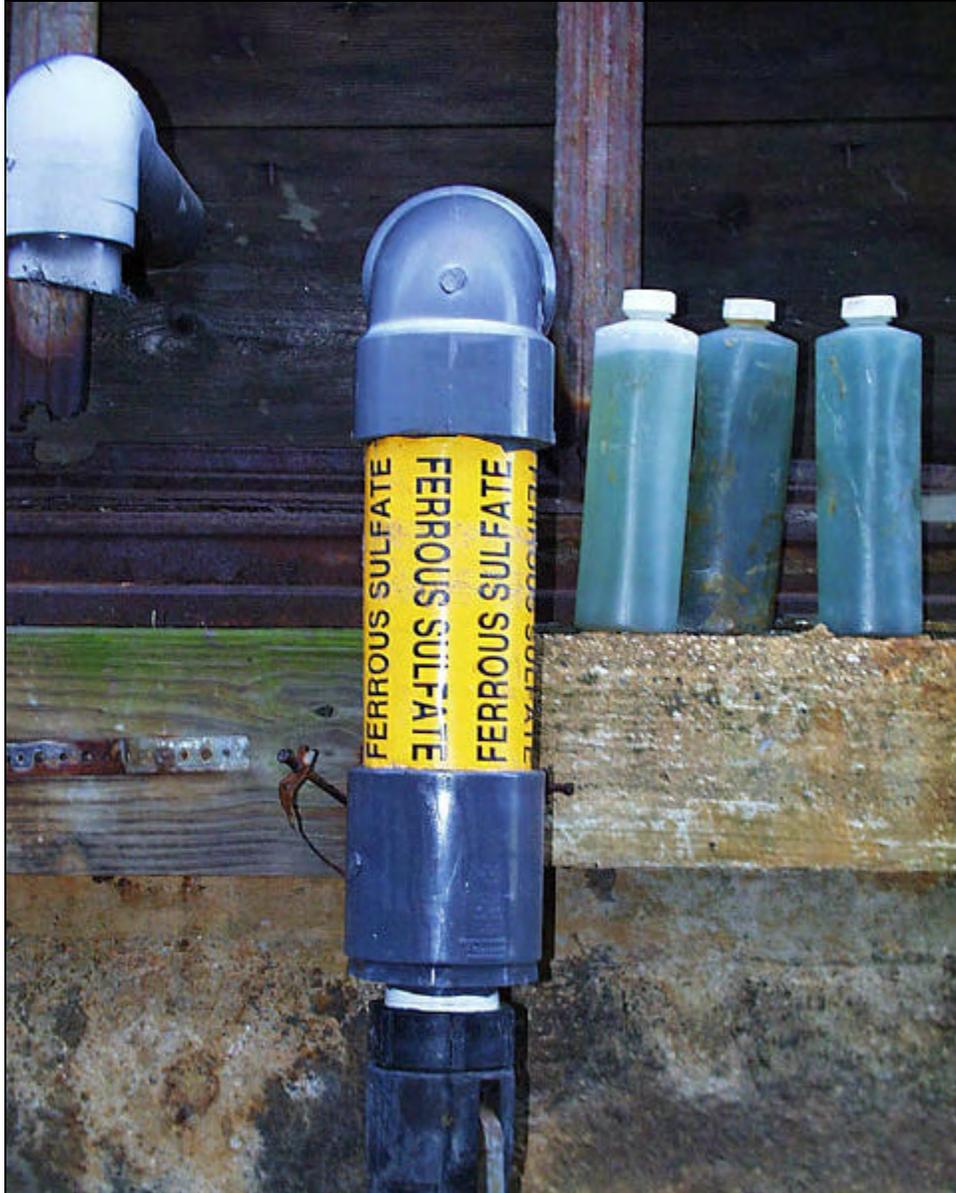
cargo tank into the storage tank containing ferrous sulfate. (See figure 2.) (Sodium hydrosulfide solution reacts with ferrous sulfate solution to produce hydrogen sulfide, a poisonous gas.)

**Figure 2.** Close-up view of ferrous sulfate transfer coupler

The company’s unloading areas for sulfuric acid and sodium hydrosulfide were both equipped with padlocks to help prevent the unauthorized unloading of a chemical into a storage tank. Postaccident investigation revealed that a padlock was attached to the sulfuric acid coupler to prevent a transfer hose from being attached. Though not directly related to the accident, the investigation revealed that the padlock that was supposed to secure the sodium hydrosulfide transfer coupler was not installed but was lying nearby. Rust outlined the padlock on the wood surface where it lay.

In addition to establishing the new procedures, the company has placed barrier gates at the entrances to all three bulk chemical unloading areas, placed locks on all access doors and transfer couplers, and installed an emergency remote alarm button at each transfer location.

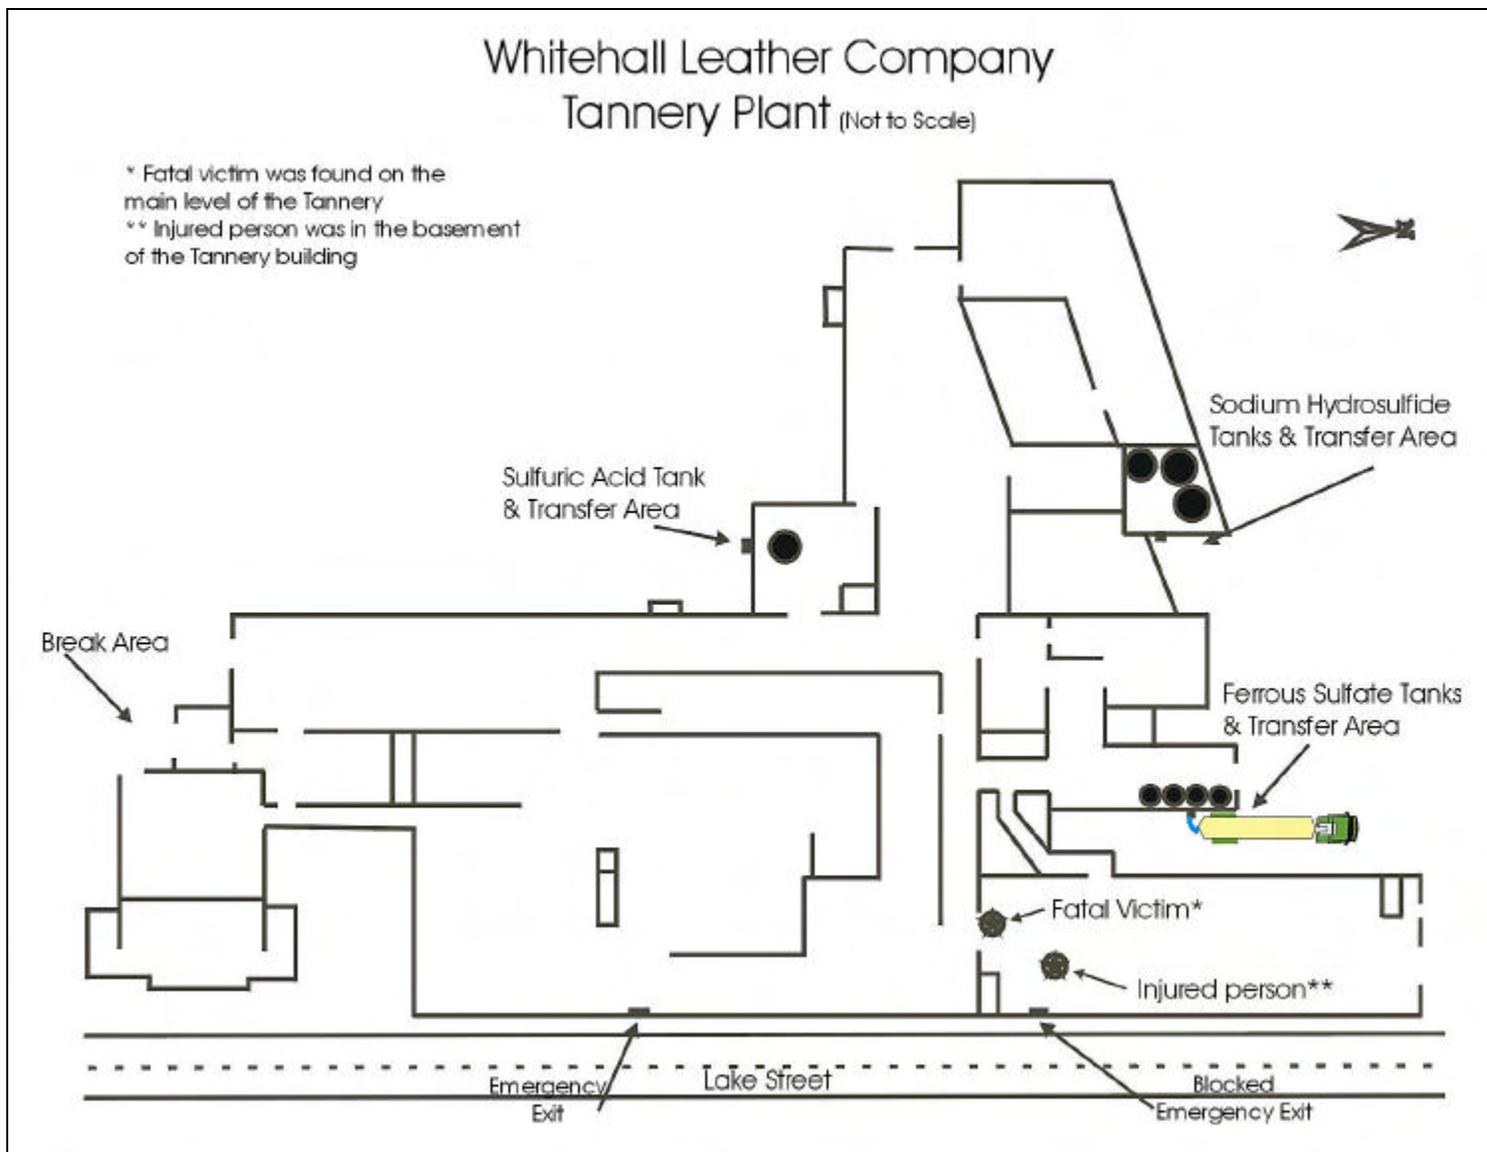
The ferrous sulfate transfer area was on the northeast side of the tannery facility. (See figure 3.) The connection was not equipped with a lock or any other safety or protective device.

**Figure 3.** Whitehall tannery layout indicating the locations of the sodium hydrosulfide and ferrous sulfate transfer areas and the location of the cargo tank at the time of the accident
