PIPELINE ACCIDENT REPORT

NATURAL GAS EXPLOSION AND FIRE IN
SOUTH RIDING, VIRGINIA
JULY 7, 1998

NTSB/PAR-01/01

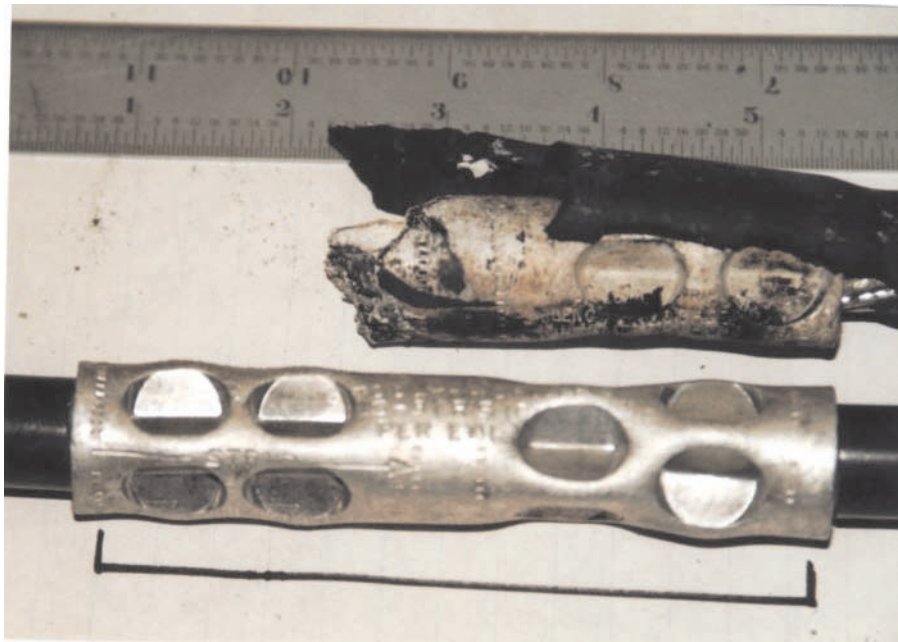
Cable B was completely separated. Between the two separated ends of the cable lay a clod of dirt. Portions of the interior of the clod showed a glassy appearance consistent with exposure to high heat. One end of the parted cable was attached to what remained of a crimp connector. Almost a third of the 4-inch-long crimp connector was missing. (See figure 5.)

Figure 5. Top: An aluminum crimp connector that was attached to one of the burned electrical cables found in proximity to the damaged natural gas pipeline. Bottom: An exemplar crimp connector (without its cold-shrink insulation).

Examination of the separated end of the connector revealed that approximately 60 percent of the surface was melted and had a glassy appearance, consistent with exposure of the connector to high temperature.¹¹ Removal of a small area of the melted and glassy material revealed white aluminum hydroxide deposits underneath. The aluminum hydroxide deposits were also observed on the remaining 40 percent of the damaged surface and on portions of the exterior surface of the connector. Aluminum hydroxide is a corrosion product that forms on aluminum that is exposed to moisture in a low-oxygen environment. Cuts and tears of various sizes were found in the cold-shrink insulation installed over the crimp connector immediately adjacent to the separation.

Removal of a small area of the melted and resolidified material from the heat-damaged section of cable B revealed aluminum hydroxide deposits indicative of corrosion. The corrosion deposits were also observed on the unmelted 40 percent of the damaged surface of cable B, as well as on portions of the exterior surface of the connector. This corrosion likely resulted from moisture that reached the crimp connector of cable B through the cuts and tears in the crimp connector insulation.

Because the cable ends inside the crimp connector do not meet, the full current load of the conductor must be transferred through the crimp connector. Unimpeded current flow thus depends on there being firm contact between the crimp connector and the cable ends. Evidence indicates that in this accident, the corrosion that occurred on and/or within one side of the splice connection reduced the contact resistance between the cable end and the crimp connector. Because the rate of corrosion of aluminum can be significantly accelerated when the material is energized,²² the amount of corrosion likely increased fairly rapidly, reducing the metal-to-metal contact. When the contact resistance increased sufficiently, the connector was no longer capable of supporting the required current flow without overheating and arcing. This arcing generated heat sufficient to destroy a portion of the conductor and the connector and to soften and weaken the nearby gas pipeline. Therefore, given the evidence of prior excavation damage to the insulation on cable B and the evidence of corrosion on the sides of the crimp connector near the damage, the Safety Board concludes that the damage to the protective insulation covering the splice in the electrical conductor identified as cable B allowed moisture to reach the crimp connector, causing corrosion that increased electrical resistance between the crimp connector and the cable sufficient to cause the splice to overheat and fail.
