# NATIONAL TRANSPORTATION SAFETY BOARD

## PIPELINE ACCIDENT REPORT

**SAN JUAN GAS COMPANY, INC./ENRON CORP.  
PROPANE GAS EXPLOSION IN SAN JUAN, PUERTO  
RICO, ON NOVEMBER 21, 1996**

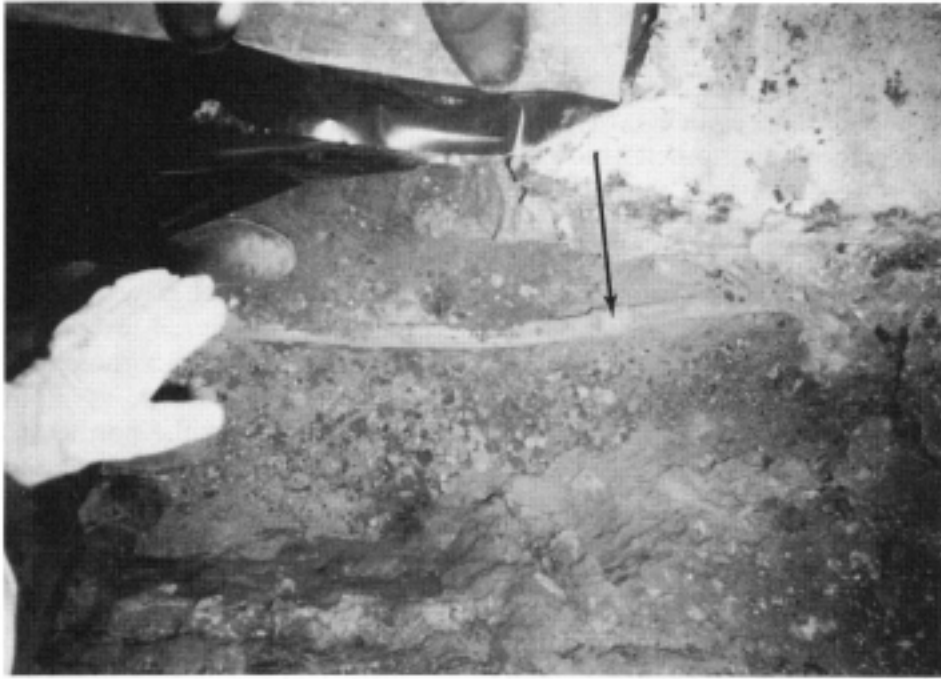
**Figure 5. Location of Crack in Plastic Gas Line to Chicken Kingdom.**

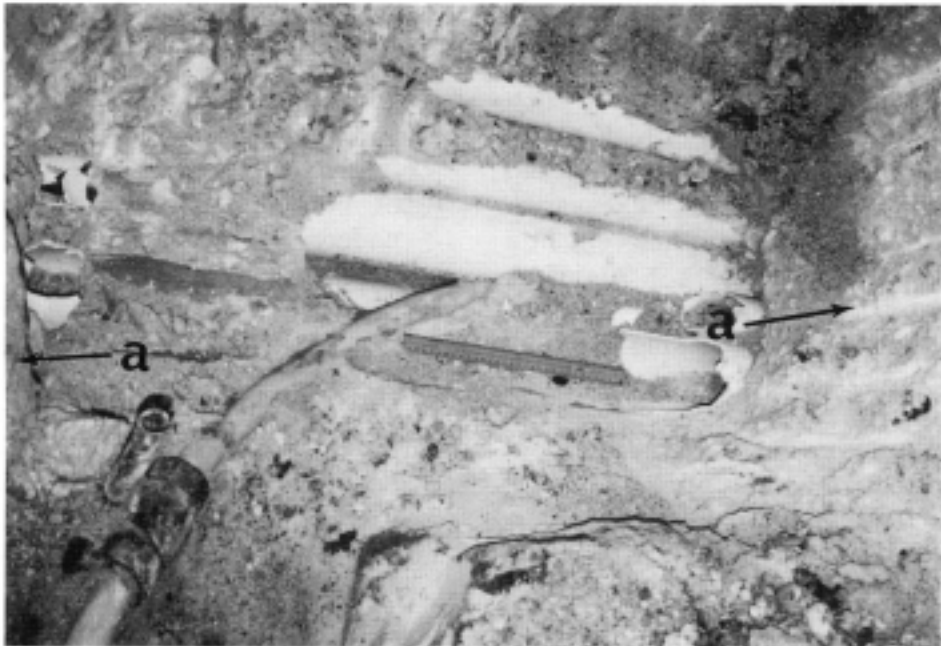
**Figure 6. Plastic Gas Line Entering Telephone Conduit Bundle in Concrete under Camelia Soto. (Arrows point to the concrete walls on each side of the excavation.)**

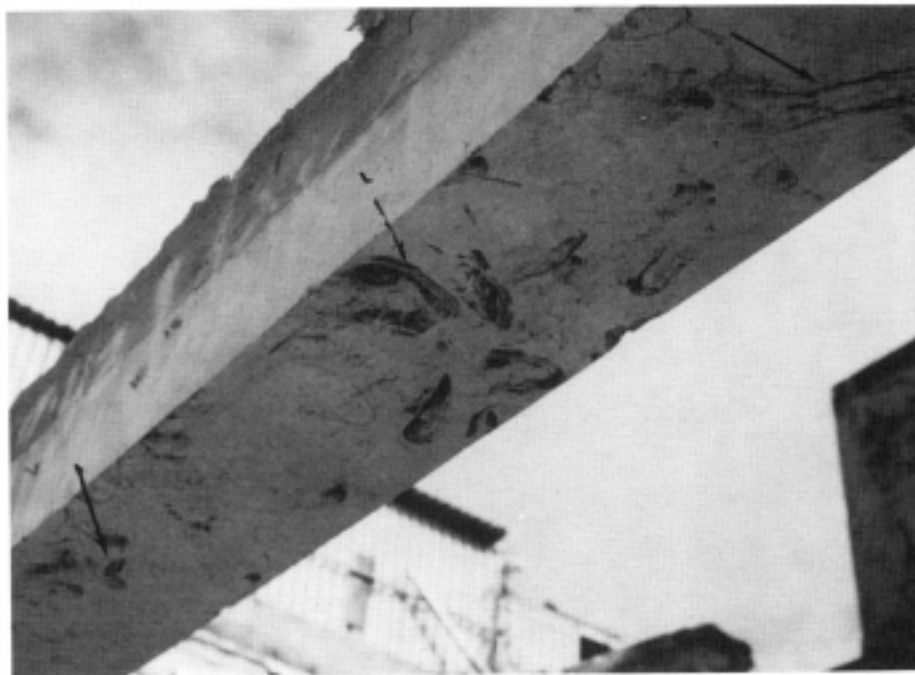
**Figure 9. Shoe Sole Imprints on Bottom of Beam in Basement of HV Building.**

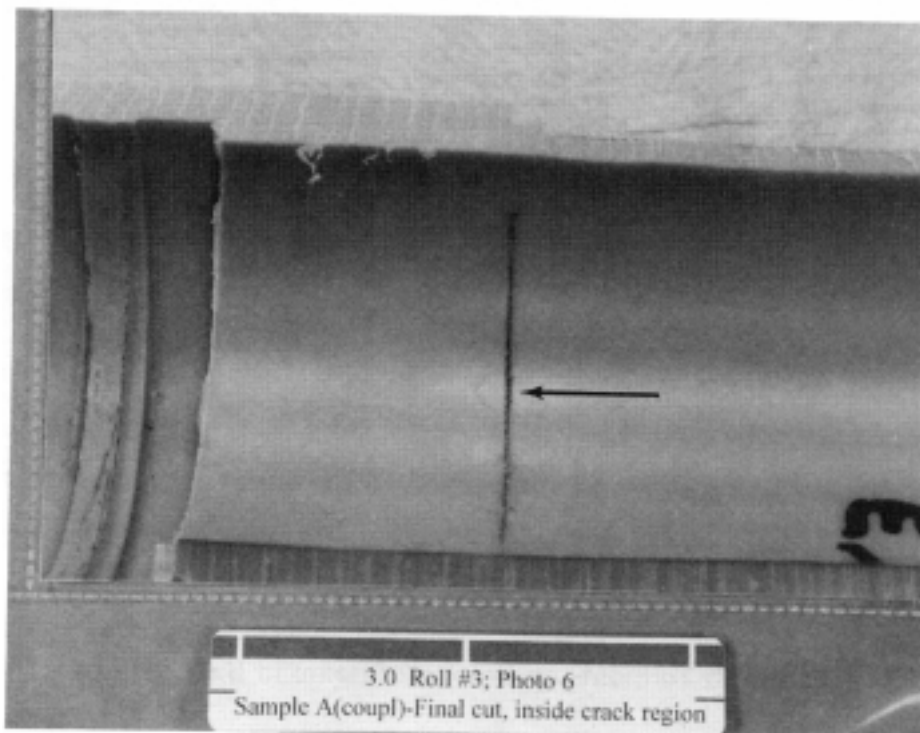
**Figure 10. Crack in 1 ¼ Inch Plastic Gas Service Pipe to Chicken Kingdom.**
