# An overview of fire protection of Swedish wooden churches

Brandforsk project 500-061

**SP Sveriges Provnings- och  
Forskningsinstitut**  
SP Rapport 2006:42  
ISBN 91-85533-28-9  
ISSN 0284-5172  
Borås 2006

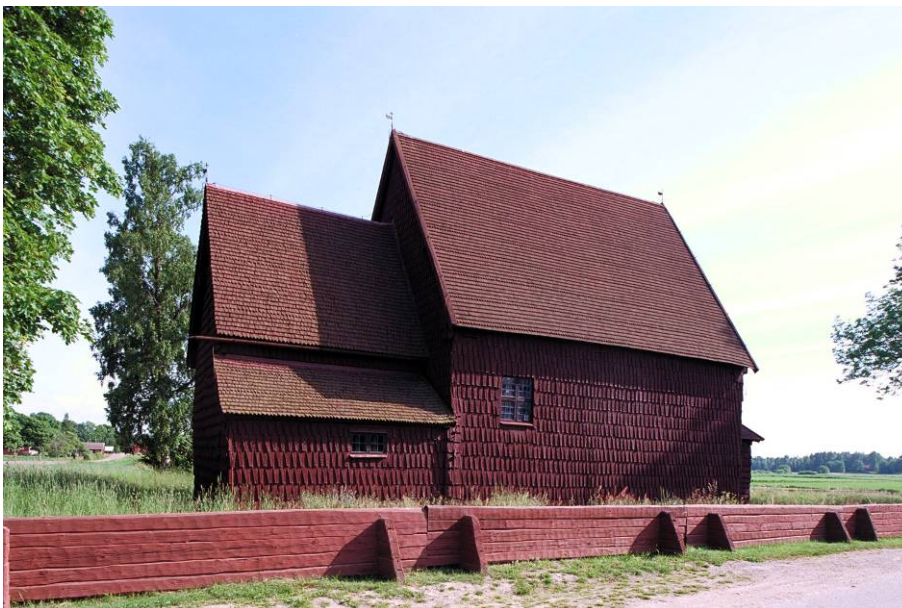
*Figure 1 The Södra Råda church was completely destroyed in a fire in November 2001. Photo: Swedish National Heritage Board.*

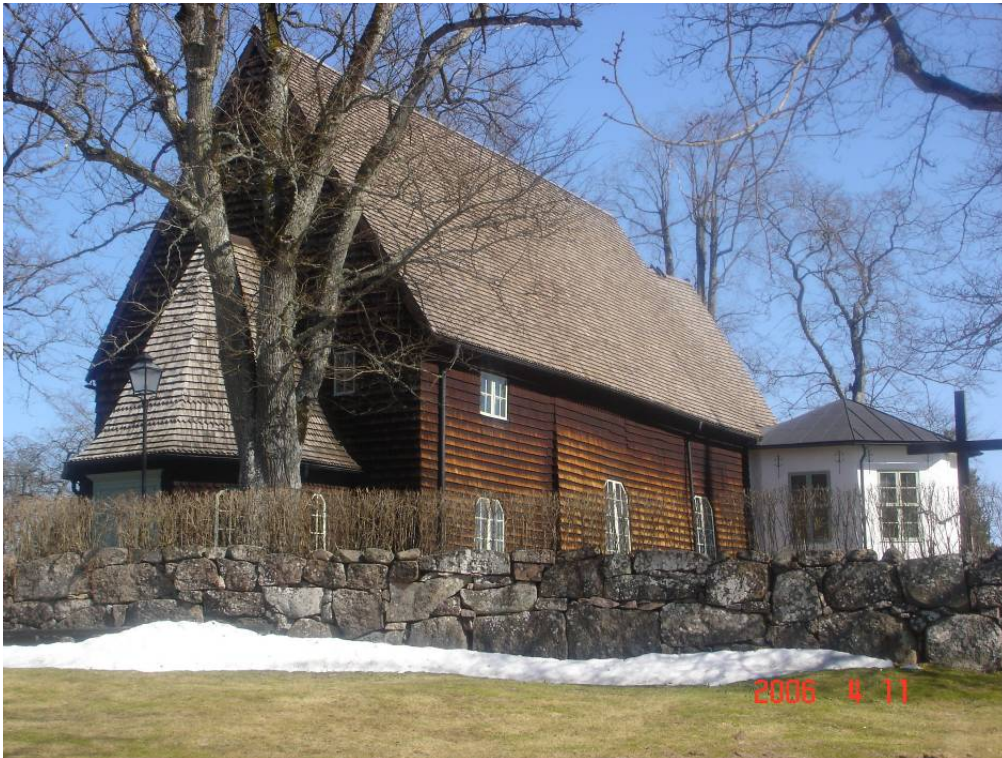
On the evening of Friday, August 26, 2005 an arson fire was avoided thanks to an observant church caretaker named Margit Andersson. At about 7 p.m. she visited the church to lock it for the night. She took a walk inside to ensure that everything was in proper order. However, back home she wondered if she shouldn't go back for another check, she reminded herself about talks the day before concerning a burglar in the nearby Djursdala church. Therefore, she went back at about 10 p.m. After unlocking the door to the church she made the observation that a key wasn't in its intended position, it should have been on a nail in a hidden place. She also made the observation that a candle was missing from one of the candelabra placed on a table in the sacristy.

Figure 2 Pelarne church, where an attempt to start fire was made in August 2005.

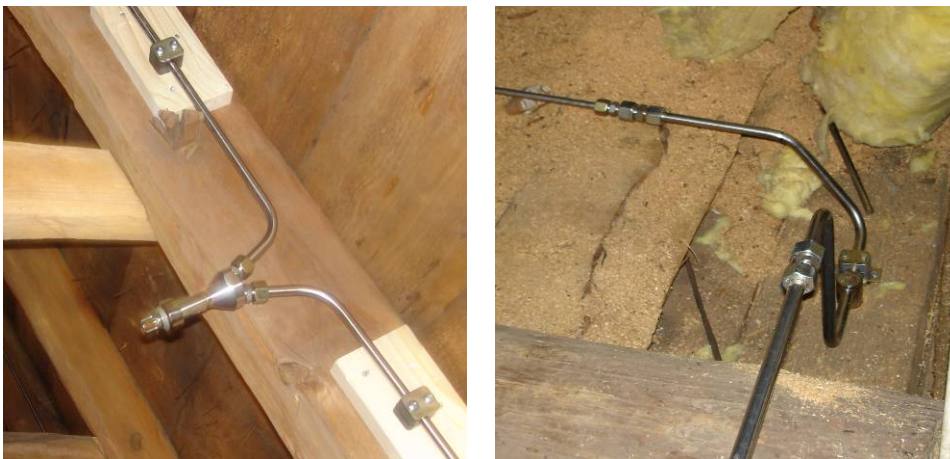
For this reason, some of the installations utilize the possibility to manually flush the system with compressed air after the water is turned off. However, it should be pointed out that it is important that flushing of the system should be undertaken immediately after system shut-down, if the ambient temperature is low. Complete flushing requires a special nozzle connection. Instead of a traditional T-connection a Y-connection is used. This connection limits the amount of standing water at the inlet of the nozzles. Each of the ends, respectively, of the branch lines of the system is equipped with a ball valve. This valve is opened and the pipe is flushed with compressed air from the other end.

*Figure 5 Y-connections are used to limit the amount of standing water at the inlet of the nozzles. To the left is shown an automatic nozzle inside the attic of Frödinge church. To the right, an automatic nozzle protecting the interior of Fröskog church, is shown.*

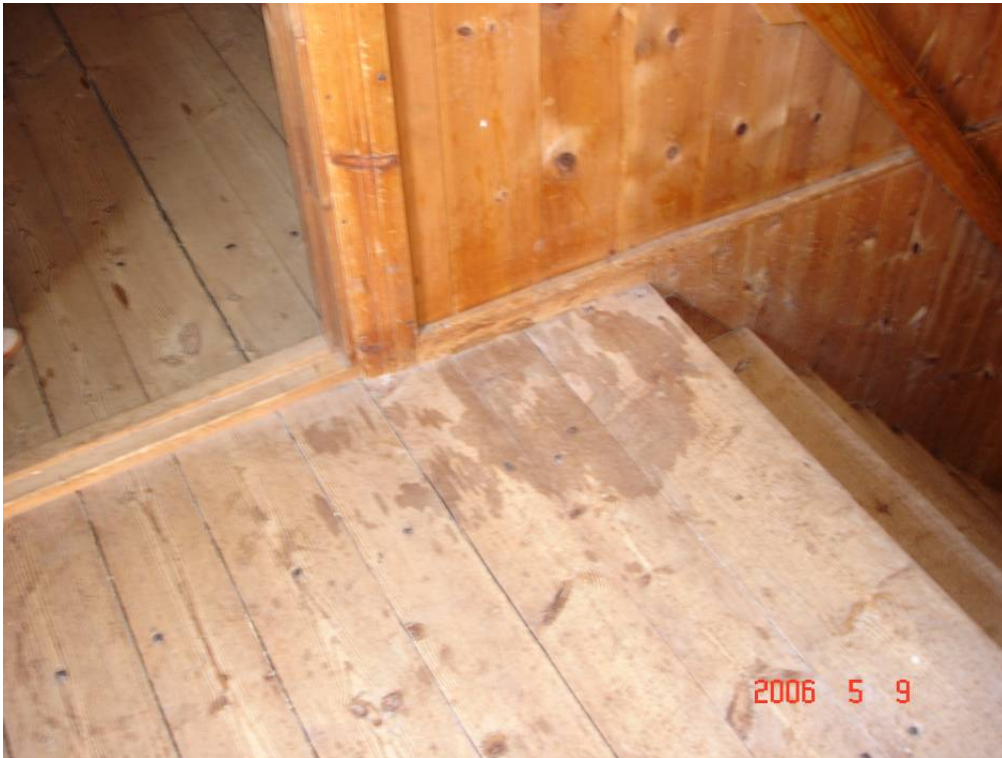
The use of an antifreeze solution increases the complexity of the system and the required maintenance work. Another drawback is that antifreeze solutions may leak and are definitely distributed during the activation of the system. The interior and items inside heritage buildings are especially vulnerable to any damage from the antifreeze solution, as documented during the installation in the Habo church. A small leakage of the antifreeze solution, consisting of a mixture of organic salts, left an intimidating spot on the wooden flooring, see figure 6.

*Figure 6 A spot on the floor at the Habo church caused by the leakage of the antifreeze solution used for (parts of) the sprinkler system.*

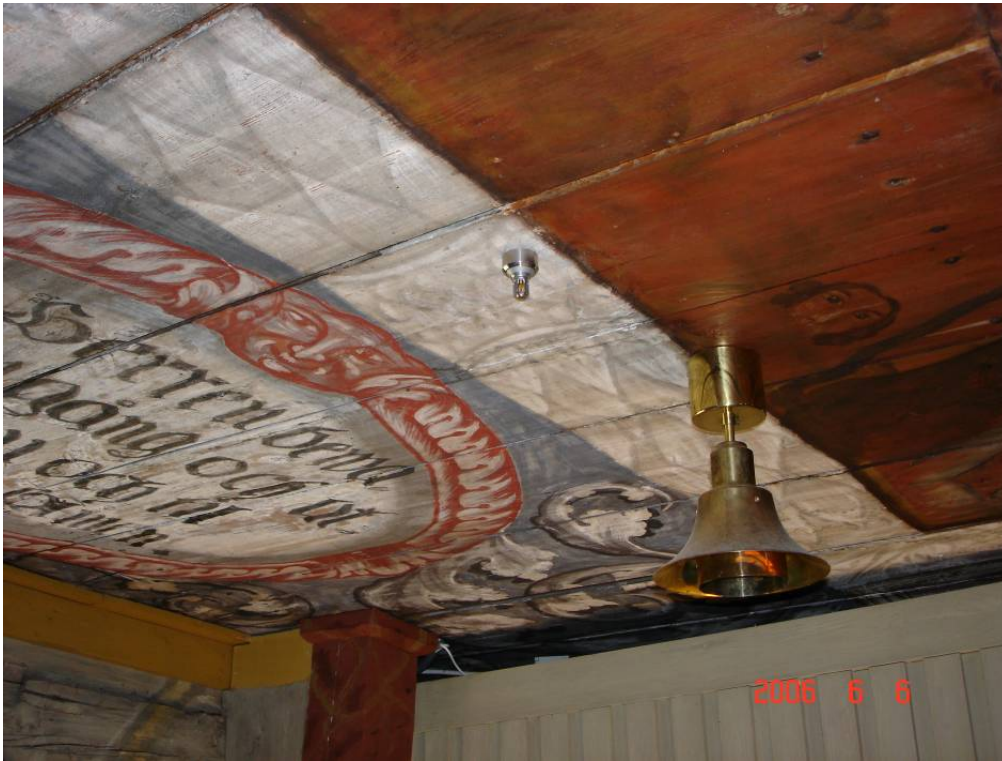
*Figure 7 An automatic high-pressure water mist nozzle in Älgårds church. The position of a nozzle is often a compromise between fire protection, cultural historical and aesthetical demands.*

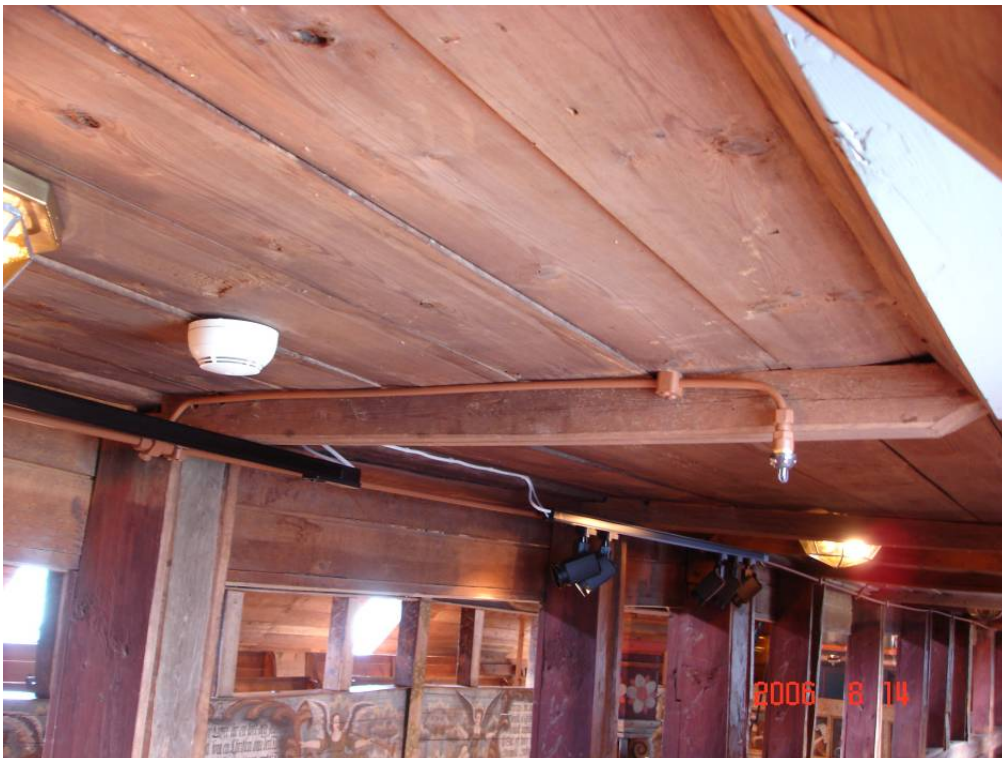
*Figure 8 Sometimes, the sprinkler piping can not be concealed, but with the smaller diameter piping associated with high-pressure water mist systems, the installation can be made very discreet as in Habo church.*

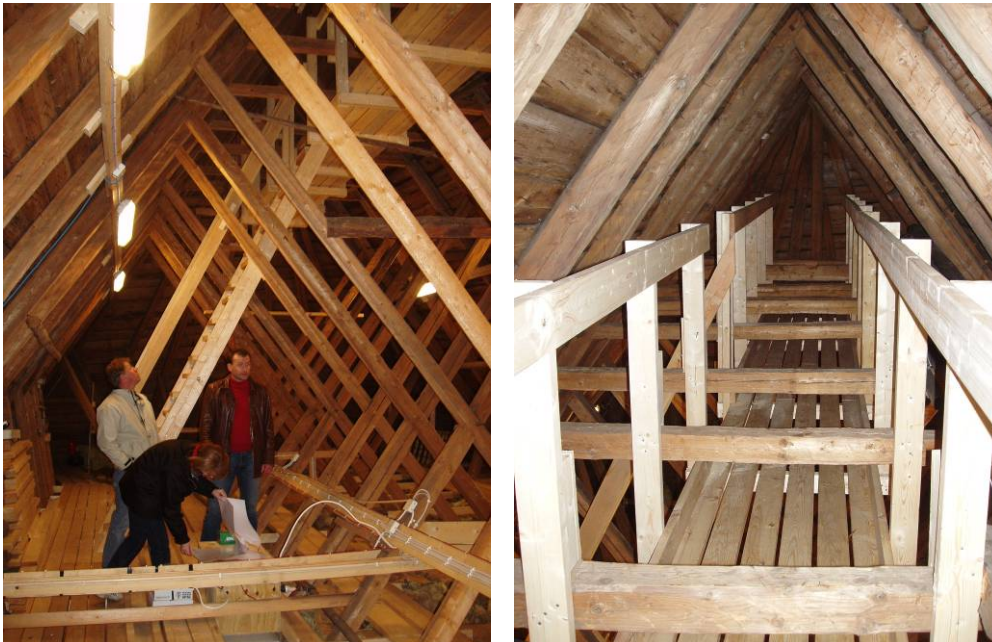
Figure 9 Permanent working platforms inside the attic of Fröskog church. The platform flooring at the top level was built under the beams, to allow full standing height. Photo: Jan G Andersson.

For system installation inside attics, the construction of permanent working platforms is recommended. This will help prevent damage to the church, facilitate the system installation and will make future inspection, tests and maintenance a lot easier. Another good reason for working platforms is the improved working safety. The figures below show working platforms at low and high level, respectively, inside the attic of Fröskog church. The platforms were installed in such a way that interference with the building was minimised and with the understanding that any future dismantling should be easily achievable.

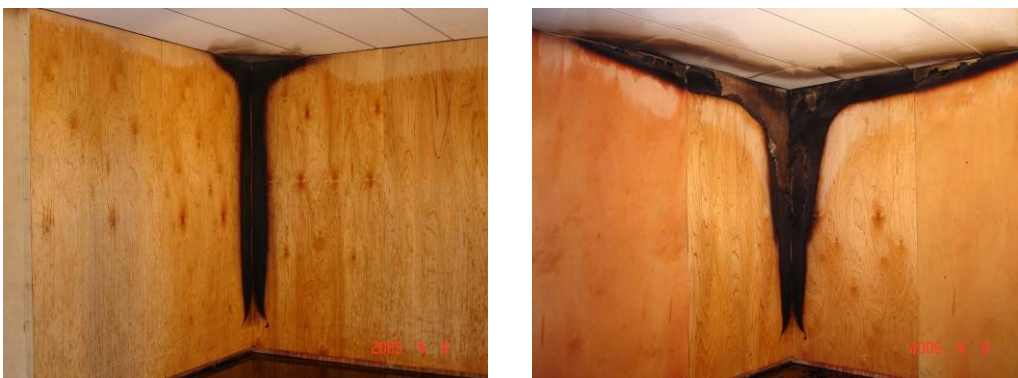
The importance of providing wetting of walls in order to reduce fire damage is illustrated on figure 13. The photos show fire damage to two corner walls with an outer layer of 3 mm plywood. The nozzle used in the photo on the left hand side had wall wetting capabilities superior to the nozzle used in the photo on the right hand side. The parts of the walls that were wetted or not wetted by the water spray are clearly distinguished. If a fire spreads up a combustible wall, the size of the fire and the associated fire damage can be large if no water, or very little water, reaches the wall.

*Figure 13* Illustrative results from two fire tests, where the nozzle used in the photo on the left hand side had wall wetting capabilities superior of the nozzle used in the photo on the right hand side. The fire source consisted of a 100 kW propane gas burner positioned close to the corner walls (not shown in the photos).

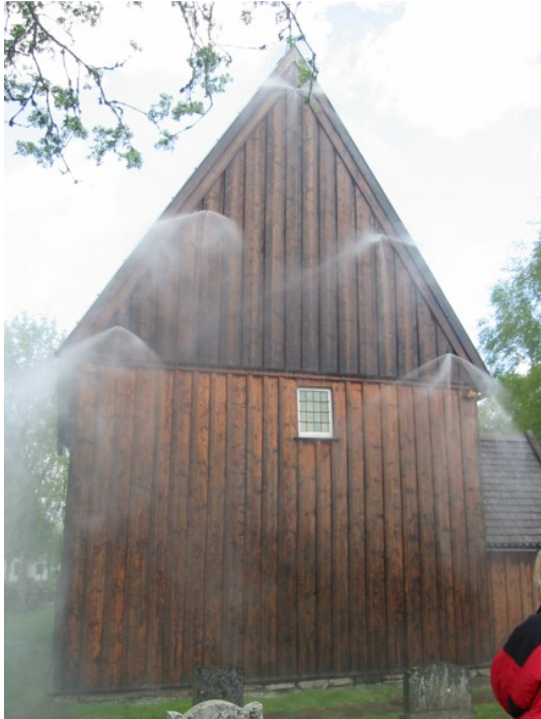
*Functional test of one of the sections that protects the facades of the church. Wind velocity was high during the test; however, the water spray from the nozzles was not significantly affected. Note: The water spray provided a more uniform and higher degree of wall wetting than indicated by the photo. Photo: Anders Lönnermark.*

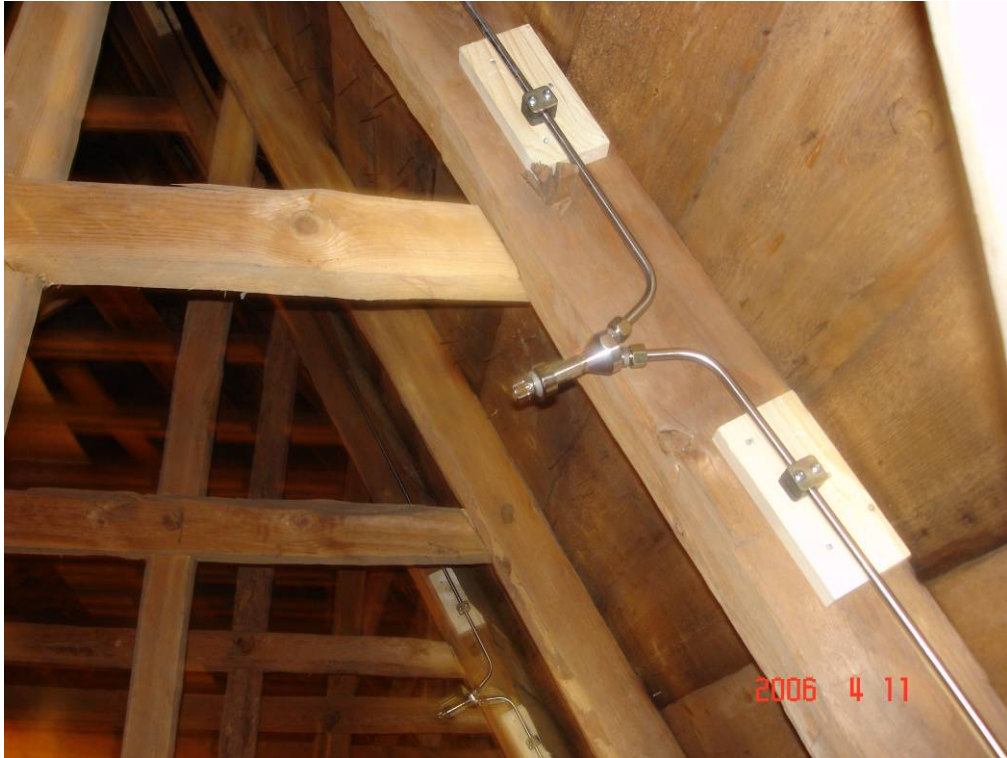
*High-pressure water mist nozzles protecting the attic of the church. Note that Y-connection is used instead of a traditional T-connection. This connection limits the amount of standing water at the inlet of the nozzles and improves the possibilities to flush the piping with compressed air after an activation.*

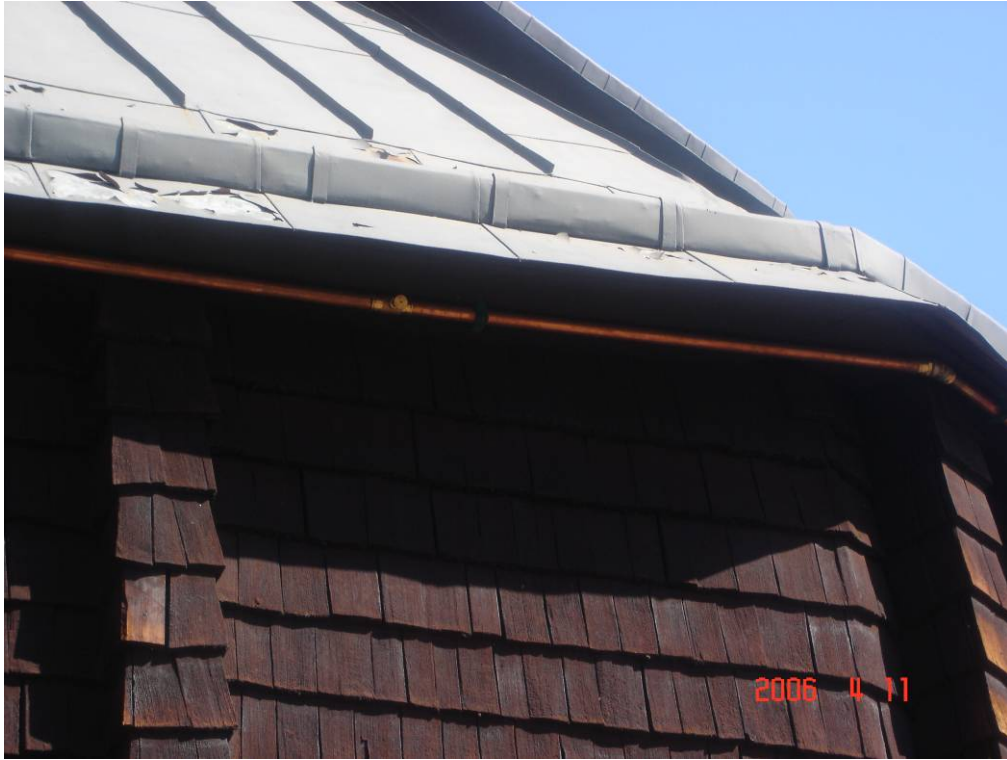
*The copper sprinkler piping for the sprinklers protecting the facades. Note: The colour of the pipe will become darker with time, making the pipe less visible, which is the reason for choosing copper over stainless steel. Standard (upright) spray sprinklers, positioned horizontally, are used.*

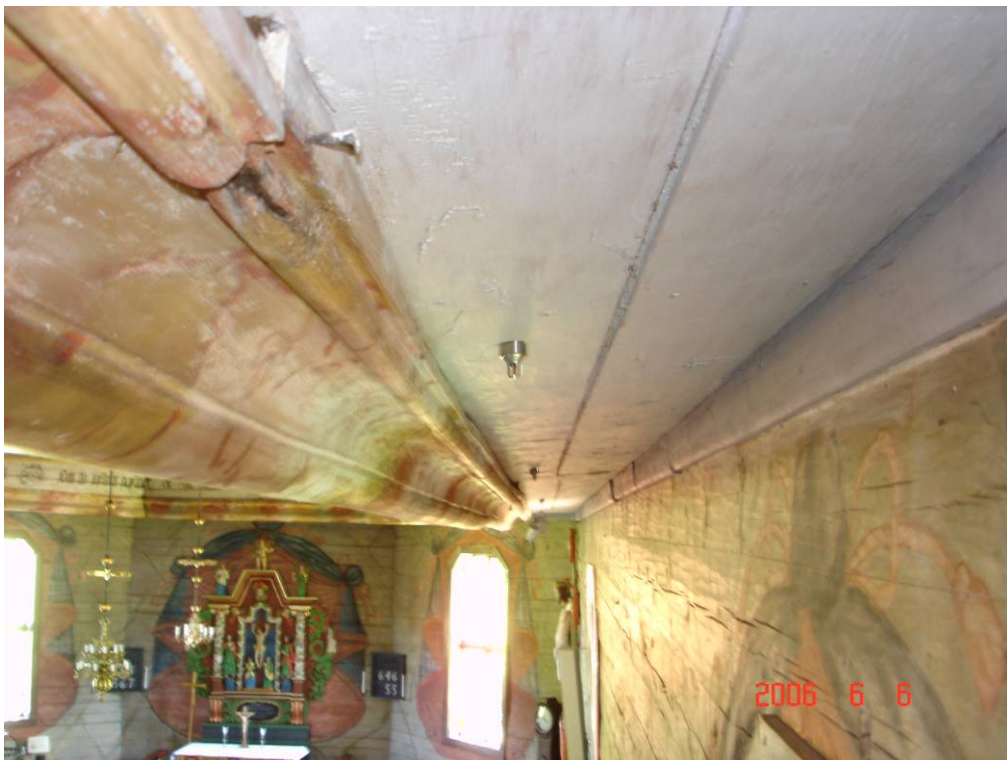
*One row of automatic nozzles positioned close to a wall. These nozzles have a smaller  $K$ -factor as compared ( $K=0,8$ ) as compared to the other nozzles used for the interior, in order to limit the amount that hits the walls paintings.*
