**Report No 10** (August 10, 2005)

#### Introduction

During a fierce thunderstorm at Pearson International Airport, an Air France Airbus 340 with 309 people aboard skidded off the end of runway 24L at 4:09 pm. The plane overshot the East-west runway by approximately 200 meters (660 feet), crashed through barriers and fell into a small ravine near a stand of trees close to the busy highway 401. A short time later the plane burst into flames.

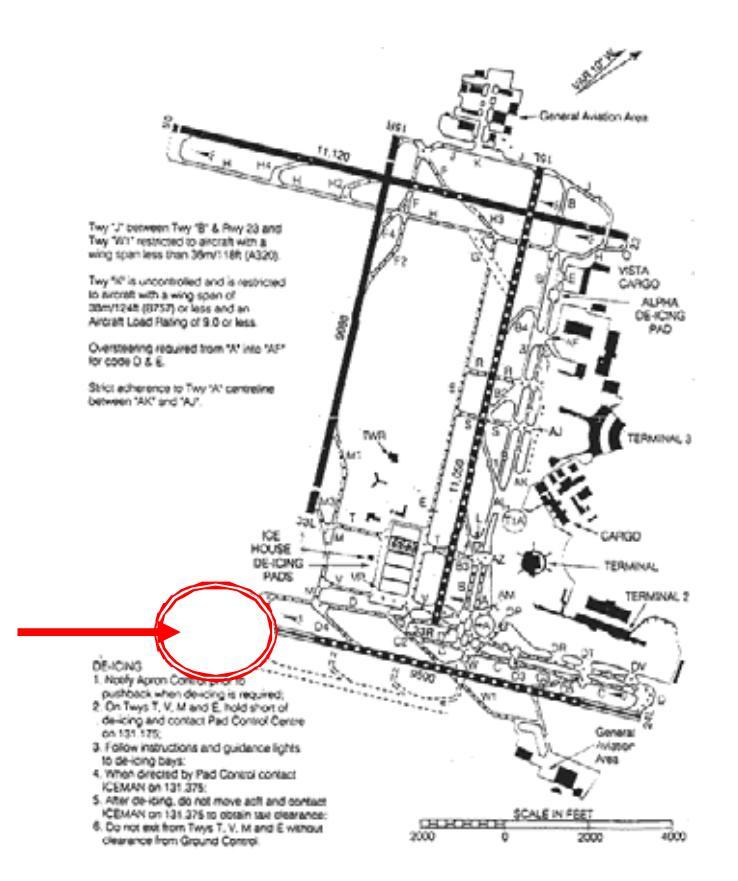
The burning wreckage and clouds of black smoke were seen on live video captured by different sources including CTV cameras at highway 401. Firefighting efforts continued for several hours.

The crashed airplane was an Airbus A340-300 with the registration number F-GLZQ and it has been in service since 1999. The aircraft was last inspected on July 5, and it had flown 28,418 flight hours across a total of 3,711 flights.

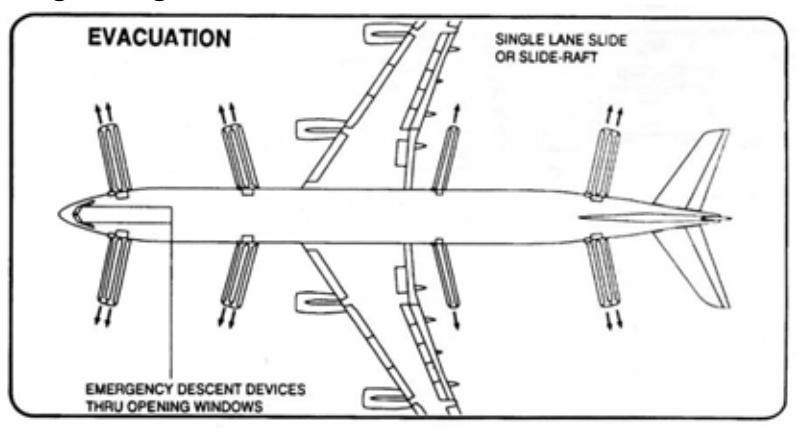
Graphic showing the eight available exits at an Airbus A 340 aircraft:

After the aircraft came to halt in the ravine, the occupants tried immediately b escape from the wreckage while flames were visible outside the fuselage. Four of eight doors of the A 340 failed to open or were not opened. One of the used doors was difficult to open. In addition two emergency slides failed to deploy properly. It is not known as of yet whether this was caused by a failure of the device itself or improper handling by crew members or passengers (i.e., pulling the slide/raft disengage handle).
