United States Fire Administration

Technical Report Series

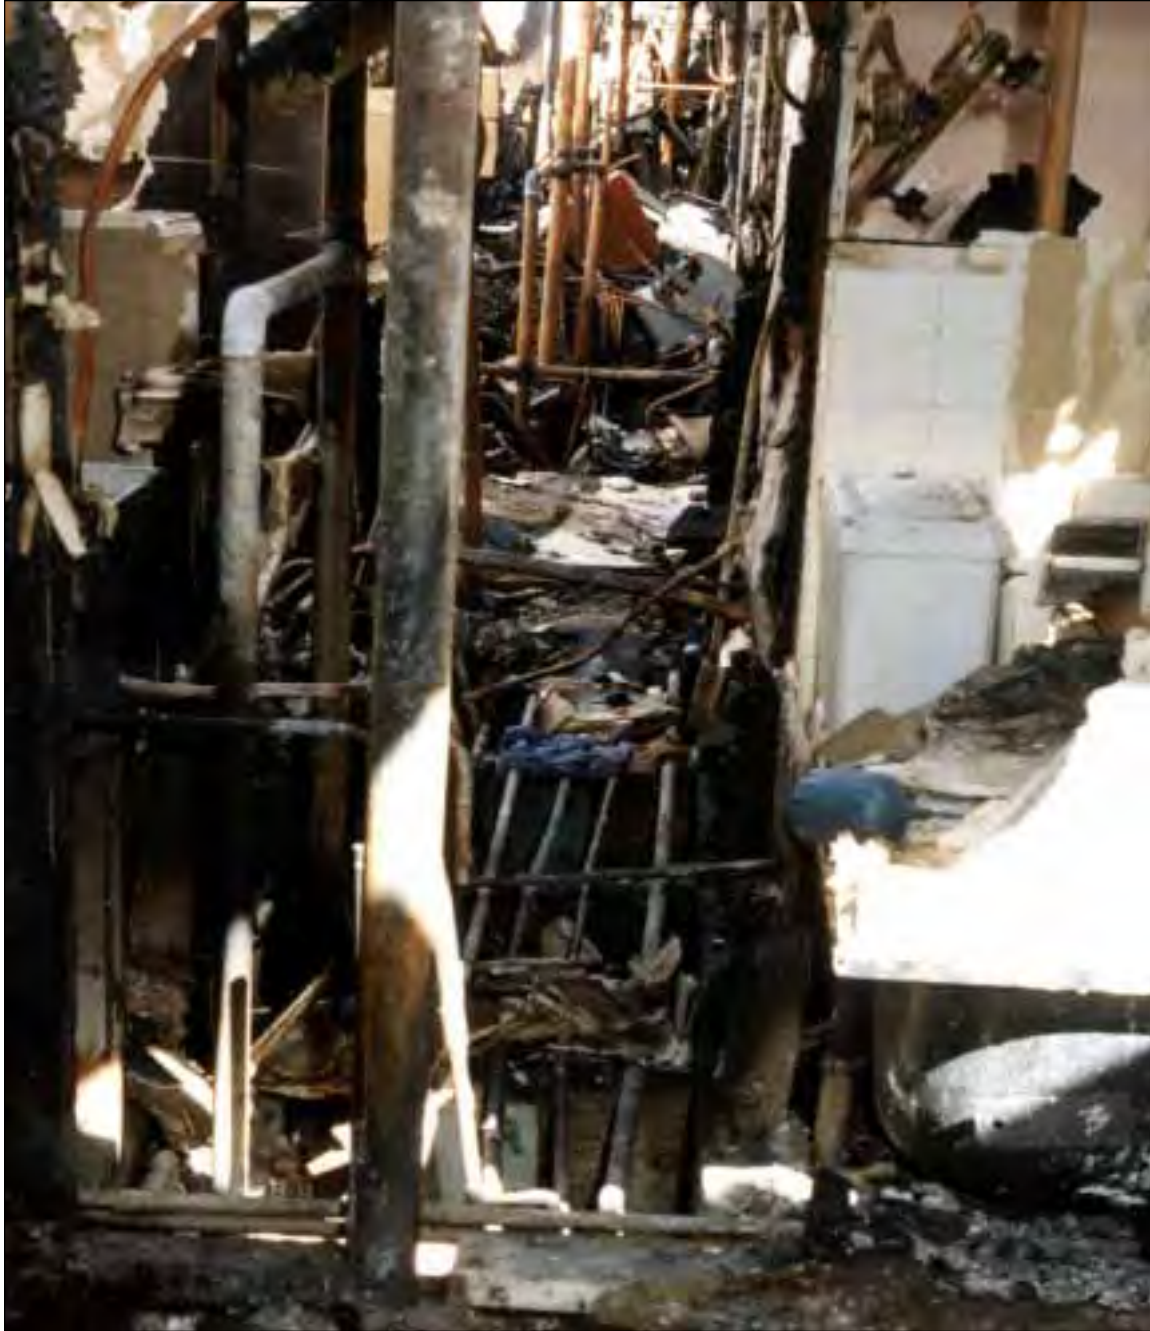
7. The west end of the utility chase in the front wing. Room 222 is to the left and Room 211 to the right. The second floor utility chase walls were burned away.

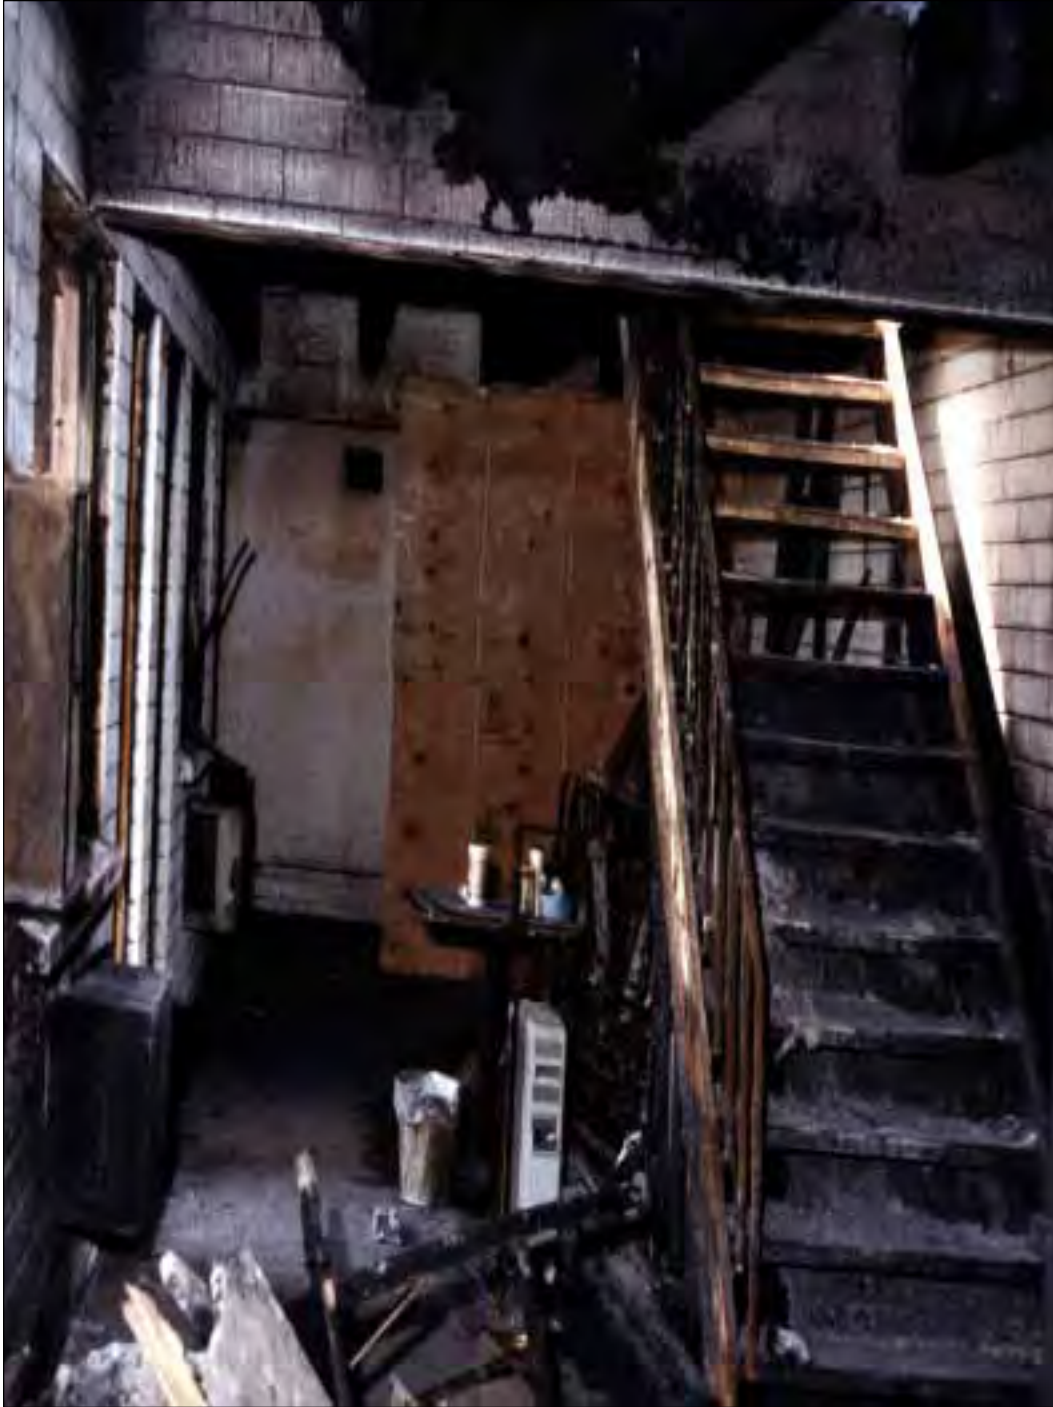
8. The 200 level breezeway area outside of Rooms 220 to 222 looking west. The open stairway to the 300 level is on the right. Under the stairs is another storage room whose wood stud and gypsum board walls were destroyed by the fire.

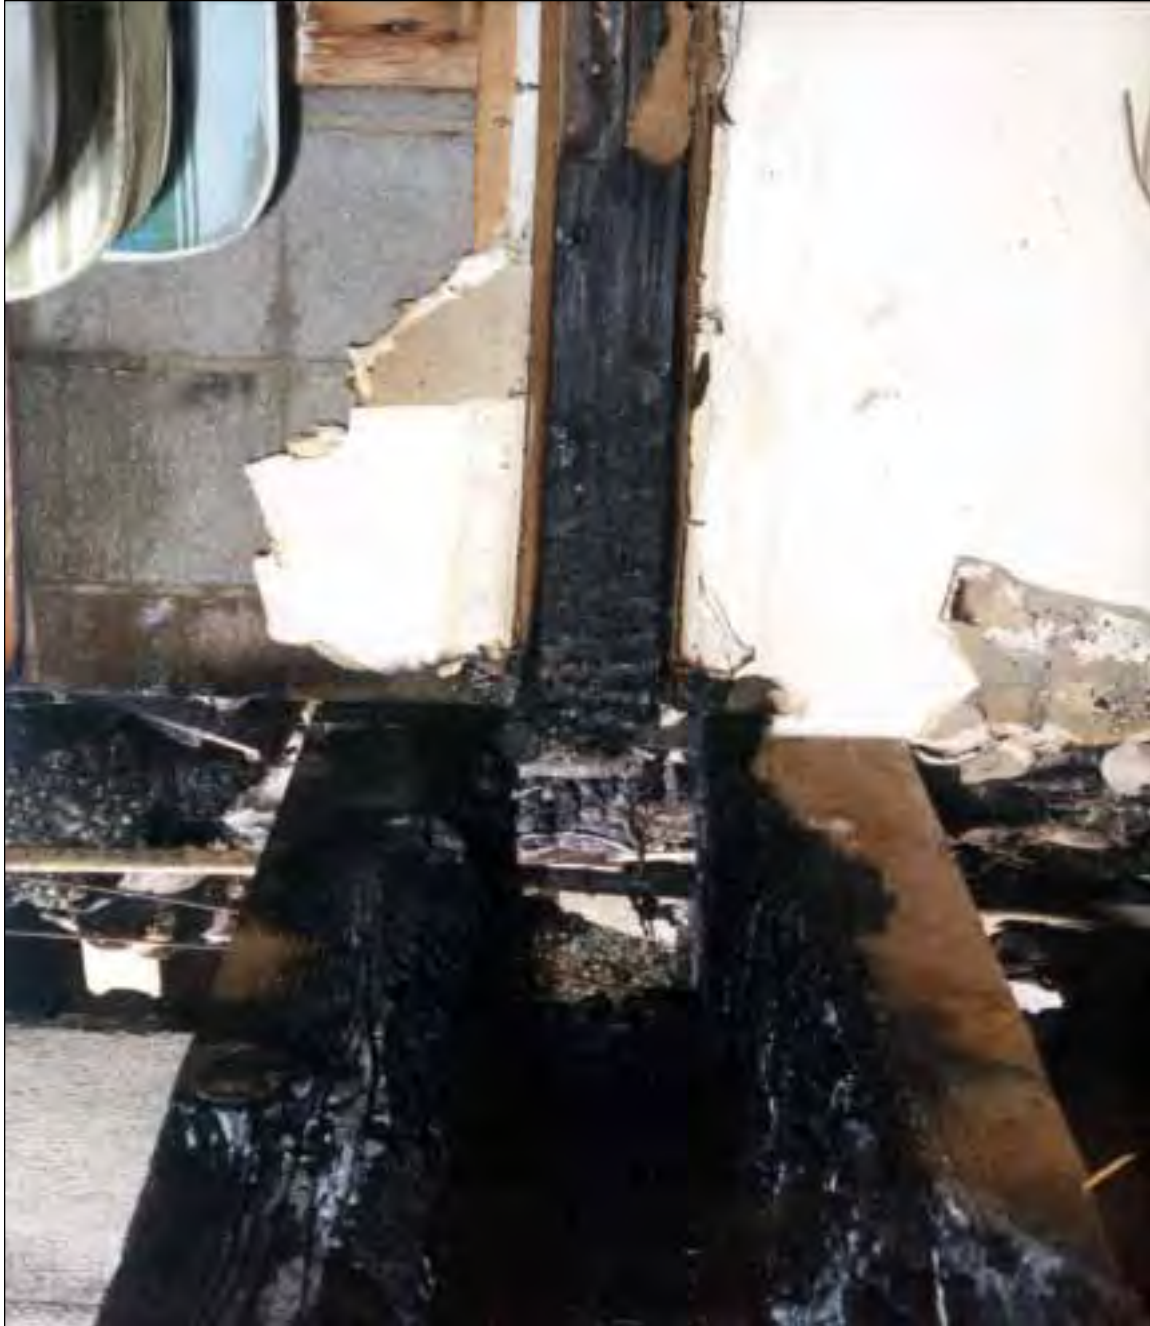
9. A separation wall between 100 level guest rooms that was burned from the inside out. The parallel wood beams formed the top of the wall and the communication to the utility chase is at the back.

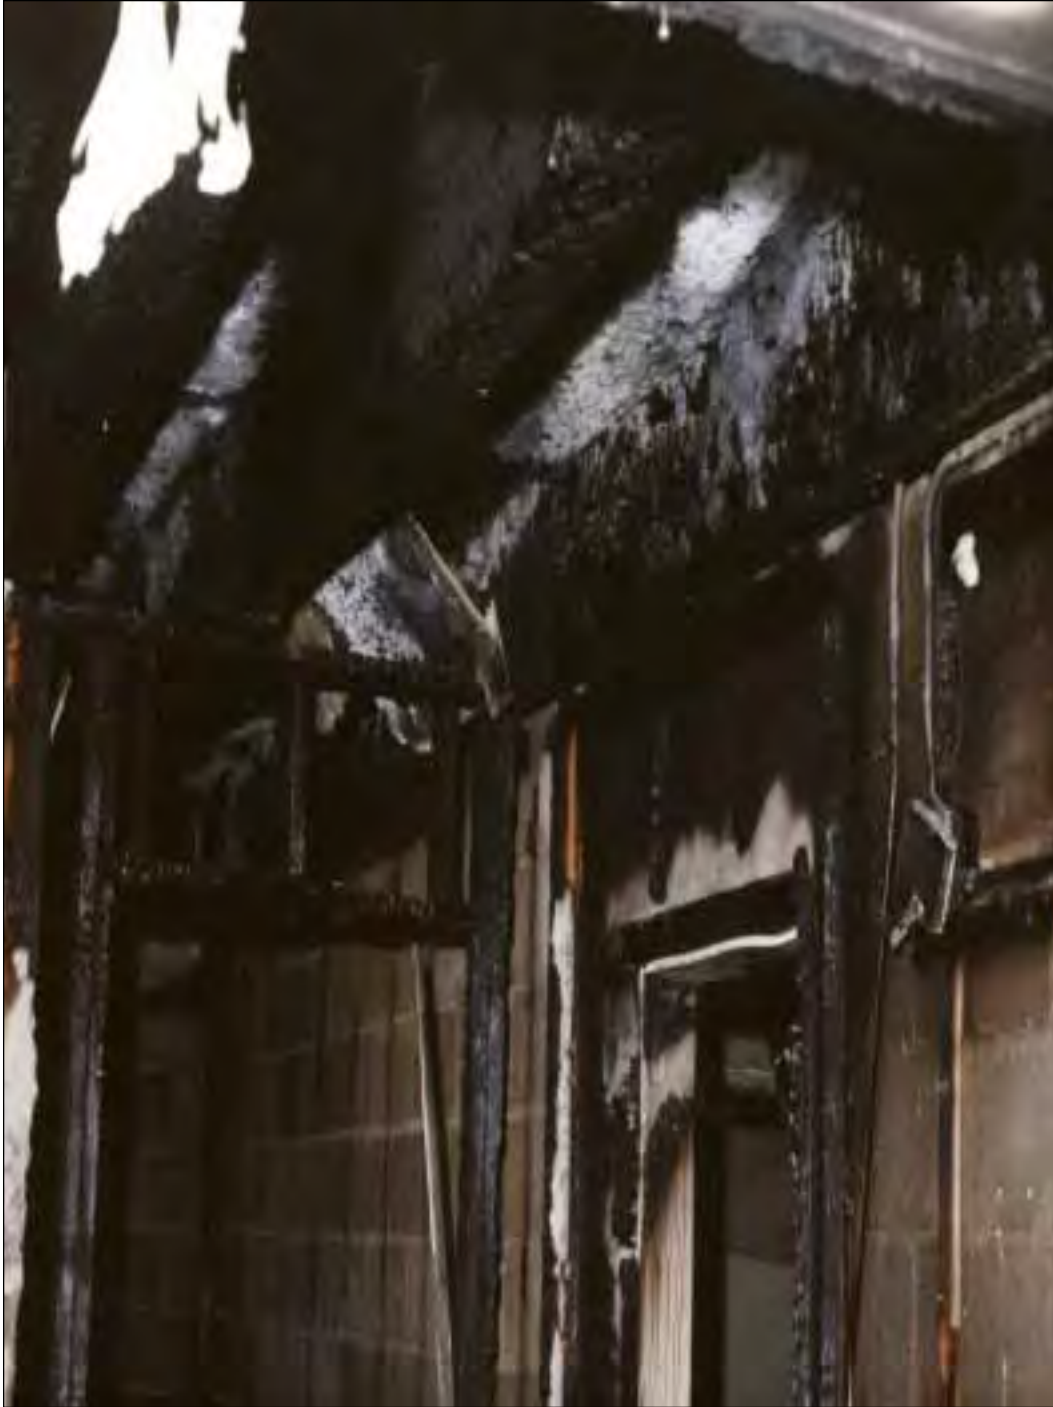
10. The top of the door frame for the 100 level closet determined to be the point of origin. The open stairway to the 200 level is to the top left off the photograph.
