# Research helps the fighting of a silo fire again

SP's experience in research into fighting silo fires has again been of benefit, this time in connection with a fire in a wood powder silo at Jönköpings Energi. The following is a brief description of the events and some pictures from the work.

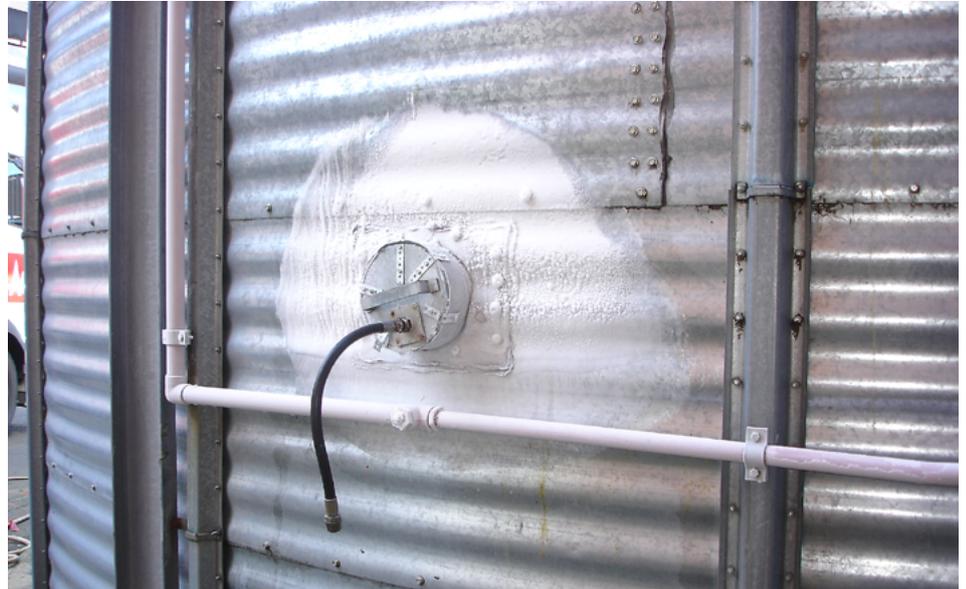
*Ice formed around the CO<sub>2</sub> piping system and in the wood powder.*

During the day, the intensity of the fire was controlled by injection of more carbon dioxide into the top of the silo at regular intervals. The lower injection points had been disconnected because of the freezing at an injection point. SP's personnel arrived at about 15:00 and set up equipment for measuring CO, CO<sub>2</sub> and O<sub>2</sub> concentrations, as well as the tempera-

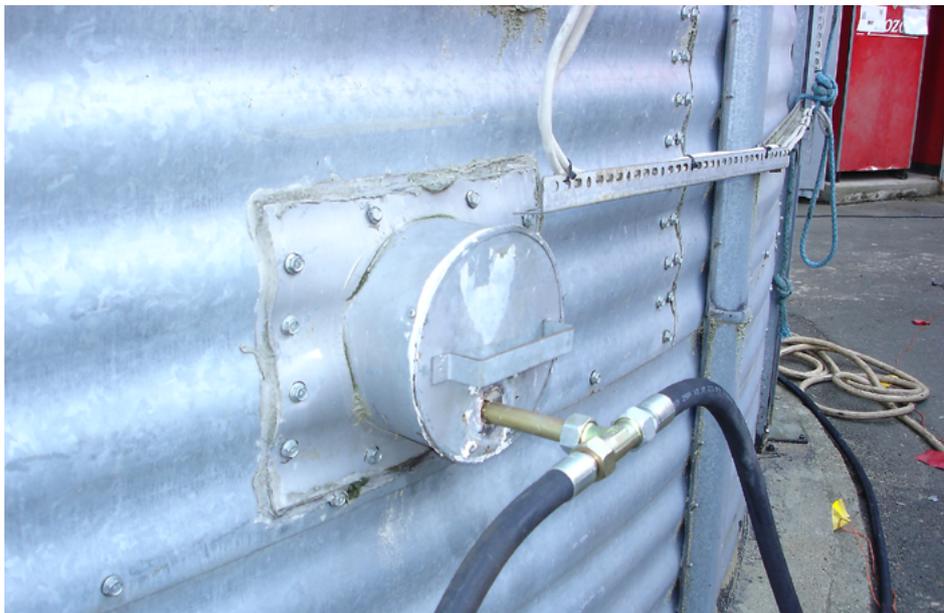
*The carbon dioxide nozzles were removed and replaced by lances for injection of nitrogen into the wood powder.*

ture inside the top of the silo. We also assisted in planning continued tackling of the fire. With this information, personnel from Jönköpings Energi quickly manufactured four injection lances and a hose system. The lances were inserted into the silo through the frozen carbon dioxide delivery positions, thus slowly driving nitrogen up through the wood powder. After the gas equipment and nitrogen had arrived, the injection of nitrogen started shortly after 20:00 on Thursday evening. After a few hours' gas injection, it could be seen that the smoke from the top of

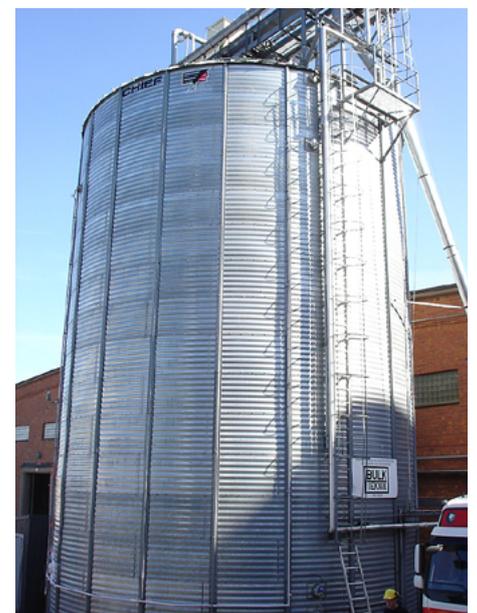
*The silo in which the fire occurred.*

The 15 m high silo, used for the storage of wood powder, has a diameter of 10 m, giving a total volume of about 1000 m<sup>3</sup> and a maximum storage capacity of 200 tonnes of wood powder. At the time of the fire, the silo contained about 130 tonnes.

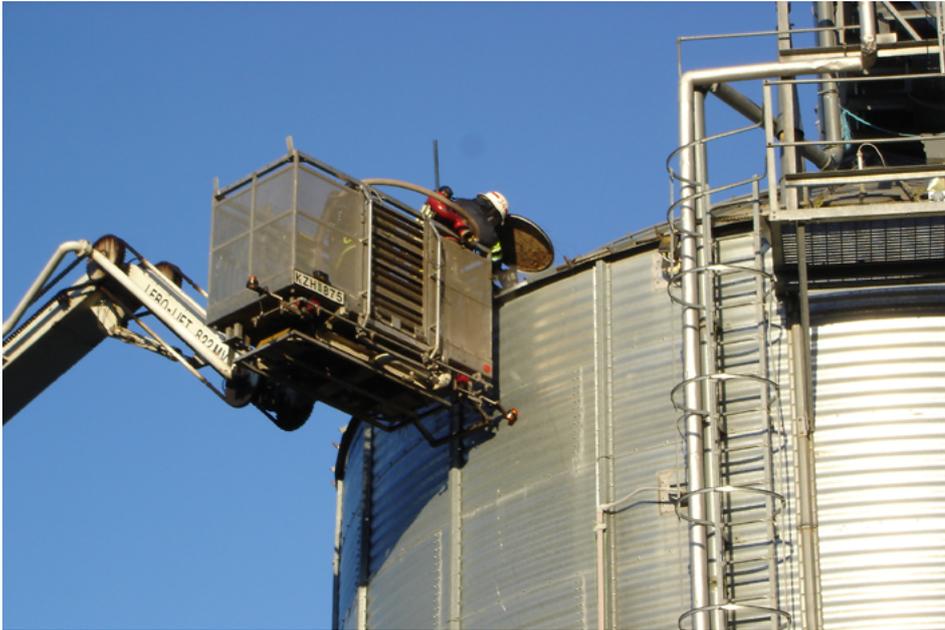
The fire and rescue service checked regularly the surface of the pellets for combustion zones with an IR camera.

and recommendations, as well as with instrumentation for monitoring the effect of fire-fighting actions. The Fire and Rescue Service had already ordered a tank of liquid nitrogen, with an evaporator, for continued fire-fighting. Throughout the work, the Fire and Rescue Service had been monitoring the top surface of the wood powder with an IR camera at hourly intervals through one of the covers in the top of the silo.

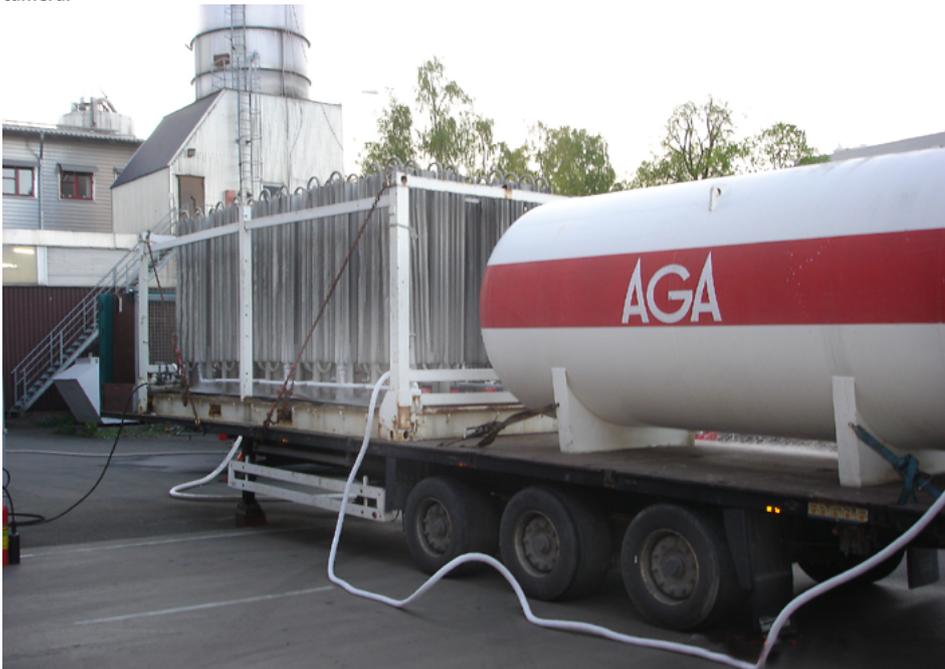
The nitrogen tank and evaporator parked by the silo.
