THE KANSAS CITY TRAGEDY— PART 2

MICHAEL S. ISNER
Fire Protection Engineer
NFPA Fire Investigations Division

The conclusion of the NFPA investigative report looks at the tragic aftermath, analyzes the cause and origin, and cites the lessons to be learned from the fatal explosions in Kansas City last November.

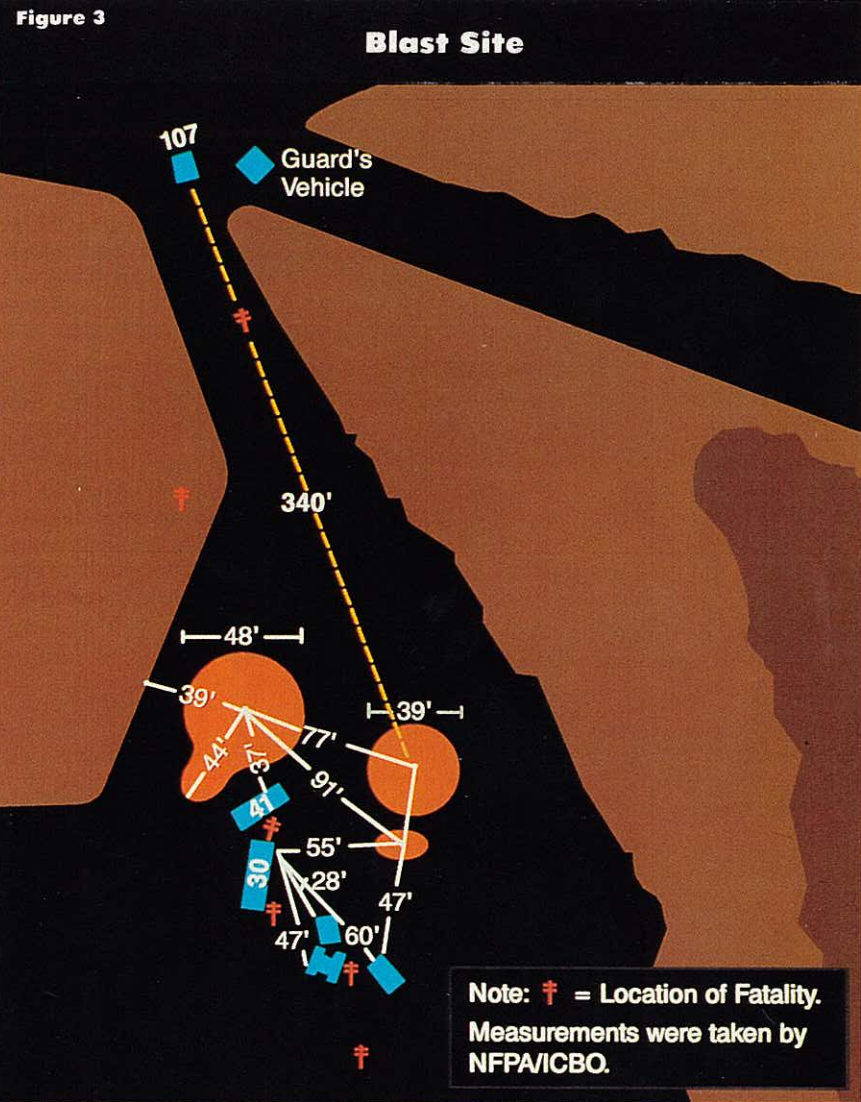
ALL SIX FIRE FIGHTERS FROM PUMPERS 30 AND 41 WERE killed in the first explosion. The figure shows the location of the bodies. The battalion chief's driver, who was standing next to the guard's vehicle on the north access road, received minor injuries; he was released from the hospital the same day.

Pumper 41 was nearest the crater where Trailer No. 2 once had been. The fire pump and the occupant cab of Pumper 41 were still attached to its chassis, but most of this vehicle's body was missing. The remaining components of the cab were so heav-

Pumper 30 lay about 8 to 10 feet south of the other pumper. Though heavily damaged, this vehicle's major body components remained in place on the chassis, and Pumper 30 was recognizable.

Three craters marked the locations of the two parked trailers. When Trailer No. 1 exploded, two craters were formed, one 38 feet across and 6 feet deep, the other 20 feet long and 4½ feet deep. It is not known why two craters were formed, but an

imaginary line drawn between the center of the craters corresponds to the longitudinal axis of Trailer No. 1 as it reportedly was parked. The third crater showed where Trailer No. 2 had been parked. This crater was 49 feet across, 6½ to 7 feet deep, and had a 20-foot elongation at one point. It is assumed that the direction of the elongation corresponds to the longitudinal axis of Trailer No. 2.

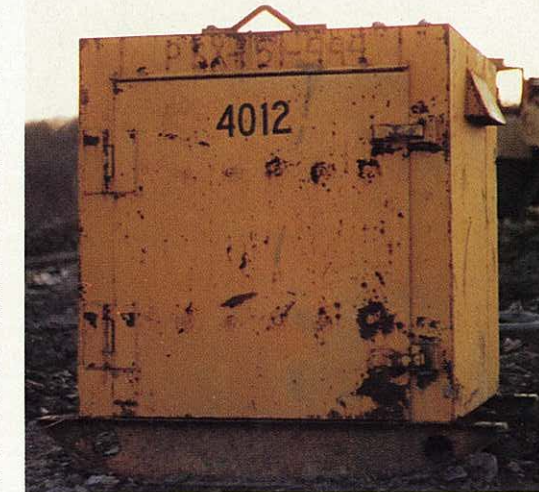
Blasting caps were stored in this yellow magazine, which measures about 5-by-5-by-5 feet. It was one of two magazines not involved in the explosions.

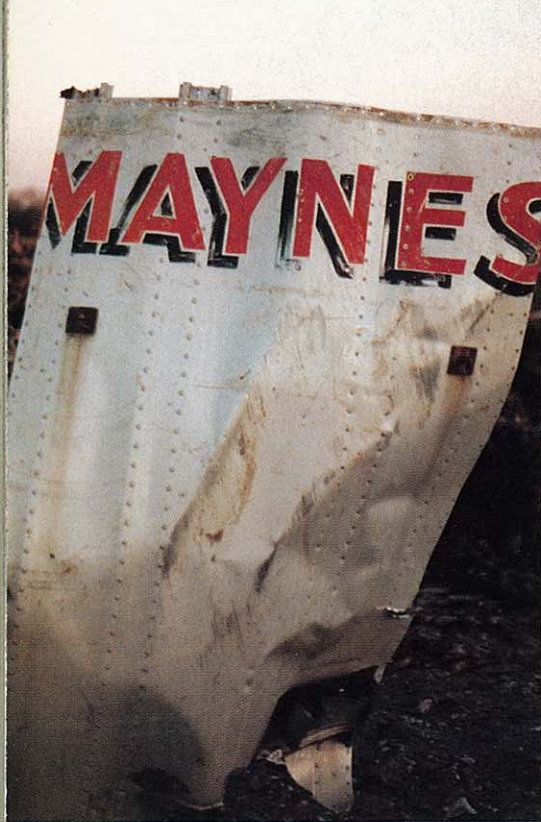
This is the largest single piece of debris from the semi-trailers. It probably came from Trailer No. 2, since Trailer No. 1 is the one that was burning prior to the first blast.

Fragments of trailer siding found on the berm indicate that the first blast caused heavy damage to Trailer No. 2. Unburned trailer pieces were thrown clear of the blast and fire area, and many showed evidence of having been struck on the outside by rocks and of having been bent inward by forces outside the trailer. If these pieces had been from Trailer No. 1, one would expect to find evidence of an internal pressure forcing the trailer walls outward. A blast force sufficient to blow fragments from Trailer No. 2 onto the berm also would have caused a shock stress on the commodity stored inside. Shock is one of the factors that can affect sensitive ANFO mixtures. In addition, the blast force probably would have upset the arrangement of materials stored in Trailer No. 2. Some of the material could have been blown around, but most of it probably would have stayed in a pile.
