Technical Report Series

The World Trade Center Bombing: Report and Analysis

Federal Emergency Management Agency

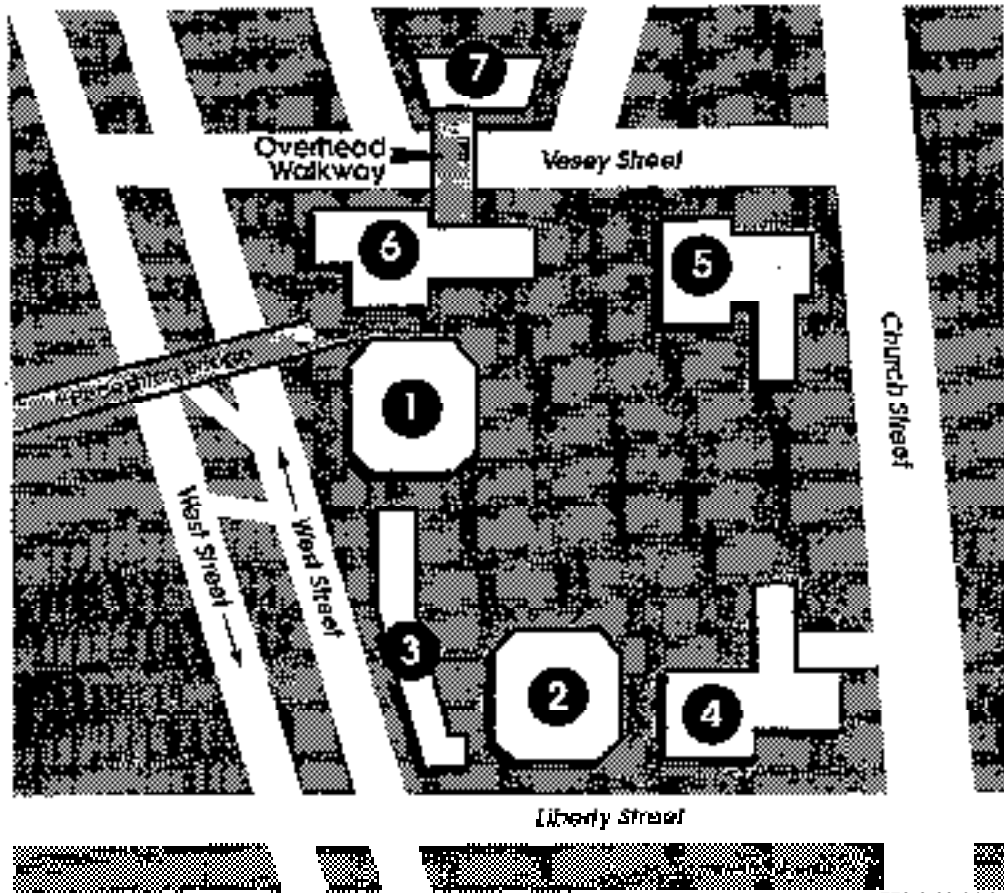
World Trade Center Complex

- 1 World Trade Center - 110- story office tower
- 2 World Trade Center -110- story office tower
- 3 World Trade Center -22- story Vista Hotel
- 4 World Trade Center -9- story office building
- 5 World Trade Center -9- story office building
- 6 World Trade Center -8- story Customs House
- 7 World Trade Center -47- story office building

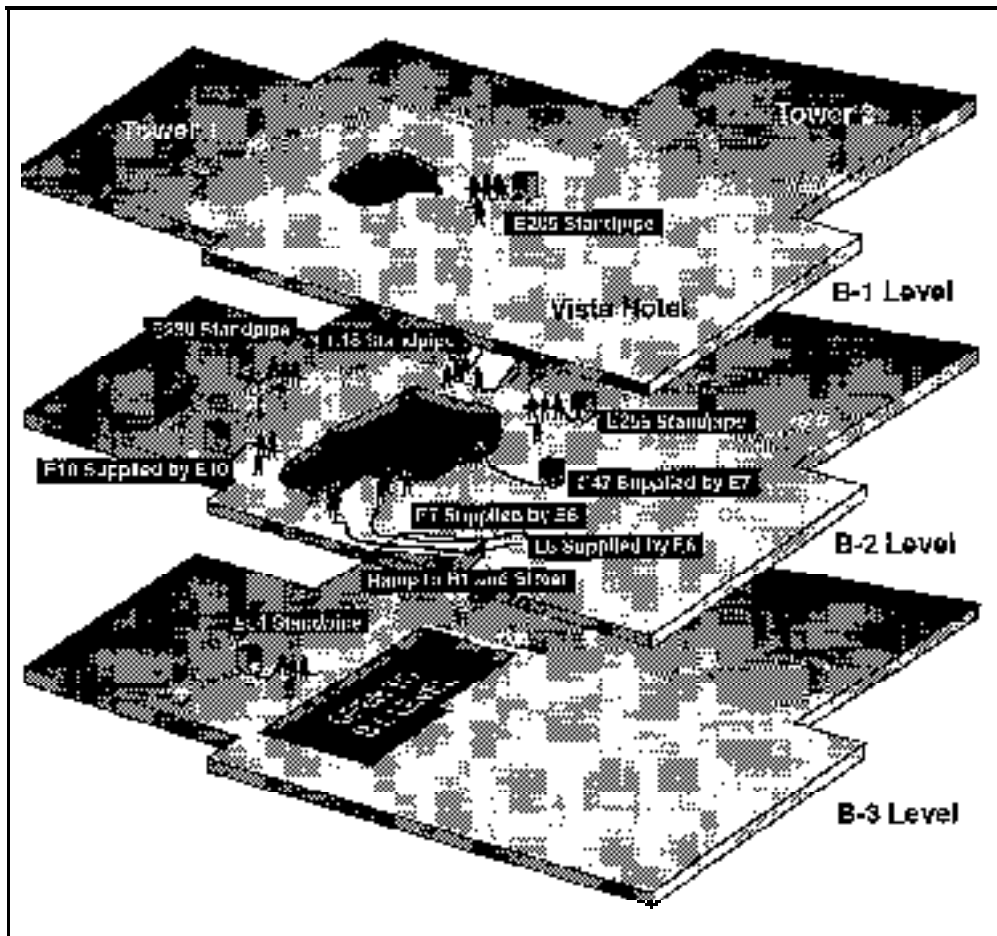
Handlines Deployed in Fire Extinguishment

There were numerous fires on both the B-2 and B-3 levels. Members extinguished fires in offices, a cafeteria, locker rooms, workrooms, free-burning rubble, and at least 50 burning automobiles; lines also provided protection to Firefighter Kevin Shea, who had fallen into a crater and was vulnerable to numerous fires burning around him. As they advanced, firefighters on the attack lines searched for, and in some cases removed, victims from cars and under rubble.

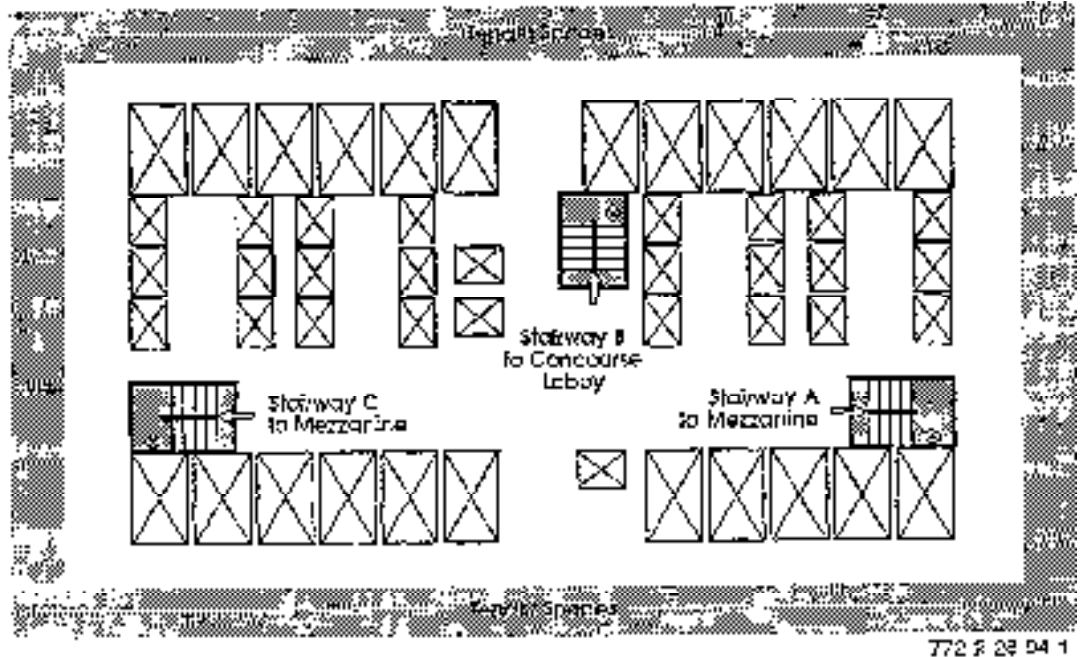
Elevator and Stairway Configuration, Towers

1. With barriers between below grade areas and Tower 1 breached, stack effect in control, and the force of the explosion behind it, smoke migrated to upper floors through shafts within minutes.

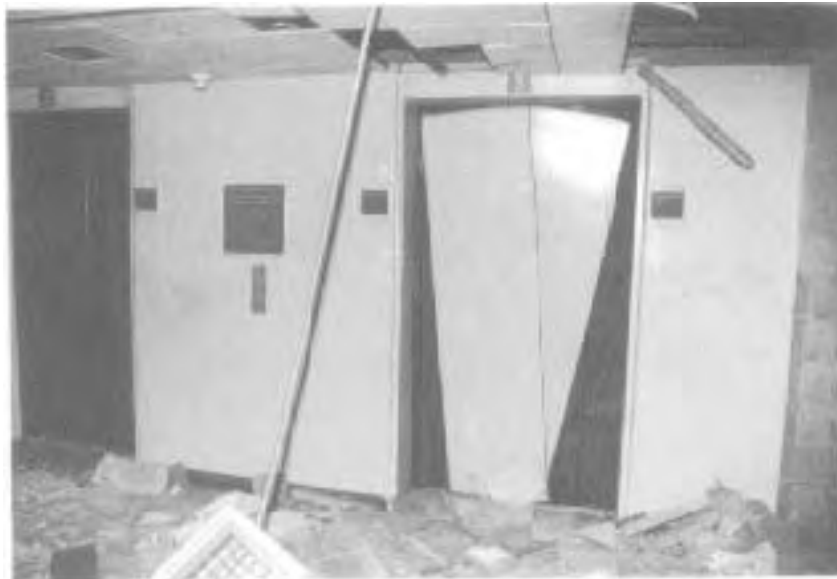
Damaged elevator doors and enclosures on the B-2 level presented a vertical channel for smoke spread into Tower 1. (Photo courtesy of Port Authority Risk Management.)

Above grade. The large quantities of smoke that had been generated prior to the fire's knockdown became a major operational factor. Due to the destroyed elevator shaft doors at the B-2 level, the hole in the Vista Hotel meeting room with the blown-out glass partition wall between the Vista Hotel and Tower 1, and doors being opened on all floors by people evacuating - and with the stack effect working - most floors and all stairways of Tower 1 and the Vista Hotel became charged with smoke. Tower 2 had a smoke condition but to a lesser degree. The smoke condition in Tower 1 was the worst of the three buildings above grade.

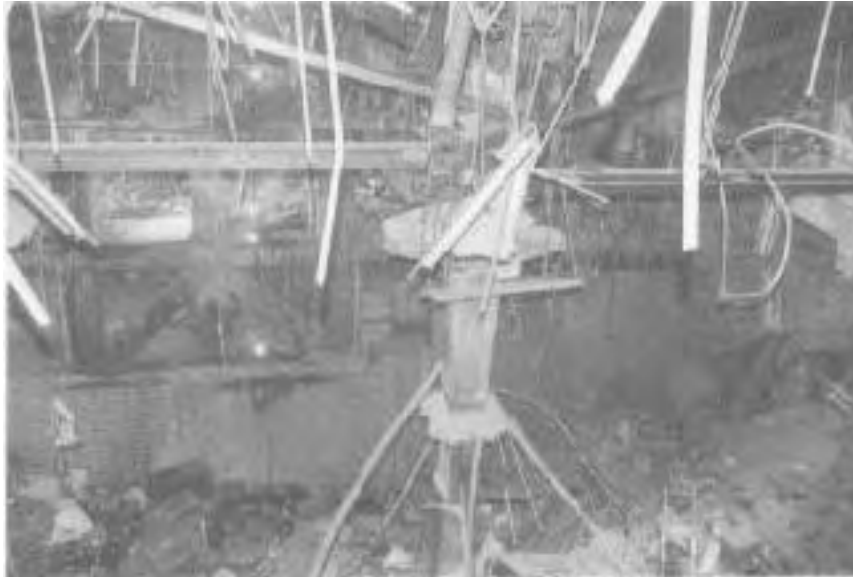
A view of the crater from the B-1 to B-5 levels. Note the steel column. Horizontal supports were destroyed in some cases, but the columns did not give. (Photo courtesy of Port Authority Risk Management.)

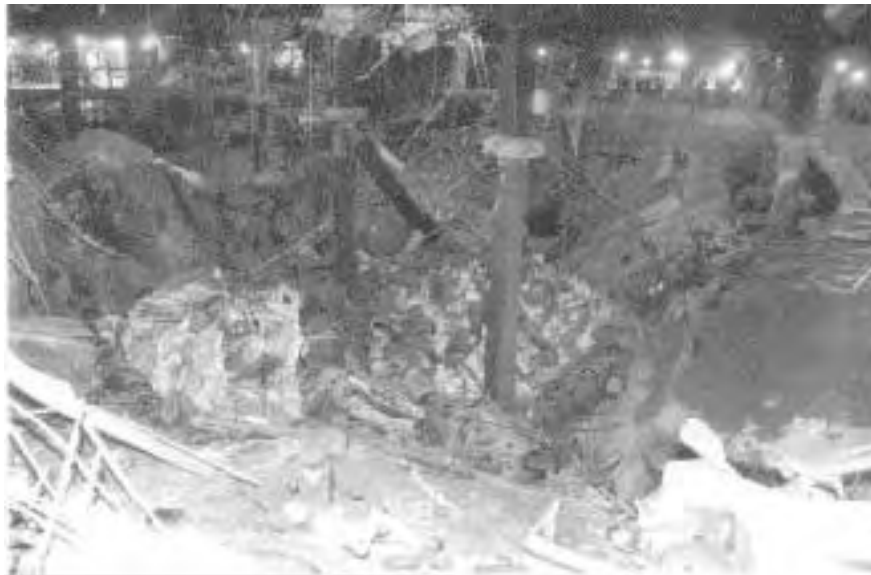
The crater, looking from the B-2 level down to B-5, taken during the investigation/restoration phase. (Photo courtesy of Port Authority Risk Management.)

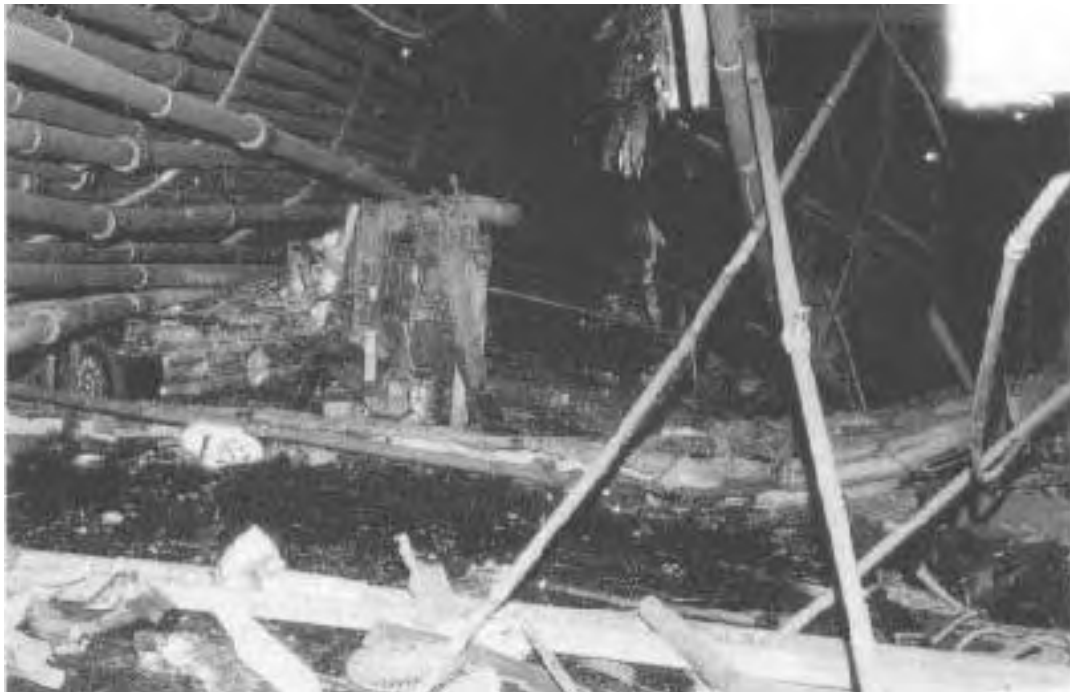
Building systems in the vicinity of the blast were destroyed. Here, twisted electrical conduit has landed on top of what was once a car. (Photo by FDNY Photo Unit.)

Damage/hazard assessment. Lights were brought into the below-grade areas. Damage from the blast was extensive. The B-2 level surrounding ground zero was completely destroyed. Piping and conduit were snapped like twigs. Masonry walls and steel-reinforced concrete flooring were blown apart. Cars were strewn about like toys. Steel columns were shocked but held.

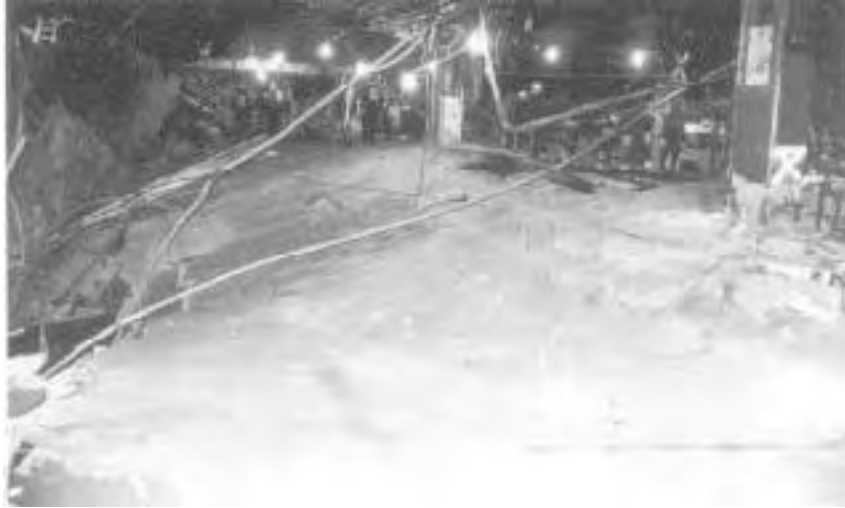
The sloping, hanging steel-reinforced concrete floor at the perimeter of the crater was a major hazard for units operating on the crater fire, particularly in the heavy smoke condition. (Photo by FDNY Photo Unit.)

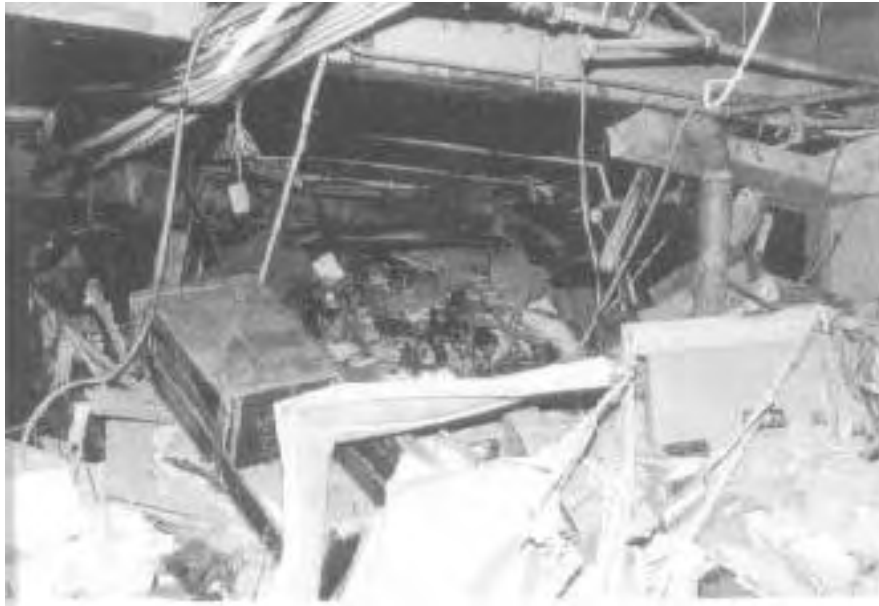
This destroyed office area on the B-2 level is typical of the debris piles faced by searching firefighters. (Photo courtesy of Port Authority Risk Management.)

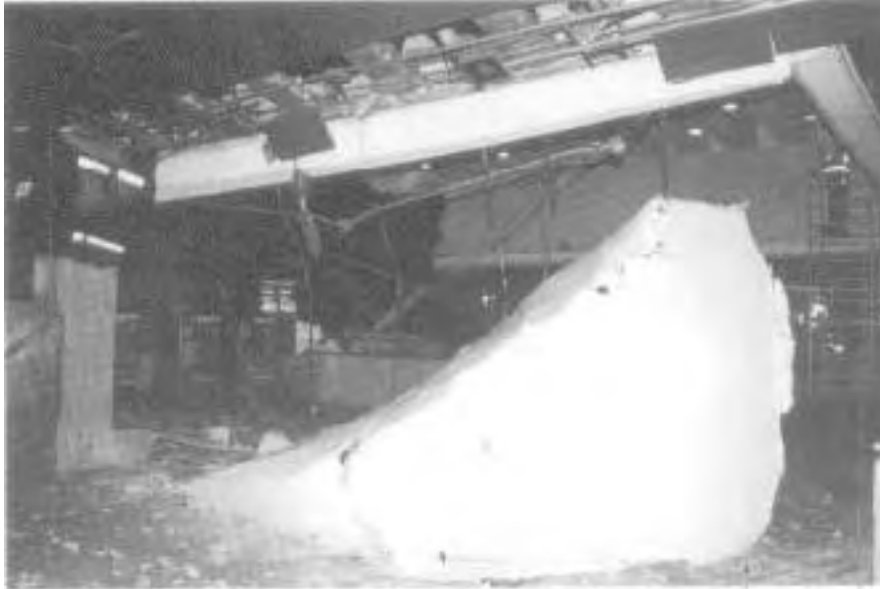
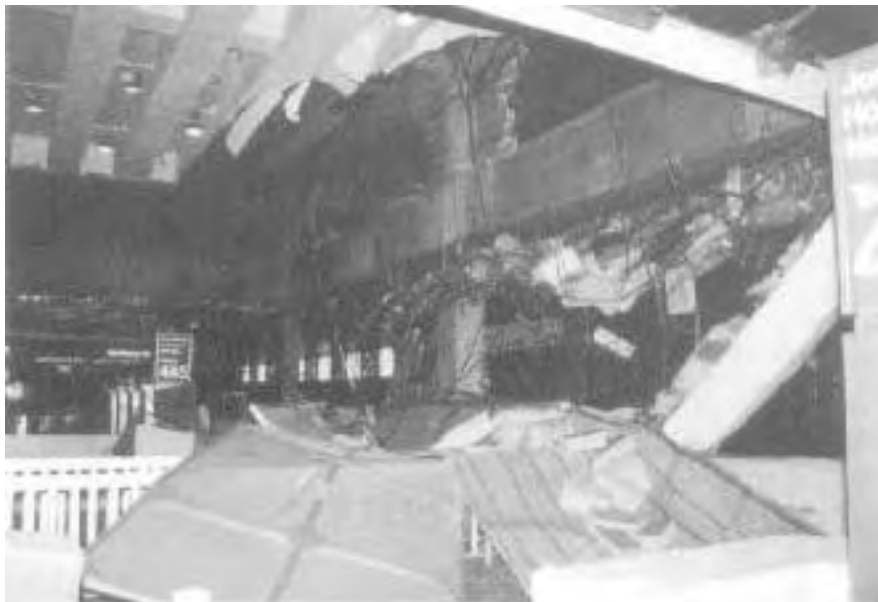
The explosion collapsed a portion of ceiling on the B-5 level onto a PATH train concourse. (Photos courtesy of Port Authority Risk Management.)

- Debris from the blast traveled through a three-level architectural opening (spanning B 3 through B 5) and crashed down on refrigeration equipment on B 5.
- A ceiling of the PATH train station on the B-5 level collapsed.
- A 24-inch-diameter water supply pipe from the Hudson River to the air-conditioning chillers, as well as other smaller refrigeration/air-conditioning and domestic water pipes, were ruptured.
- Domestic water lines to the emergency generators were damaged on the B-6 level.

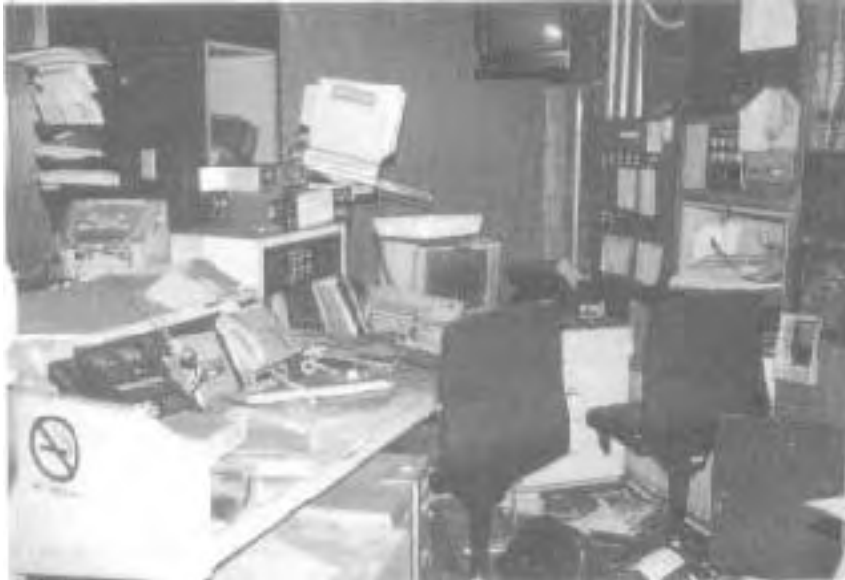
The Port Authority Command/Communications Center on the B-1 level, approximately 50 feet from the blast hole on that level, was damaged and communication with occupants in the towers was lost. (Photo courtesy of Port Authority Risk Management.)

- A 5,000-square-foot hole was opened on the ramp leading to the parking garage below.
- The Port Authority command/communications center was heavily damaged and rendered inoperable.
- Walls and ceilings were heavily damaged.
- Elevators were damaged.
- Seven steel columns were damaged and left without lateral support.

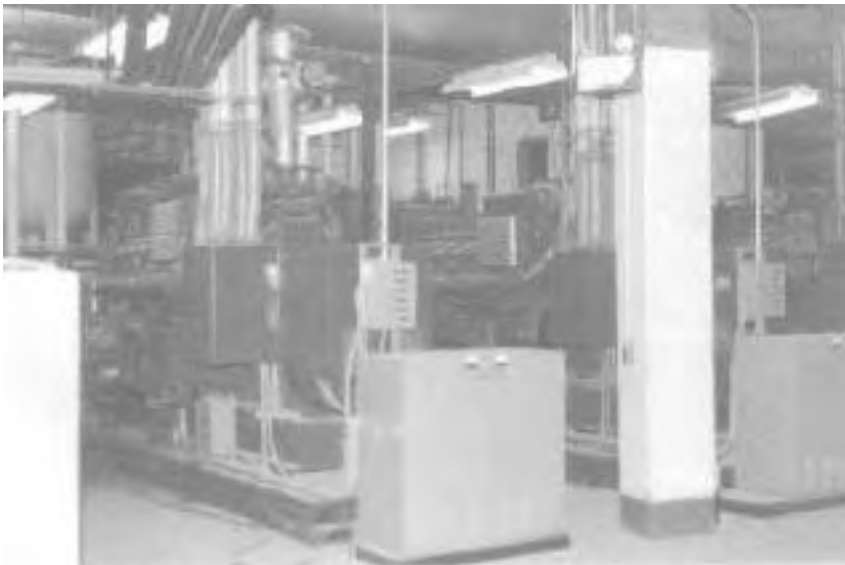
Emergency generators on the B-6 level. Cooling water lines for these units were ruptured by the blast, shutting down all emergency power. (Photo courtesy of Port Authority Risk Management.)

- emergency generators, located in the B-6 level, had their domestic water cooling lines broken by the blast. They ran for 20 minutes, then shut down because of overheating;

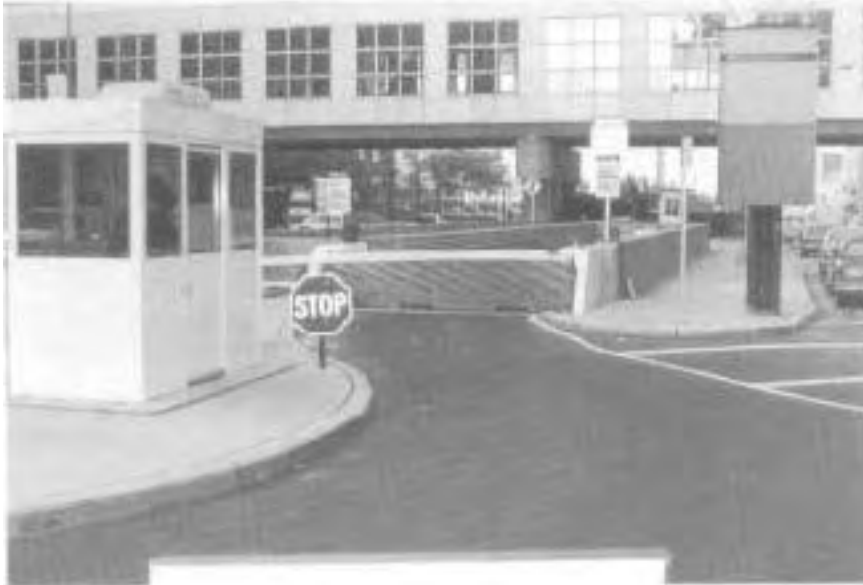
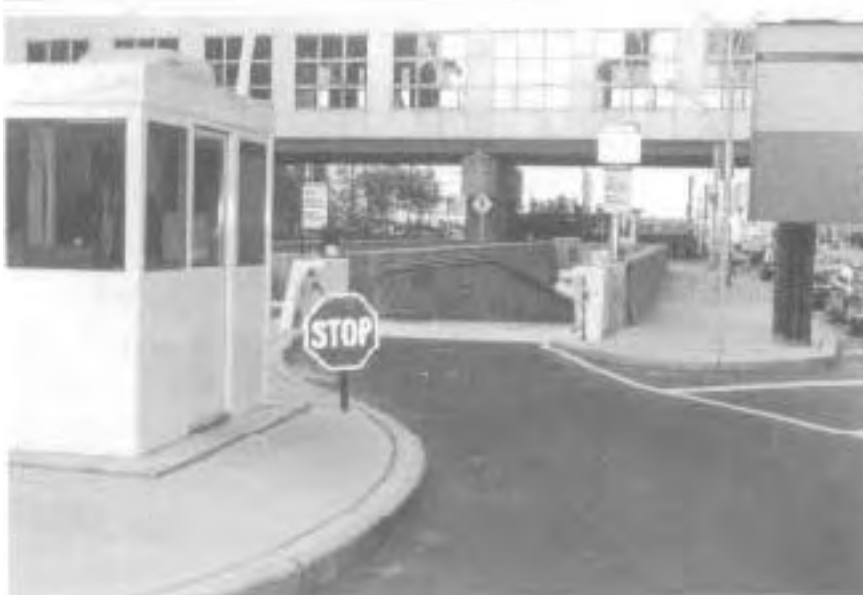
Controlling access to public buildings is a major concern for building management. After the incident, Port Authority, in addition to many security changes, installed substantial barriers to unauthorized vehicle access. The barrier, controlled by security personnel in the booth, folds down when the driver has been cleared to enter. (Photos courtesy of Port Authority Risk Management.)
