Alert2003-05

Safety Alert

Aerosol Can Danger

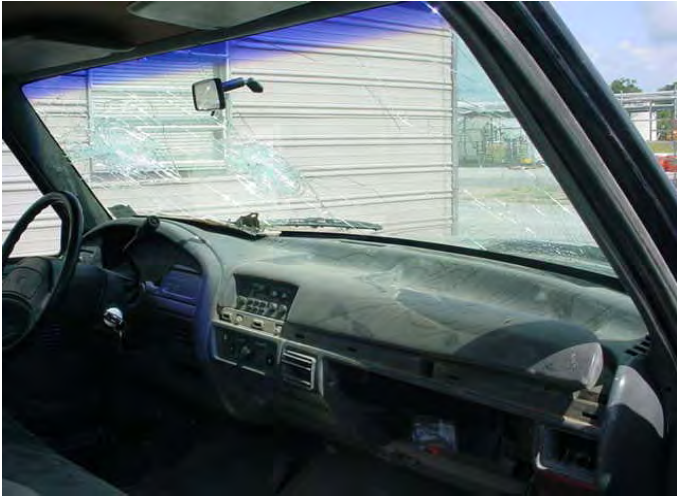
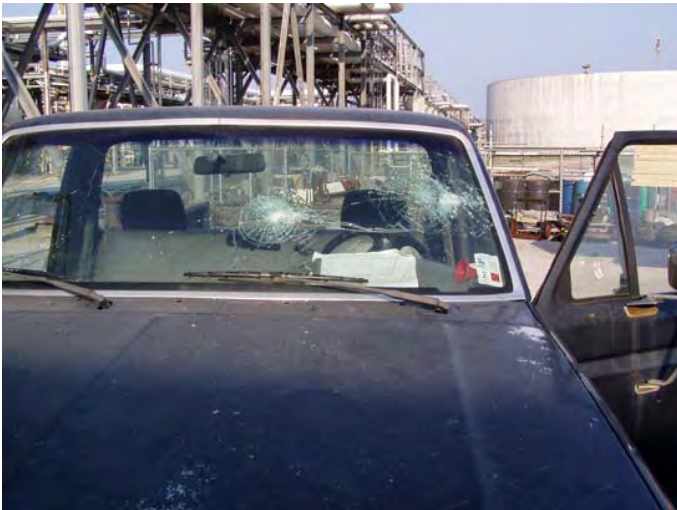
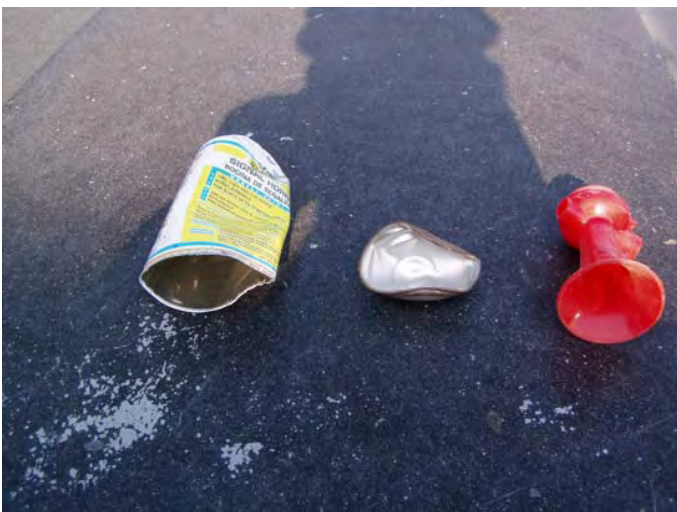
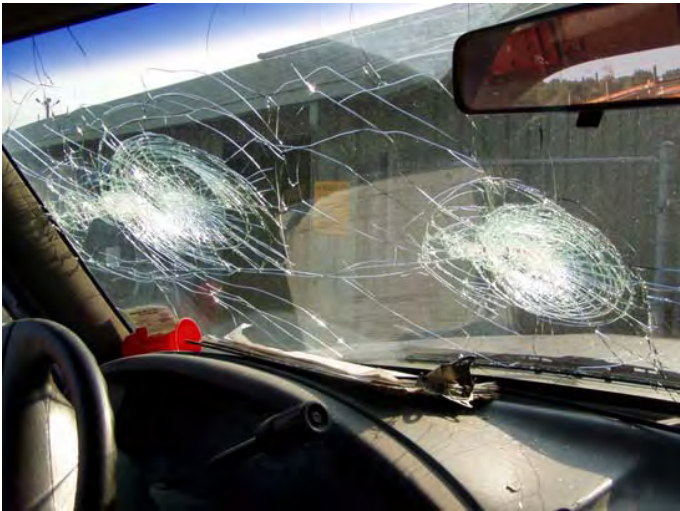
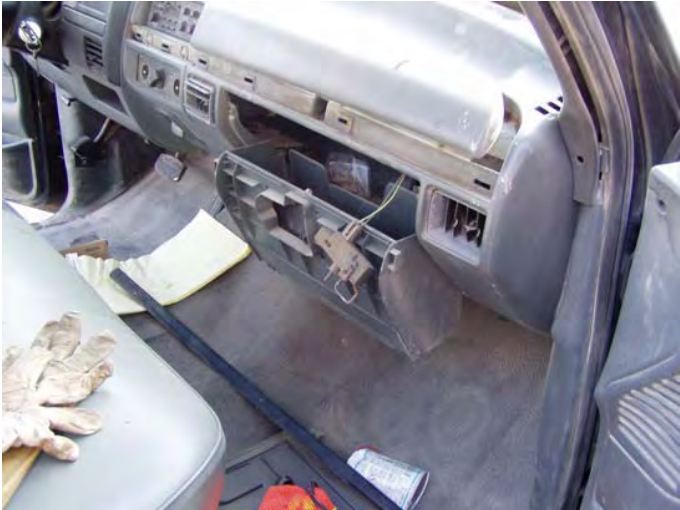
An accident occurred at a Jacobs location recently, which resulted in damage to the interior of a project pickup truck but fortunately no injuries. The damage occurred when an aerosol can that was part of a warning air horn device overheated when it was left in the glove box of the truck over a weekend and the can exploded.

The aerosol can was placed in the glove box prior to the weekend and left there. The accident occurred on the weekend of June 7th, when the external temperature was in the 90s.

Sometime during the two-day weekend, the can heated up enough to cause it to rupture and blow out of the glove box. When the can ruptured, it apparently blew the glove box door off and bounced around the cab of the truck striking the windshield and the rear of the seat.

The temperature in the truck with the windows closed was approximately 155 degrees F, which greatly exceeded the manufacture's recommendations for storage conditions.

- Control the use and storage of aerosol can activated air horns by making them a checkout item from the tool room.
- Educate the workforce in the dangers of the improper storage of these cans, as well as other similar types of small compressed air containers (such as; spray paint, fix-a-flat, WD-40, etc.). Approved storage cabinets should be used. Read and follow the warning information listed on the container labels.
- List these air horns on the Safe Plan of Action (SPA/JSA) as a potential hazard and take appropriate precautionary measures.
