## Urban Wildlands Fire Pebble Beach, California

**Urban Wildlands Fire  
Pebble Beach, California  
(May 31, 1987)**

**Investigated by: Hugh W. Graham**

This is Report 007 of the Major Fires Investigation Project conducted by TriData Corporation under contract EMW-86-C-2277 to the United States Fire Administration, Federal Emergency Management Agency.

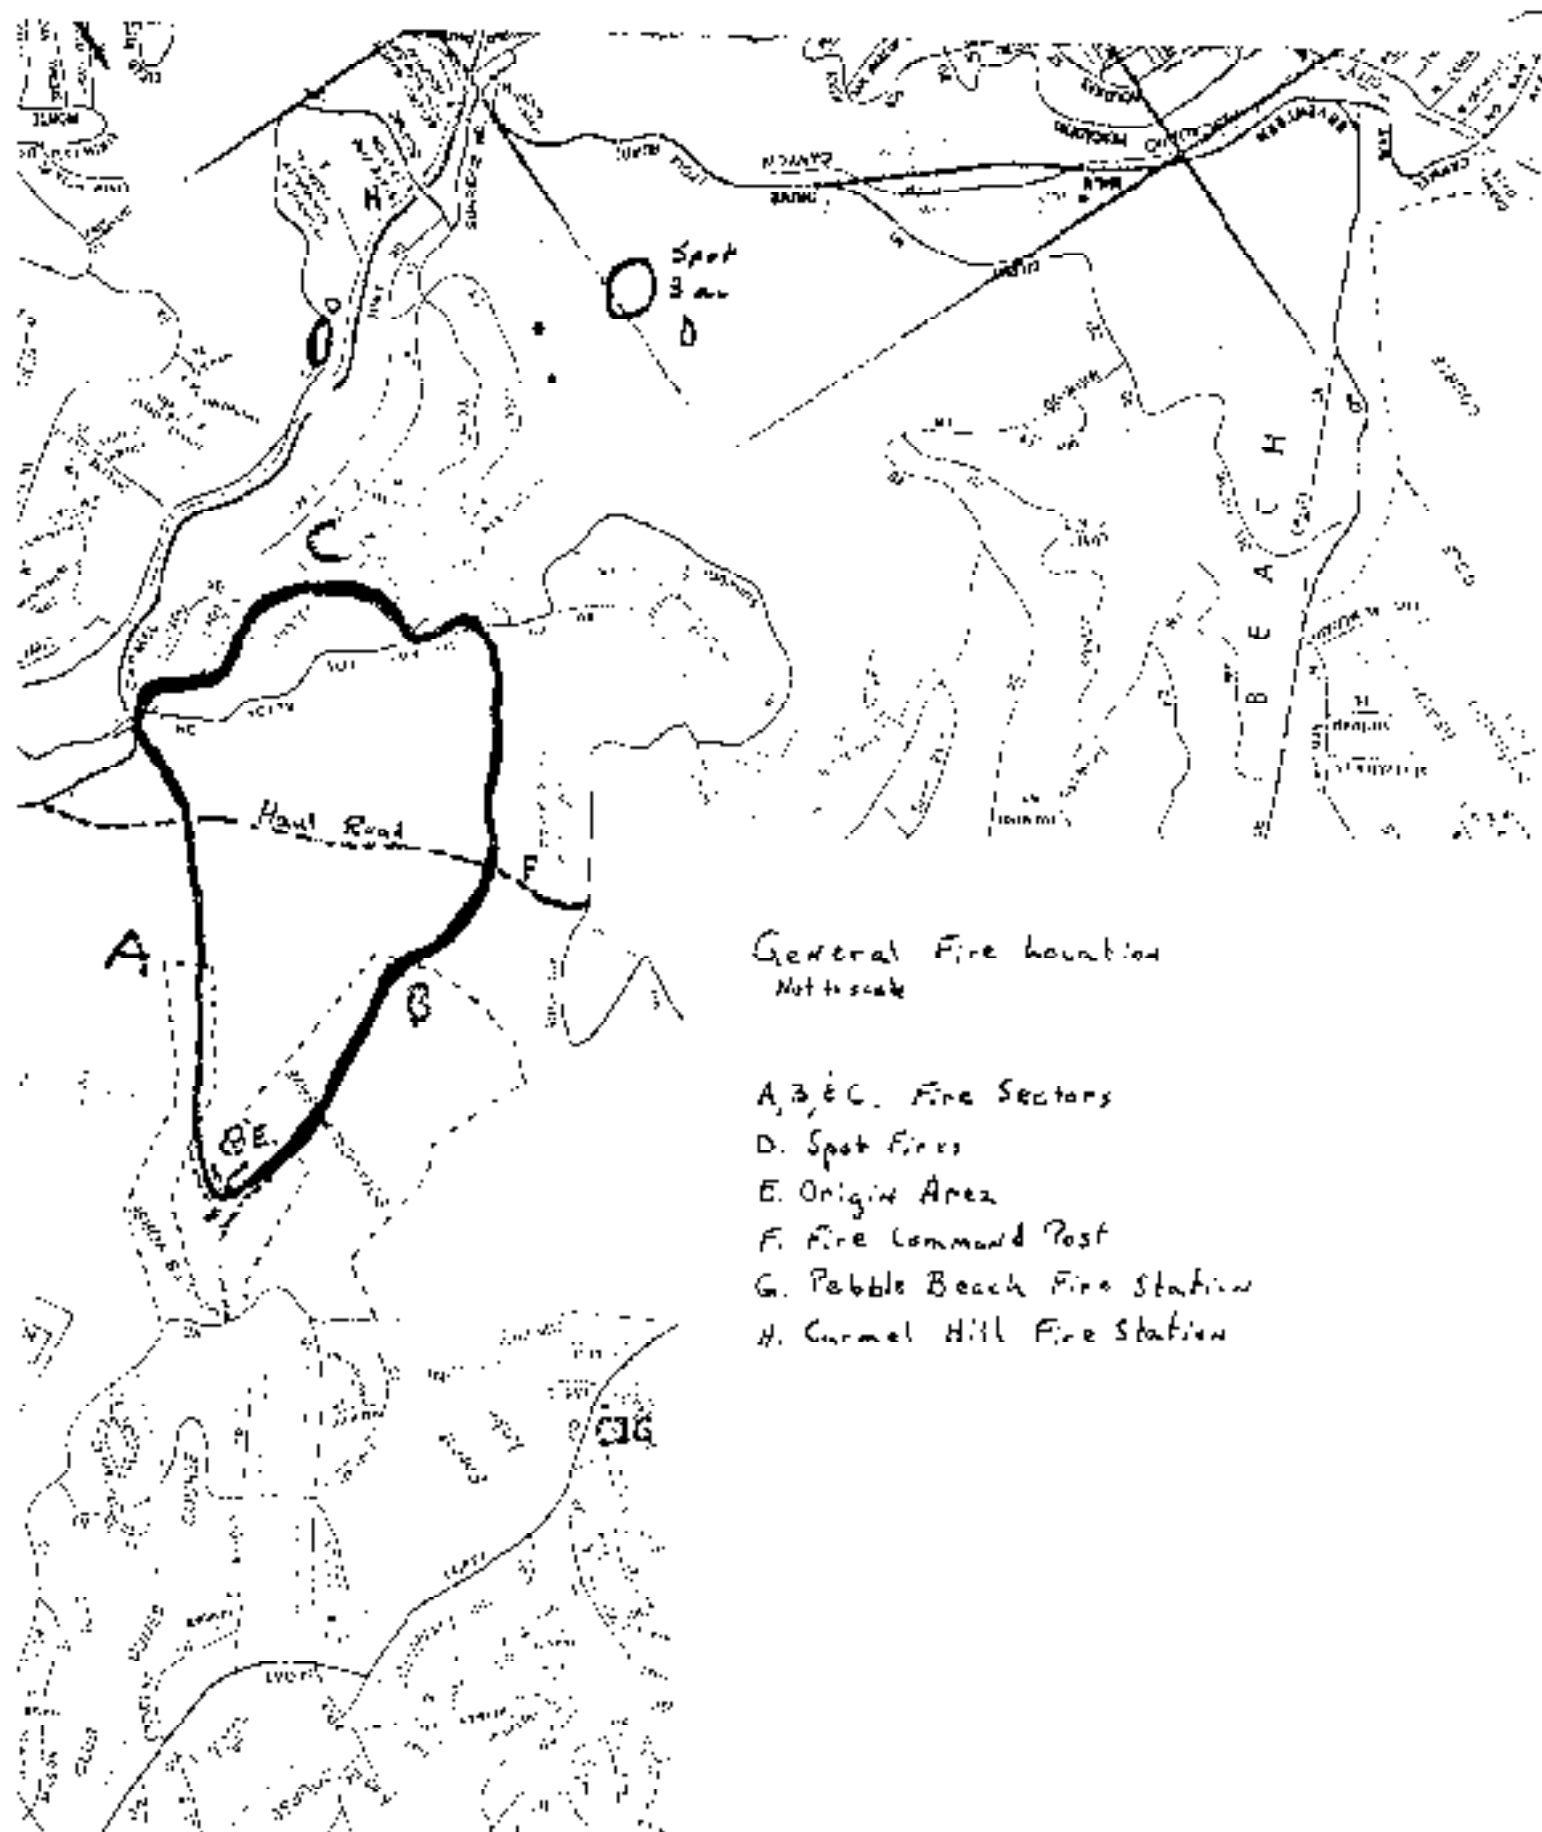
General Fire Location  
Not to scale

- A, B, C. Fire Sectors
- D. Spot Fires
- E. Origin Area
- F. Fire Command Post
- G. Pebble Beach Fire Station
- H. Carmel Hill Fire Station
