Three Firefighter Fatalities in Training Exercise Milford, Michigan

**Three Firefighter Fatalities in Training Exercise
Milford, Michigan
(October 25, 1987)**

Investigated by: J. Gordon Routley

**This is Report 015 of the Major Fires Investigation Project conducted
by TriData Corporation under contract EMW-86-C-2277 to the U.S. Fire
Administration, Federal Emergency Management Agency.**

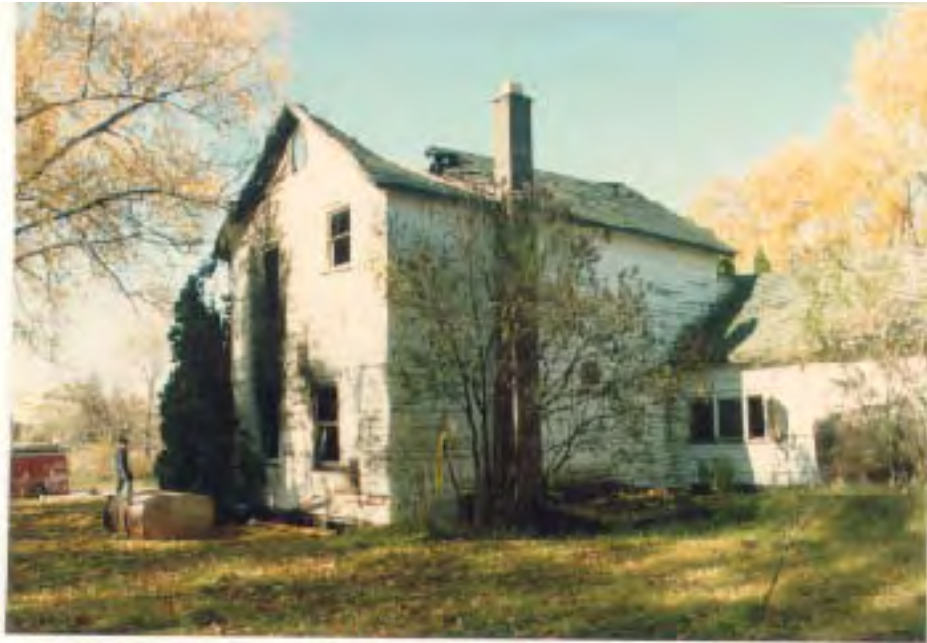
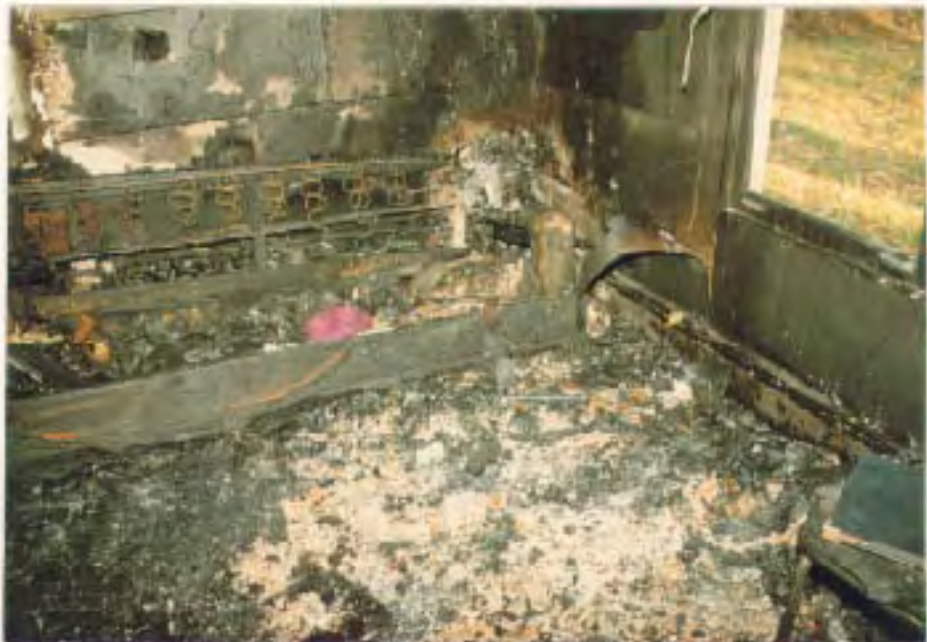
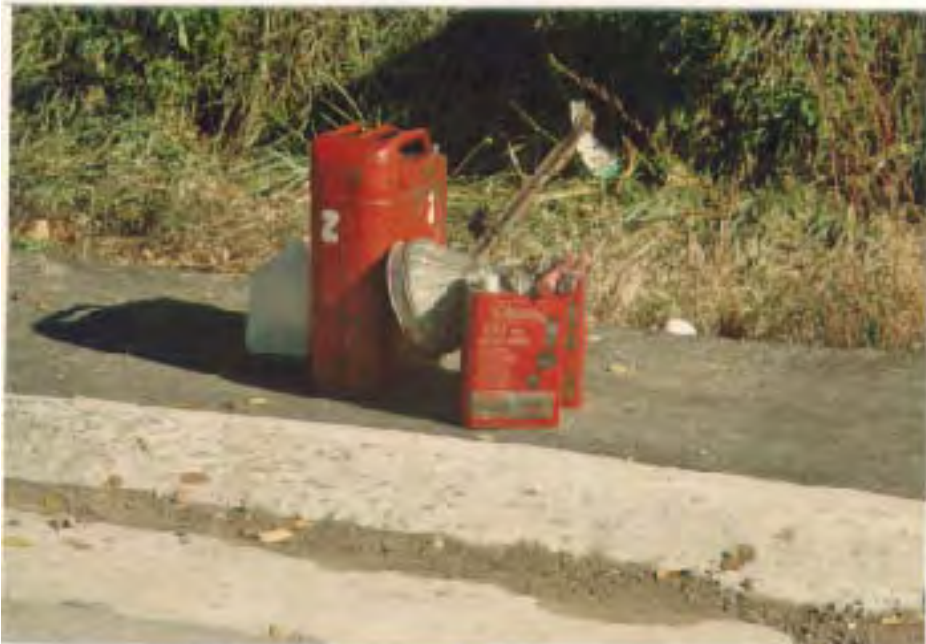
Following are photographs of the farmhouse used in the Milford training fire, fire damage, and accelerant containers. Also presented are Two diagrams showing the floorplans of the house and the point of origin (P.O.) for each arson set listed below. In addition, there were several puddles of accelerants (flammable pours) and trails of accelerant connecting several of the P.O's.

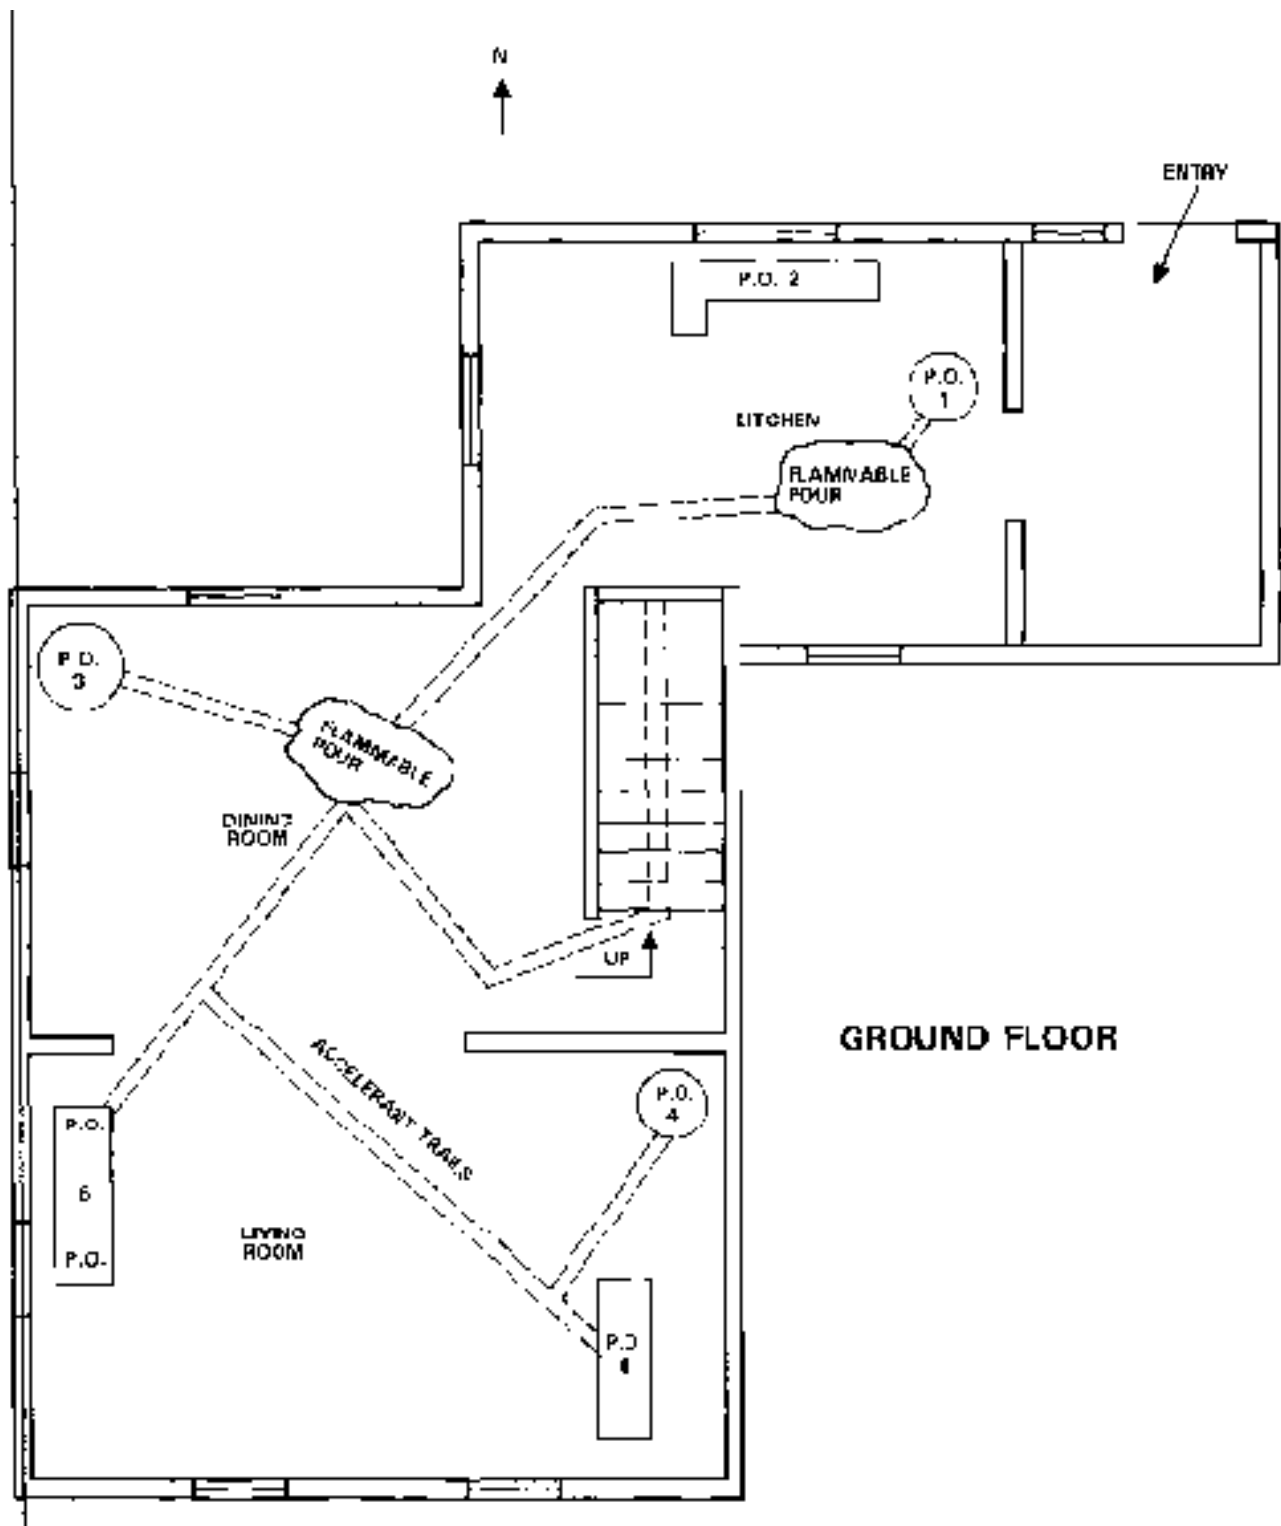
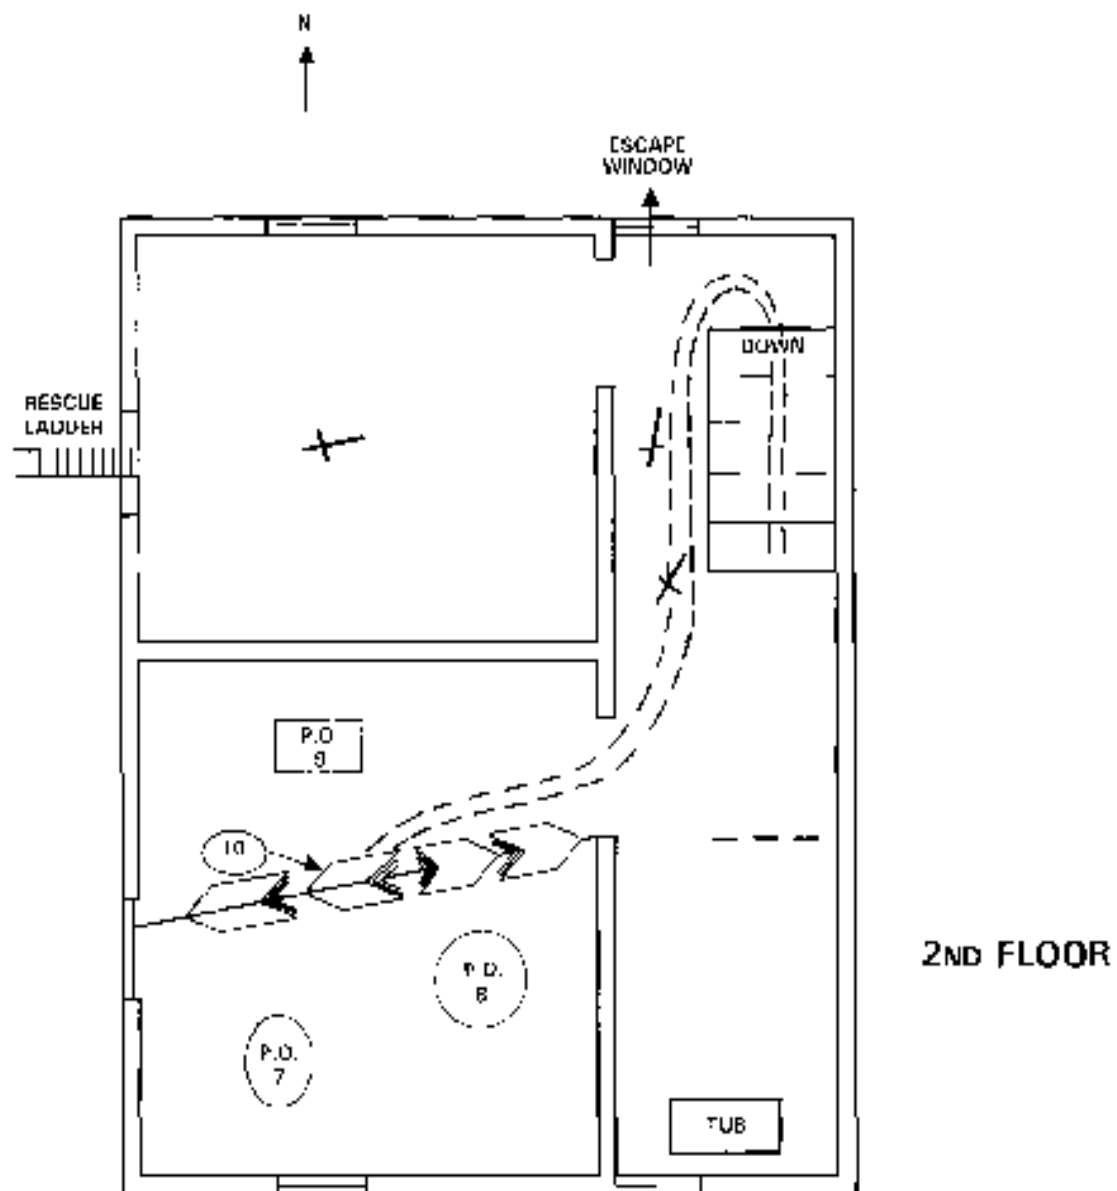
1. Papers in oven (kitchen)
2. Accelerants and papers on "kitchen counter"
3. Rubber glove filled with flammable liquid
4. Rubber glove filled with flammable liquid
5. Couch with accelerant pour
6. Couch with accelerant pour
7. Plastic jug containing accelerant
8. Accelerant poured on clothing
9. Clothing in open dresser drawers accelerant pour
10. Accelerant-soaked newspapers on string
