Interstate Bank Building Fire Los Angeles, California

Interstate Bank Building Fire Los Angeles, California (May 4, 1988)

Investigated by: J. Gordon Routley

**This is Report 022 of the Major Fires Investigation Project conducted
by TriData Corporation under contract EMW-8-4321 to the United
States Fire Administration, Federal Emergency Management Agency.**

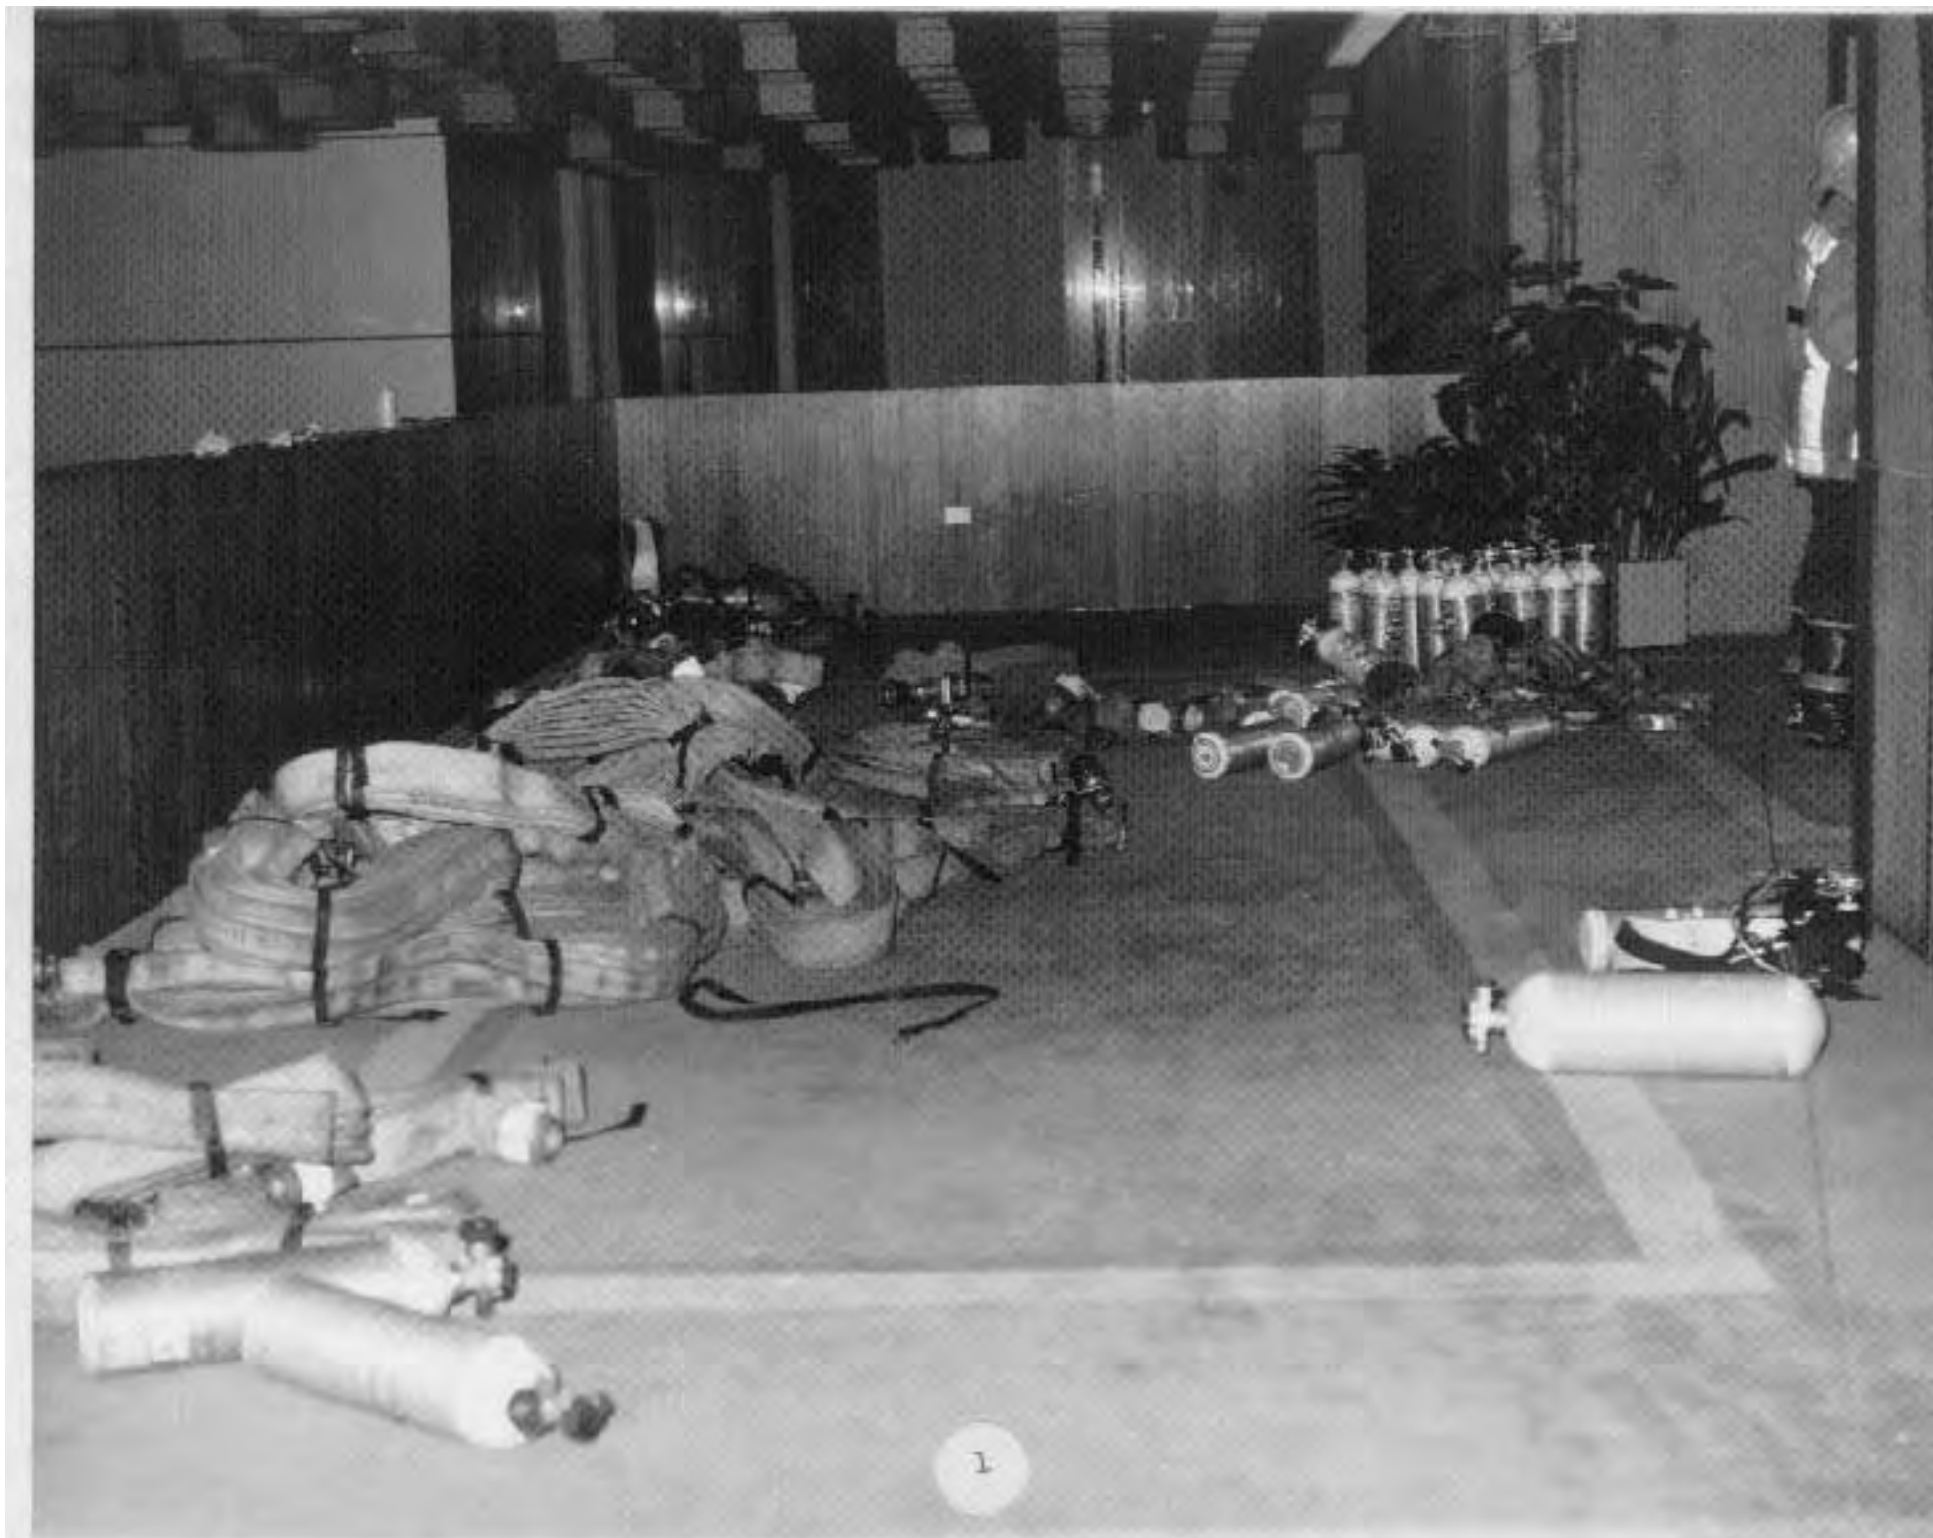
1. Lobby control equipment pool.
2. Empty air bottles in staging.
3. Task Force 15 Returning to staging
Note hoods and water in stairwell.
4. Tenth floor staging area.
5. Helicopter searching 50th floor for
trapped civilians.
6. Wilshire Incident Command.
7. Evidence of smoke in elevator shaft
at 42nd floor.
8. Stairwell 6 at 22nd floor showing smoke leakage.
9. Twisted aluminum framework northeast corner of
building.
10. Void between floor and exterior glass.
11. Plate glass windows on the 16th floor.
