\$10 Million Marina Fire Bohemia Bay, Maryland

\$10 Million Marina Fire Bohemia Bay, Maryland (January 6, 1989)

Investigated by: Randolph E. Kirby

This is Report 026 of the Major Fires Investigation Project conducted by TriData Corporation under contract EMW-88-C-2649 to the United States Fire Administration, Federal Emergency Management Agency.

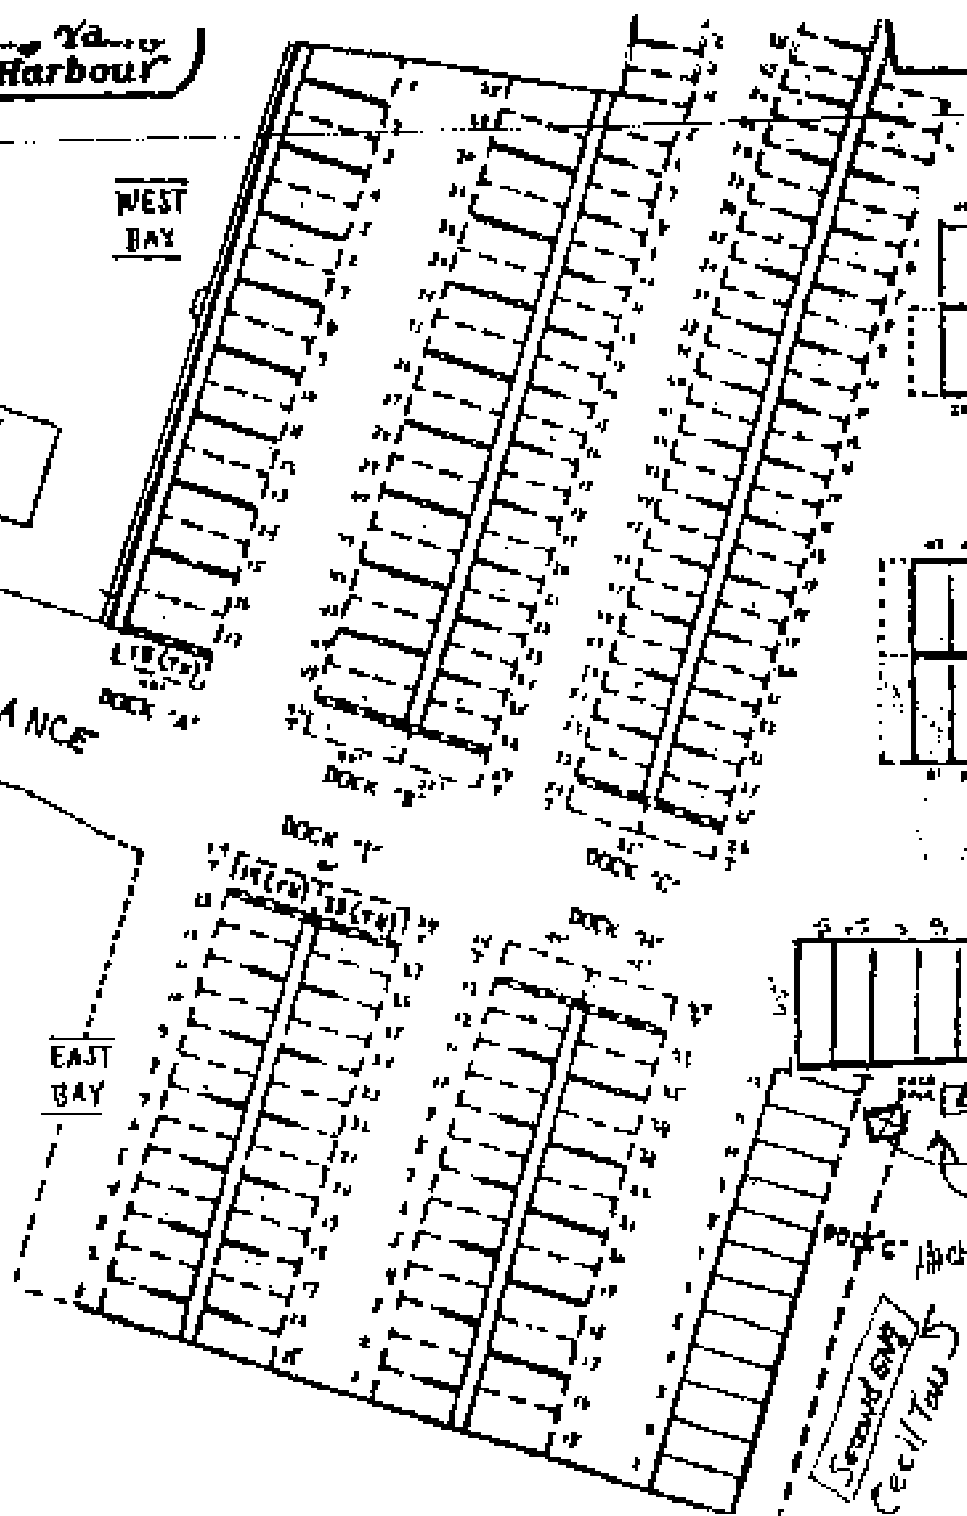
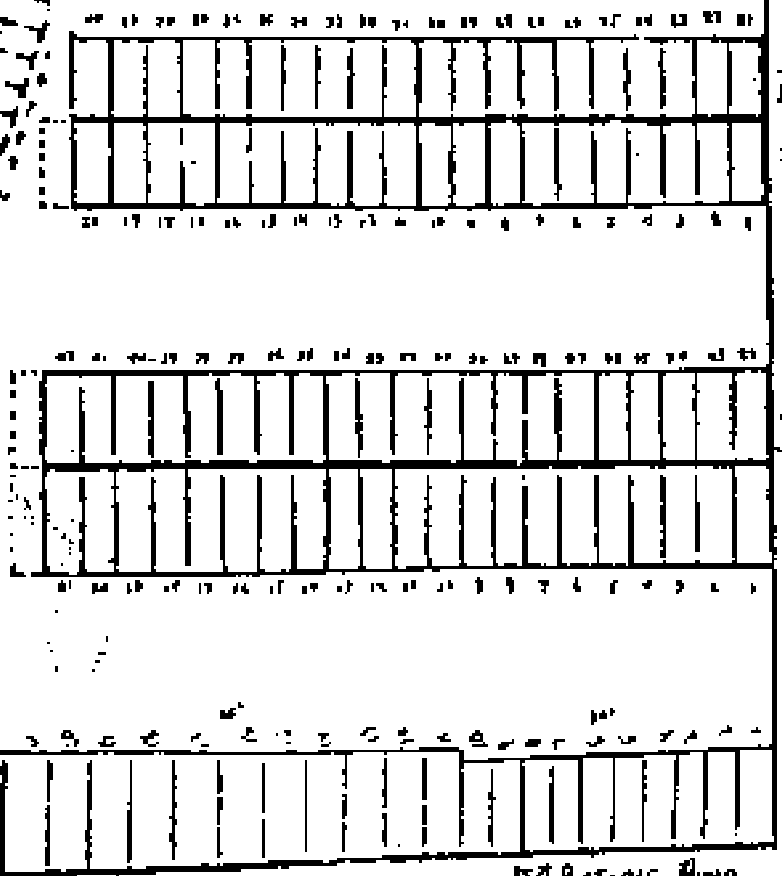
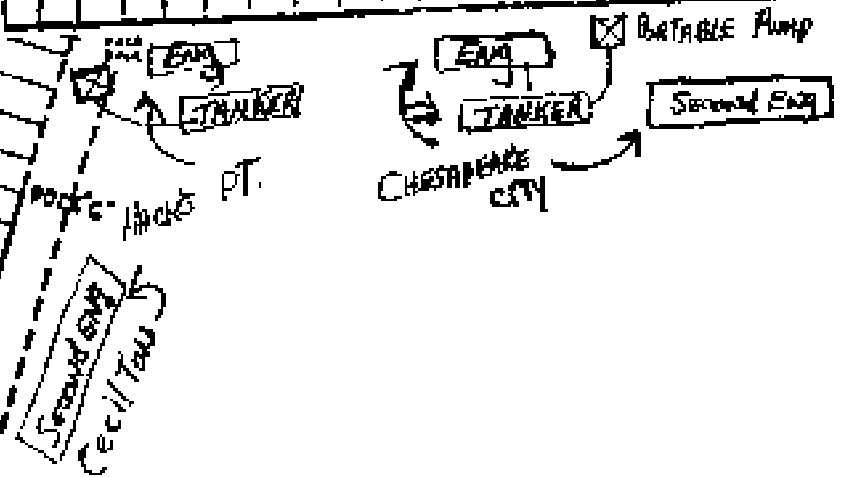
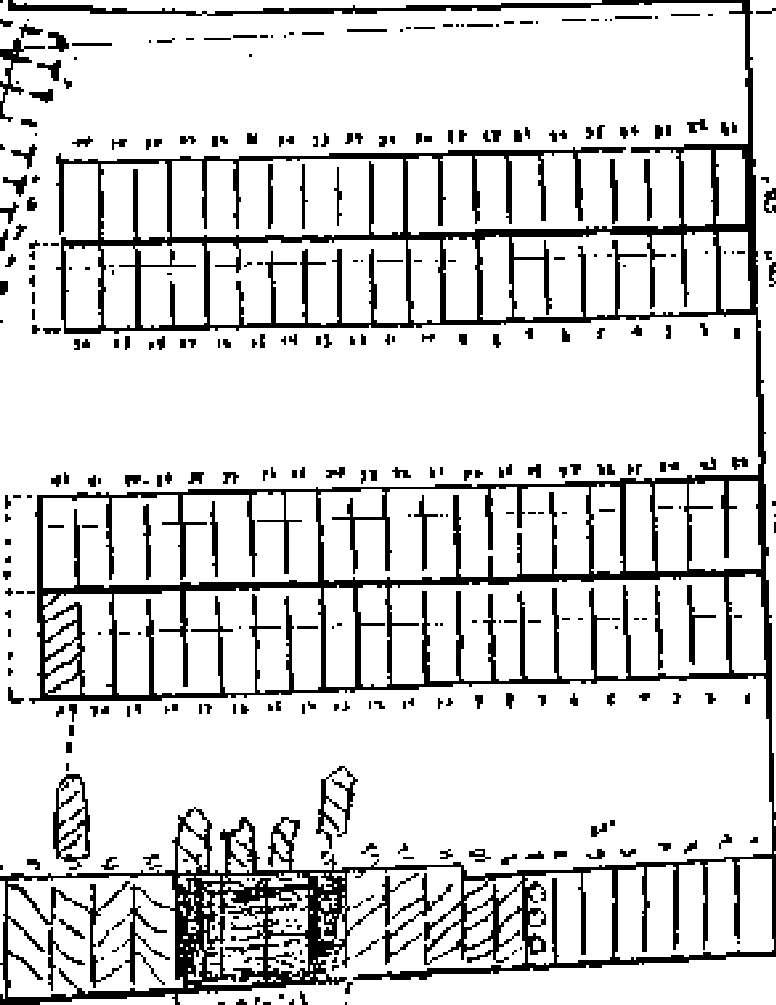
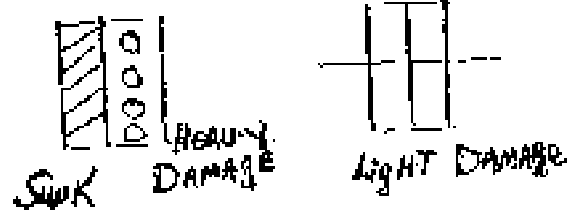
EXTENT OF FIRE DAMAGE TO Buildings & Docks

The close proximity of the boats (approximately four feet between them) created a tremendous potential fire hazard.

The fire required the use of six engines, three tankers, and 28 firefighters. It was brought under control at approximately 0500 hours. Major damage was confined to the 'F' dock structure and connecting finger piers. (Damage is discussed below.) There were no deaths or injuries.
