Twelve-Fatality Nursing Home Fire Norfolk, Virginia

Twelve-Fatality Nursing Home Fire Norfolk, Virginia (October 5, 1989)

**Investigated by: Randolph E. Kirby
Hollis Stambaugh**

**This is Report 034 of the Major Fires Investigation Project conducted
by TriData Corporation under contract EMW-88-C-2649 to the United
States Fire Administration, Federal Emergency Management Agency.**

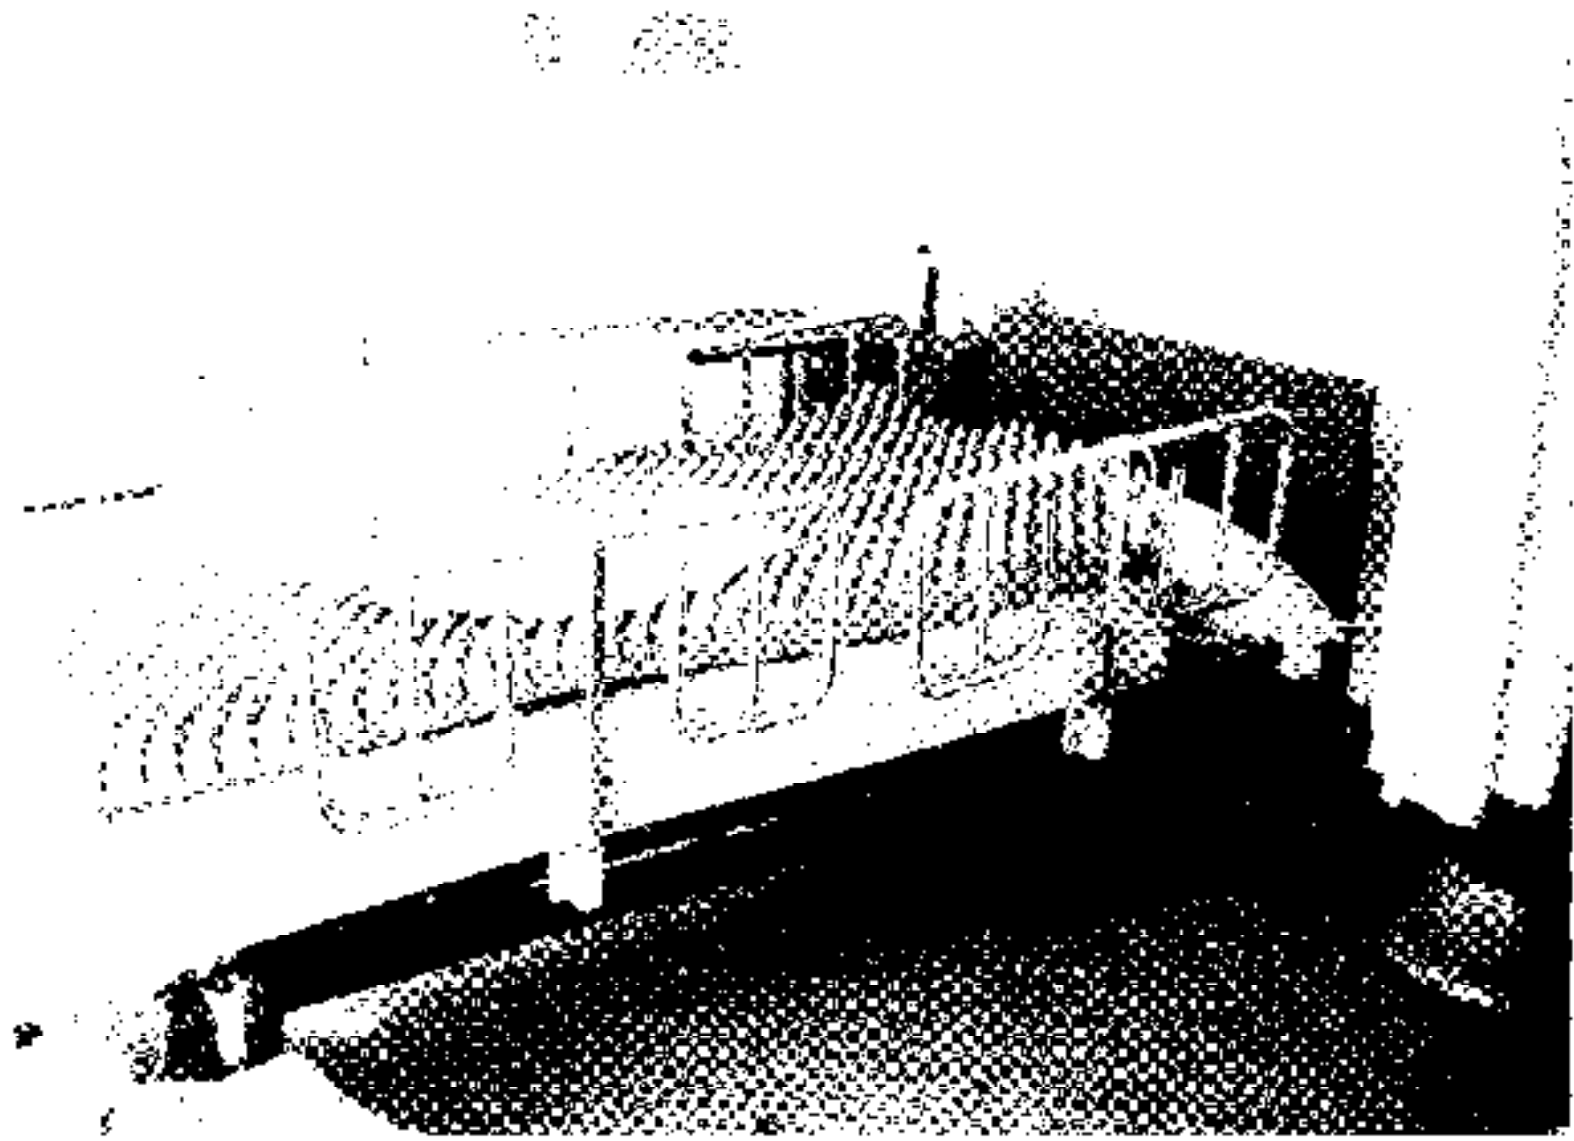
Smoke barrier doors, located in the hall and within 20 feet of the room of origin, failed to close, allowing smoke to completely penetrate the second floor. The interior fire alarm system was pulled. Due to a blown fuse in the main fire alarm control panel, that system also failed to operate and no alarm was sounded.

**FIRE
DOOR**

PLEASE
KEEP CLOSED
