Technical Report Series

Ten Elderly Victims from Intermediate Care Facility Fire Colorado Springs, Colorado

Ten Elderly Victims from Intermediate Care Facility Fire Colorado Springs, Colorado (March 4, 1991)

This is Report 050 of the Major Fires Investigation Project conducted by TriData Corporation under contract EMW-90-C-3338 to the United States Fire Administration, Federal Emergency Management Agency.

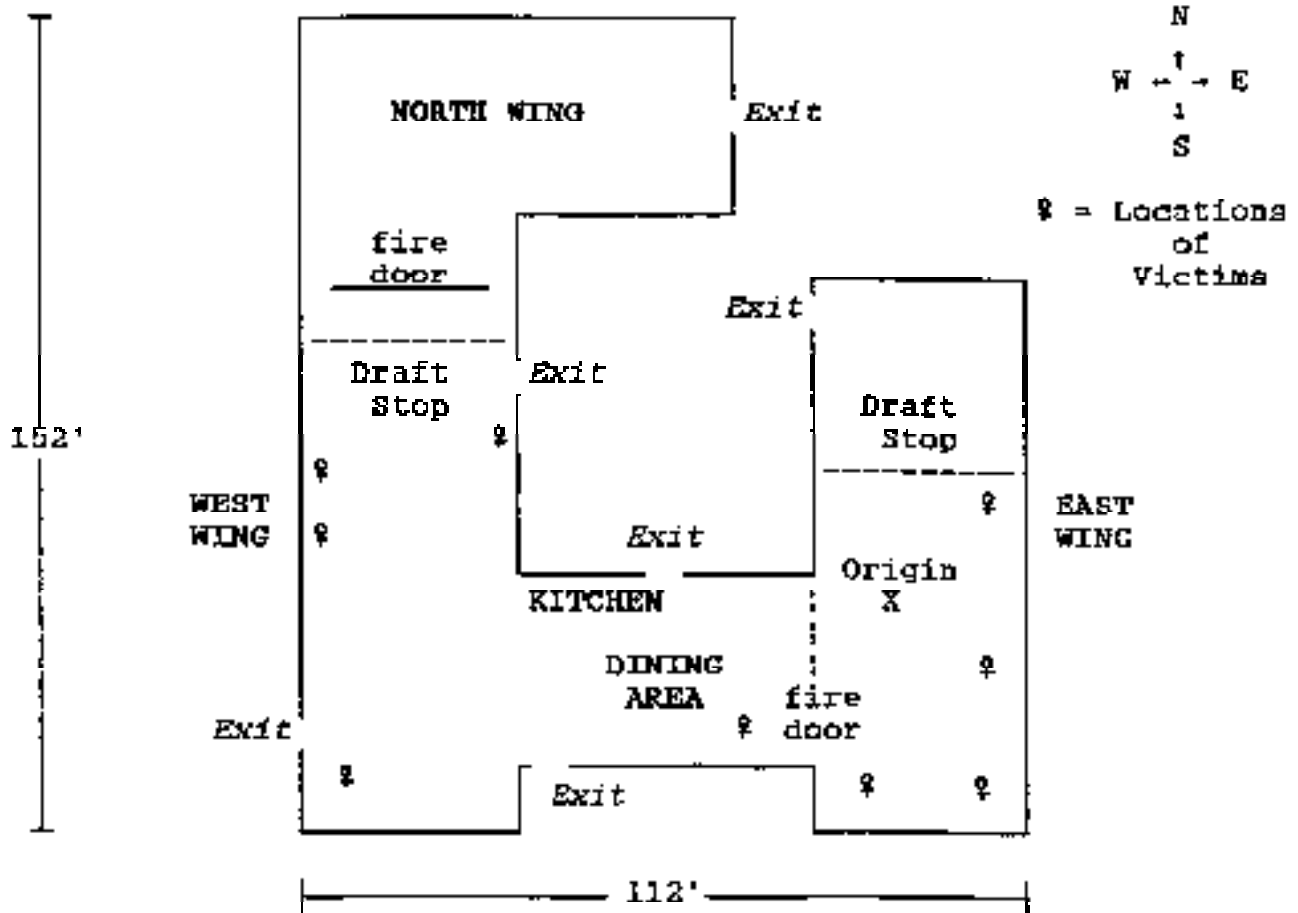
The building is a single-story, brick veneer structure. It is configured as 4 interconnected wings which enclose a center courtyard. The north and east wings do not connect at the northeast corner of the property, allowing access to the center courtyard. The sketch below illustrates the general layout of this 11,590 square foot building.

The east wing contains 8 resident rooms and a smoking room. There is a draft stop separating the north one-third of the attic from the larger south portion. This draft stop, however, is breached by an opening measuring approximately 4' by 4' according to an electrician performing work in the building the week before the fire.
