Technical Report Series

Apartment Complex Fire, 66 Units Destroyed Seattle, Washington

**Apartment Complex Fire,
66 Units Destroyed
Seattle, Washington
(September 21, 1991)**

This is Report 059 of the Major Fires Investigation Project conducted by TriData Corporation under contract EMW-90-C-3338 to the United States Fire Administration, Federal Emergency Management Agency.

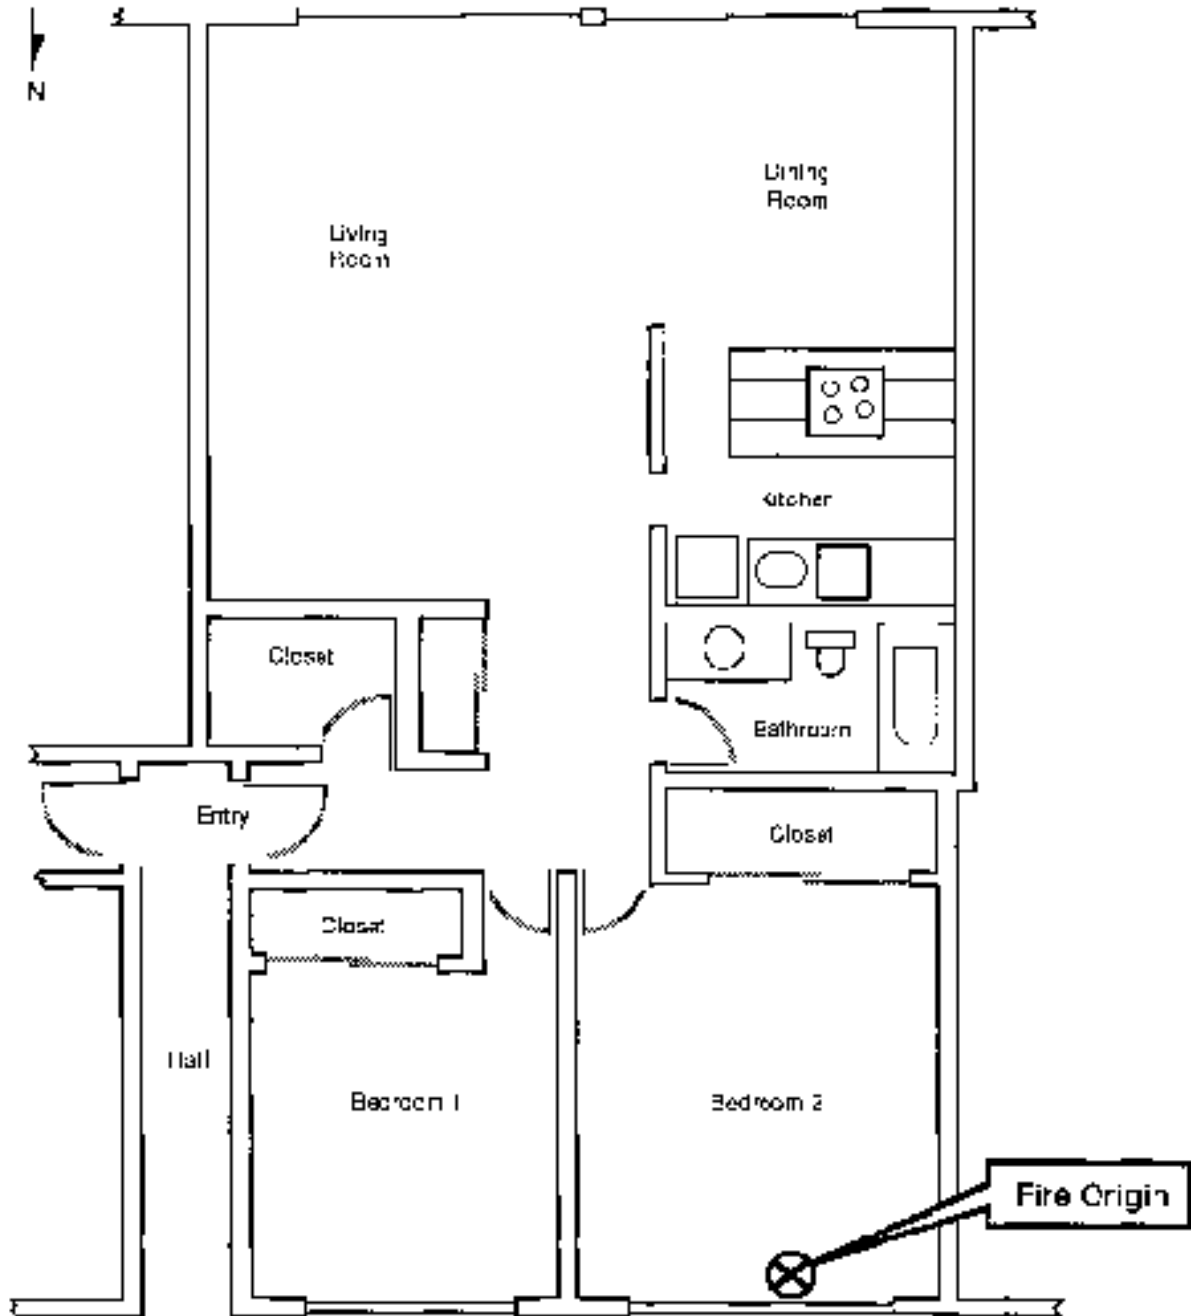
FLOOR PLAN OF APARTMENT OF FIRE ORIGIN

The candle was placed in a plate on a dresser in her bedroom. As the candle burned down, the mother kept the fire going by feeding it with some paper envelopes. When the fire flared up, she tried to blow it out, which caused flaming debris to scatter. A piece of flaming paper fell behind the dresser and ignited something on the floor -- probably clothing or the rug. (Clothes were scattered about the floor, and remnants were found by the dresser.)

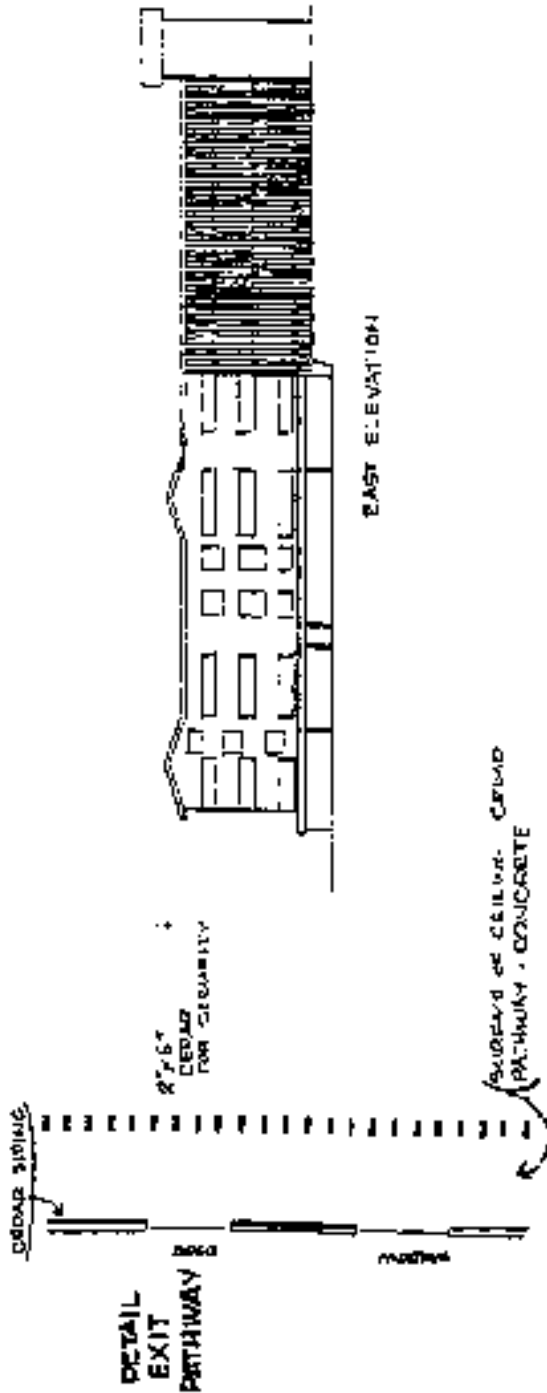
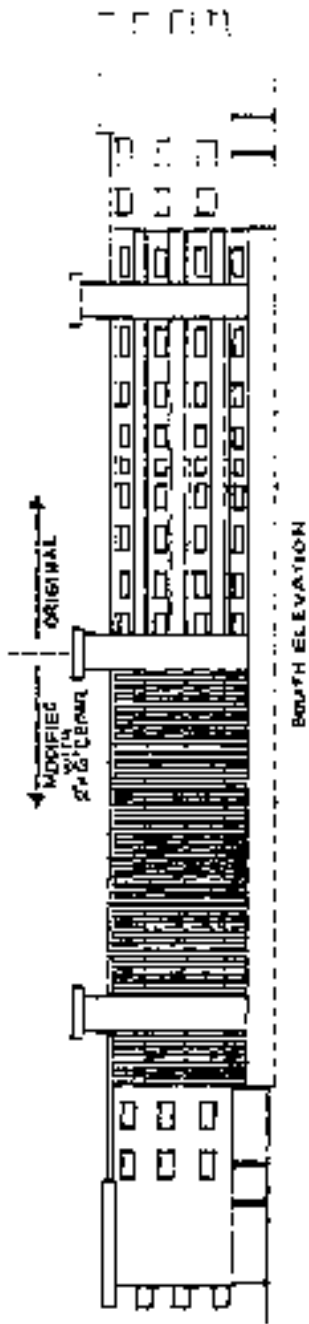
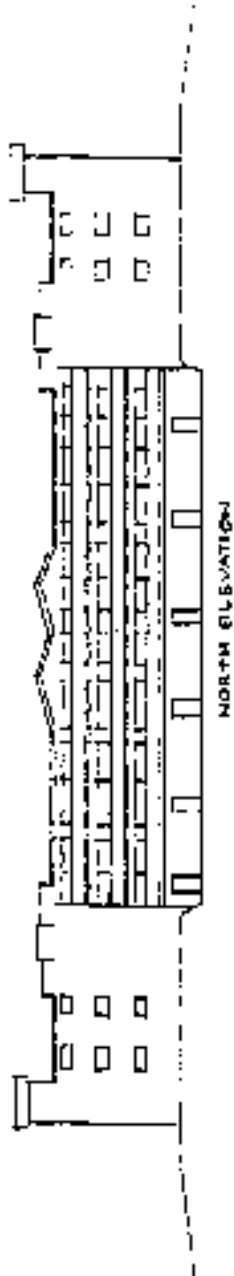
DETAIL
EXIT
PARTIWAY

The exterior facades of the walkways on the fronts of the buildings were 4-story high decorative lattices comprised of 2" x 6" vertical cedar boards approximately on 9-inch centers. (The space between the vertical cedar boards was about seven inches.) The lattices had 10-foot widths separated by 5-foot brick fascia. These lattices were both for aesthetics and security. The wood had been covered with oil-based stain. The wood had dried out in the approximately 30 days without rain prior to the fire.

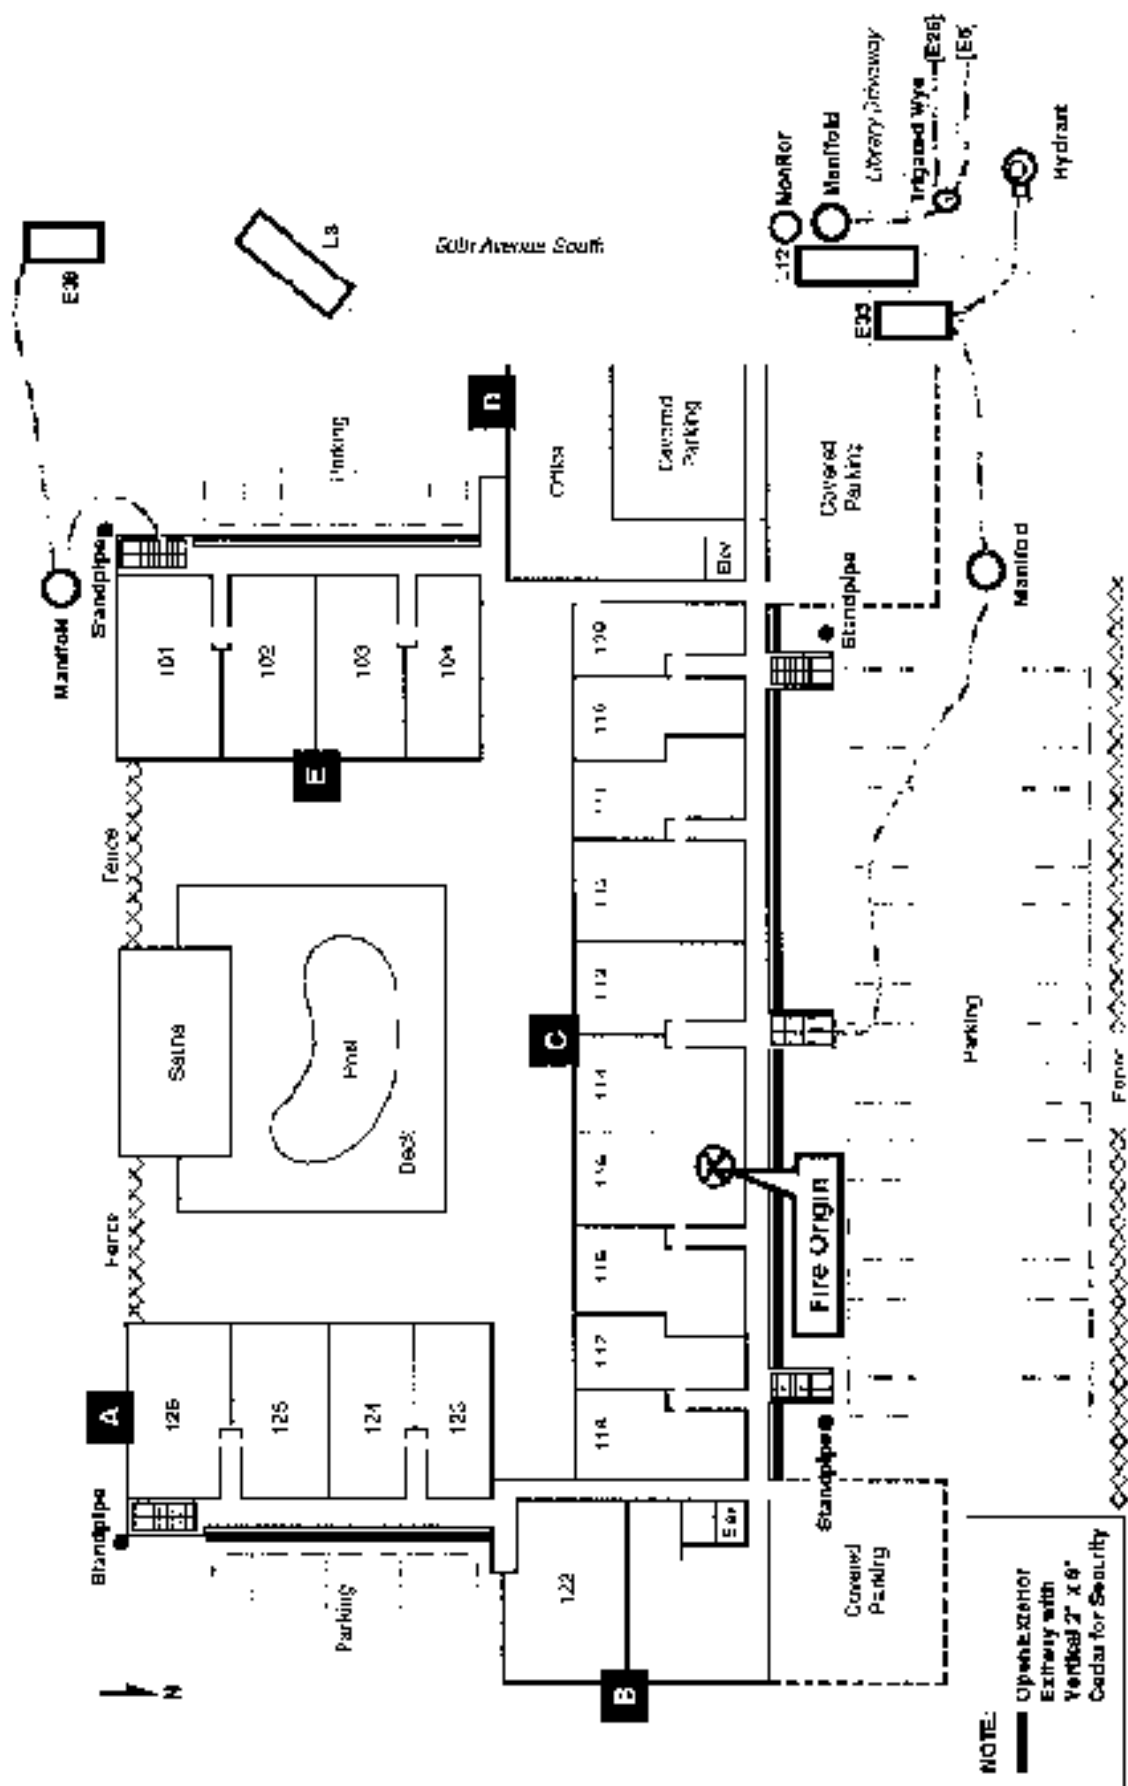
PLAN OF VILLA PLAZA APARTMENT COMPLEX 5 Connected Buildings

NOTE:
 — Open/Exterior
 Extruded with
 Vertical 2" x 6"
 Cedar for Security
