## Four Firefighters Killed, Trapped by Floor Collapse Brackenridge, Pennsylvania

**Four Firefighters Killed,  
Trapped by Floor Collapse  
Brackenridge, Pennsylvania  
(December 20, 1991)**

**Investigated by: J. Gordon Routley**

This is Report 061 of the Major Fires Investigation Project conducted by TriData Corporation under contract EMW-90-C-3338 to the United States Fire Administration, Federal Emergency Management Agency.

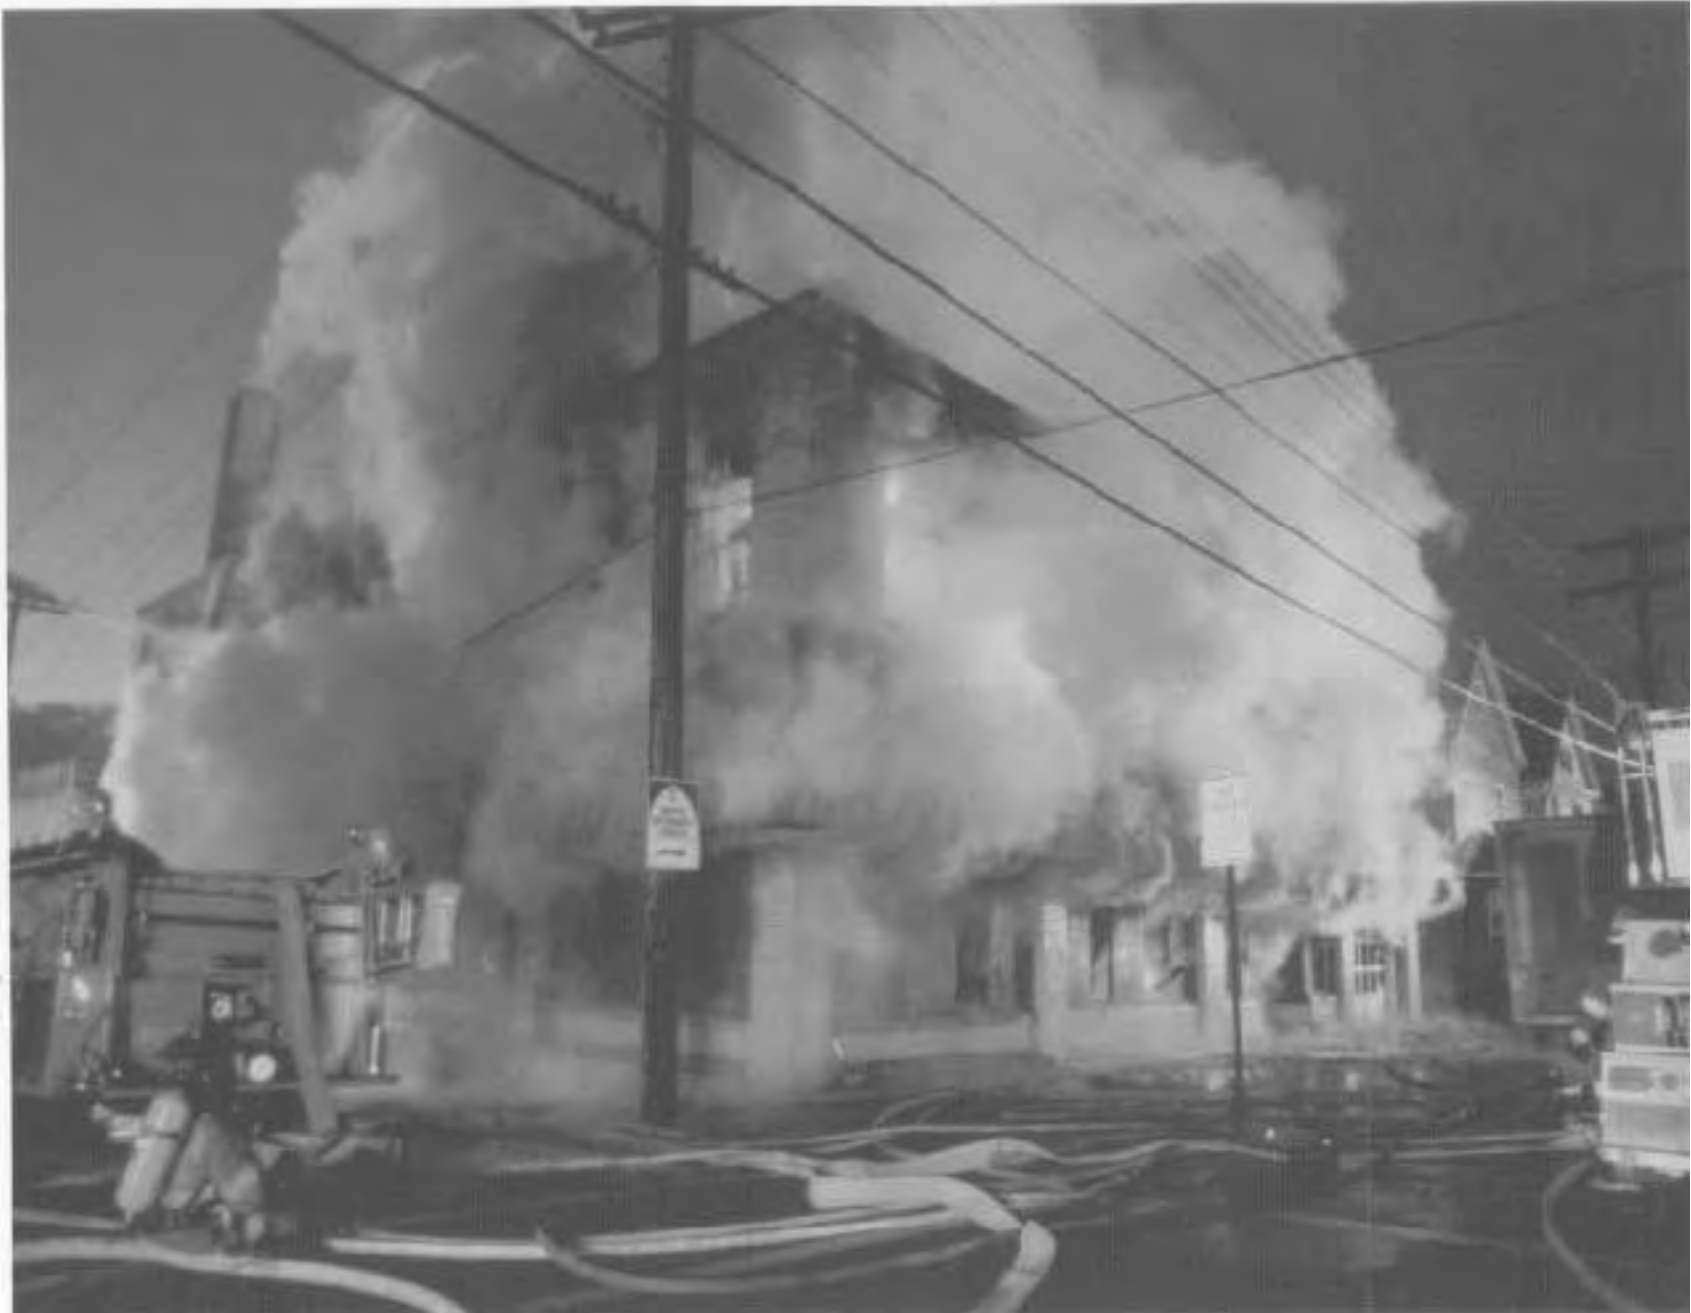
At the height of the fire; firefighters have pulled back.

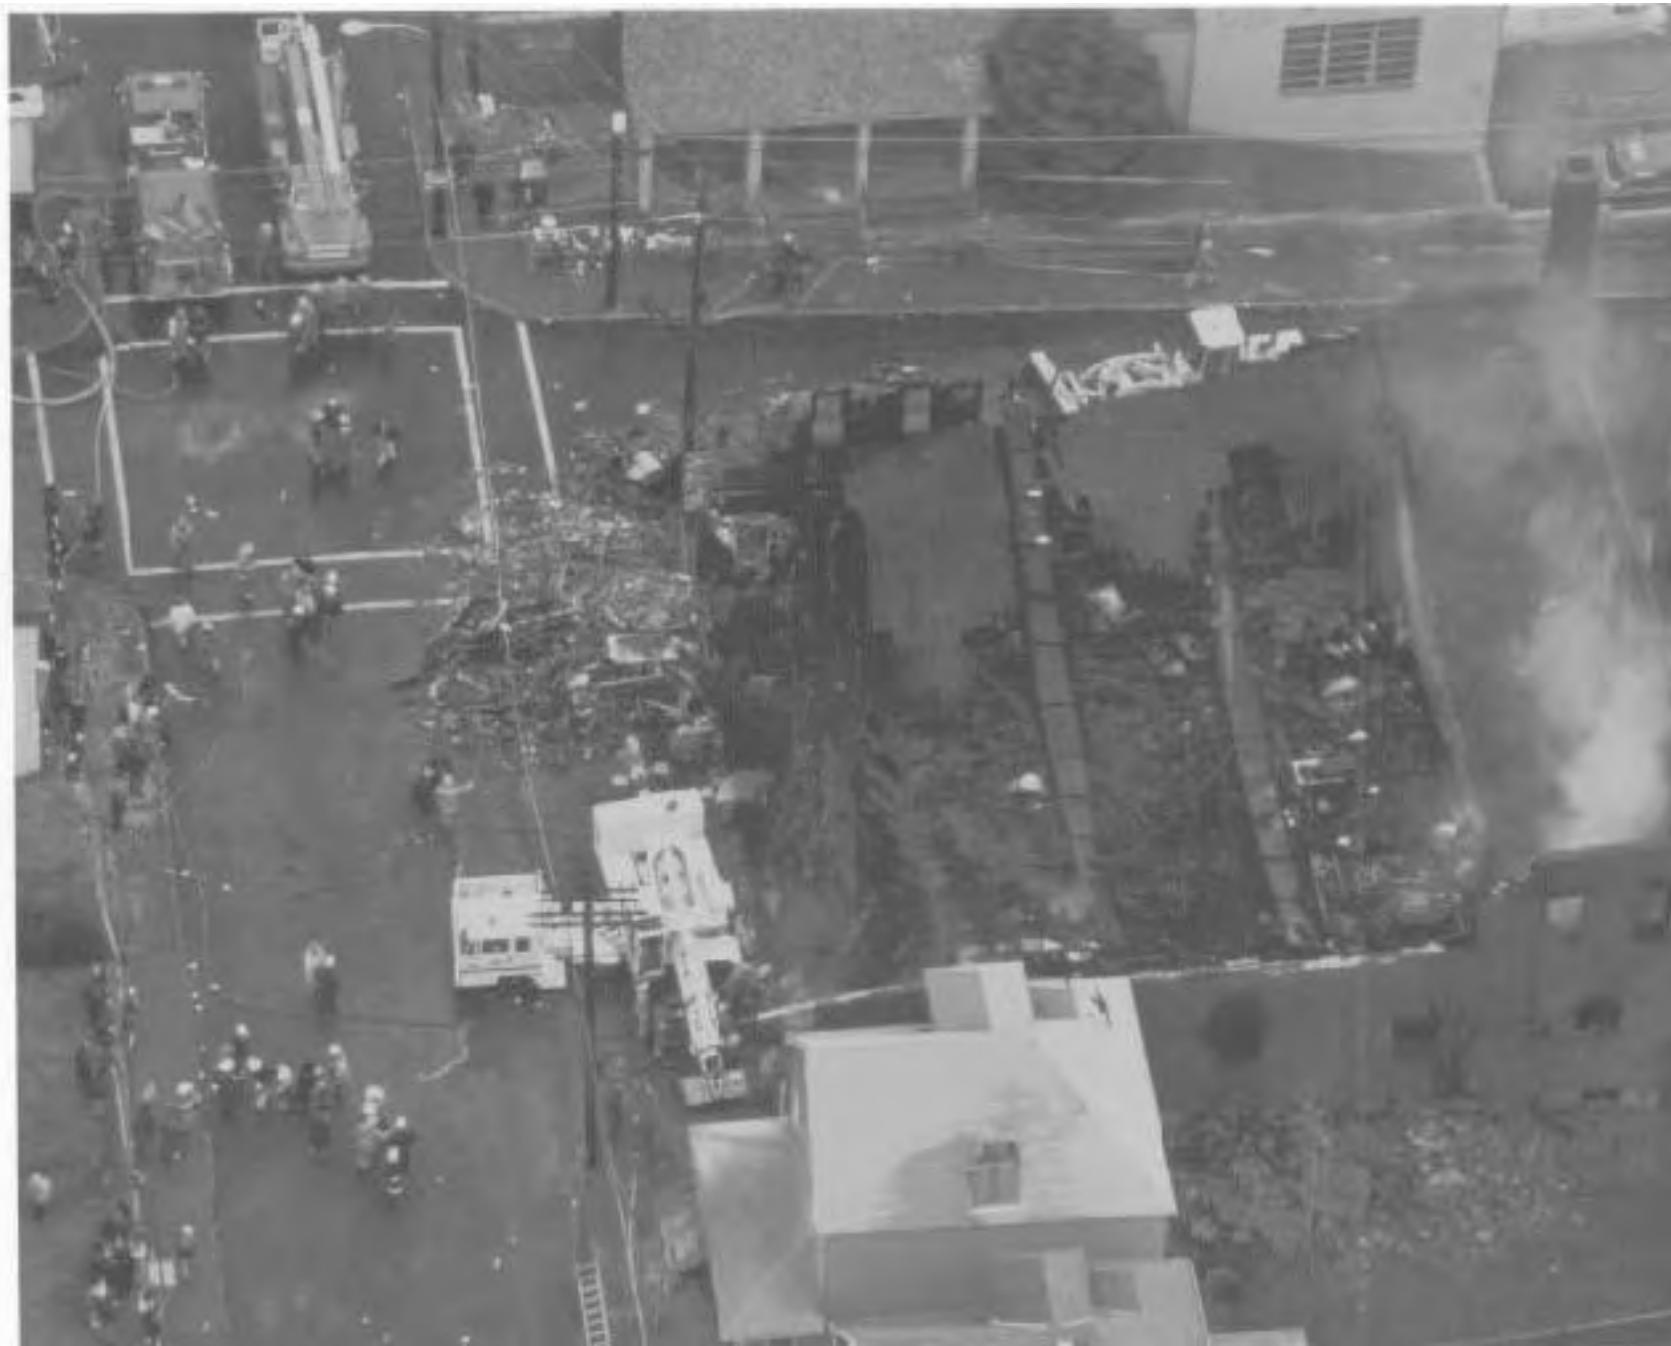
Aerial view of fire building after the fire.

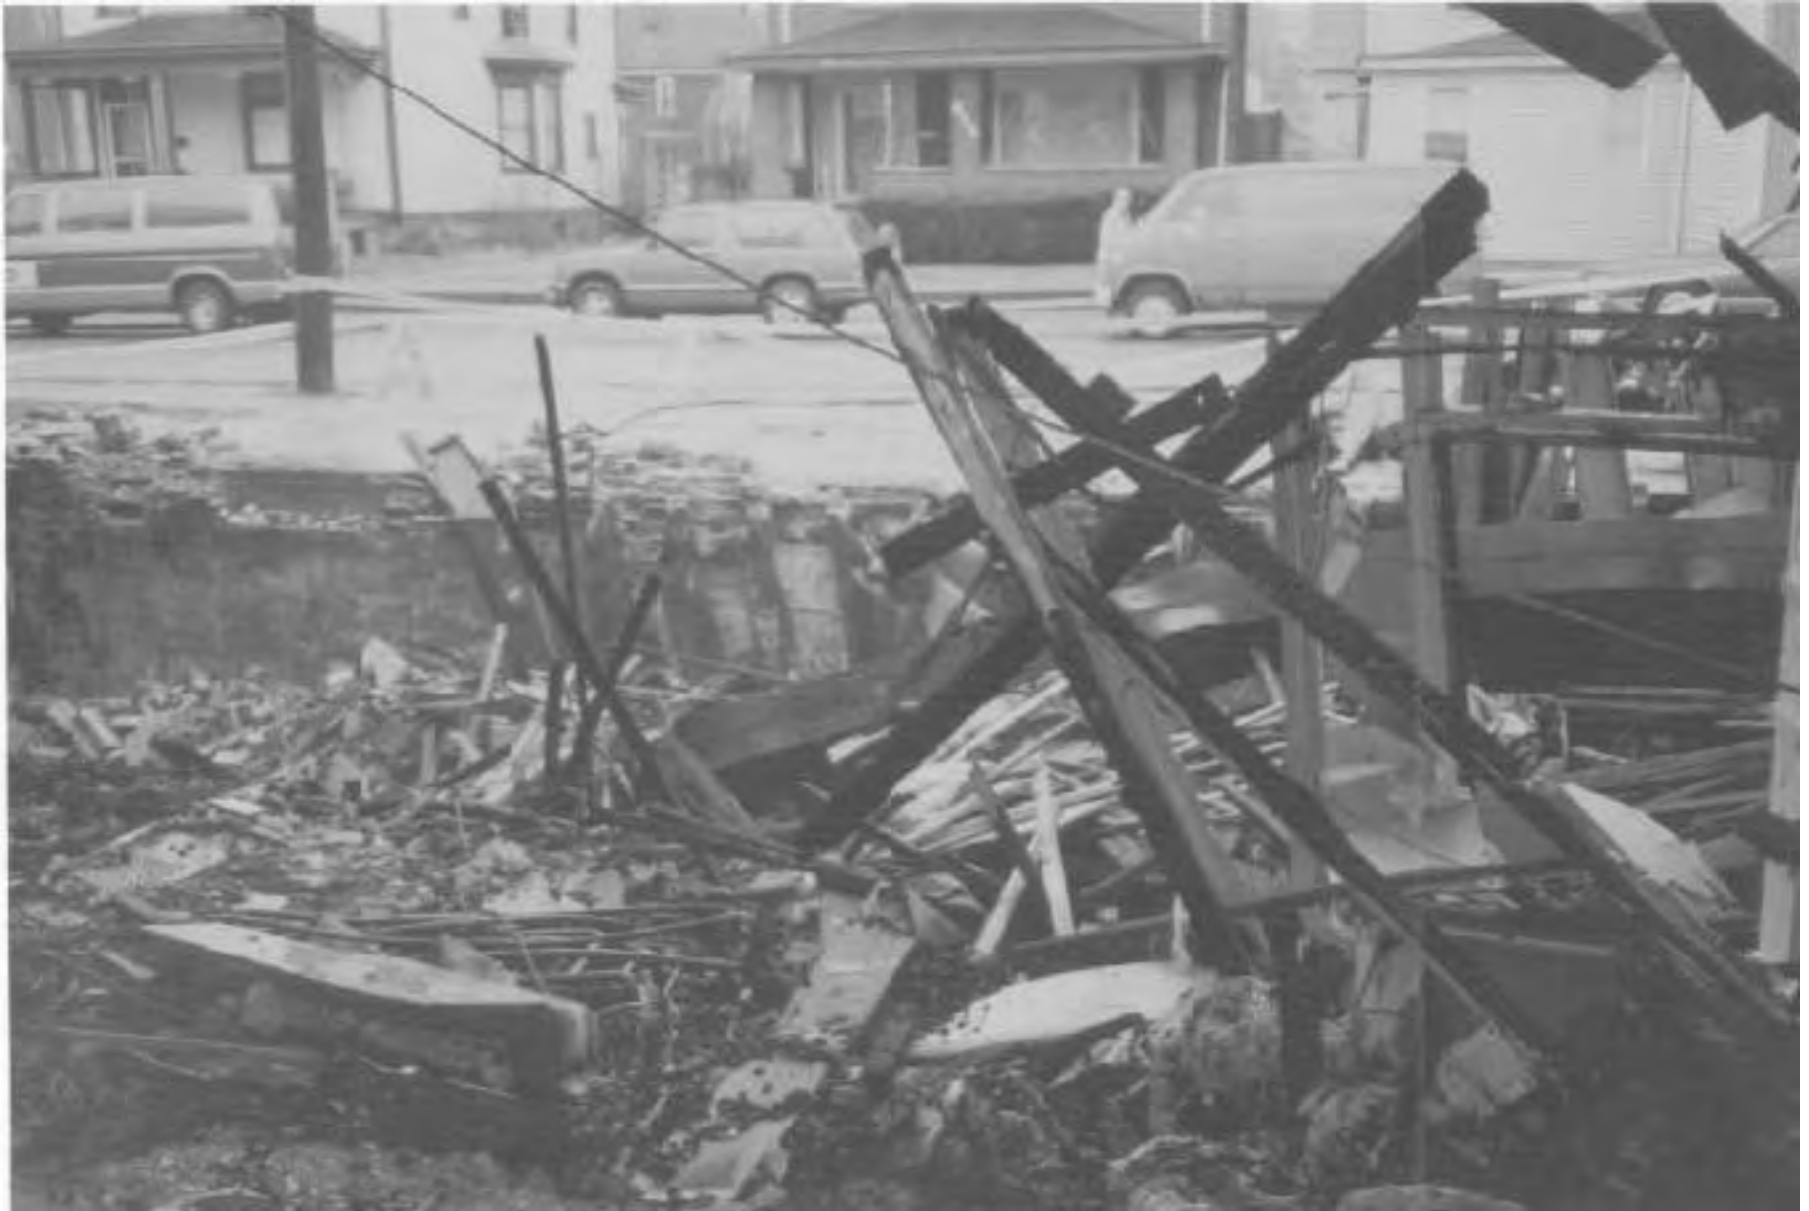
Looking toward Brackenridge Ave. from ground floor, near location where bodies were found. Debris in foreground is from first and second floors and from roof structure. Bent-over ends of floor joists are visible at the point of attachment to the basement wall.

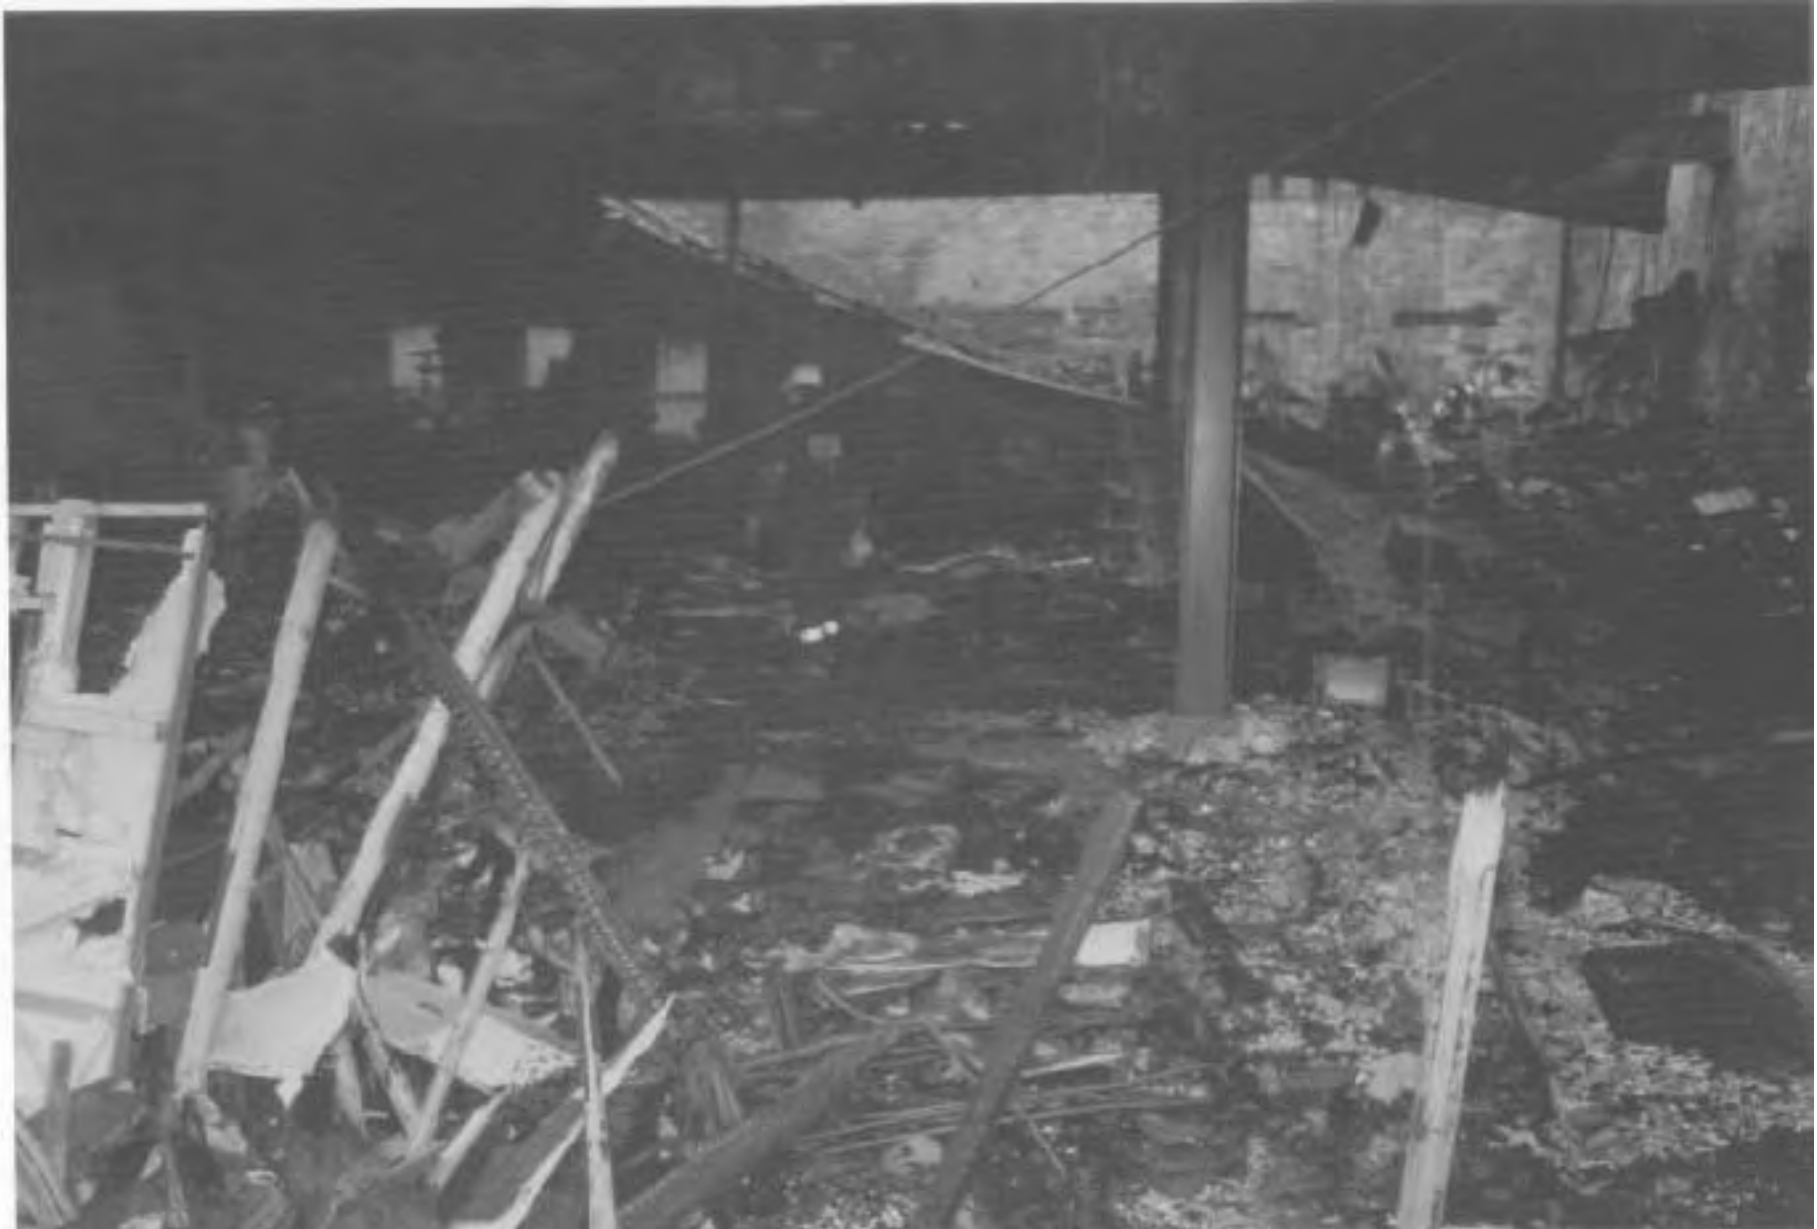
Ground floor area, showing unprotected steel column and ramp to second floor.

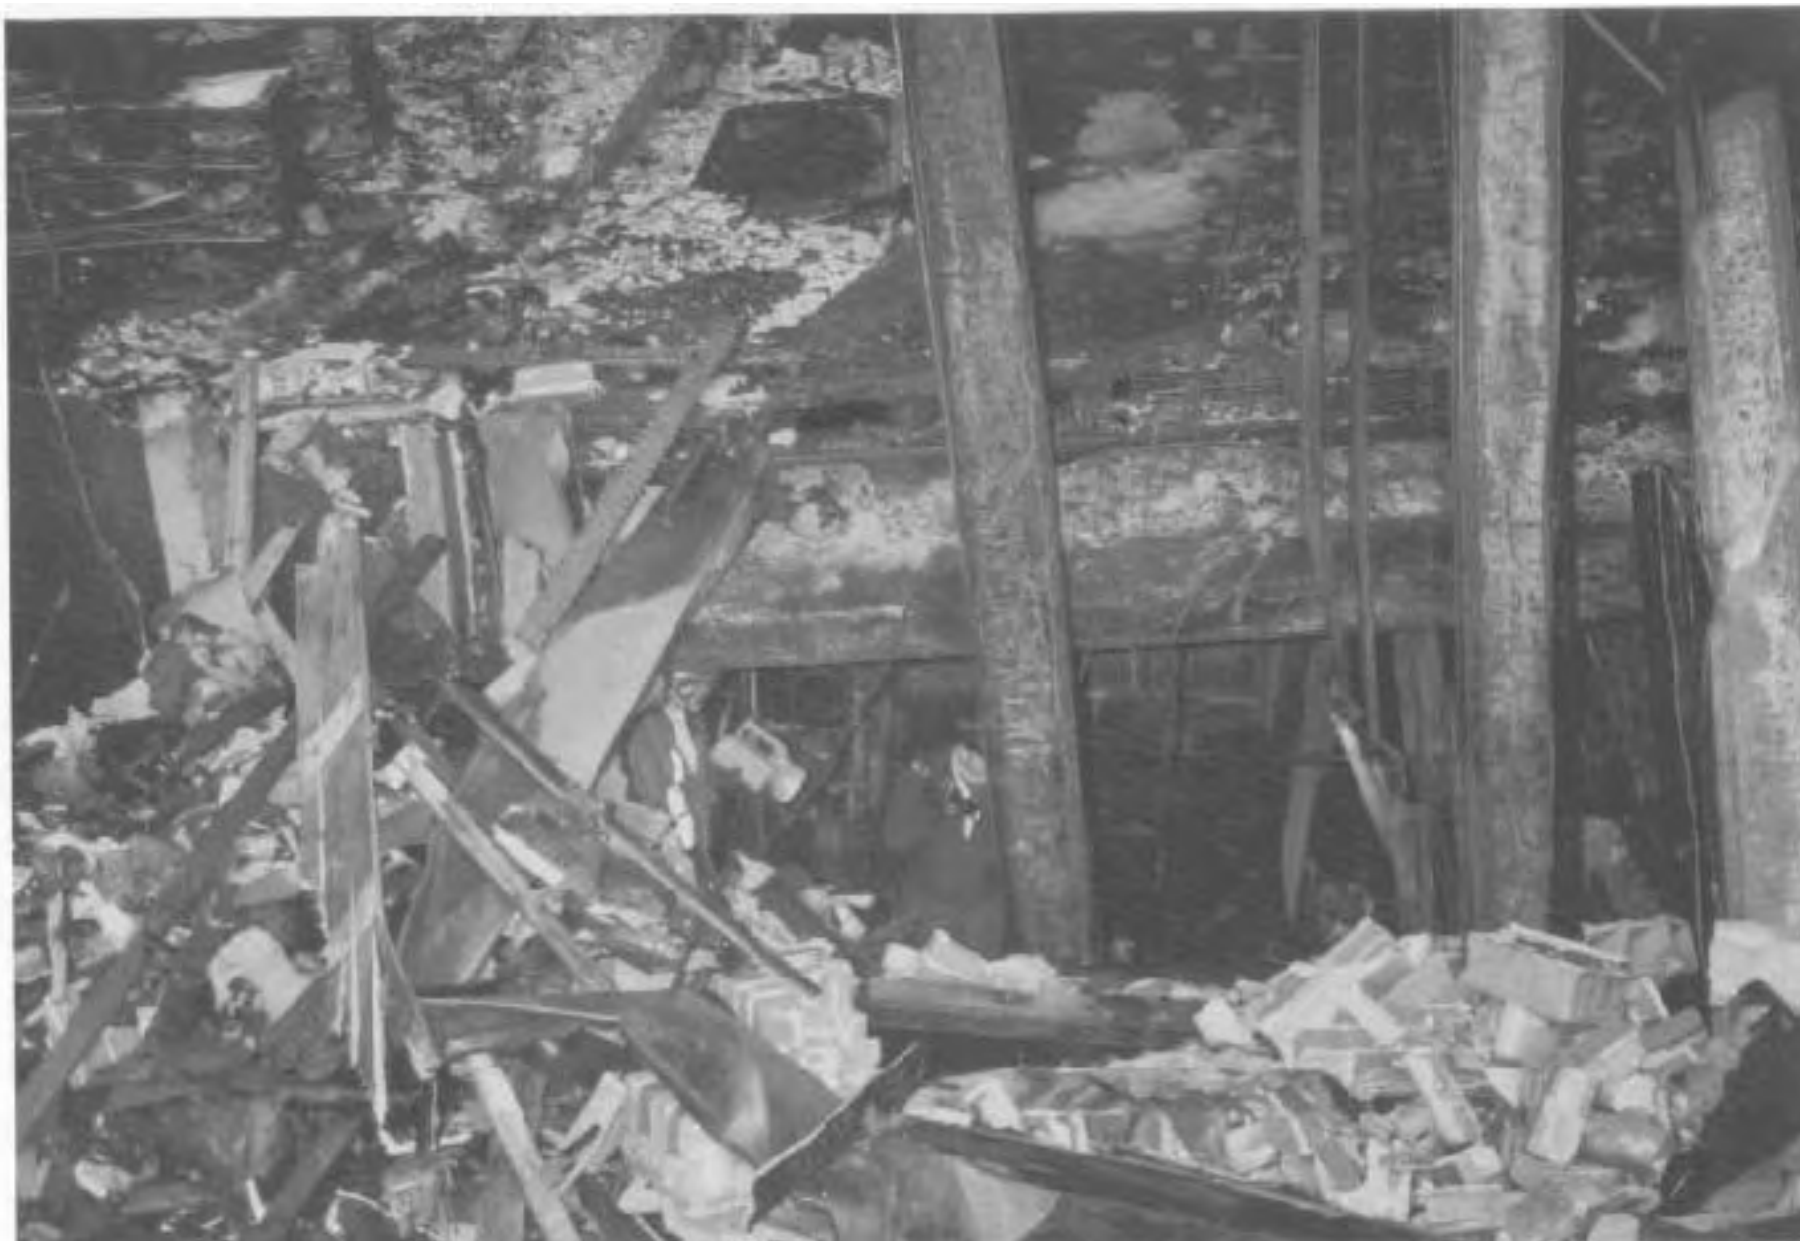
View from sidewalk in front of building (Brackenridge Ave.) looking into basement.  
Note thin concrete slab, supported by steel joists resting on steel beams.

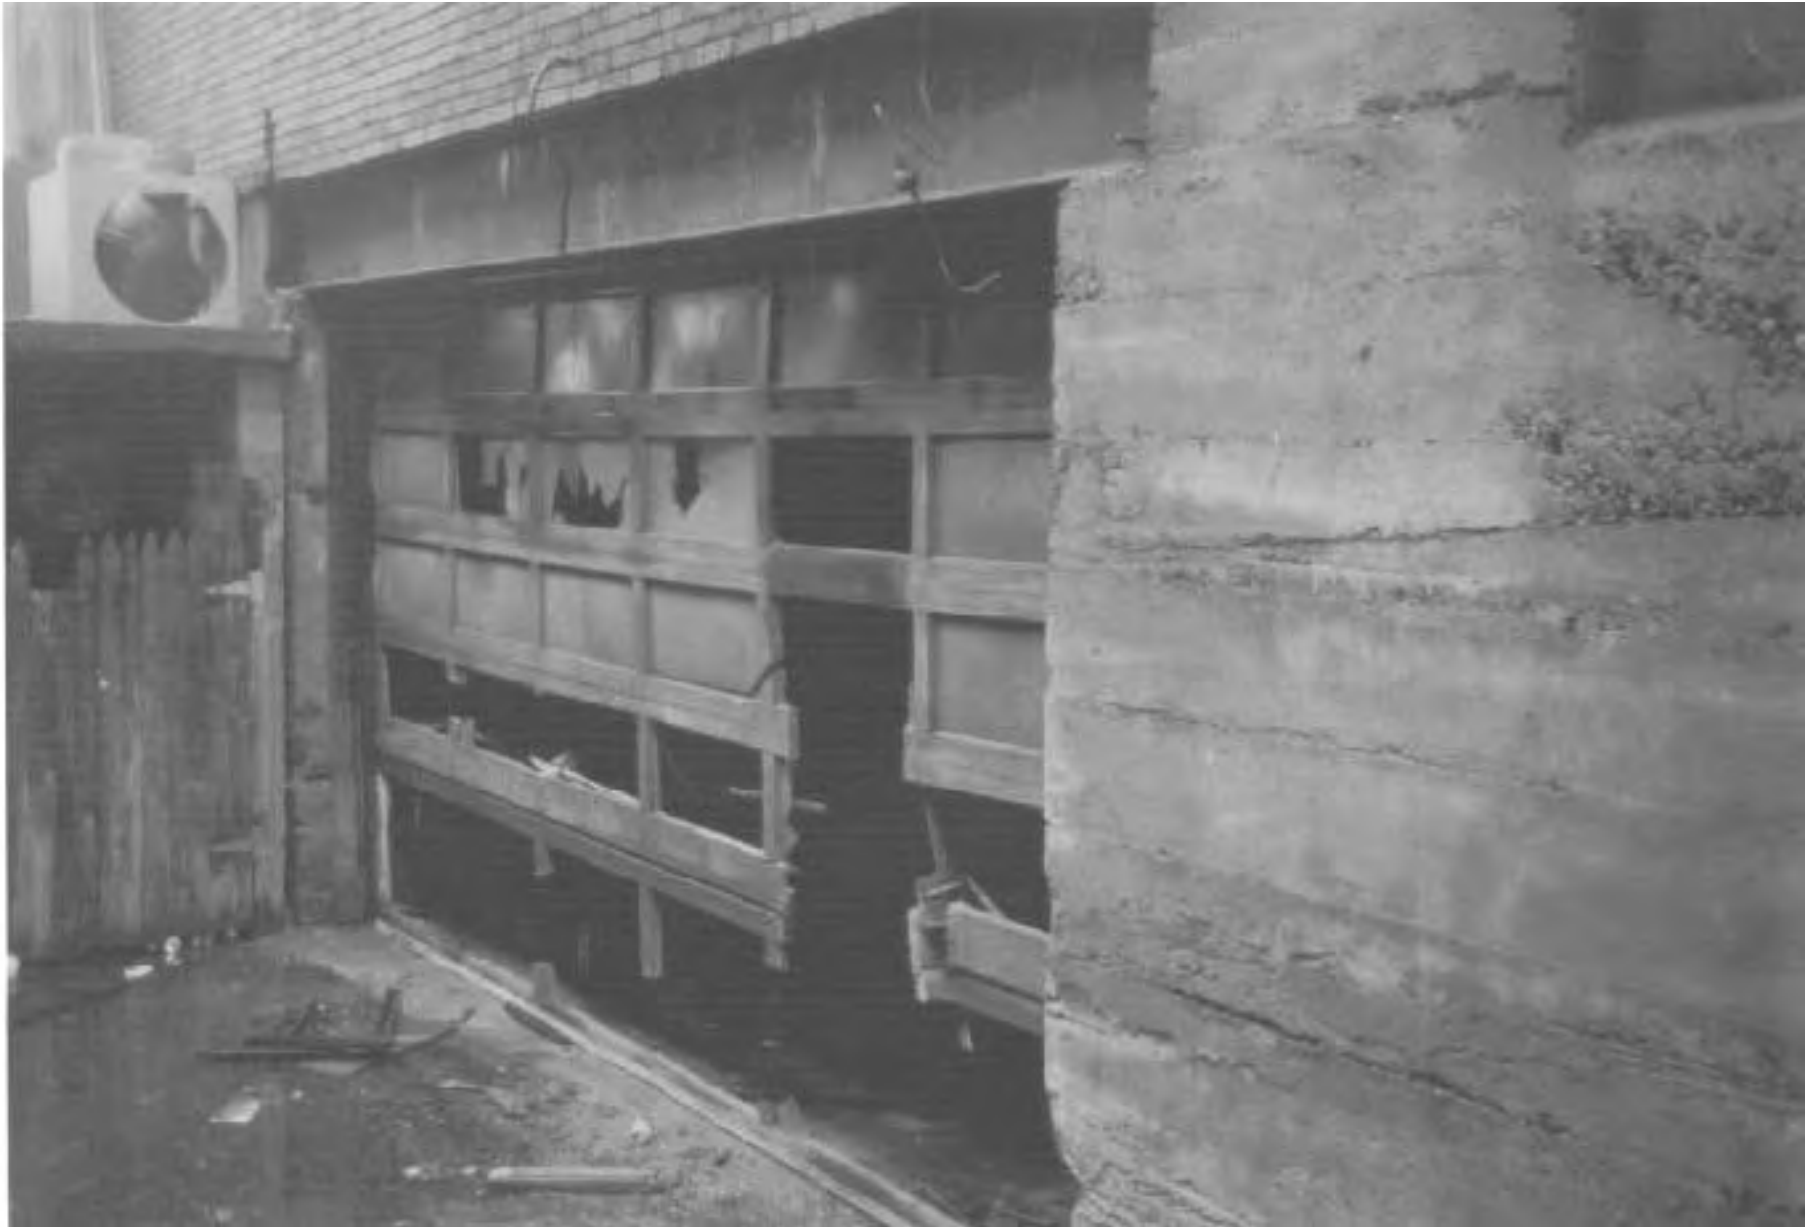
Roll-up door at the rear of the fire building has been cut with circular saws to allow crews to enter the basement.  
Initial entry by Eureka crew was through the bottom panels - larger opening was made later.

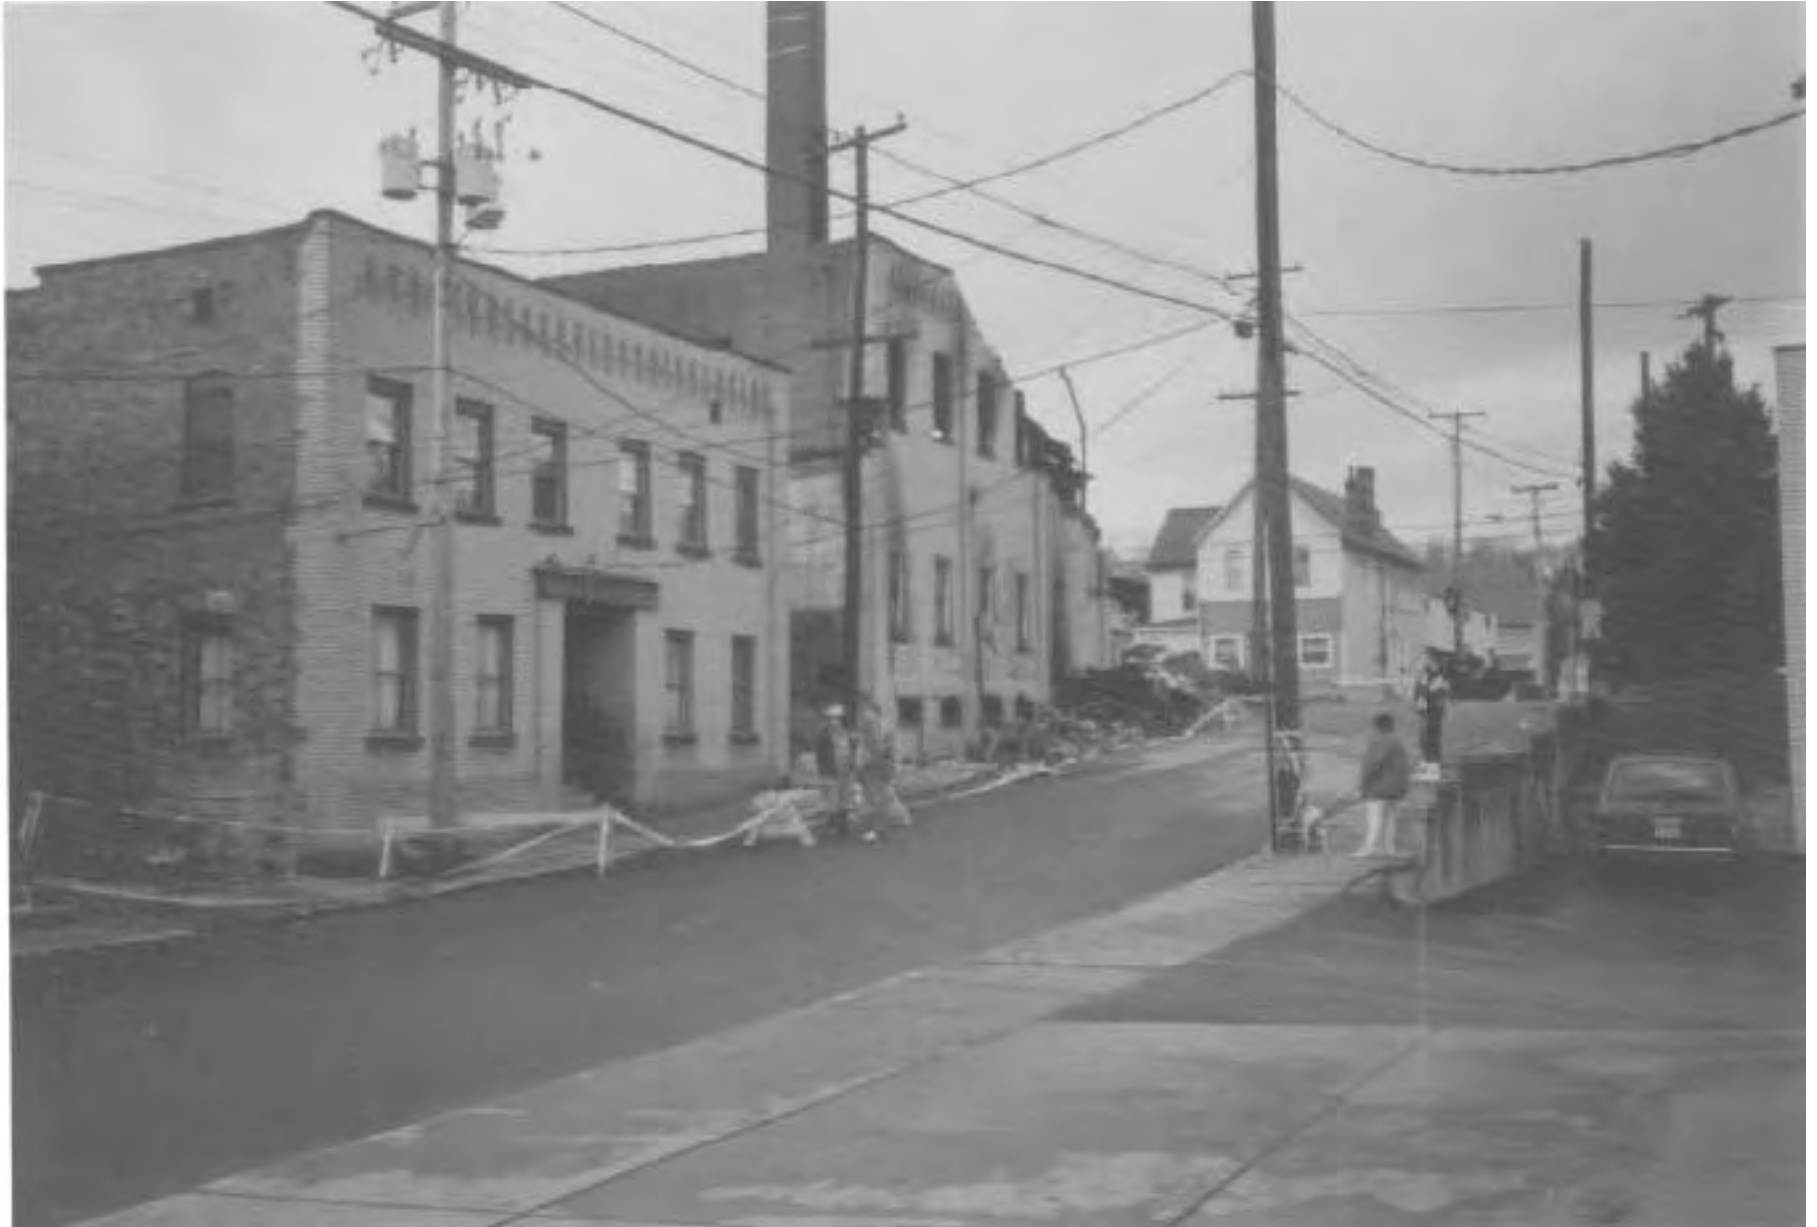
Looking from Pioneer Hose Company Station 50 toward fire building. Entrance to rear driveway (access to basement) is between buildings. Bridge once spanned driveway from second floor of building on left to the fire building.
