## **Ten-Fatality Board and Care Facility Fire Detroit, Michigan**

# **Ten-Fatality Board and Care Facility Fire Detroit, Michigan (June 2, 1992)**

**Investigated by: Mark Chubb**

**This is Report 066 of the Major Fires Investigation Project conducted  
by TriData Corporation under contract EMW-90-C-3338 to the United  
States Fire Administration, Federal Emergency Management Agency.**

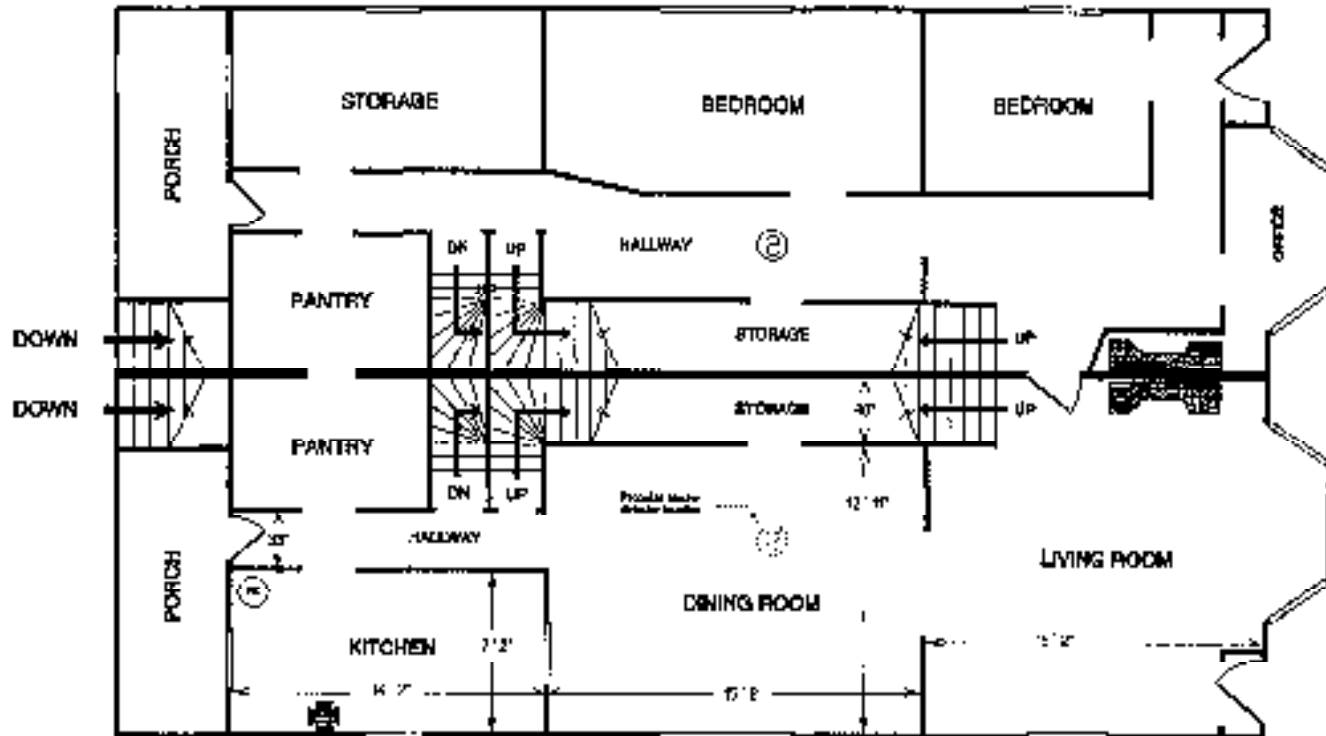
NU-WAY DEVELOPMENT CENTER  
 88-90 PINGREE STREET, DETROIT, MICHIGAN  
 FIRST FLOOR

Detroit fire investigators believe the fire started when carelessly discarded smoking materials ignited trash in a kitchen waste receptacle. Investigation revealed that the fire started in the kitchen near the floor between the stove and kitchen counter on the east side of the room. (For floor plans, see Appendix A.) A distinctive V-shaped burn pattern was clearly evident on the outside wall adjacent to this area pointing to the likely point of origin. Combustible interior finish on this wall likely provided additional fuel as the fire grew and spread. Other combustibles, including containers of cooking fat on a shelf directly above the point of origin, 'probably became involved allowing the fire to grow rapidly. The

Sometime shortly after 2:00 a.m., Mr. Fluckes reportedly heard sounds in the kitchen and rose to investigate.’ Approaching the rear of the dwelling, he observed a large fire in the kitchen through a pass-through opening to the dining room. When he arrived in the rear corridor at the open door to the kitchen, he reportedly attempted to enter to fight the fire, beating back the flames with his hands in an unsuccessful attempt to reach the fire extinguisher in the northeast corner of the room.

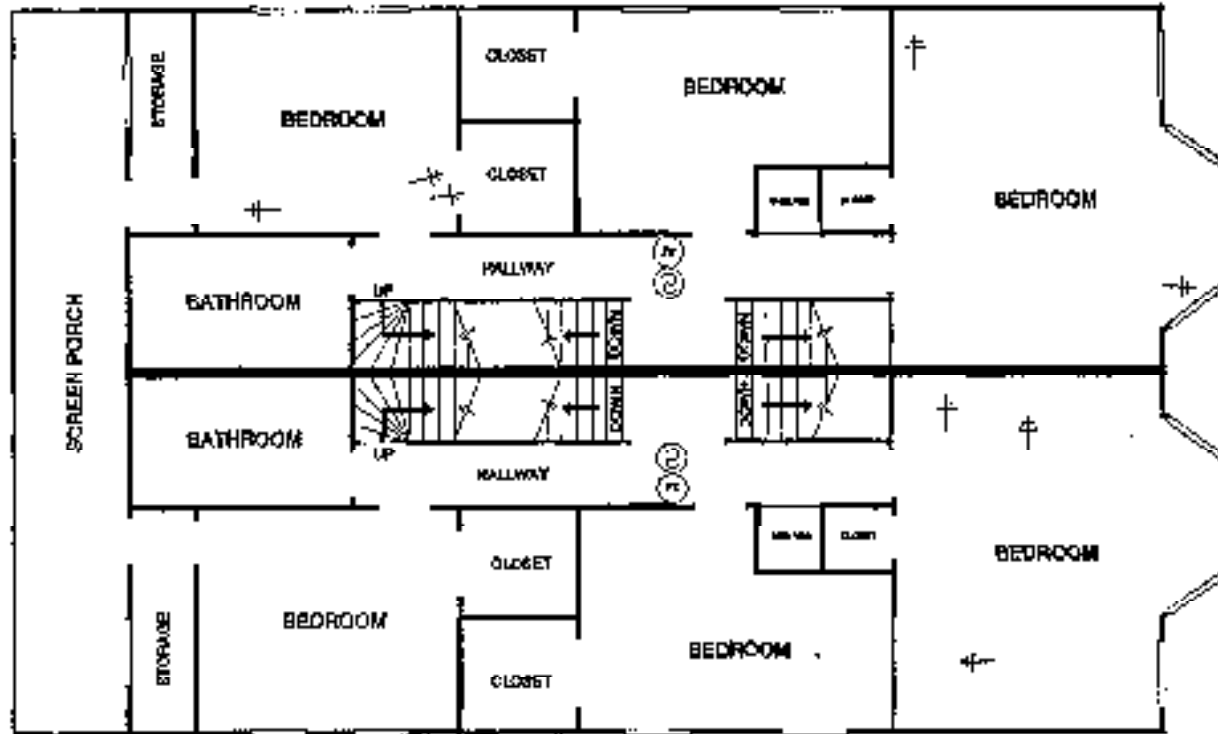
SECOND FLOOR

The floor plan in Appendix A shows the locations of the victims. They were distributed throughout the building. The same number of victims was found on the east side as the west side and in the front part of the building as the rear. Eight of the victims were found on the second floor and two on the third floor.

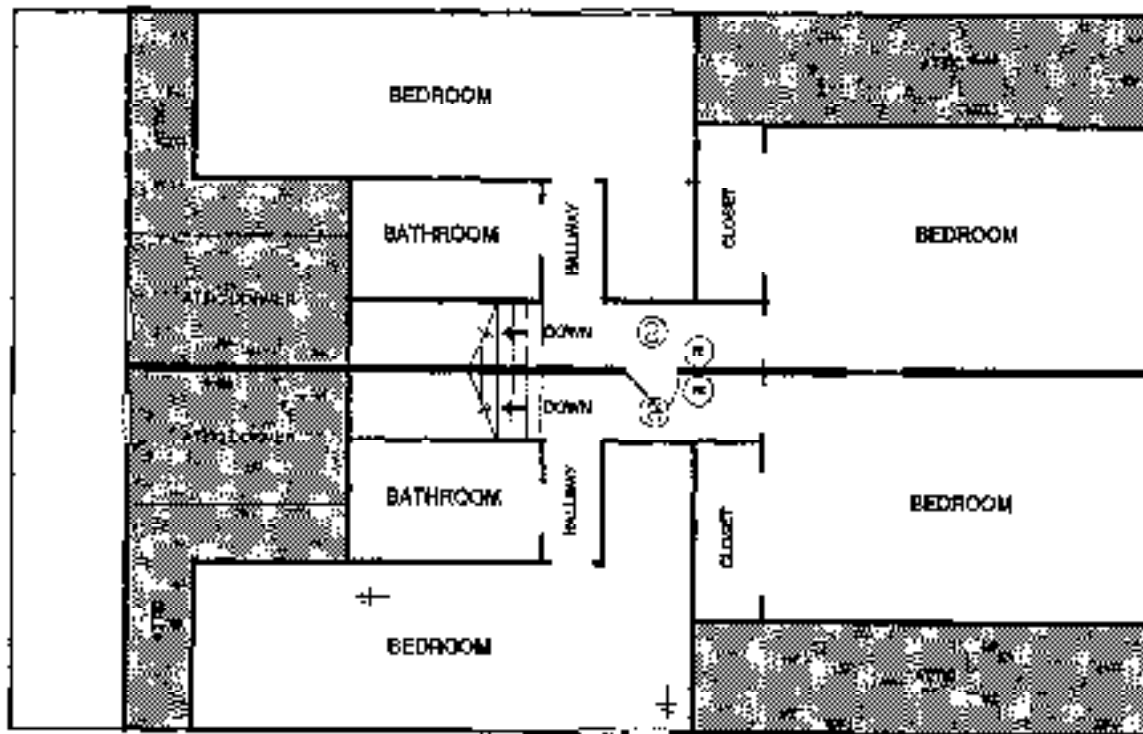
THIRD FLOOR

At some point during this sequence, smoke detectors installed in the house activated, alerting Glenn Gregory, a resident in the third floor southwest bedroom. He was watching a late-night movie and proceeded downstairs immediately to investigate. On the first floor he observed through the pass-through opening that the fire extending up the back wall of the kitchen and witnessed Mr. Fluckes trying unsuccessfully to control the fire. Mr. Gregory attempted to dial 911 from the telephone in the dining room but reported that he received busy signals on two successive attempts.

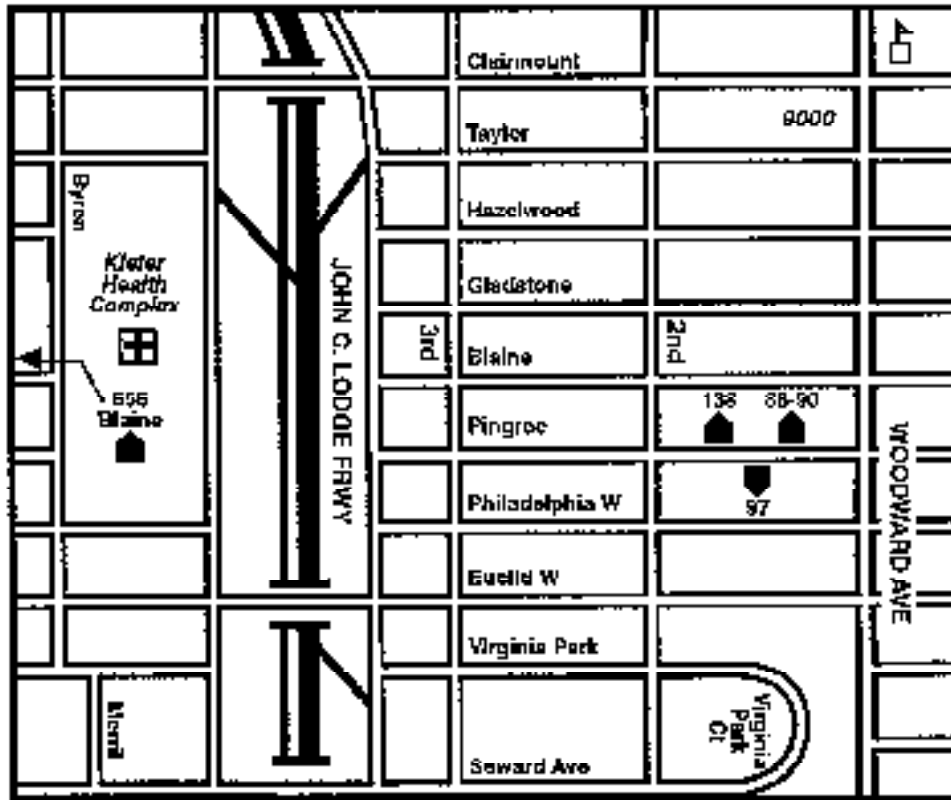
## Area Map

The above map shows locations of other adult board and care facilities operated by the owners of Nu Way Development Center. Previous fires at two of these houses on Pingree Street involved residents of 88-90 Pingree Street.
