Floor Collapse Claims Two Firefighters Pittston, Pennsylvania

Floor Collapse Claims Two Firefighters Pittston, Pennsylvania (March 15,1993)

Investigated by: J. Gordon Routley

**This is Report 073 of the Major Fires Investigation Project conducted
by TriData Corporation under contract EMW-90-C-3338 to the United
States Fire Administration, Federal Emergency Management Agency.**

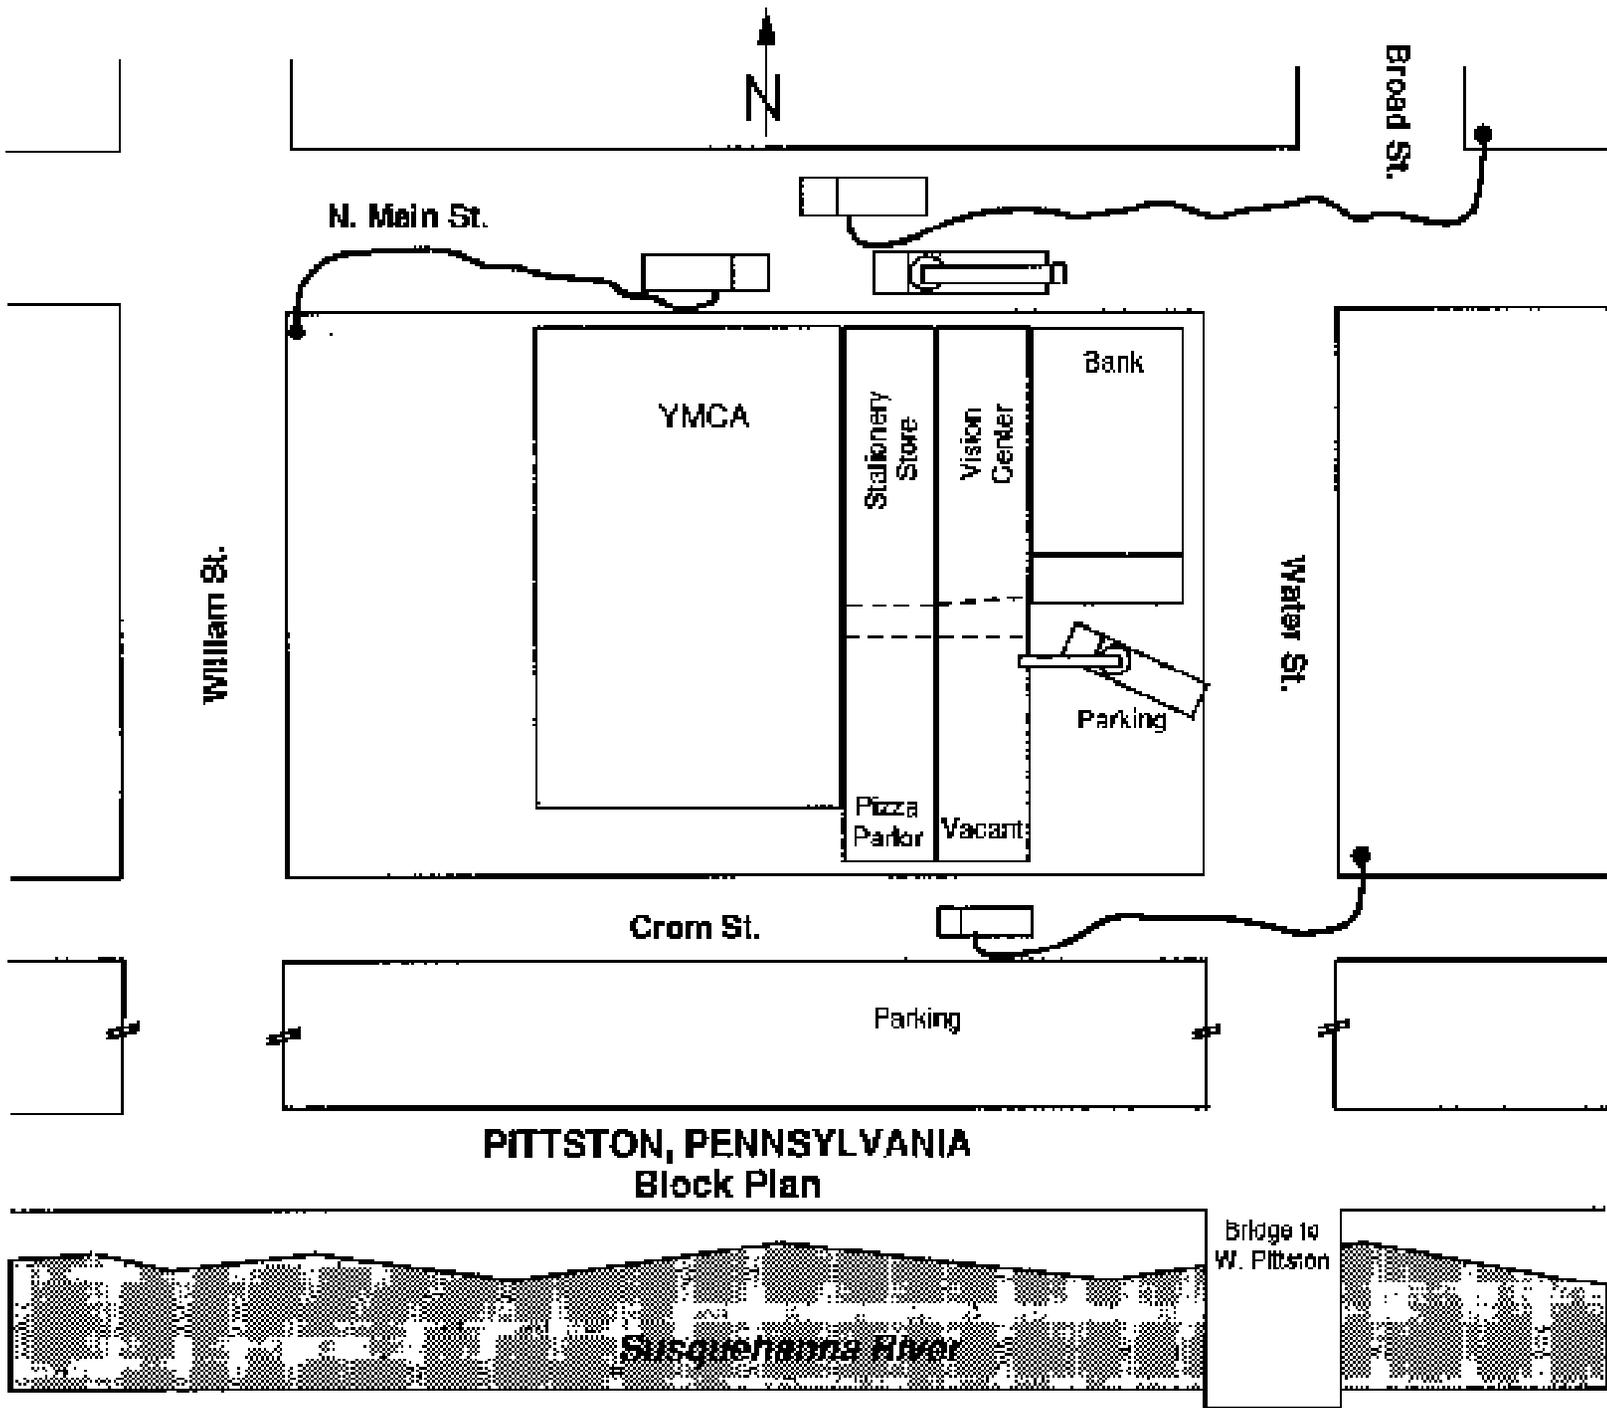
**PITTSTON, PENNSYLVANIA
Block Plan**

The arrangement of the interconnected buildings created some very unusual and dangerous conditions for firefighters. From the vision center there was no access from the upper level to the lower level, except to go around to the rear of the building and enter from Crom Street, through the vacant office space. This also created dead end spaces on both levels, estimated at more than 140 feet from the street entrances on each level, where the only way out was the way a firefighter would have entered.
