Technical Report Series

Four Firefighters Die in Seattle Warehouse Fire Seattle, Washington

Investigated by: J. Gordon Routley

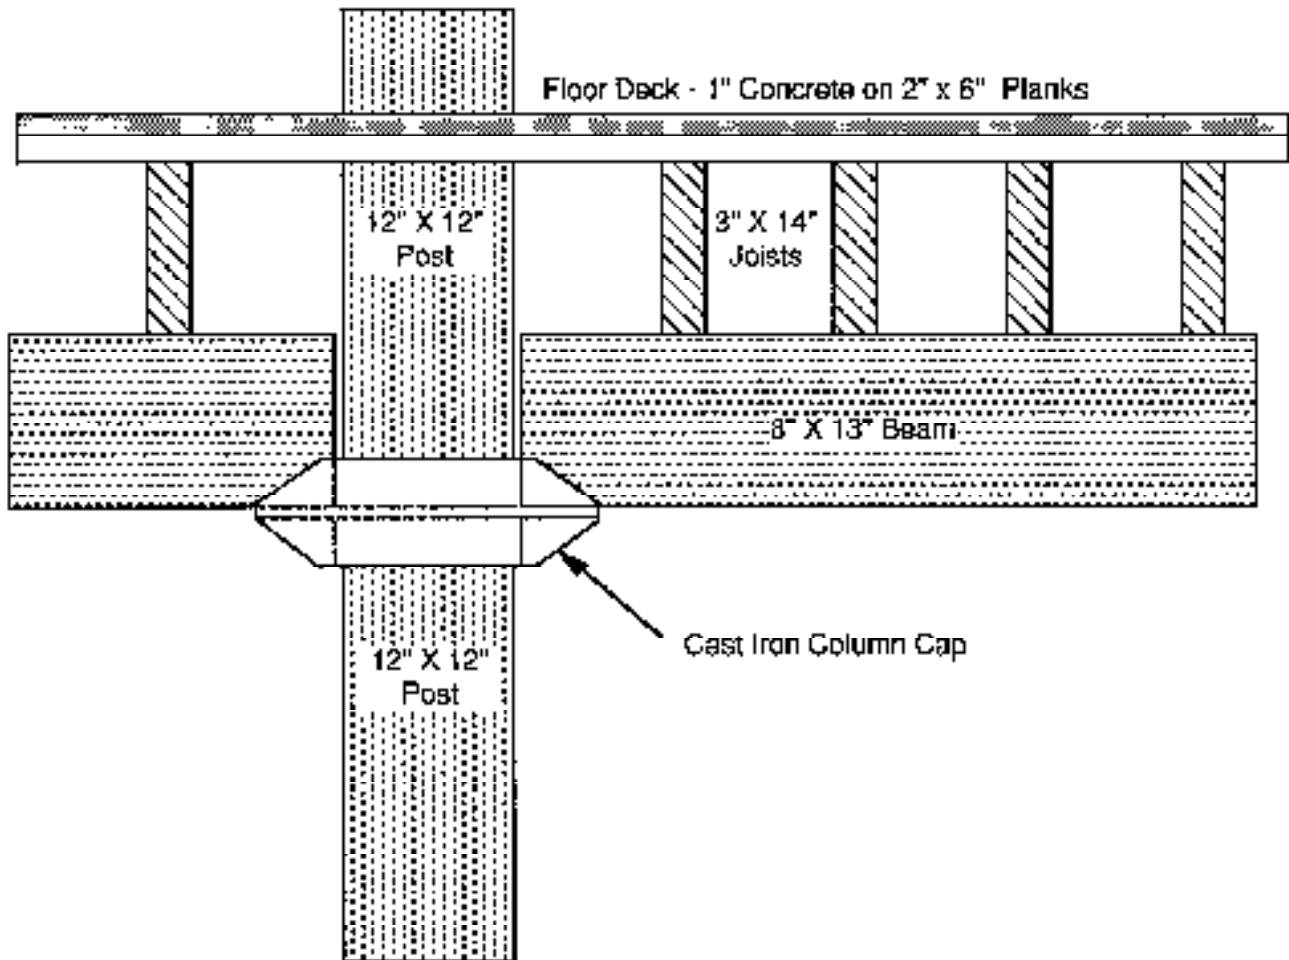
DETAIL OF UPPER FLOOR DECK AND COLUMN CONNECTIONS

The hidden flaw in the structure was the support for the ends of the new floor joists along the north wall. The original roof was supported by a ledge that was incorporated in the brick wall. Because the new floor was four to five feet higher than the roof, a wood frame "pony wall" was fabricated from 2 x 4 inch wood members and erected on top of the ledge to support the ends of the new floor joists. This assembly did not have the inherent fire resistance of the more massive wood members and could be expected to fail rapidly under fire conditions. The failure of this assembly would release the ends of the floor joists and result in a sudden floor collapse.

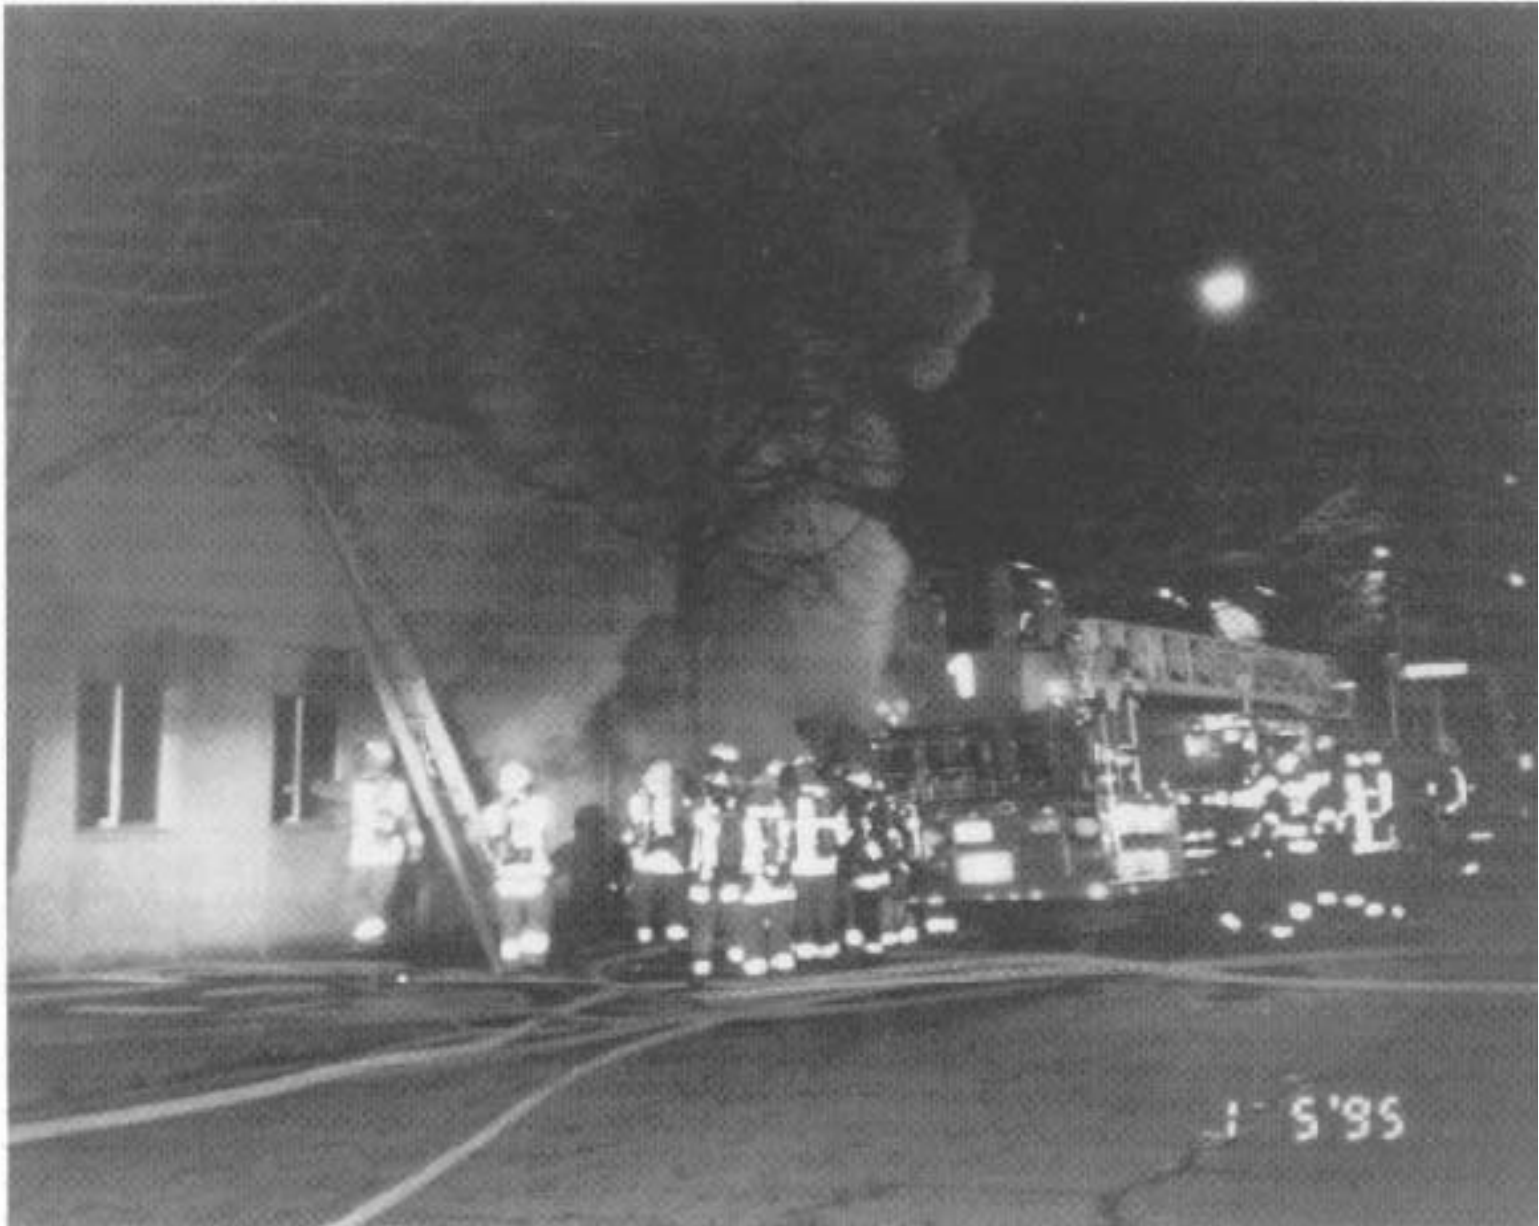
A large volume of fire was visible to units approaching from the west in the early stages of the incident. The outline of the lunchroom is visible next to the tallest flames.
