Three Firefighters Die in Pittsburgh House Fire Pittsburgh, Pennsylvania

United States Fire Administration Major Fire Investigations Program

Investigated by: J. Gordon Routley

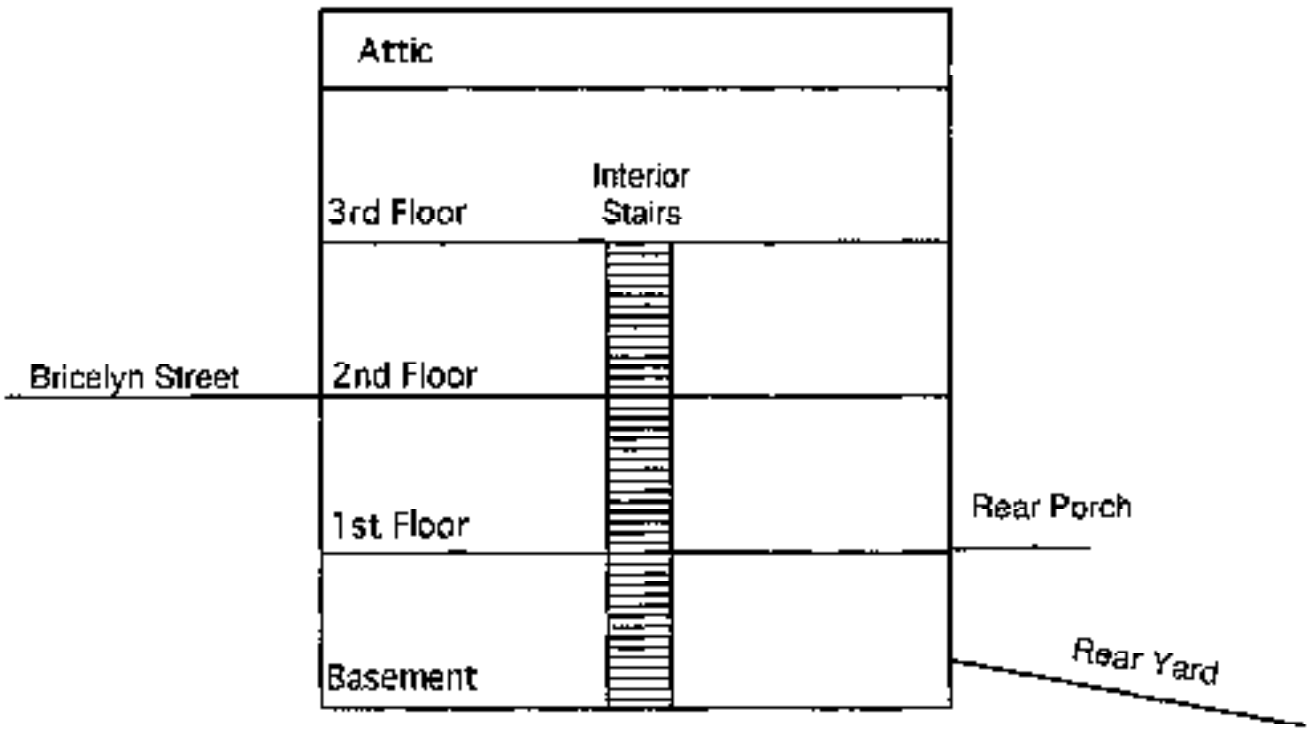
INTERIOR CROSS SECTION

The three stair sections were stacked, one directly above another, and divided each floor into front and rear sections. A wood door at the top of the basement stairs opened into a narrow vestibule on the first floor; when this door was open it blocked the opening between the kitchen at the rear and the family room at the front. There were no doors in the stairways between the first and second or the second and third floors.

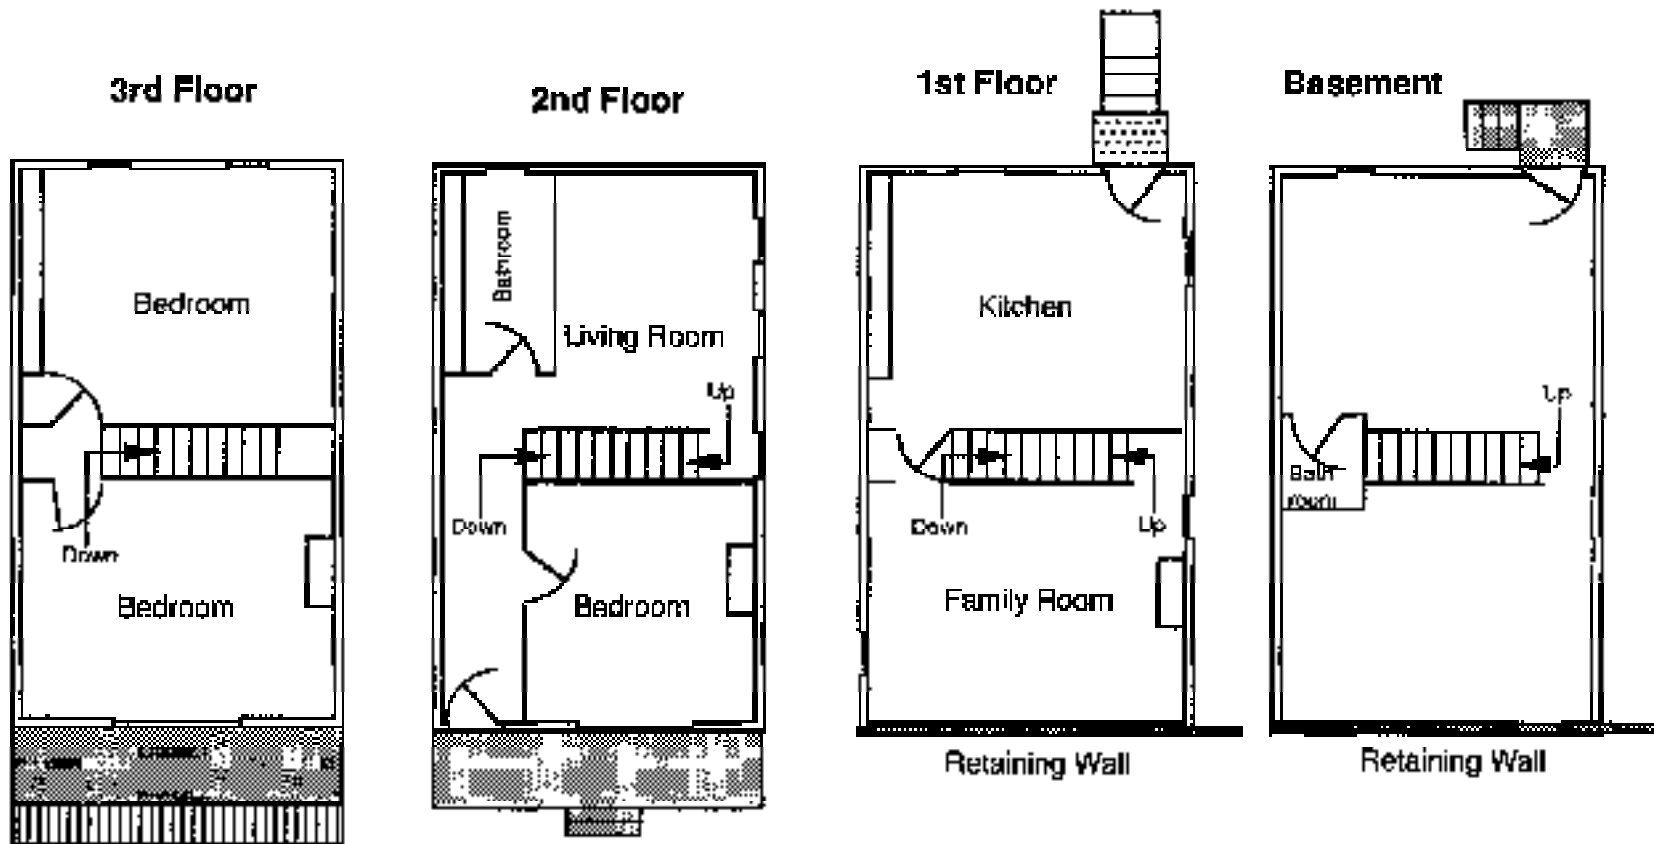
FLOOR PLANS 8361 Bricelyn Street

The kitchen and family room were located on the first floor, the living room and one bedroom were on the second floor, and two additional bedrooms were on the third floor. The heating equipment, a washer and

drier, and storage areas were located in the basement. The furnace, water heater and clothes drier were all fueled by natural gas.

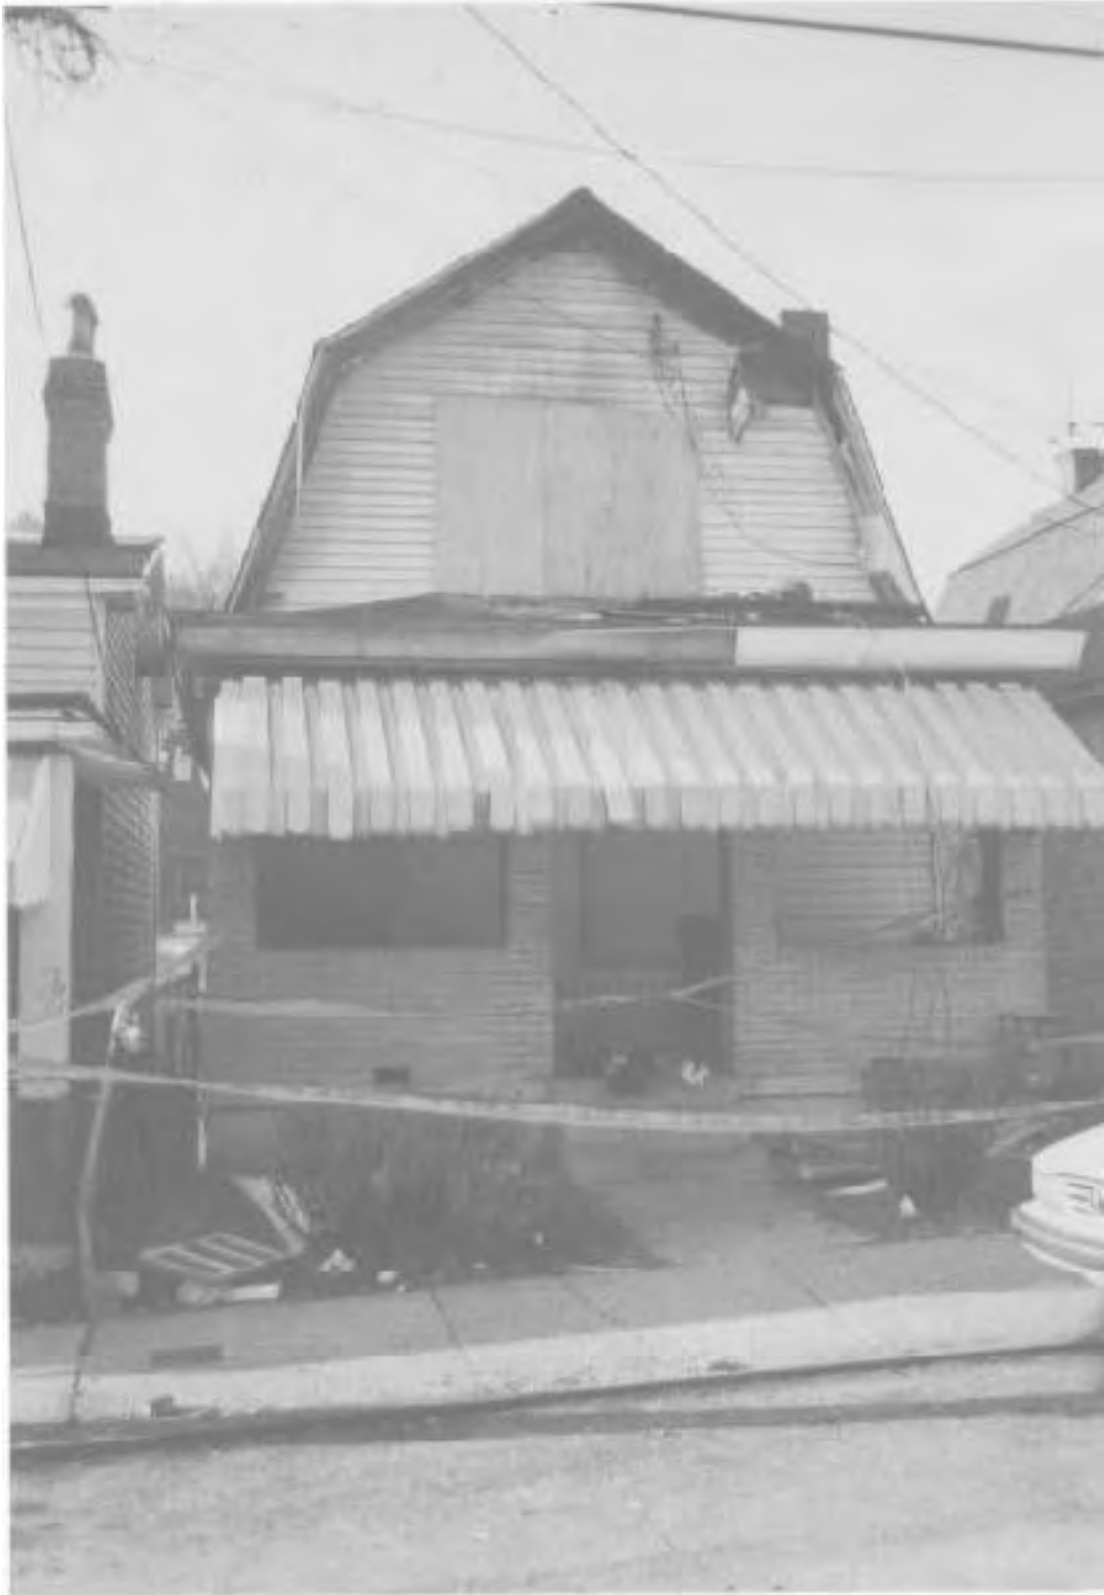
Front view of 8361 Bricelyn Street.

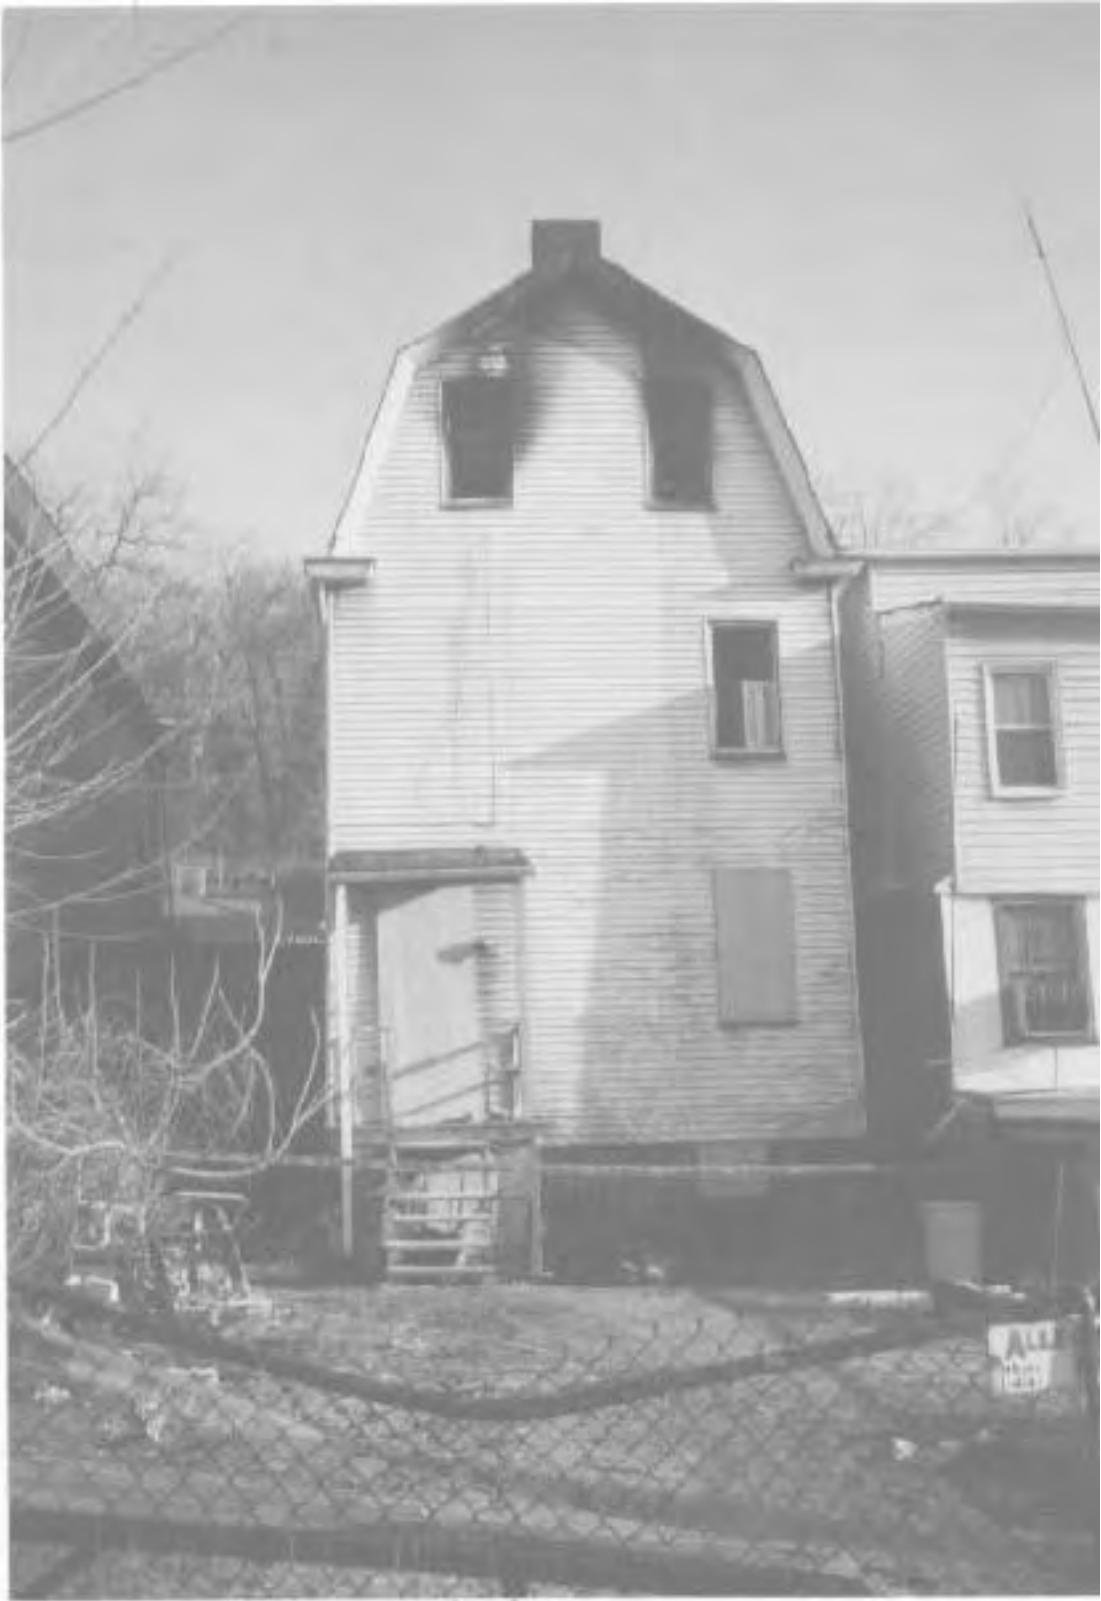
Rear view of 8361 Bricelyn Street.
