Hospital Fire Kills Four Patients Southside Regional Medical Center Petersburg, Virginia

**Hospital Fire Kills Four Patients
Southside Regional Medical Center
Petersburg, Virginia
(December 31, 1994)**

This is Report 080 of the Major Fires Investigation Project conducted by Varley-Campbell and Associates, Inc./TriData Corporation under contract EMW-94-C-4423 to the United States Fire Administration, Federal Emergency Management Agency.

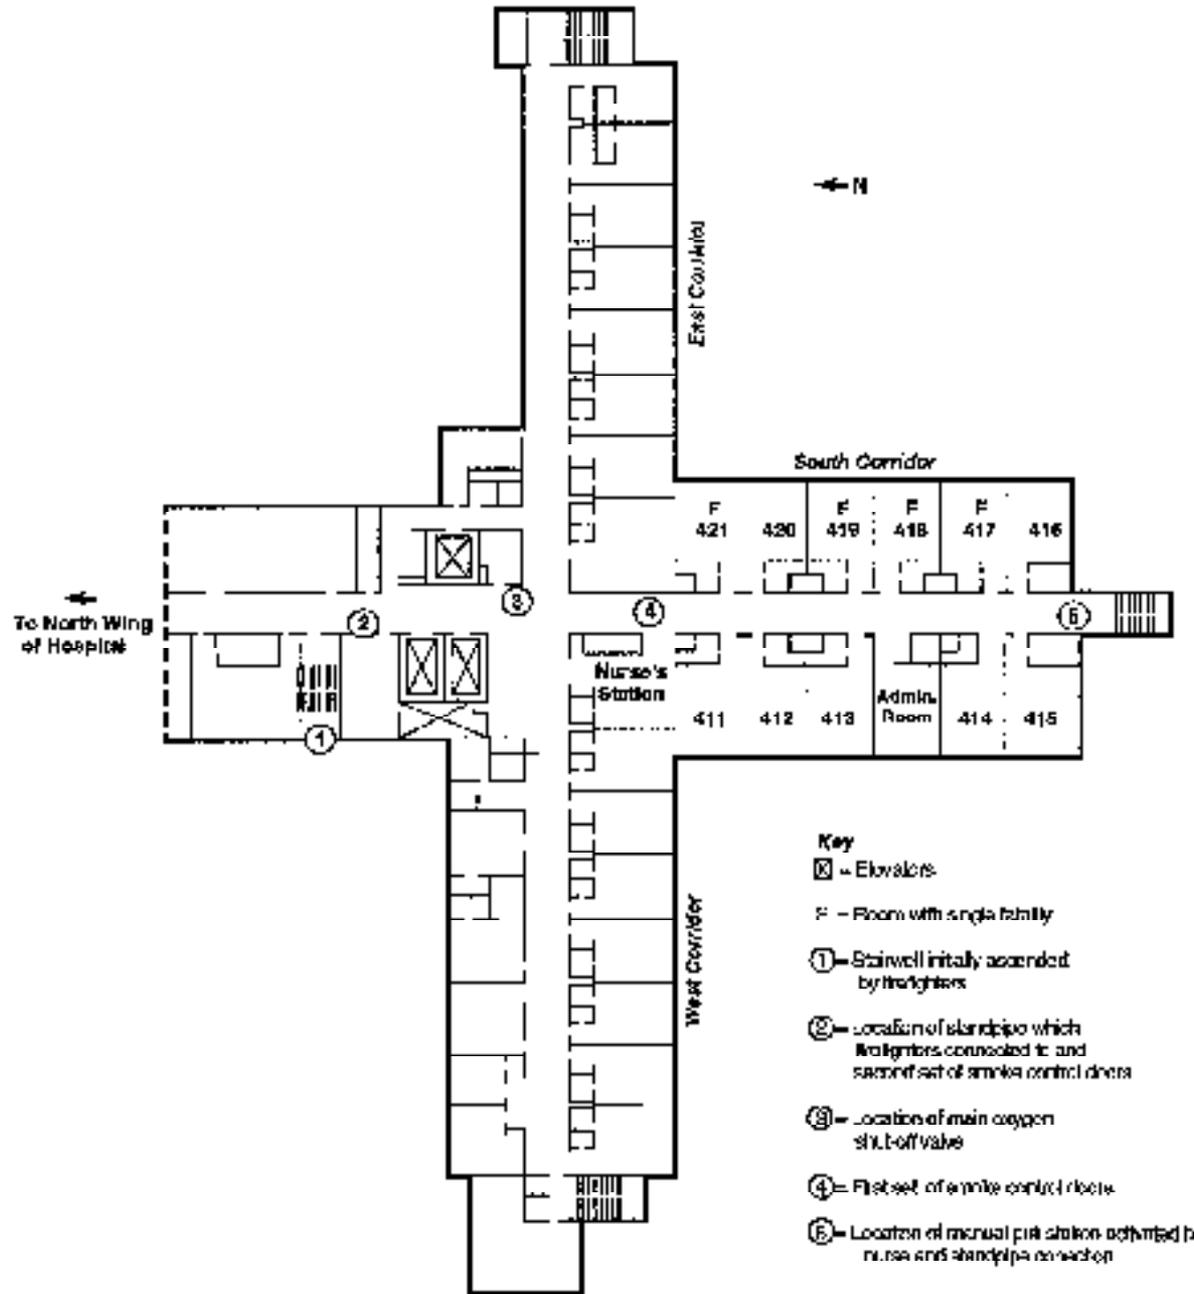
Four-South Floor Plan

The fire was contained to the room of origin with slight extension into the adjacent corridor. There was heavy smoke and heat damage to the corridor, and heavy smoke infiltrated adjacent patient rooms (see

Appendix A for floor diagram). Hospital staff and nurses rescued several patients before firefighters arrived. Three patients in rooms adjacent to the fire room died from smoke inhalation, and one patient in the fire room died from a combination of smoke inhalation and burns. Three firefighters were treated for minor smoke inhalation after their breathing apparatus ran out of air during rescue operations. Several nurses and patients also suffered minor injuries from smoke inhalation.
