Aerial Ladder Collapse Incidents

Aerial Ladder Collapse Incidents (April 1996)

This is Report 081 of the Major Fires Investigation Project conducted by Varley-Campbell and Associates, Inc./TriData Corporation under contract EMW-94-C-4423 to the United States Fire Administration, Federal Emergency Management Agency.

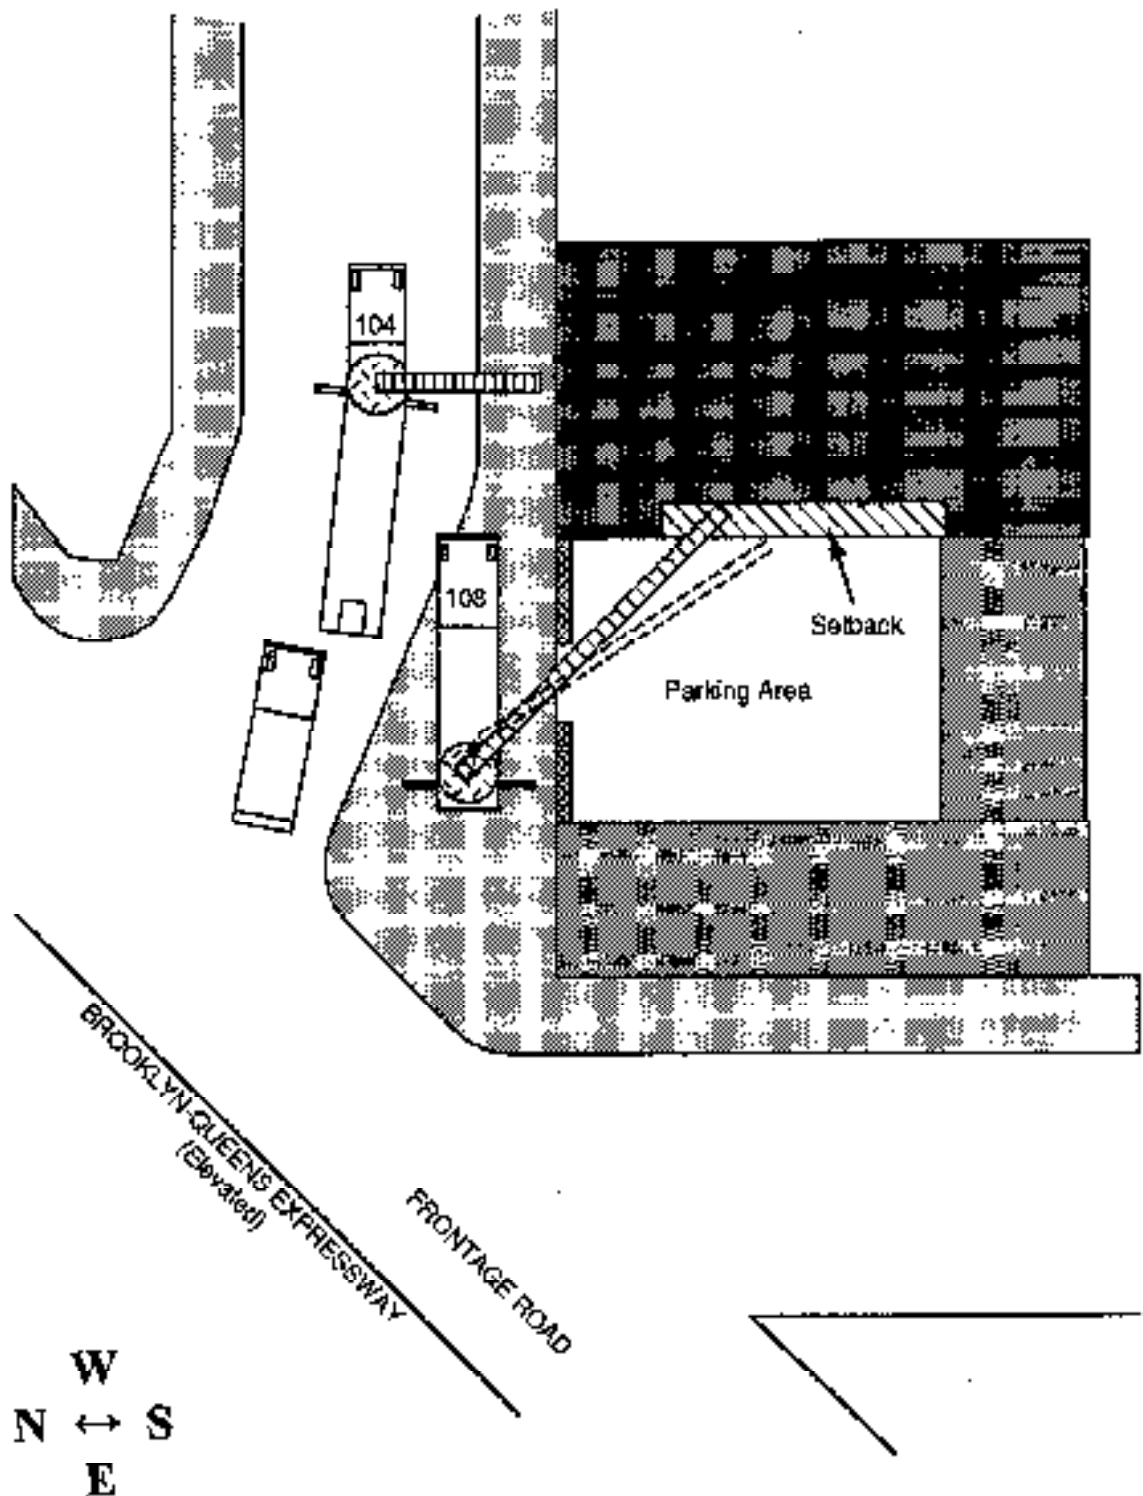
Figure 1. Apparatus Positions at New York City Ladder Collapse

The first arriving ladder company, Ladder 104, stopped in front of the building and raised their aerial ladder to the fifth floor, adjacent to the fire apartment (see Figure 1). In this situation the second due ladder company, Ladder 108, is expected to provide a ladder to the roof. Because Ladder 104 is a tractor trailer apparatus and several other vehicles were parked on the street in front of the fire building, Ladder 108 had limited access to position their apparatus within reach of the building.

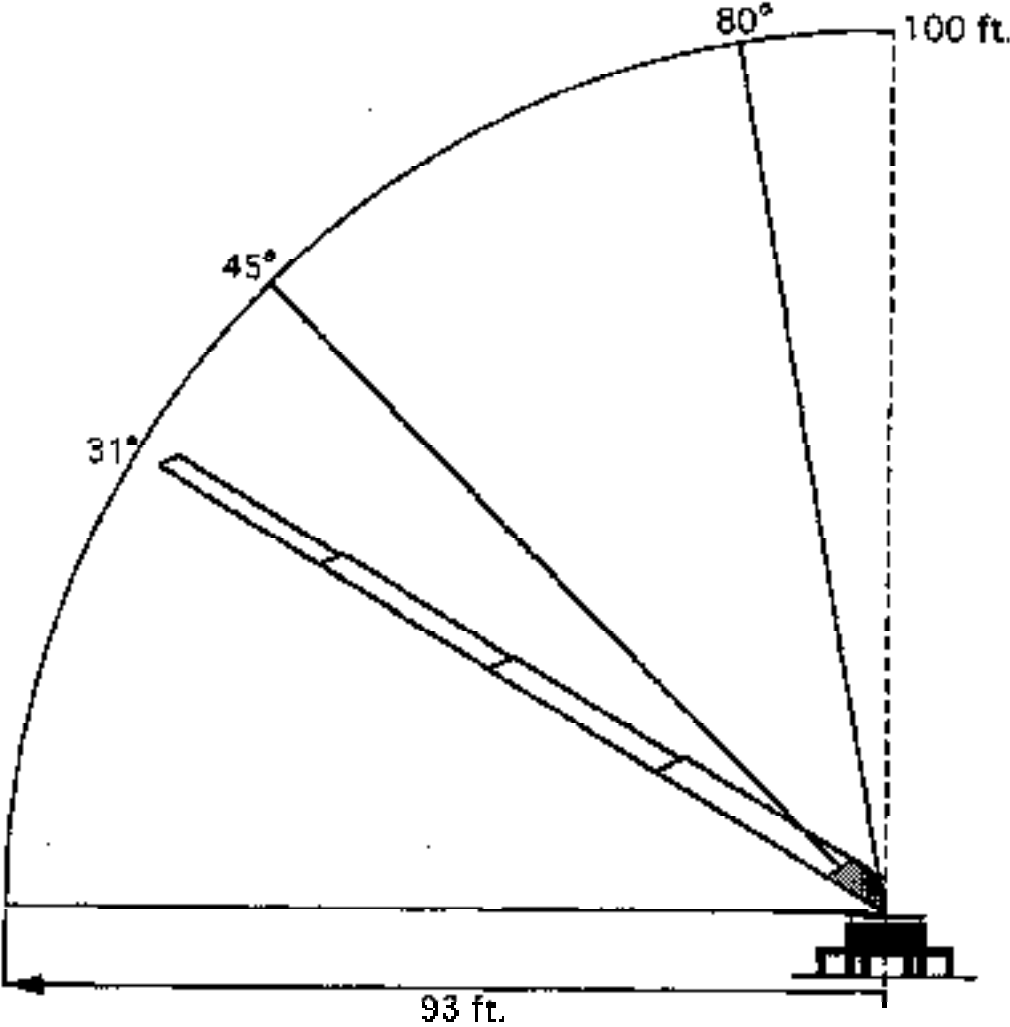
Figure 3. Ladder Position and Angle: New York Ladder Collapse

Load Conditions - To establish the elevation and extension of the ladder at time of failure, a similar vehicle was parked in the same location and the ladder was raised to the same window. To reach the window, the ladder was placed at an elevation angle of 31 degrees and approximately 91 feet, which is three feet short of its maximum extension (see Figure 3). It was rotated approximately 45 degrees to the right of the centerline of the vehicle.

It is believed that the father dropped approximately three feet onto the ladder, which had already slipped off the window ledge. This would add a factor for the dynamic load. Witnesses reported that the tip of the left beam of the ladder was scraping against the brick wall below the sill and the entire ladder was oscillating before the father landed on the tip, which

indicates that it was close to the point of failure and may have already begun to fail. It failed catastrophically when the added weight of the father was applied.

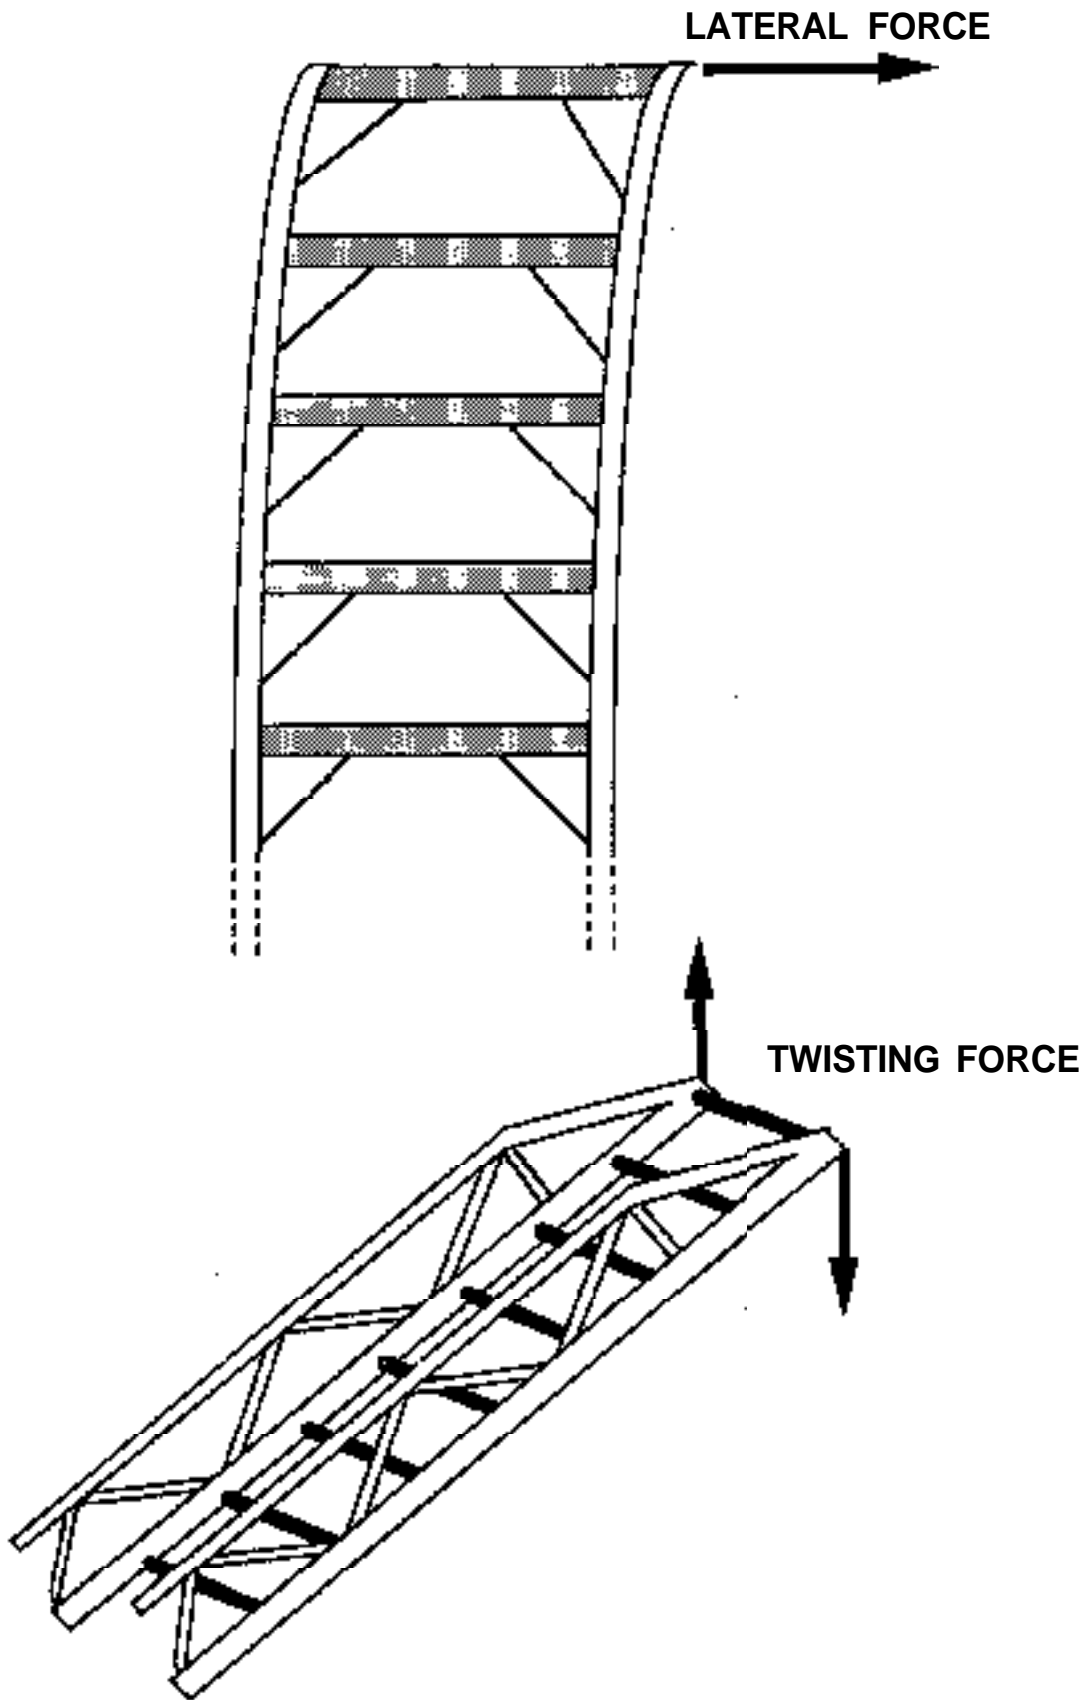
Figure 4. Lateral Forces and Twisting Forces in Aerial Ladders

The angle and reach that were required in the situation encountered by Ladder 108 would have been within the allowable operating range of a newer ladder. Under the same circumstances the 250 lb. tip load rating would have been exceeded; however, it is unlikely that the ladder would have collapsed under the same operating conditions, particularly with the tip supported by the window sill. The safety factors that are incorporated in the design of the new ladders would have allowed this rescue to be safely accomplished with a newer ladder.

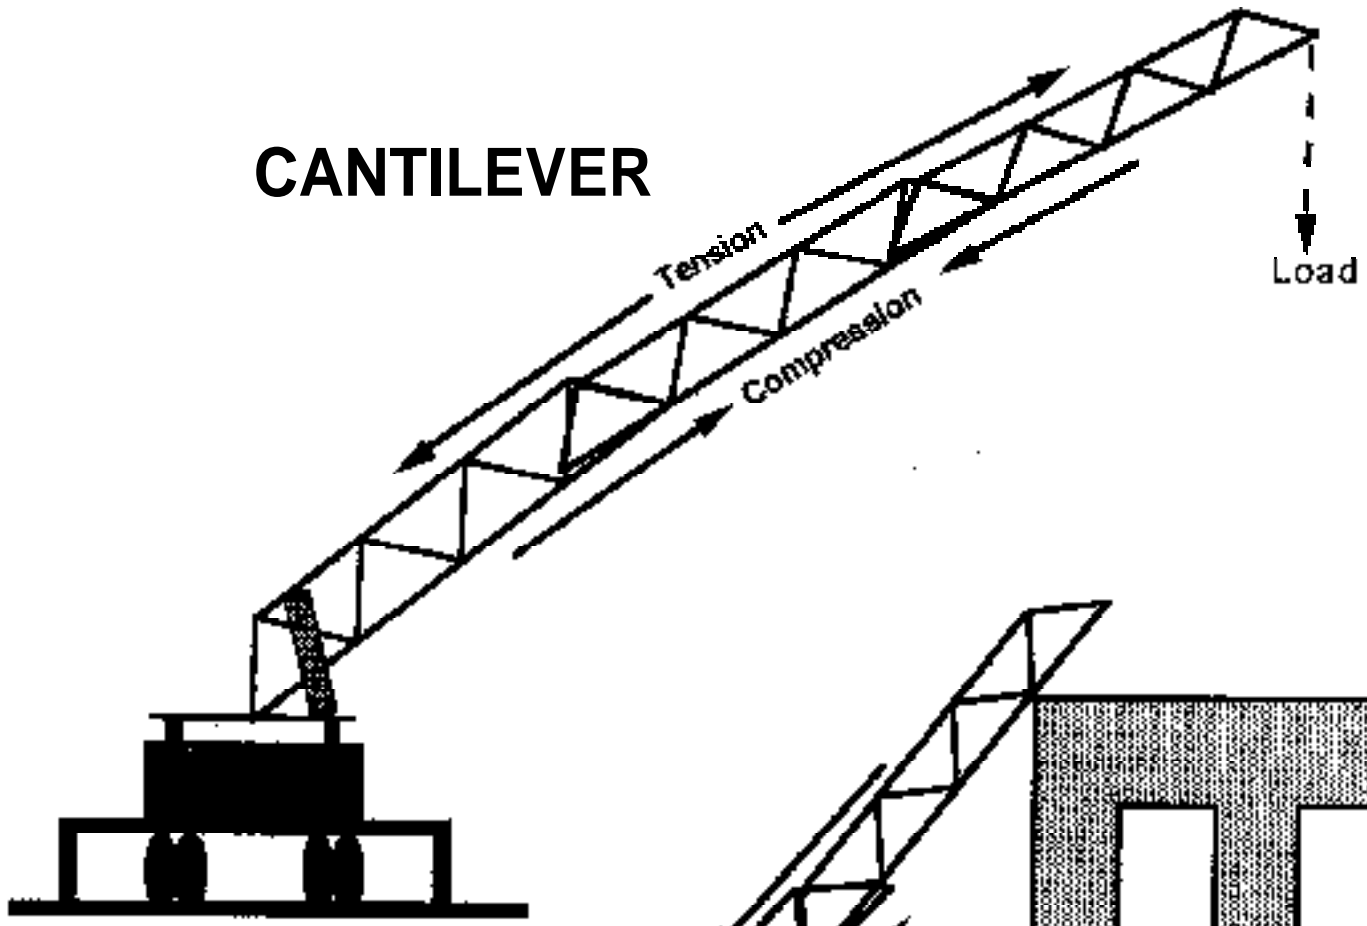
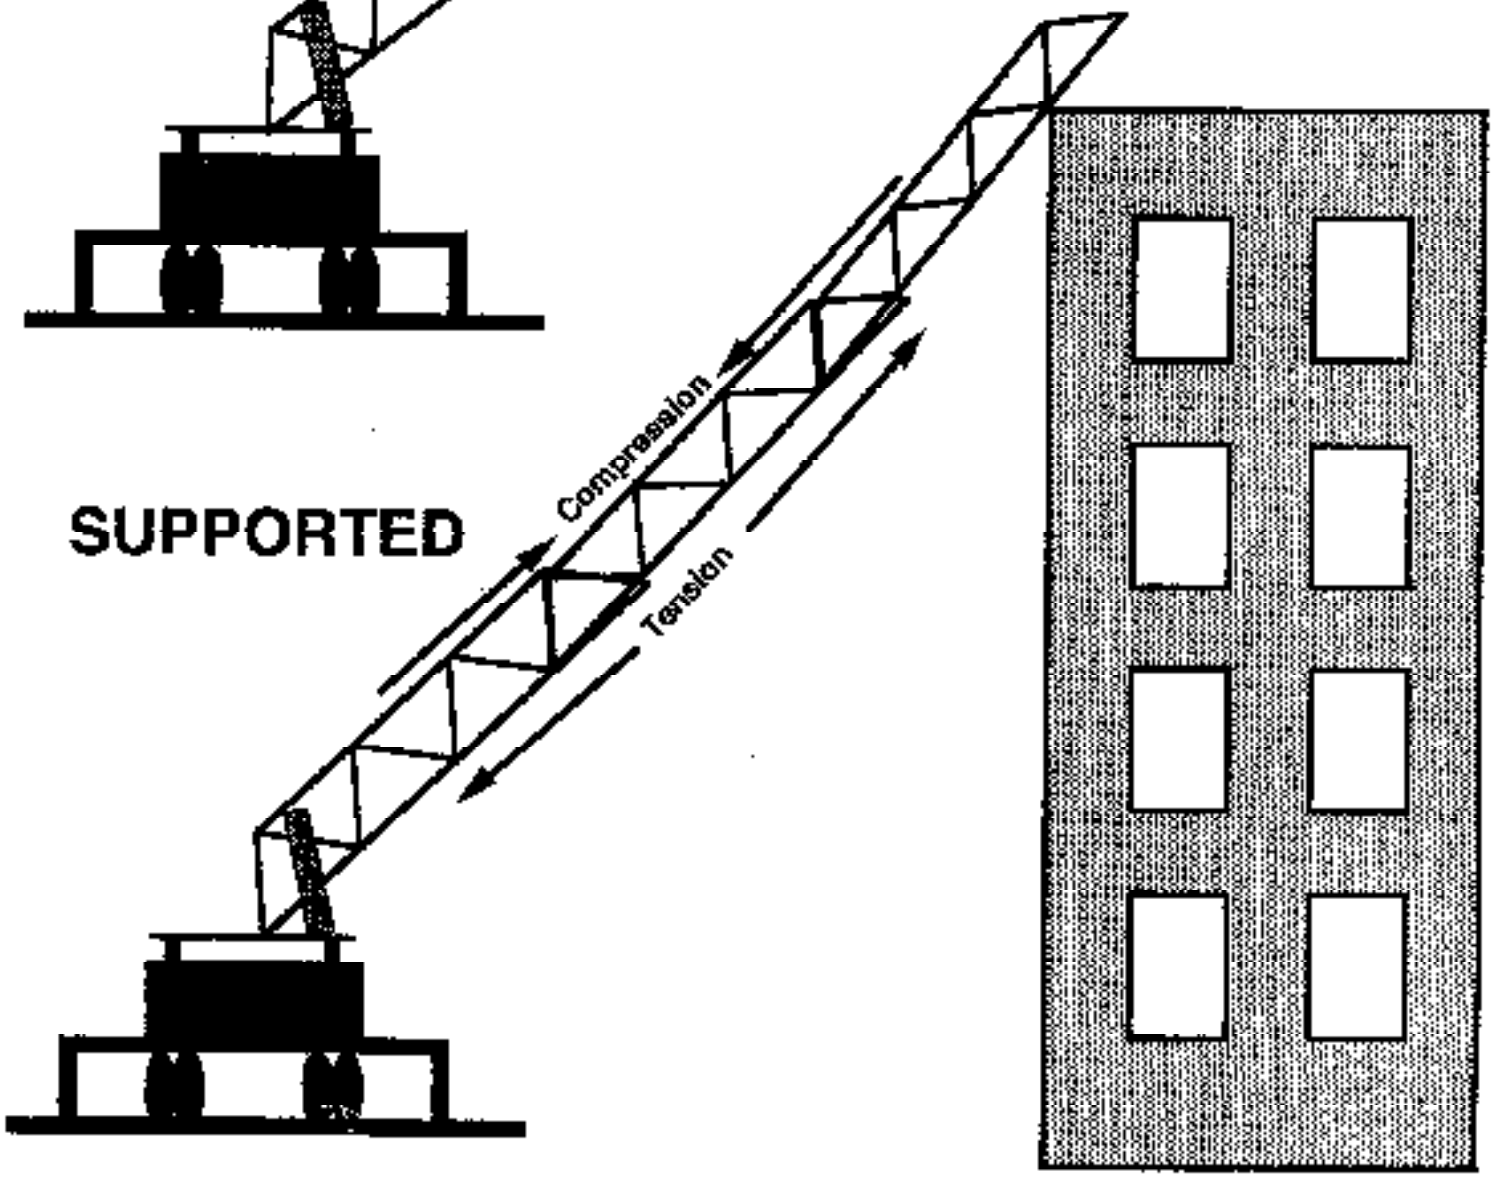
Figure 5. Forces in Ladder in Cantilever and Supported Operating Modes

The New York City collapse occurred when the capacity of the lower beam to support the compression forces was exceeded. The ladder was subjected to twisting forces caused by the contact between the building and the tip of the left beam (see Figures 2 and 5). In this situation the twisting increased the compressive load on the bed ladder at the location where the maximum bending stress is applied to the ladder, just above the area where the load is transferred to the vehicle. The inward buckling of the beam caused the right side of the ladder to fail first, which caused the ladder to twist to the right as it fell.

where the member or connection is already highly stressed to support the load, particularly if the member is defective or damaged.

Most aerial ladders are much less resistant to lateral forces than vertical forces. Lateral forces are most likely to cause a sideways failure near the base of the ladder. Most of the newer ladder designs have significantly improved resistance to lateral forces with the addition of K-bracing between the rungs and the side trusses.

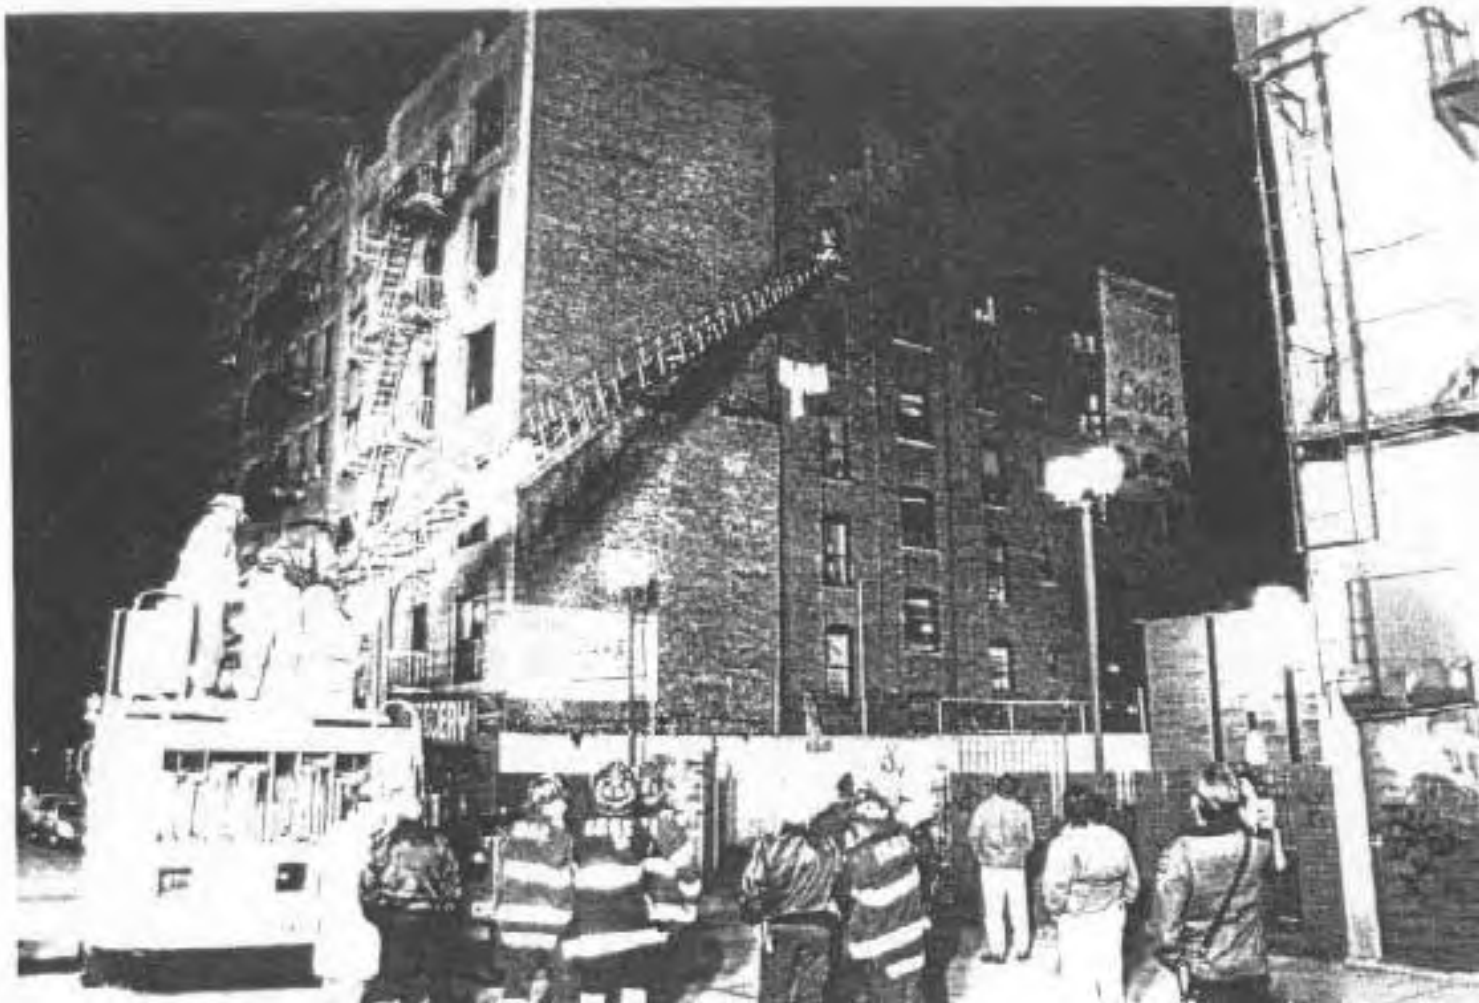
Figure 1. View of a 100 ft Aerial Ladder, Similar to the Failed Ladder, at the Site during Reconstruction of the Accident Conditions. This Figure also Shows the Truss Structure of the Ladder Sides.

The ladder is made up of four sections, which are similar in construction. Each section consists of a pair of truss structures, one on each side, which provide primary ladder strength, and a hand rail (Figure 1.) These side truss sections are connected by rungs. Each section also includes equipment for extending the ladder and to ensure interlocking.
