## Entrapment in Garage Kills One Firefighter

San Francisco, California

This is Report 084 of the Major Fires Investigation Project conducted by Varley-Campbell & Associates, Inc. under contract EMW-94-C-4423 to the United States Fire Administration, Federal Emergency Management Agency.

March 9, 1995

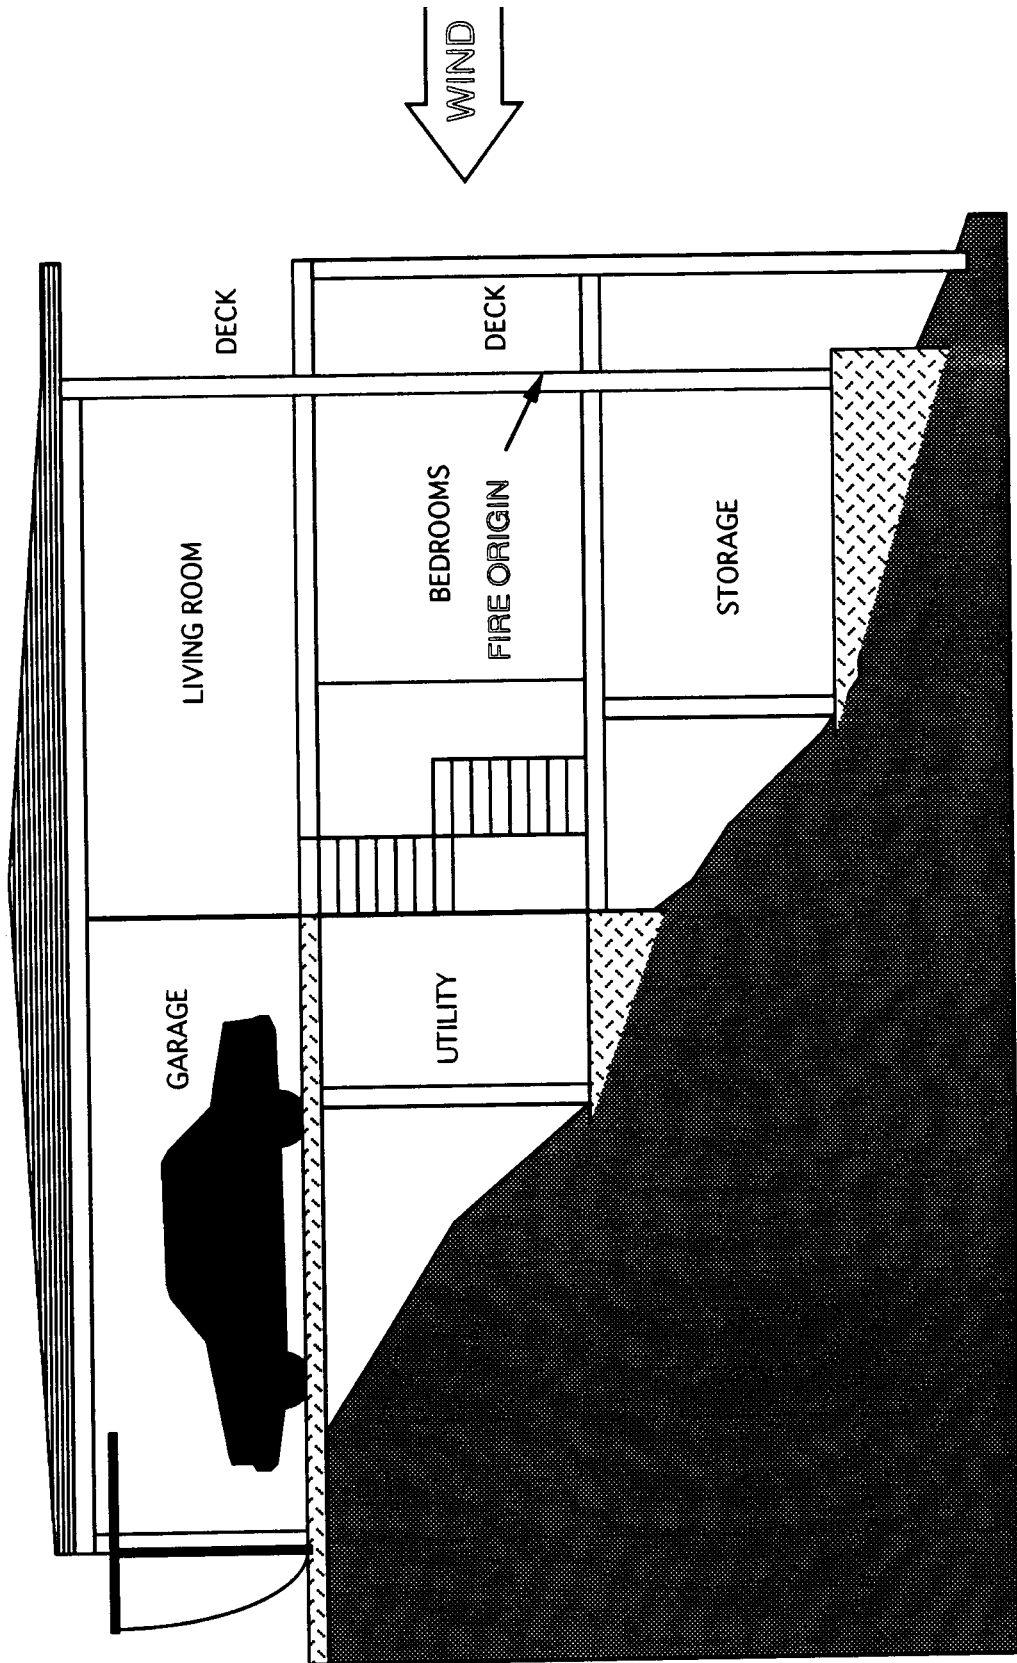
Figure 1a

The house had three levels (see Figures 1a and b). The lower level was only accessible from the back yard and was used exclusively for storage. The middle level had three bedrooms, each with a view to the south. A utility room ran the width of the house on the north side. Two full bathrooms flanked the open center stairway (Figure 3).

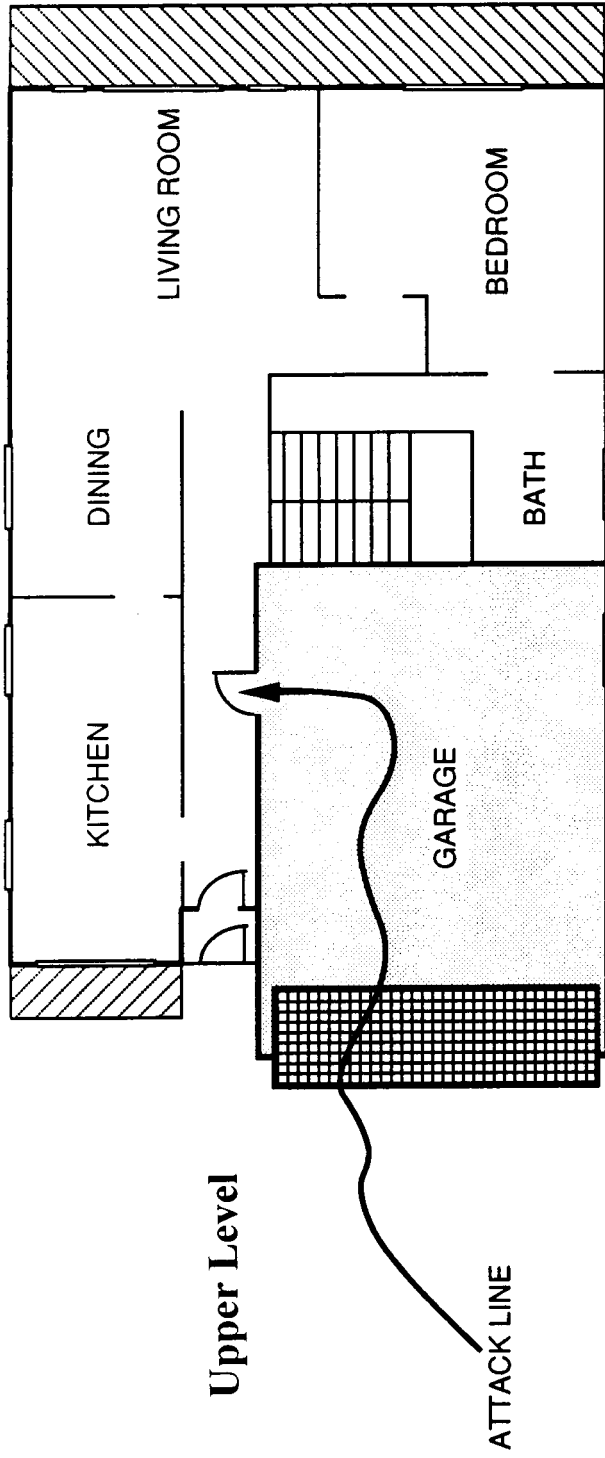
**Figure 2**

The upper floor was the only level visible from the street (Figure 2). On this level, the living room and the master bedroom faced to the south. The garage was north of the master bedroom, while the dining room and kitchen were north of the living room. Between the kitchen and the garage was an entry hall leading to the front door of the residence. The two upper levels contained about 2,050 square feet of living space.

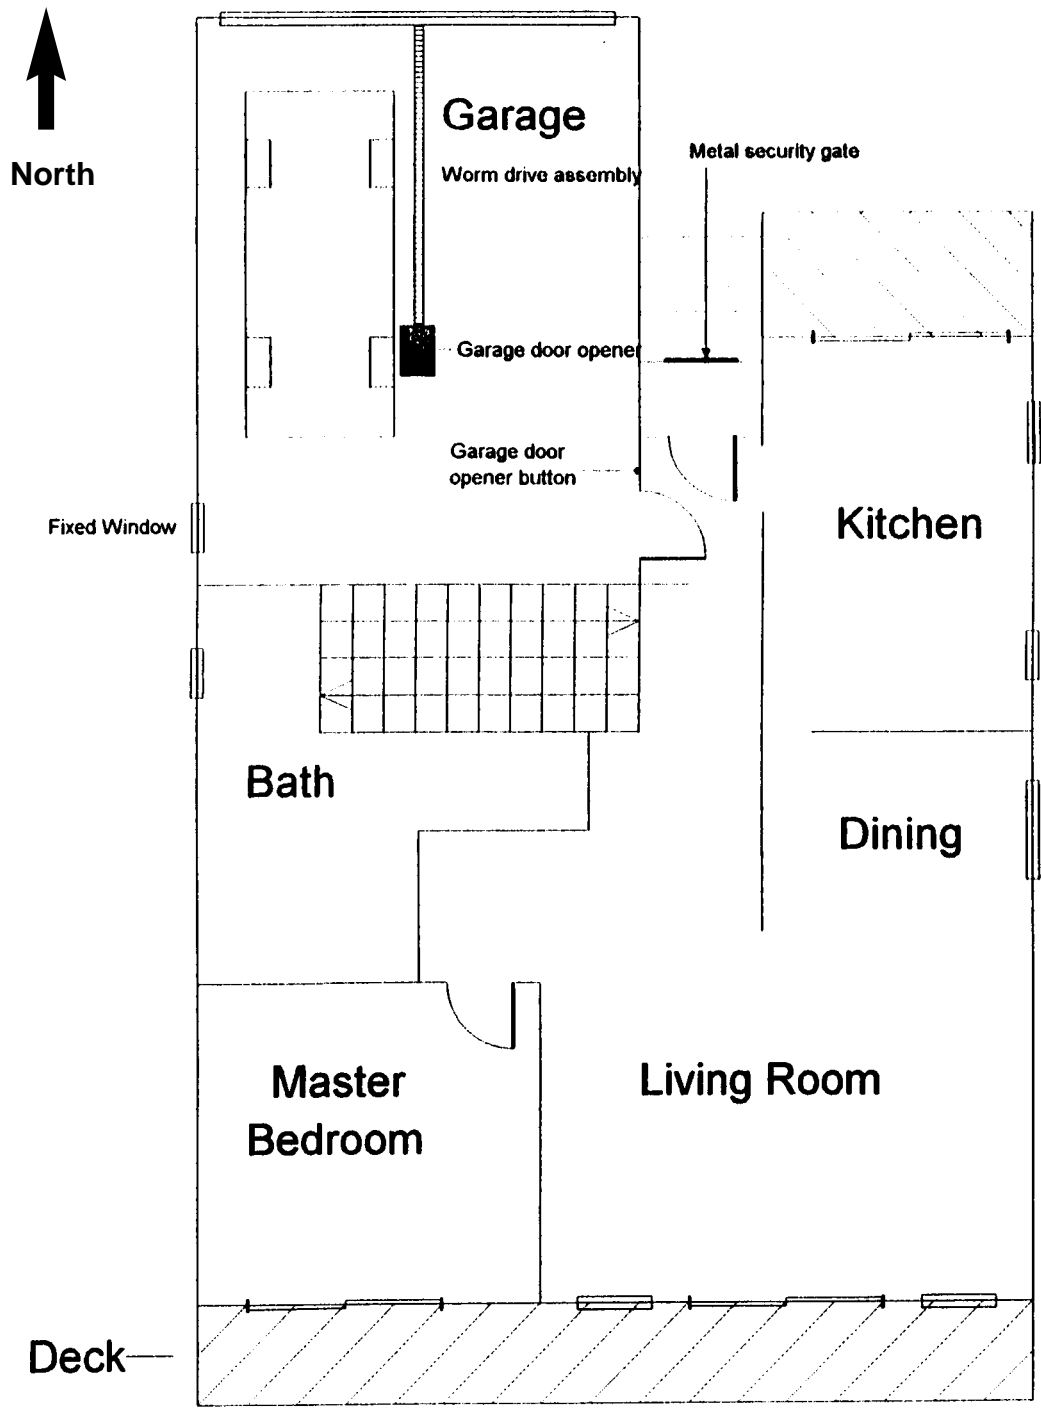
**Figure 5**

The garage door was a single panel, constructed of 3/8 inch plywood with 2x4 and 2x2 framing (Figure 4). This door was 16 feet wide, 7 feet high and weighed about 250 pounds. Connected to the door was a screw drive type mechanical garage door opener. The opener could be activated by a wall-mounted push button near the door leading to the entry hall (Figure 5) or either of two remote controls. The remotes were kept in the family cars.

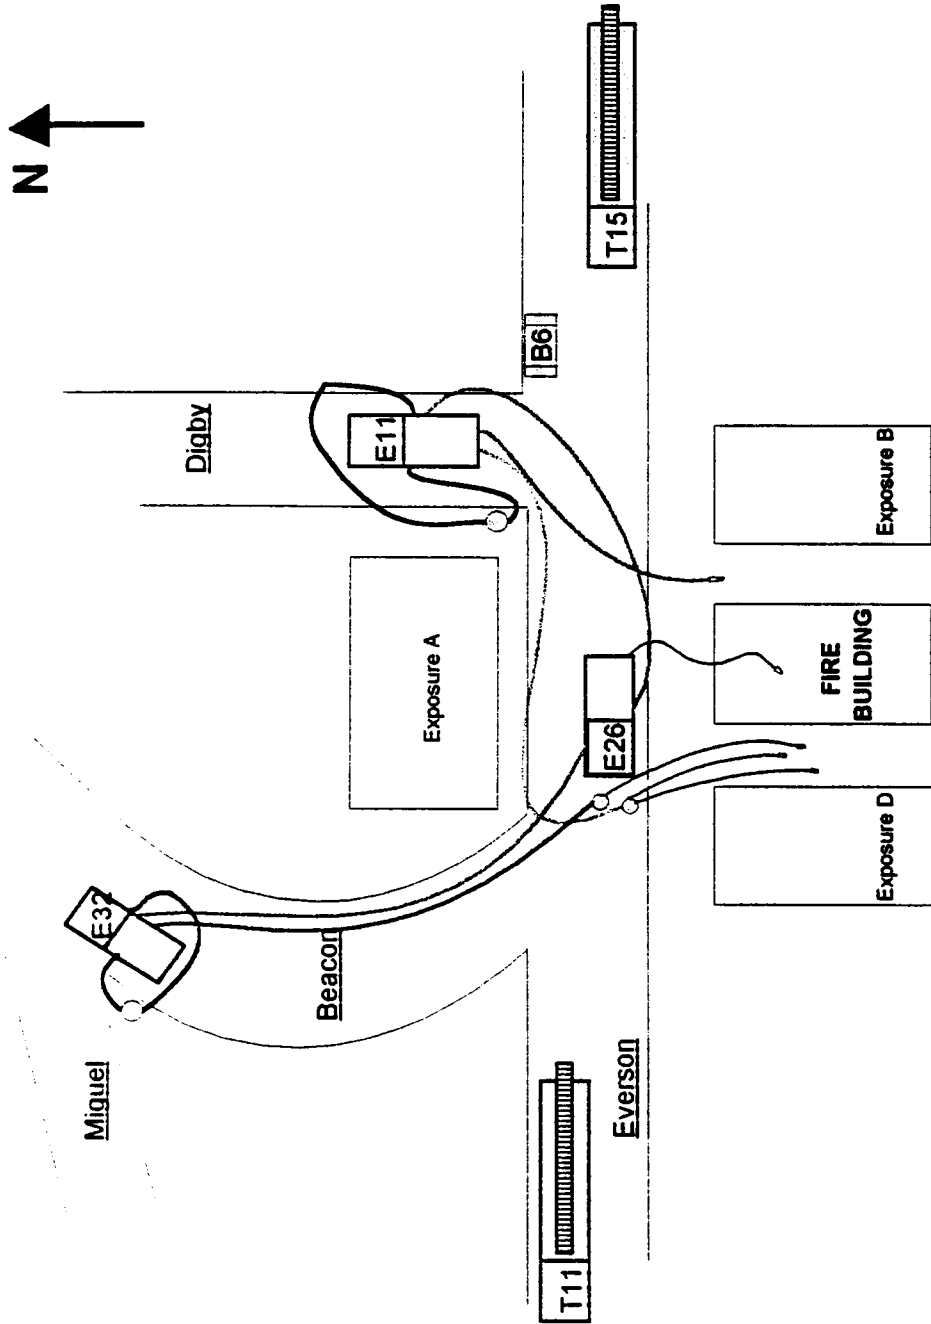
Figure 6

SFFD Engine 26 arrived on the scene at 12:59:10 and reported a “working fire.” The pump operator pulled slightly past the fire building in an effort to give his officer a look at three sides of the scene (Figure 6). A few blocks away Truck 11 had just gone back in service from another call and heard the Engine 26 report. Truck 11 told the Communications Center that they would respond to 75 Everson Street.
