Live Oak/Milstar Complex and Carpet Service Center

LaGrange, Georgia

UNITED STATES FIRE ADMINISTRATION FIRE INVESTIGATIONS PROGRAM

This is Report 086 of the Major Fires Investigation Project conducted by Varley-Campbell & Associates, Inc. under contract EMW-94-C-4423 to the United States Fire Administration, Federal Emergency Management Agency.

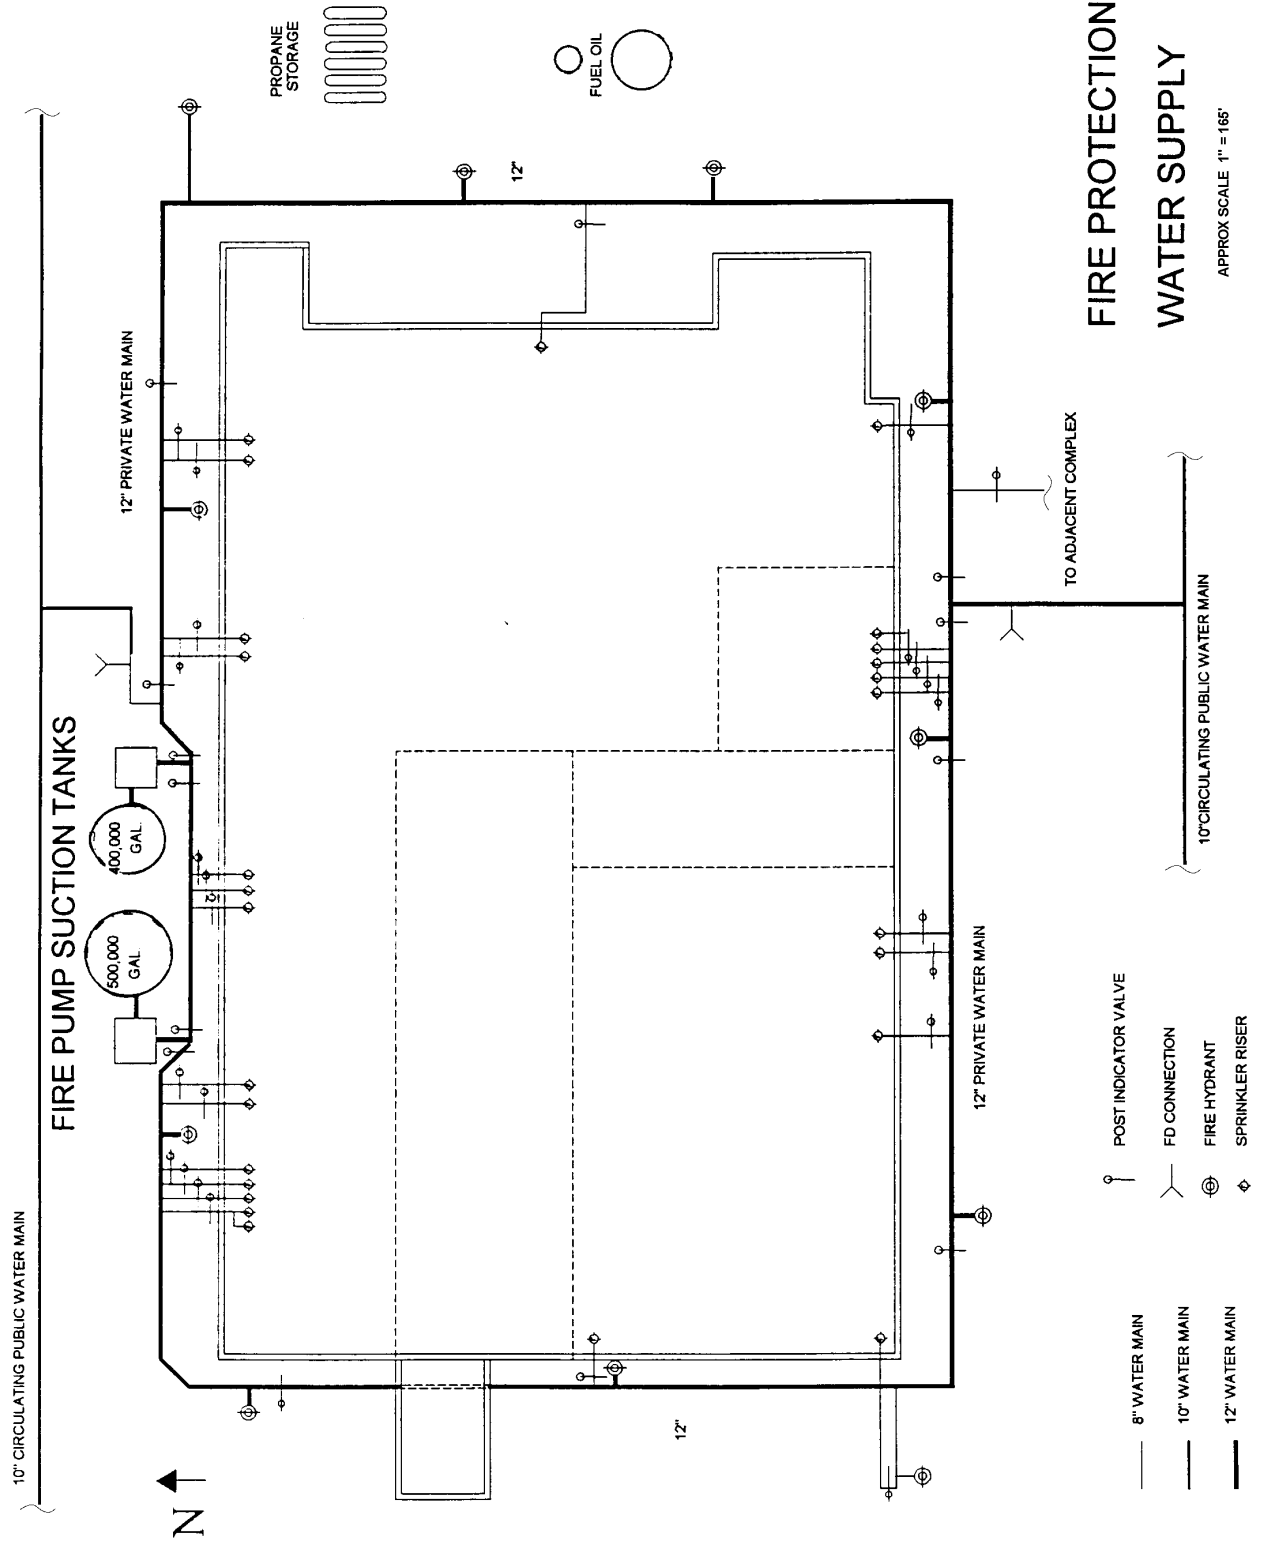
FIRE PROTECTION WATER SUPPLY

Two 8-inch automatic sprinkler risers were located near the point of origin. These risers supplied automatic sprinklers located below the roof in the area of fire origin and an area immediately adjacent. These automatic sprinkler risers or the large, horizontal supply mains connected to them were likely destroyed by the roof collapse early in the fire, interrupting the water supply to the sprinklers and resulting in additional structural collapse. The failed risers also drained water from other sprinkler systems around the area of origin. Fire protection water supplies are usually not designed for multiple sprinkler systems operating at the same time. Water flowed from broken automatic sprinkler mains and risers for over seven hours during the fire suppression efforts, severely taxing the municipal water system in the area surrounding the plant.

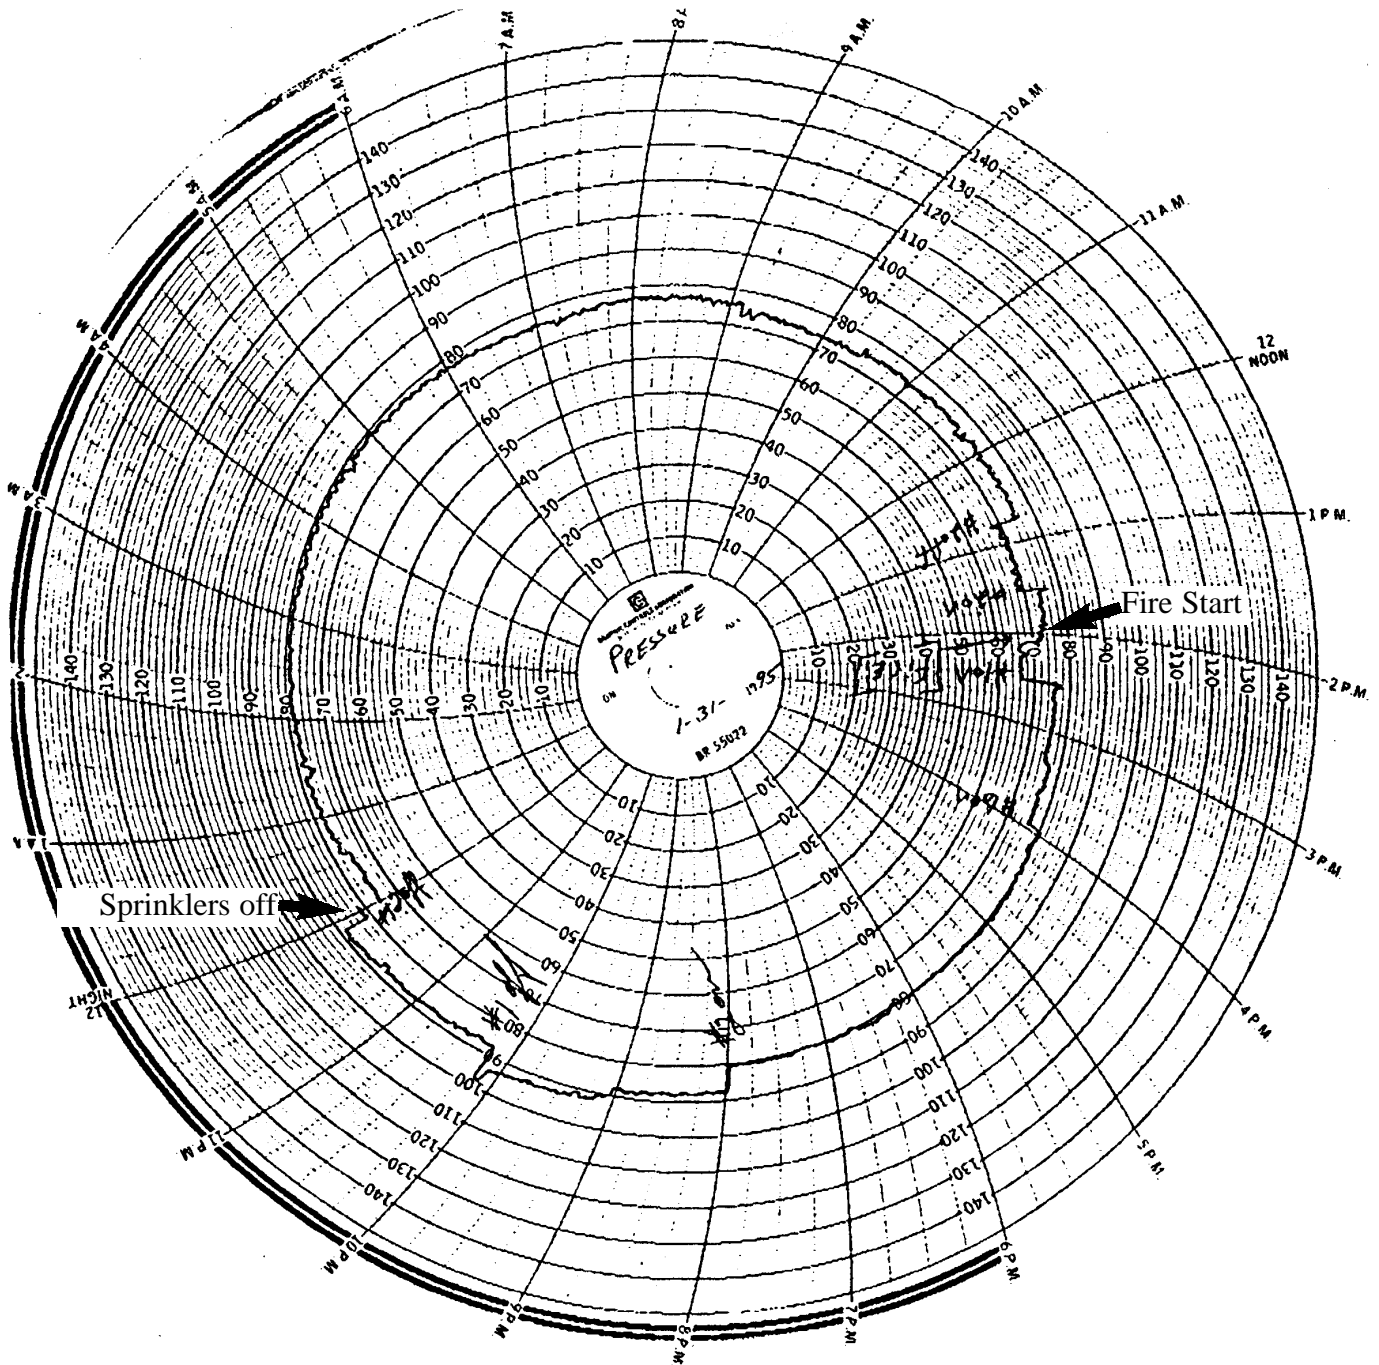
LaGrange Water Department Delivery Pressure Chart

Records indicate that during the afternoon and evening of January 31, 1995 four of the five pumps were placed into service and that nearly 10 million gallons of water was delivered that day. This figure was significantly above the normal daily consumption for the time of year. The delivery pressure chart recording at the treatment plant documents the pressure drop at the start of the fire and a spike when the city water connections to the Milliken plant were closed. During the period between these events, the treatment plant delivery pressure remained within the normal operating pressure range of 72 to 96 psi. This indicates that the water mains in the area of the fire were delivering water at their maximum rate.
