## **Two Firefighters Killed in Auto Parts Store Fire Chesapeake, Virginia**

**Two Firefighters Killed in Auto  
Parts Store Fire  
Chesapeake, Virginia**

**(March 18, 1996)**

**This is Report 087 of the Major Fires Investigation Project conducted by Varley-Campbell and Associates, Inc./TriData Corporation under contract EMW-94-C-4423 to the United States Fire Administration, Federal Emergency Management Agency.**

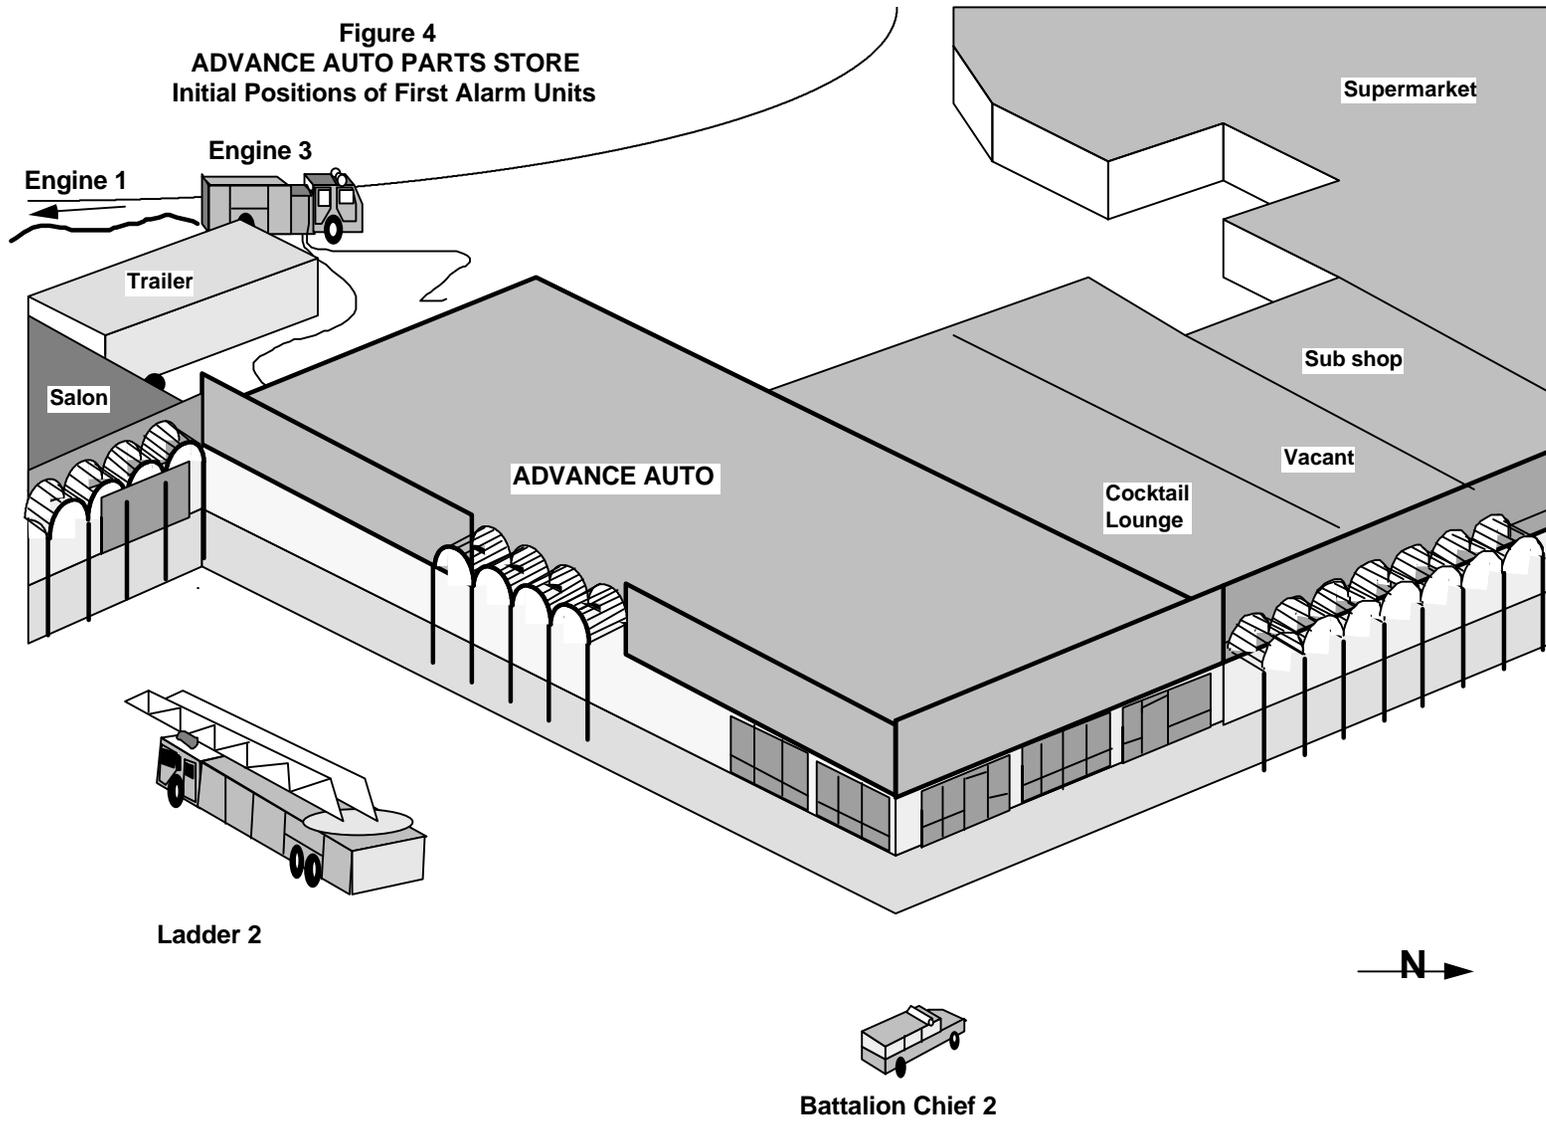
Figure 4  
ADVANCE AUTO PARTS STORE  
Initial Positions of First Alarm Units

Engine 3 took a position in front of the Advance Auto Parts Store. Hudgins and Young entered the structure from the front of the building to investigate. Conditions were clear in the store, and there was no visible smoke or flames showing. They discovered light smoke near the electrical panel in the rear of the building, and radioed to Battalion 2 that they had a fire and were checking for extension. Acting Lieutenant Hudgins then radioed for Engine 3's driver to reposition the apparatus to the rear of the building.

The driver/pump operator of Engine 3 observed light smoke coming from the roof-line on side two as he repositioned to the alley on side three of the store. Hudgins and Young met him at the rear of the building, where heavier smoke was showing from the edge of the roof. The firefighters pulled two 1 3/4-inch attack lines off Engine 3. Firefighter Young used the first attack line to sweep the rear of the building, where flames had started to come from the roof-line at the top of the rear wall. Acting Lieutenant Hudgins donned his SCBA and entered the rear of the building with the second attack line. Engine 3's driver directed Firefighter Young to assist Acting Lieutenant Hudgins, who was inside the building. Young closed the nozzle on his attack line, placed it on the ground, and followed the first attack line into the rear of the building.

Approximately eleven minutes after the time of dispatch, Battalion 2 marked on the scene, observing light gray smoke at the decorative arches in front of the building and a light haze of smoke inside the structure. Less than one minute later, Battalion 2 radioed for a second alarm, reporting "flames showing," and requested police assistance with evacuating the exposure occupancies. Two additional engines were dispatched for the second alarm. The Battalion Chief then proceeded to evacuate the exposures on sides two and four of the auto parts store (Figure 4).

Engine 1 marked on the scene approximately thirteen minutes after dispatch. As they passed by the front, a firefighter on Engine 1 noticed smoke and some fire in the front of the store, rolling down to the floor, and observed a strong draft pulling air into the building. Engine 1 then proceeded to the rear to reverse lay a supply line from Engine 3 and establish the water supply.

Once in the rear, the firefighter and the officer from Engine 1 observed one attack line from Engine 3 that stretched into the back door of the Advance Auto Parts Store. Heavy smoke was visible inside and fire was coming from the roof in the rear of the store. The officer instructed Engine 3's driver to set up a 2 1/2-inch attack line. In the time it took to prepare this line, the firefighter from Engine 1 reported that the rear entrance to the building had become fully involved with fire, and the attack line into the rear door had burned through. Engine 3 ran out of water at this time and was unable to charge the 2 1/2-inch attack line. Engine 1's officer attempted to contact Battalion 2 by radio, but was unable to get through.

Simultaneously, Ladder 2 was arriving in the front of the building and taking a position on side two of the store. While the driver was setting up the aerial to go to the roof, the officer and firefighter from Ladder 2 were preparing to enter the front of the building to assist Engine 3's crew, but the officer noted heavy smoke inside the store and a large volume of air being drawn in through the front doors.

He determined that it was unsafe for his crew to enter the building and advised his driver to set up for defensive operations. Ladder 2's officer then met with Battalion 2 in front of the building and suggested that a third alarm might be needed due to the growing size of the fire.

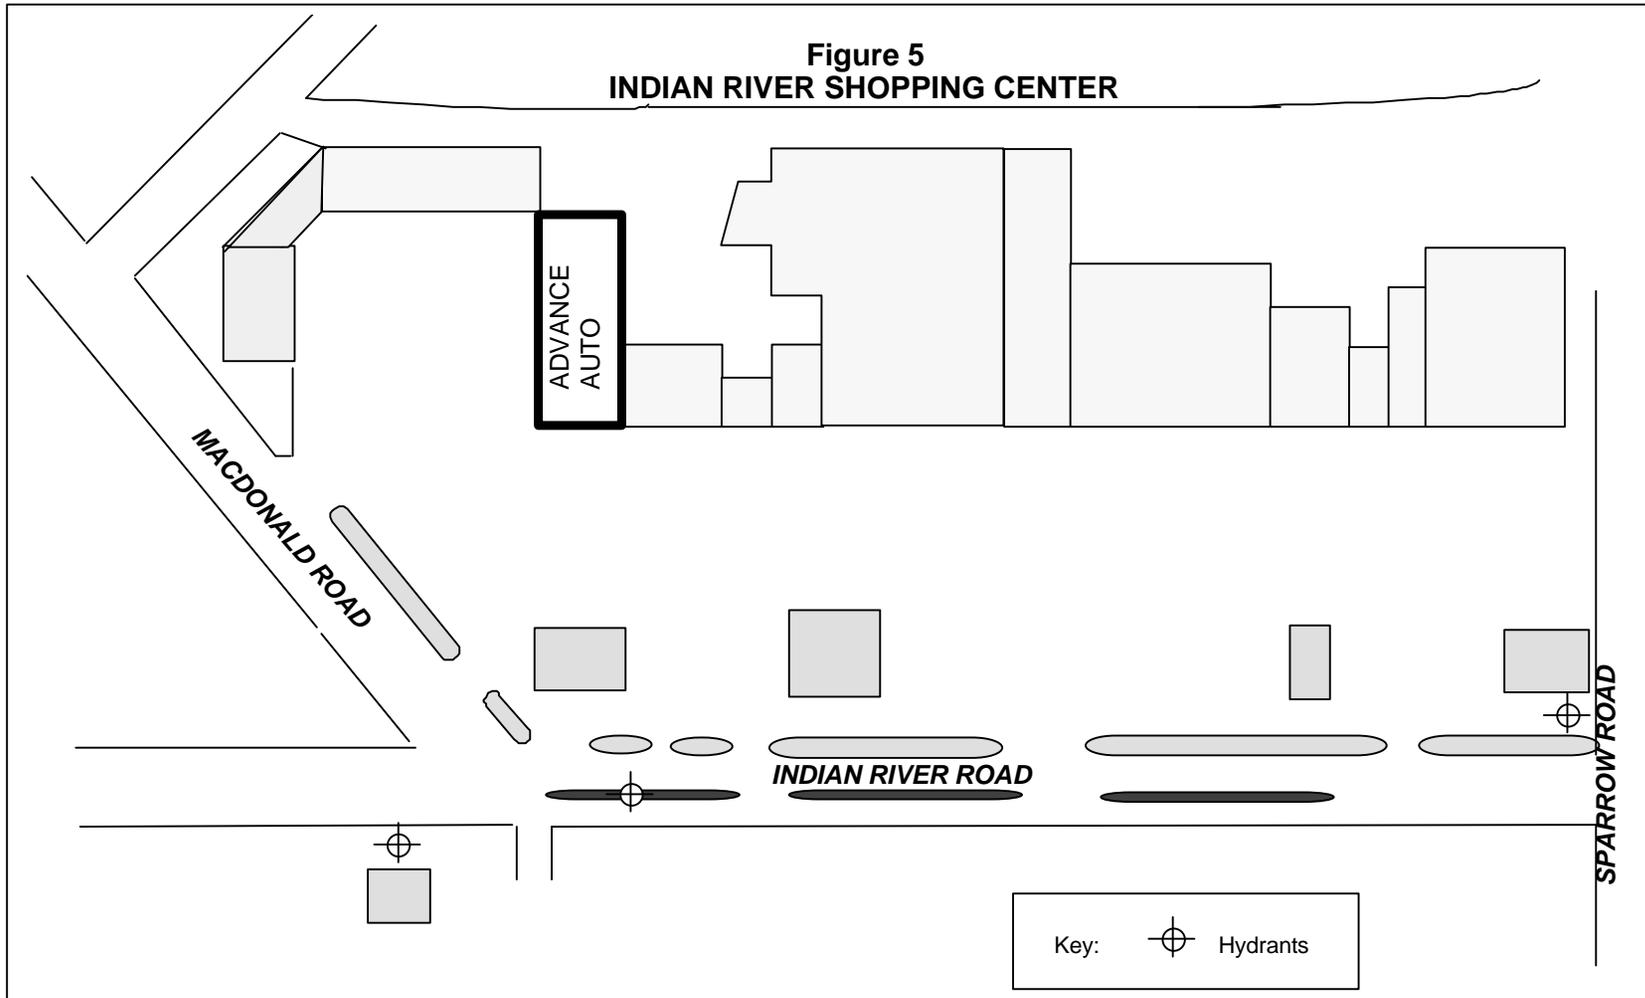
Figure 5  
INDIAN RIVER SHOPPING CENTER

About eighteen minutes after dispatch, Battalion 2 reported “a working commercial building fire fully involved.” Within the next minute, he transmitted a request for a third alarm. At this time, Engine 1 was still in the process of laying five-inch hose from Engine 3 to a fire hydrant located at the far corner of Indian River Road and MacDonald Road.
