## Old Buckingham Station Chesterfield, Virginia

# **Old Buckingham Station Chesterfield, Virginia**

**Investigated by Thomas H. Miller, P.E.**

This is Report 105 of the Major Fires Investigation Project conducted by Varley-Campbell & Associates, Inc. under contract EMW-94-C-4423 to the United States Fire Administration, Federal Emergency Management Agency.

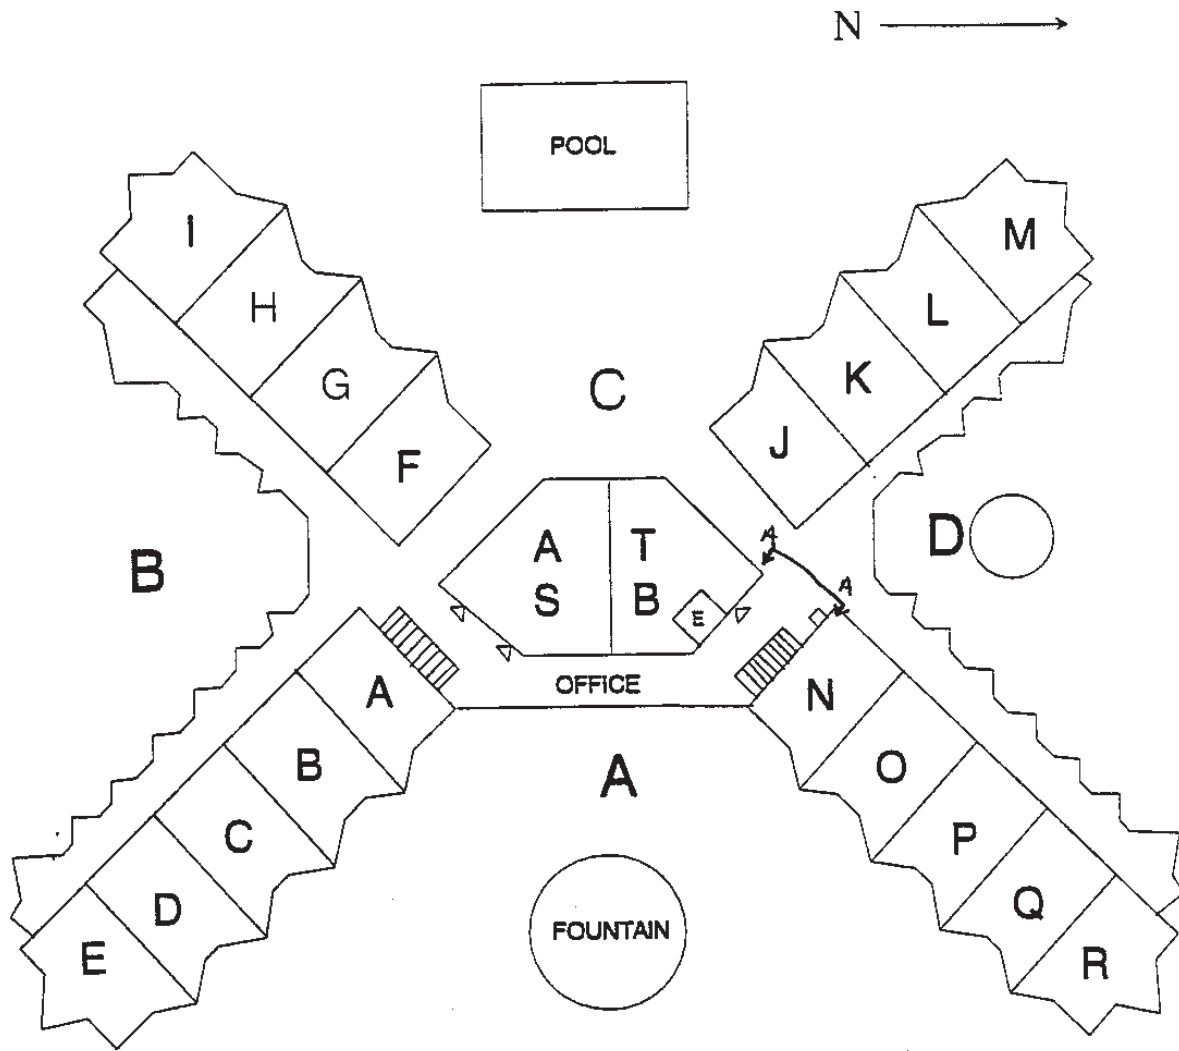
Fire investigators determined that the fire began on the second floor in a covered walkway between the northeast wing and the center core, just outside of apartment 2J. (See Appendix B for location) The cause was identified as an exterior light fixture that had been inverted from its usual operating position by one of the occupants and then wrapped with a flannel shirt to reduce the light intensity into their bedroom. The fixture's incandescent bulb was enclosed by a clear plastic globe. By inverting the fixture, the vent holes, which were intended to remove heat from the 60 watt bulb, were out of position and the plastic globe in combination with the flannel shirt held in the heat. This eventually resulted in the ignition of the shirt and the light fixture's plastic globe. The fire spread to the vinyl plastic siding and to the wooden stairway.

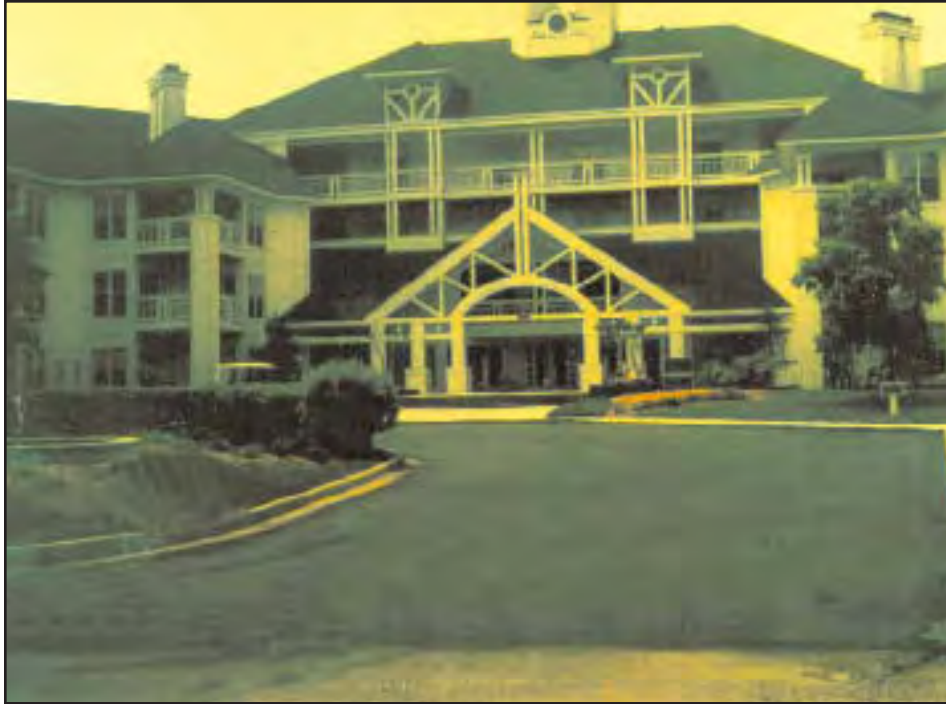
3. The main entrance to the building and the four story core building before the fire. North is to the right.

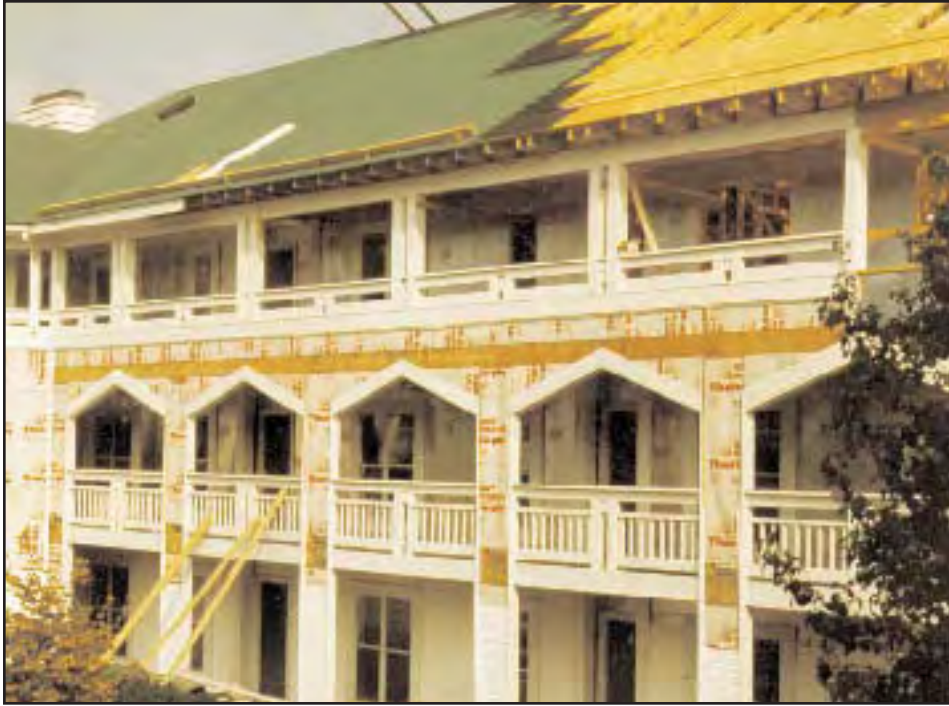
9. The exterior walkways in Sector D, with the stairway located at the left edge of the photograph. The core is out of the picture to the right.
