Sprinklered Records Storage Facility

Chicago, Illinois

**Sprinklered Records Storage Facility
Chicago, Illinois
October 29, 1996**

This is Report 106 of the Major Fires Investigation Project conducted by Varley-Campbell and Associates, Inc./TriData Corporation under contract EMW-94-4423 to the United States Fire Administration, Federal Emergency Management Agency.

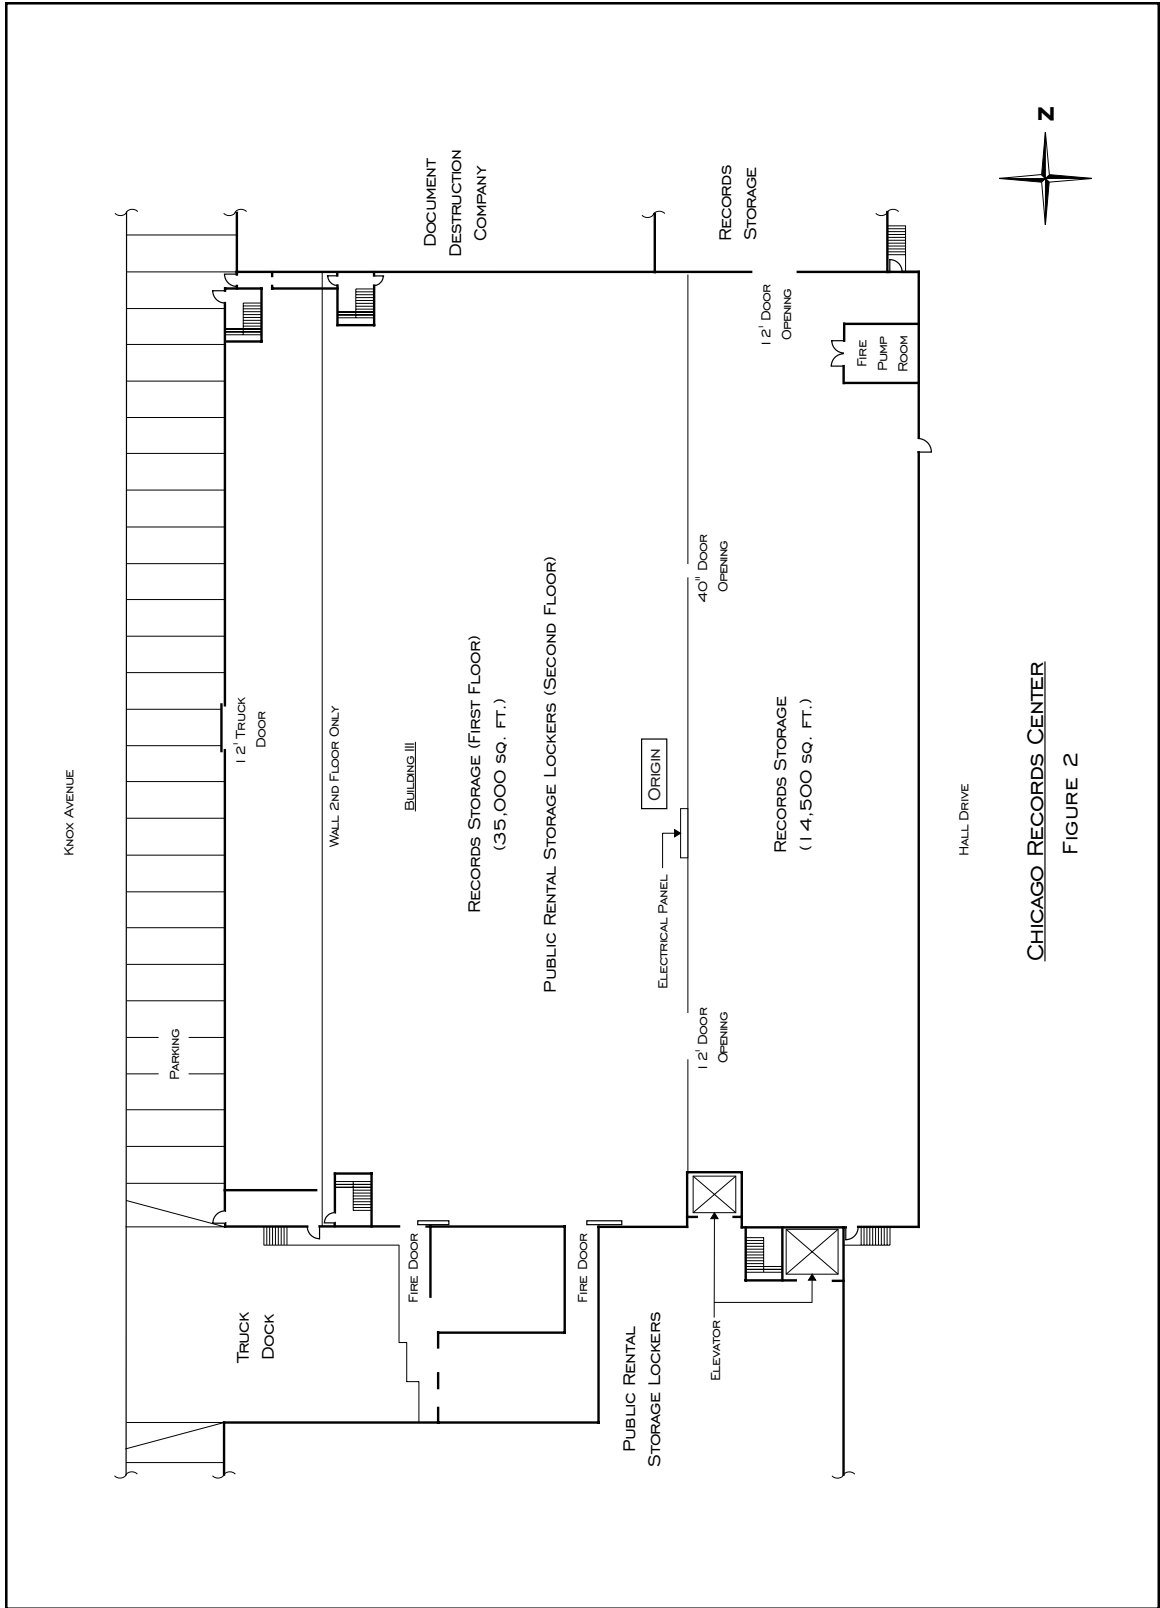
CHICAGO RECORDS CENTER
FIGURE 2

The fire occurred in the largest of several fire areas occupied by Brambles, used to store cardboard boxed paper, photographic, and financial records for clients. Building construction in the area of origin was essentially fire resistant and, although significantly damaged, did not collapse during or after the fire. The front part of the building facing Knox Avenue was a single story about 25 feet high and was one bay deep. (See Figure 1 in Appendix A) This area had a concrete roof supported by steel columns which were partially framed into the exterior masonry walls and were unprotected along the interior column line. Roughly half of the building was two stories high, with the first floor having a clear height of 25 to 28 feet and the second floor measuring 12 to 15 feet tall. There was a reinforced concrete floor between the first and second floors which was supported by concrete columns. The roof of the second floor was also concrete on concrete columns.
