Kona Village Apartments Fire Bremerton, WA

November 13, 1997

This is Report 121 of the Major Fires Investigation Project conducted by Varley-Campbell and Associates, Inc./TriData Corporation under contract EME-97-CO-0506 to the United States Fire Administration, Federal Emergency Management Agency.

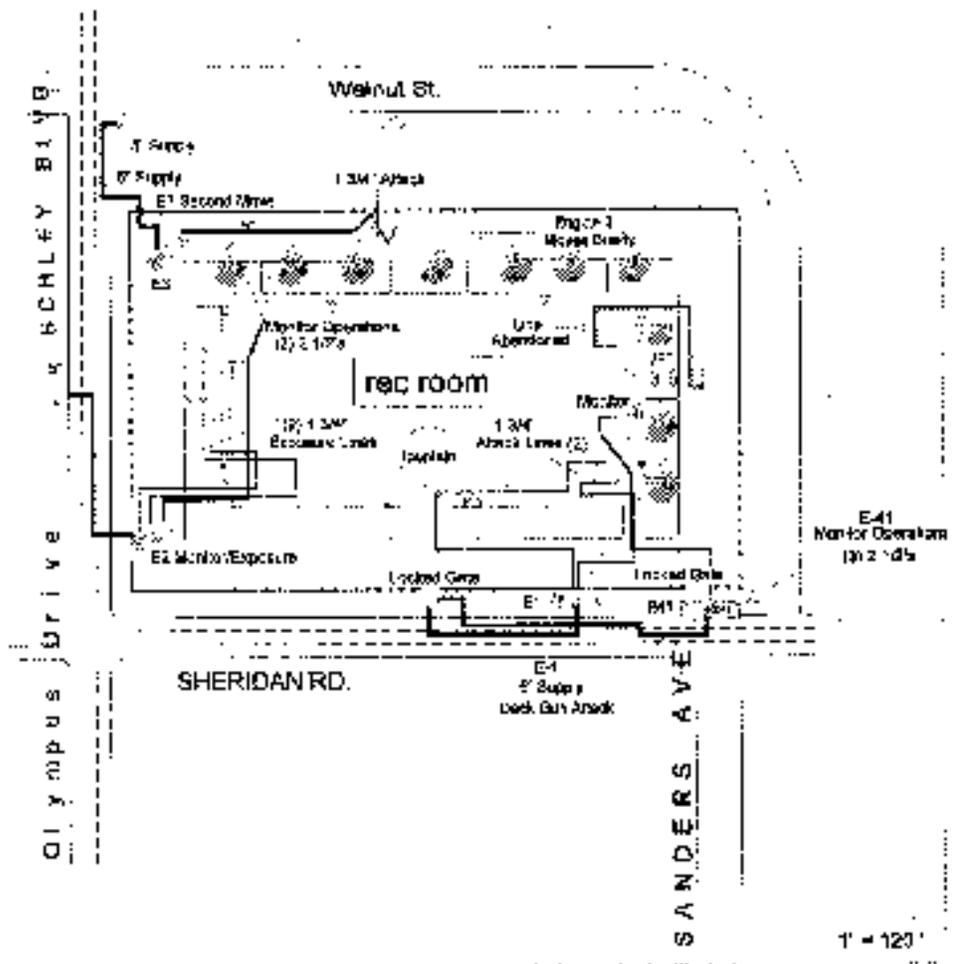
Diagram 4. Third phase of operations; cut-off fire spread, attack and extinguish

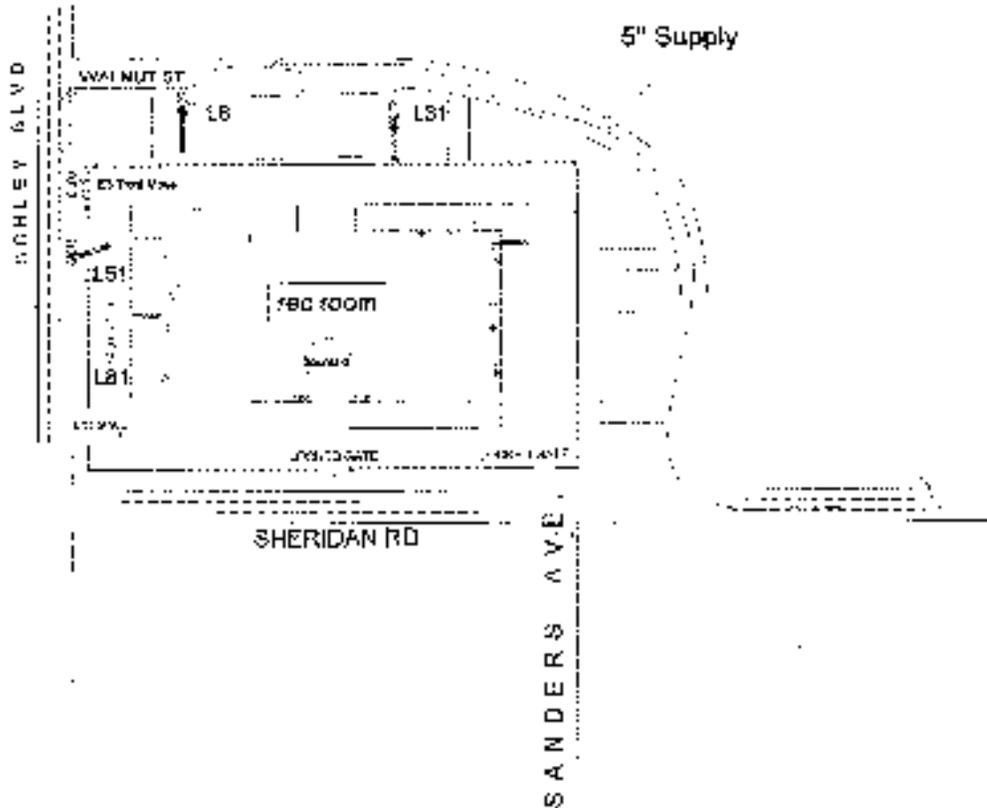
Diagram 5. Ladder company position

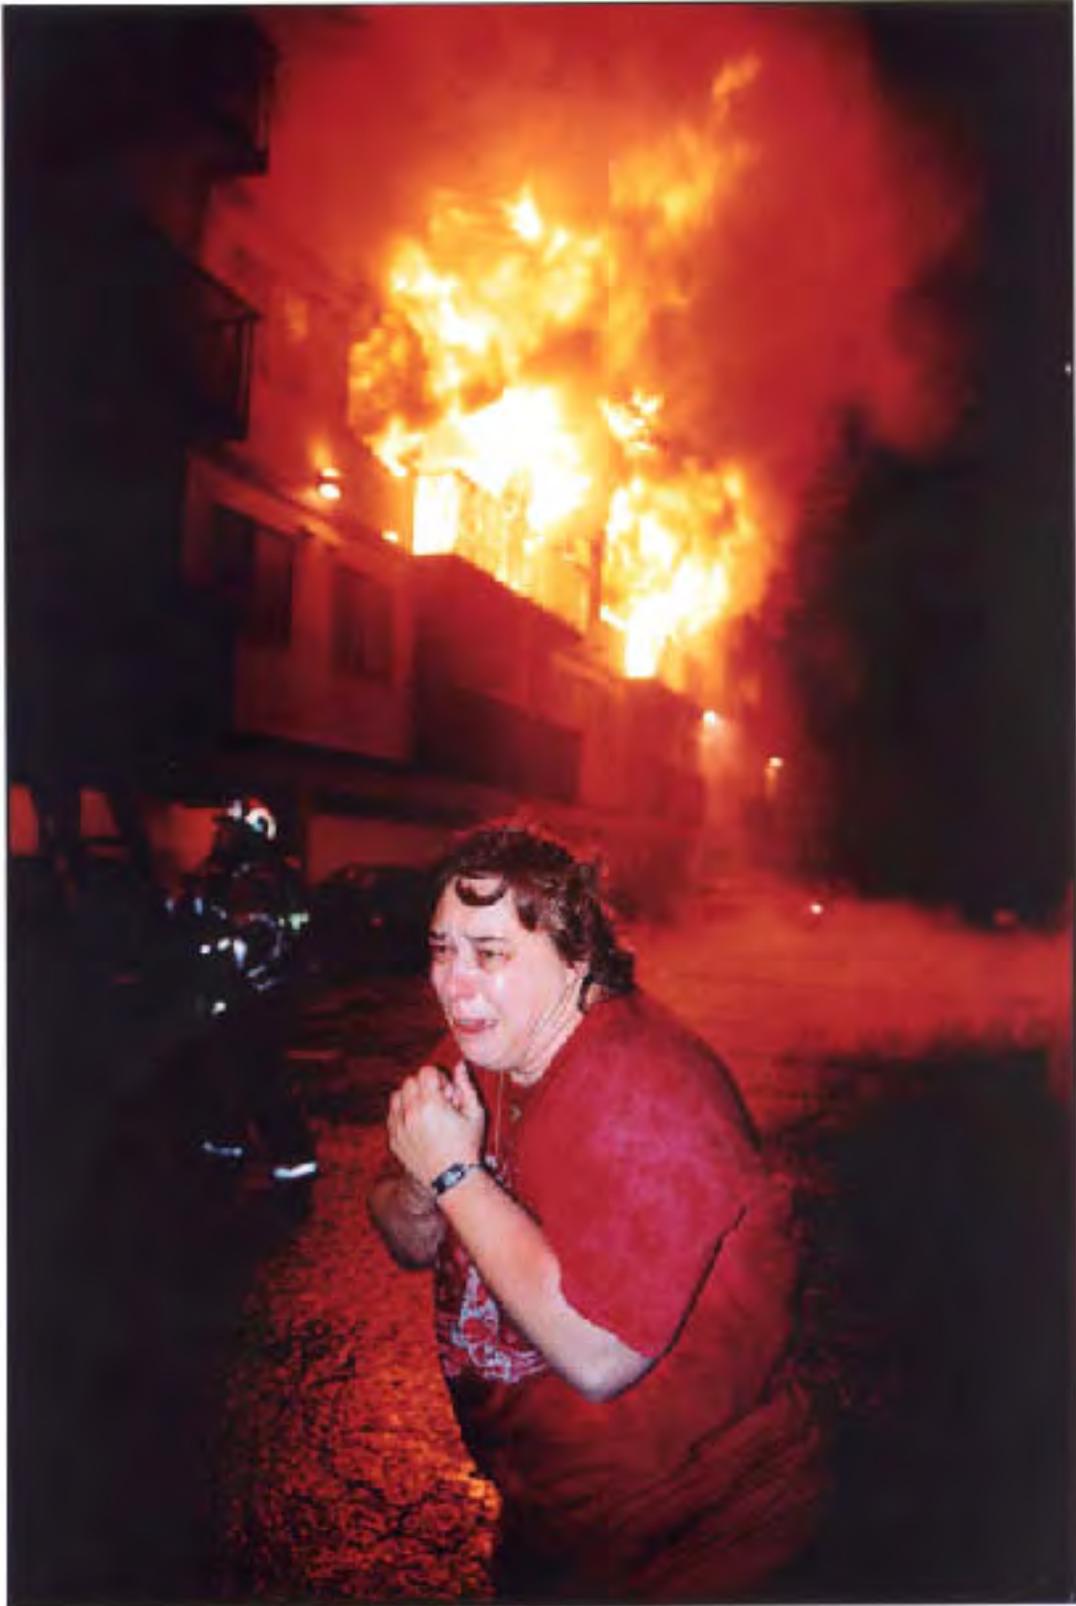
Photo 7. A Kona Village resident just rescued from upper floor by first arriving firefighters anxiously awaits the fate of her husband. Flames in background illustrate conditions on arrival of the fire department

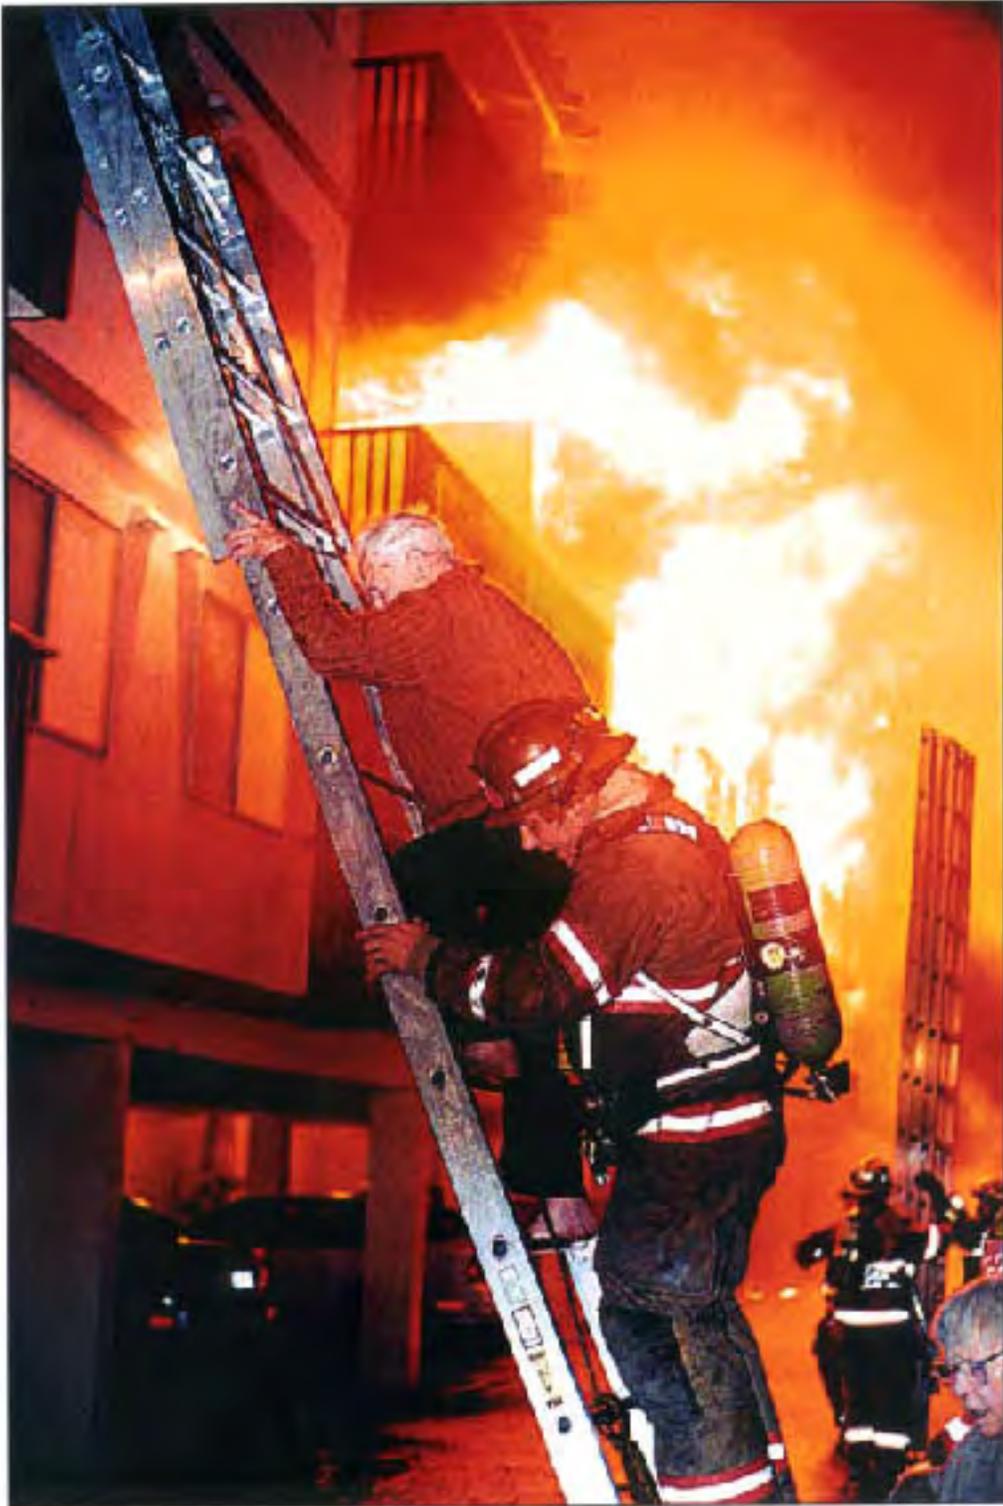
*Photo 8. Rescue of elderly tenant, spouse of woman in Photo 7, underscores problems faced by first arriving units of Bremerton Fire Department and Puget Sound Naval Shipyard Fire Department.
(Sun Photos by Larry Stegall)*
