# NATIONAL TRANSPORTATION SAFETY BOARD

## PIPELINE ACCIDENT REPORT

**SAN JUAN GAS COMPANY, INC./ENRON CORP.  
PROPANE GAS EXPLOSION IN SAN JUAN, PUERTO  
RICO, ON NOVEMBER 21, 1996**

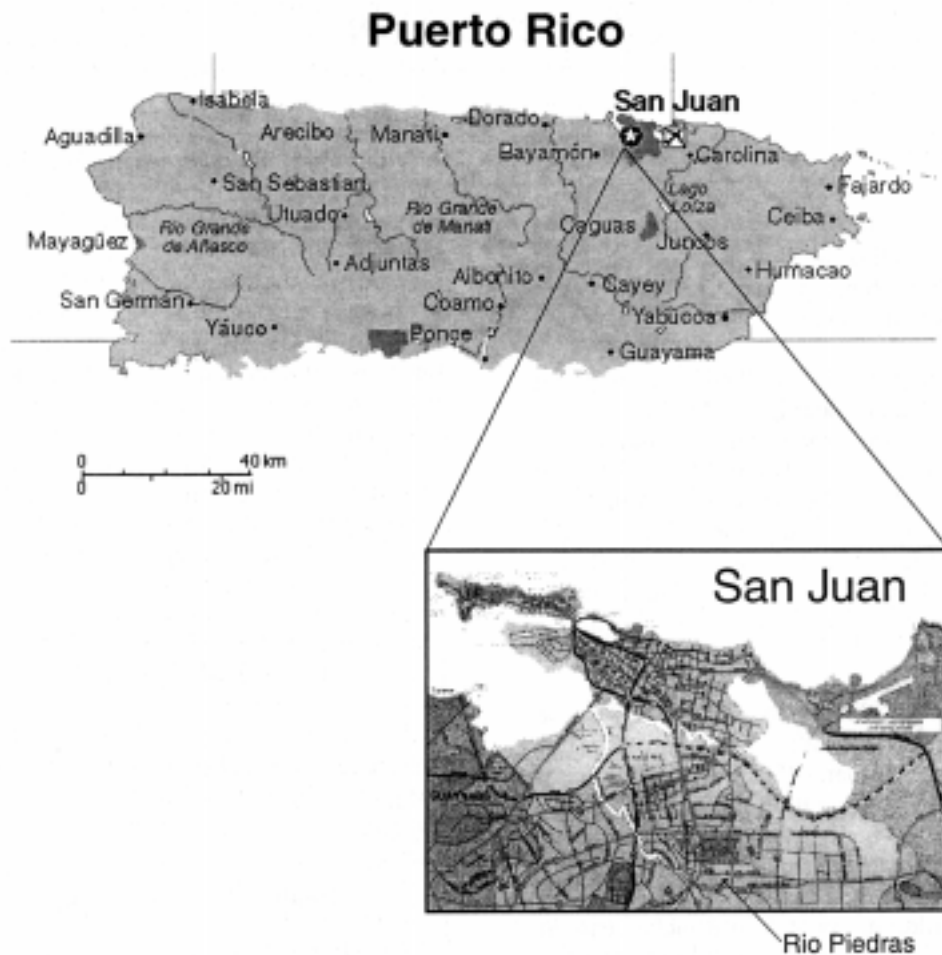
**Figure 1. Accident Location Map.**

The building was in Río Piedras, a shopping district in San Juan. (See figure 1.) The structure was a six-story mixture of offices and stores. Humberto Vidal, Inc., (Humberto Vidal) had bought the building (the HV building) in 1984, and the company's administrative offices occupied the third, fourth, fifth, and sixth floors. The first and second floors of the building housed a jewelry store, a record store, and a shoe store.

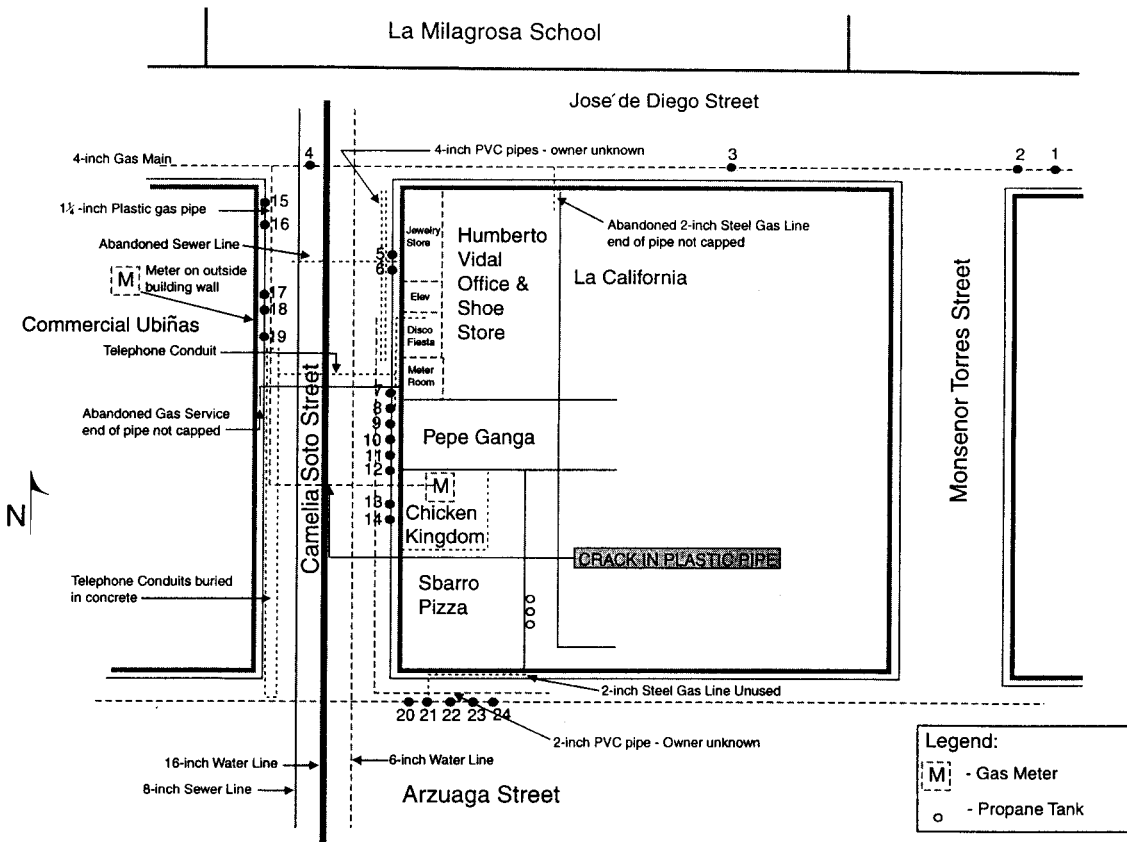
Indication Location <sup>5</sup>	CGI Reading % (LEL)	Indication Location <sup>5</sup>	CGI Reading % (LEL)
1	12	13	20 <sup>3</sup>
2	2	14	2
3	1	15	4
4	100 <sup>1</sup>	16	5
5	100 <sup>2</sup>	17	30
6	2 <sup>2</sup>	18	4
7	100	19	50 <sup>4</sup>
8	8	20	30
9	30	21	100
10	5	22	100
11	25	23	5
12	20 <sup>3</sup>	24	5

<sup>1</sup>When switching to gas scale, a 25% gas in air reading was indicated
