# An overview of fire protection of Swedish wooden churches

Brandforsk project 500-061

**SP Sveriges Provnings- och  
Forskningsinstitut**  
SP Rapport 2006:42  
ISBN 91-85533-28-9  
ISSN 0284-5172  
Borås 2006

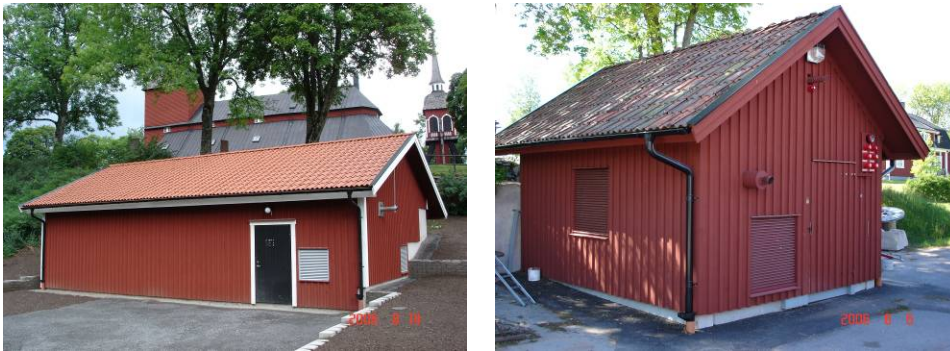
*Figure 4 Buildings built close to the churches that contain the water reservoir, pumps and associated equipment. To the left is the building for Habo church and to the right the building for Älgårås church.*

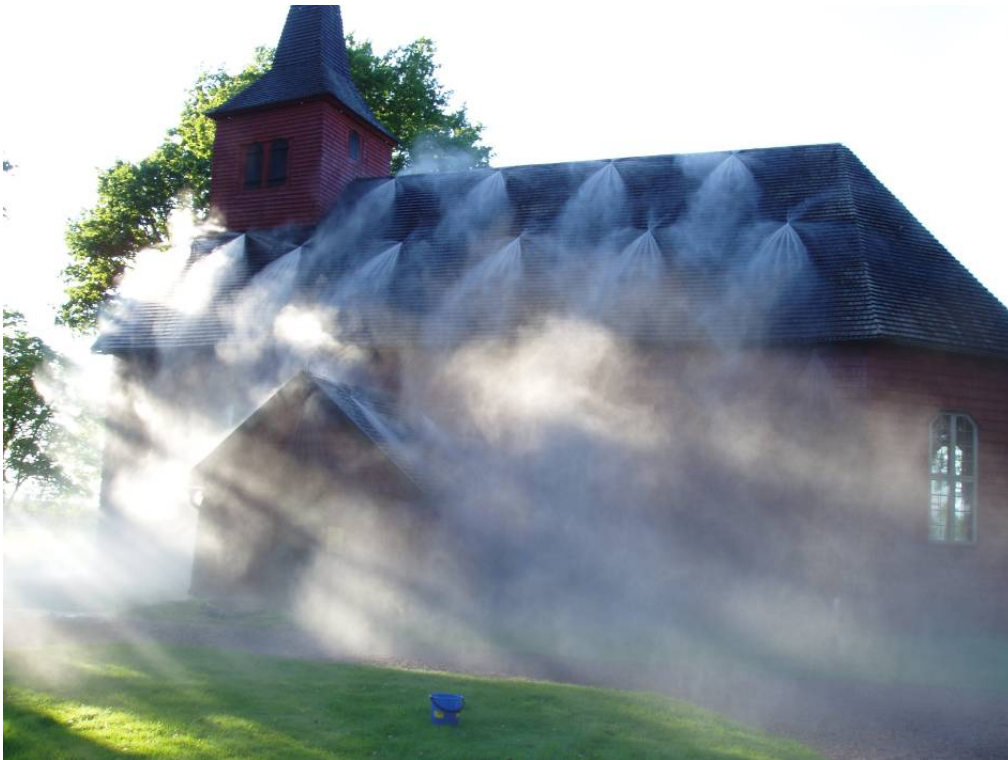
*Figure 10 Protection of the facades and the roof of Älgårds church using a water mist system. Photo: Jan G Andersson.*

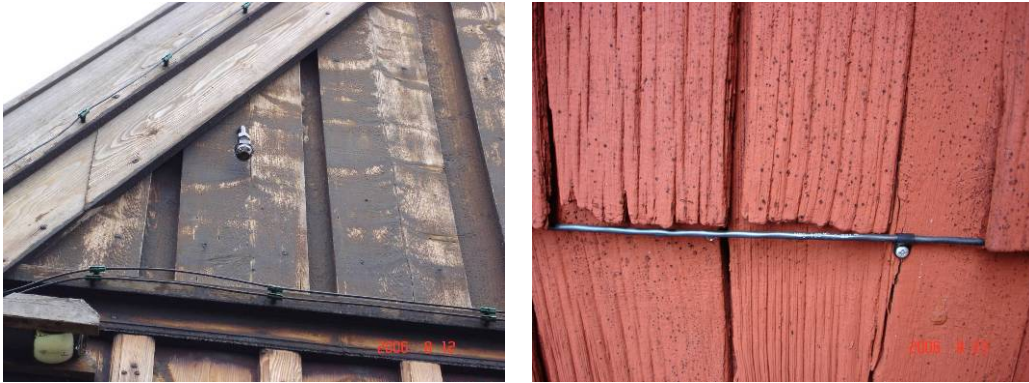
Fire detection systems for facades and roofs closely relate to the issue in the previous section, as the fire protection system usually is activated by a separate fire detection system. Figure 11 shows linear heat detection wires at the facade of Hedareds stave church. Figure 11 shows linear heat detection wires at the facade of Hedareds stave church.

*Figure 11 Linear heat detection wires at the facades of Hedareds stave church (left hand photo) and Fröskog church (right hand photo). Note the high-pressure water mist nozzle shown in the left hand side photo.*

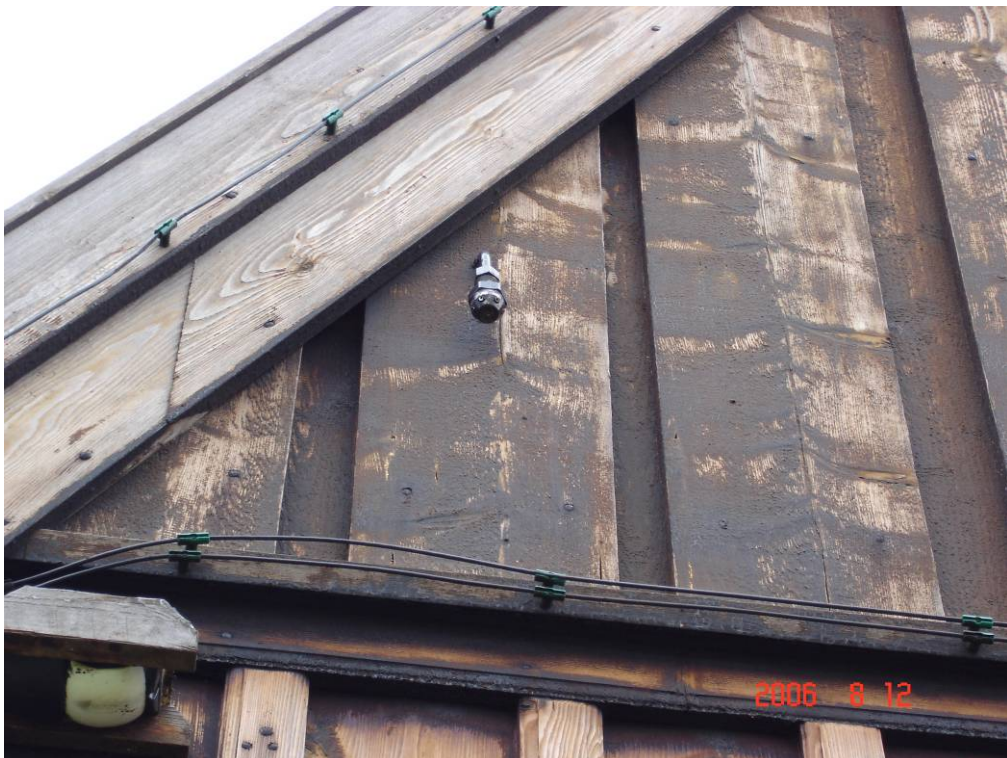
*High-pressure water mist nozzle and linear heat detection wires on one of the facades.*

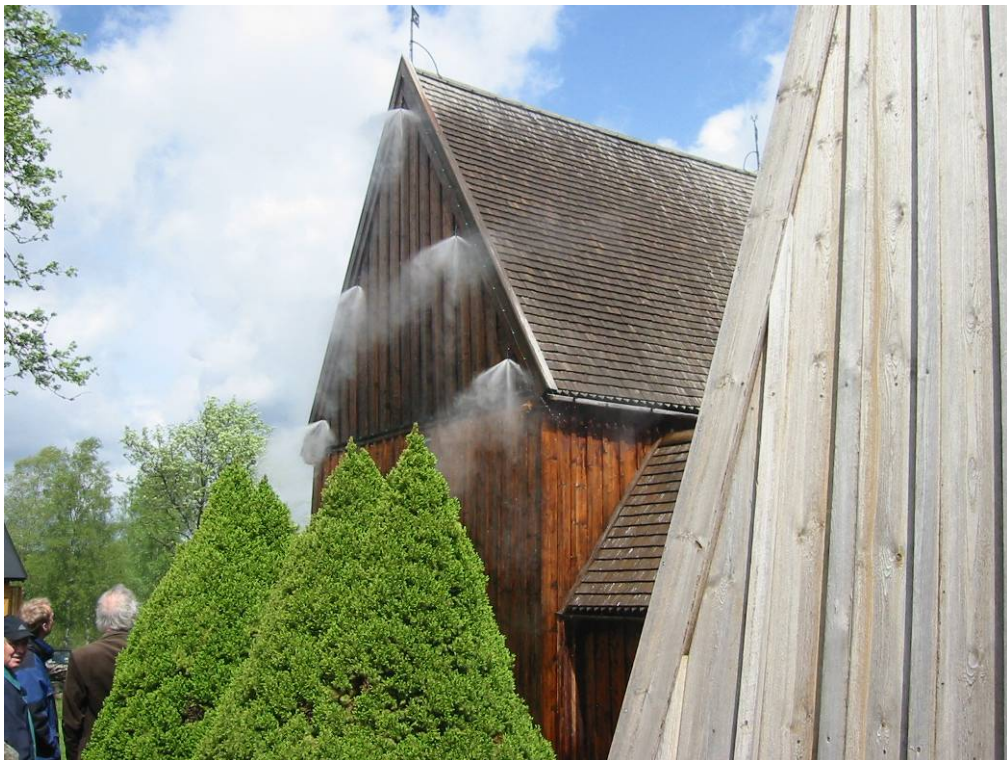
*Functional test of one of the sections that protects the facades of the church. Photo: Anders Lönnermark.*

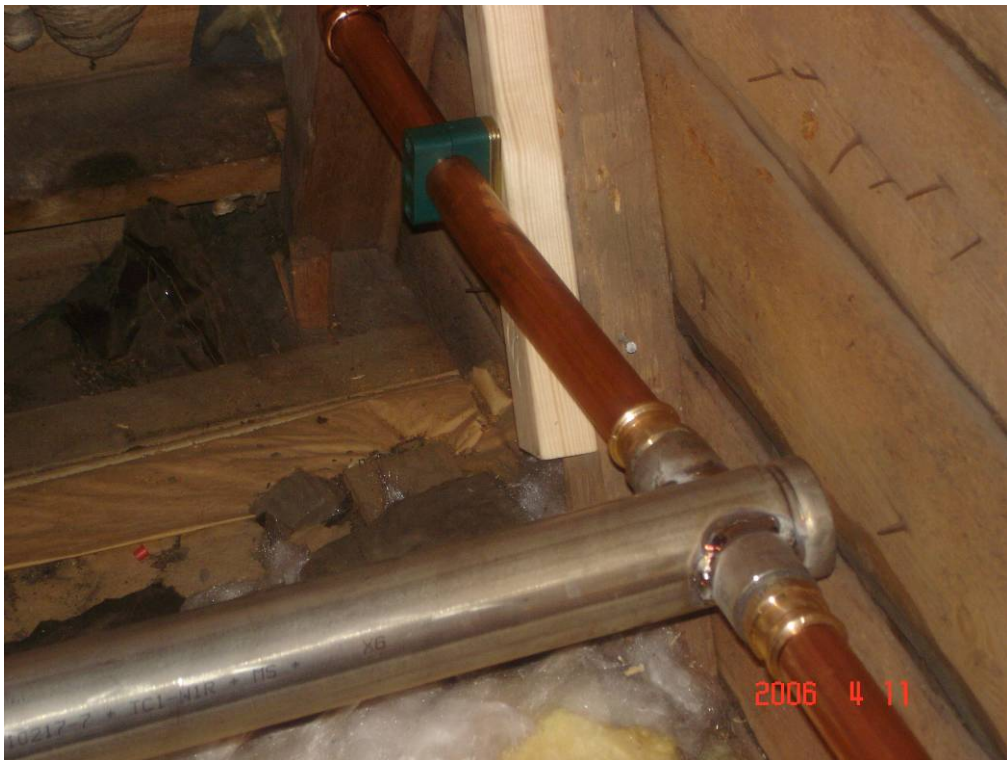
*Pipe-work, inside the attic of the church, for the sprinklers protecting the facades. A stainless steel main pipe connects to the copper piping on the outside of the building.*

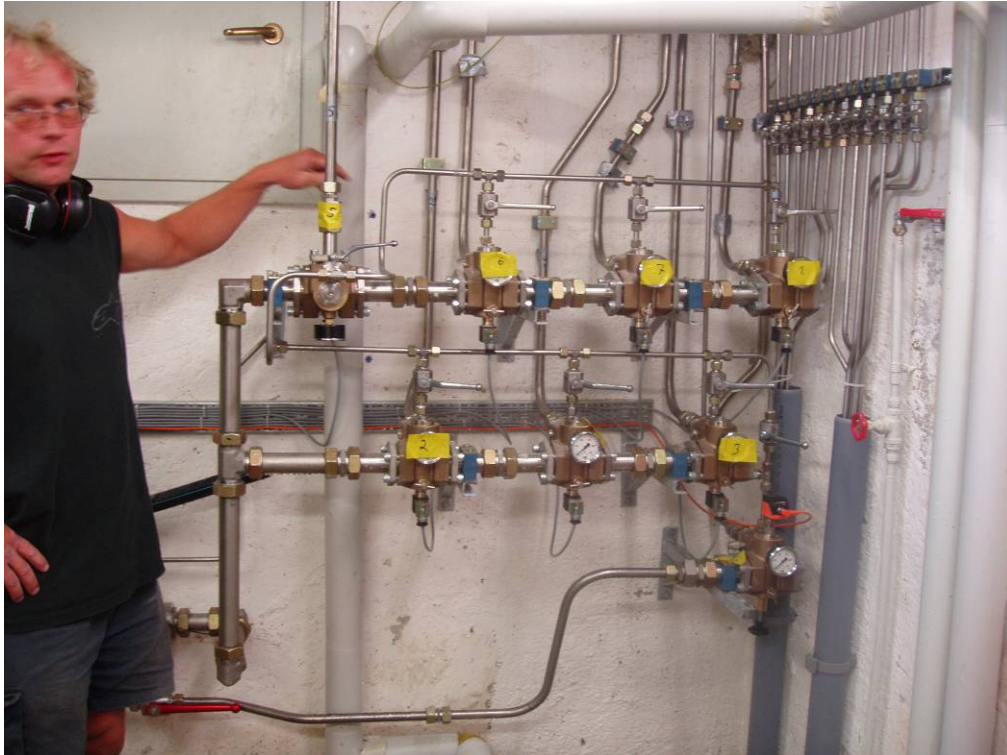
*The section valves and the valves (at the right hand side wall) that are opened when flushing the system pipe-work with compressed air. All equipment is installed in the sacristy. Photo: Jan G Andersson.*

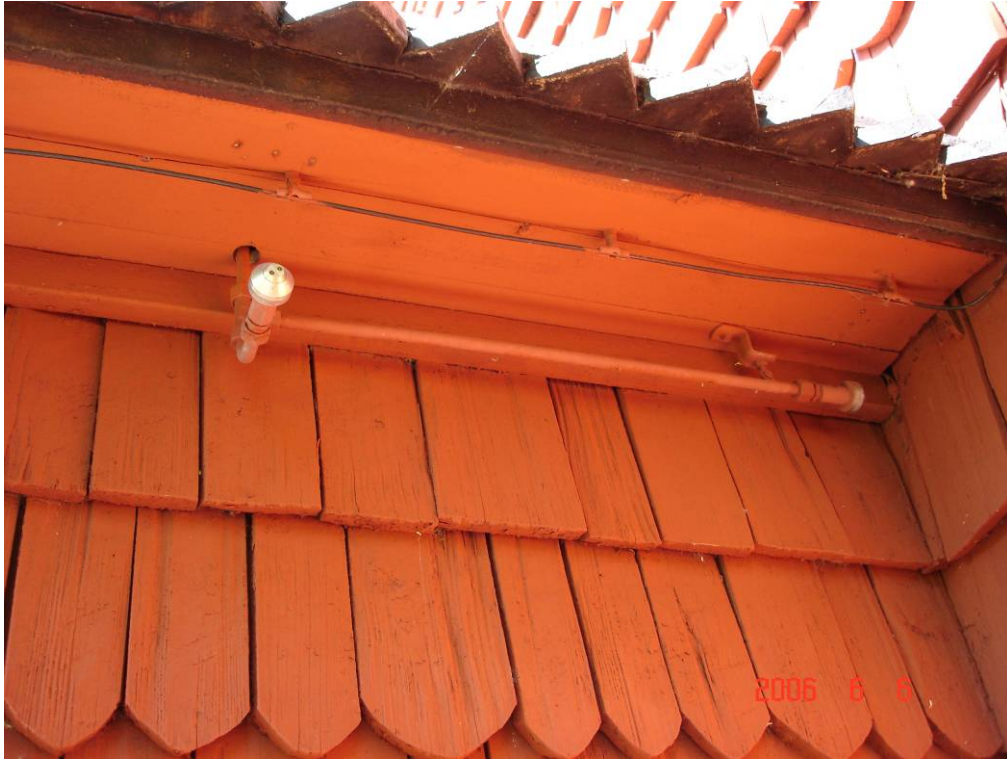
*Two of the nozzles installed to protect the facade; the nozzle to the right is directed towards the corner in order to achieve additional protection against fire spread up the corner walls. The piping has been painted red to make the pipe as discreet as possible. Note the linear heat detector wire.*

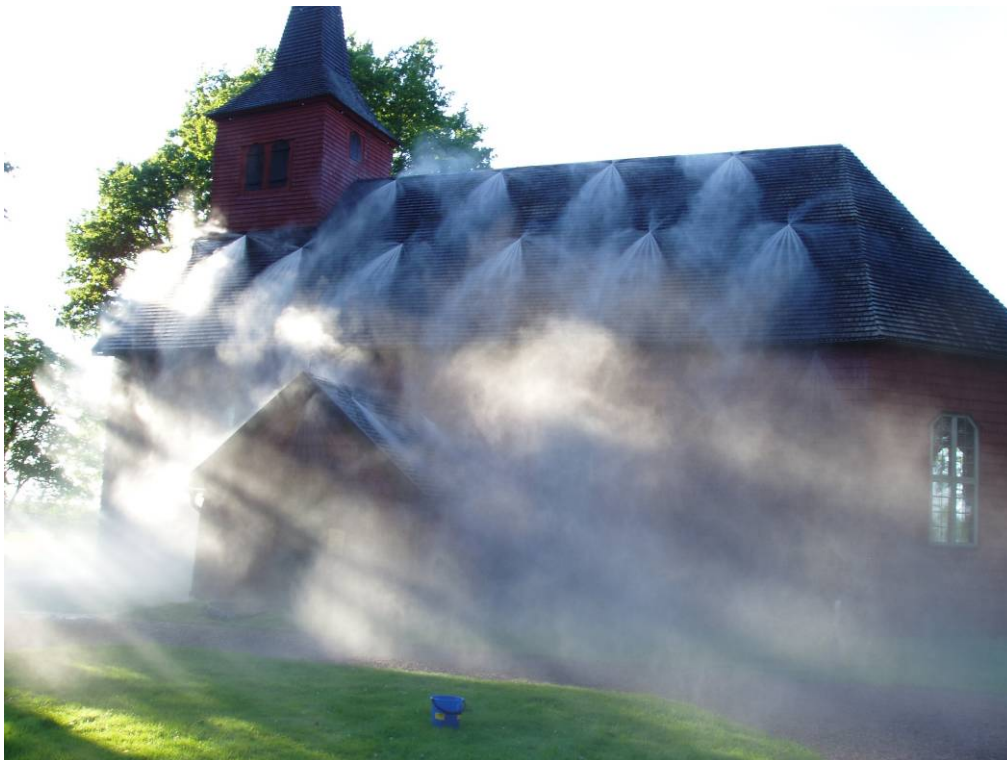
*The picture shows a functional test of the system, where several sections that protects the facades and the roof was simultaneously activated. Photo: Jan G Andersson.*

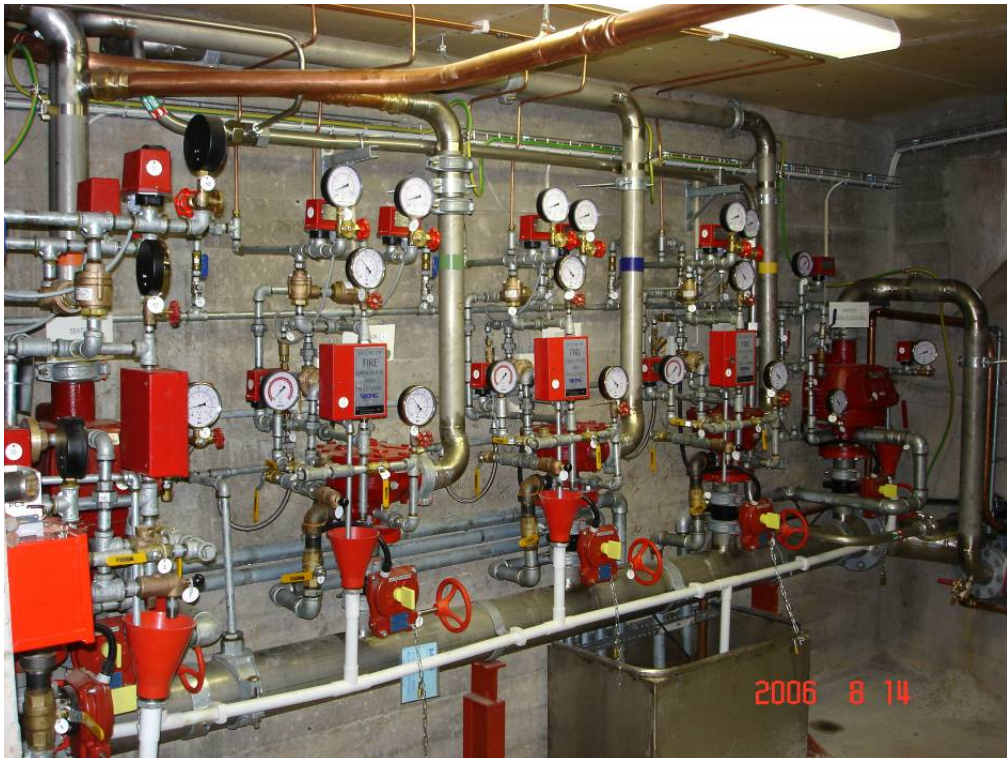
*The deluge and dry-pipe valves used with the low-pressure (sprinkler) system. This equipment is positioned inside the church.*

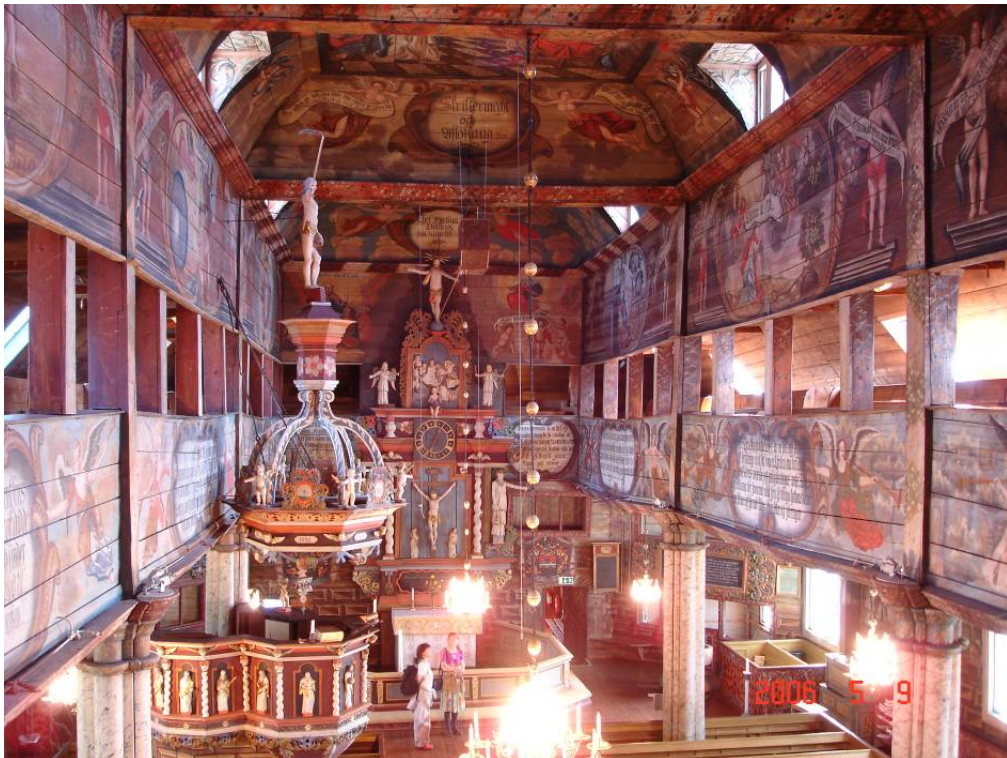
*Interior of the church. Note the sprinkler piping on each side of the balconies. The high-pressure water mist nozzles at the ceiling are not visible from floor level.*

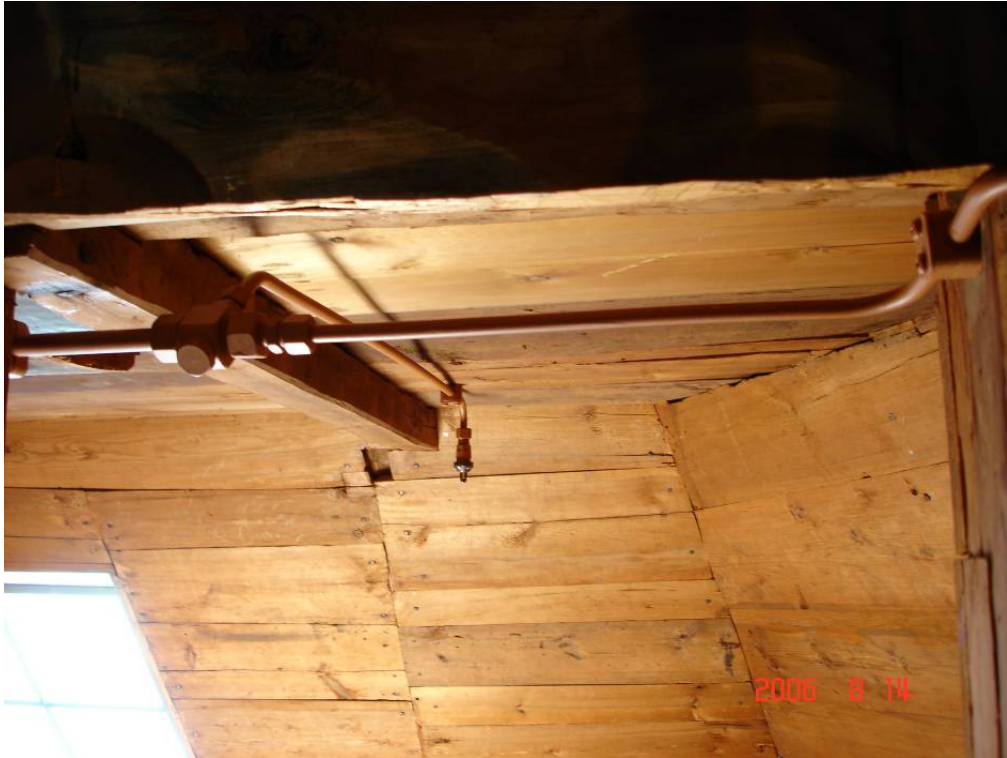
*Some of the piping could not be concealed, but are discretely installed.*

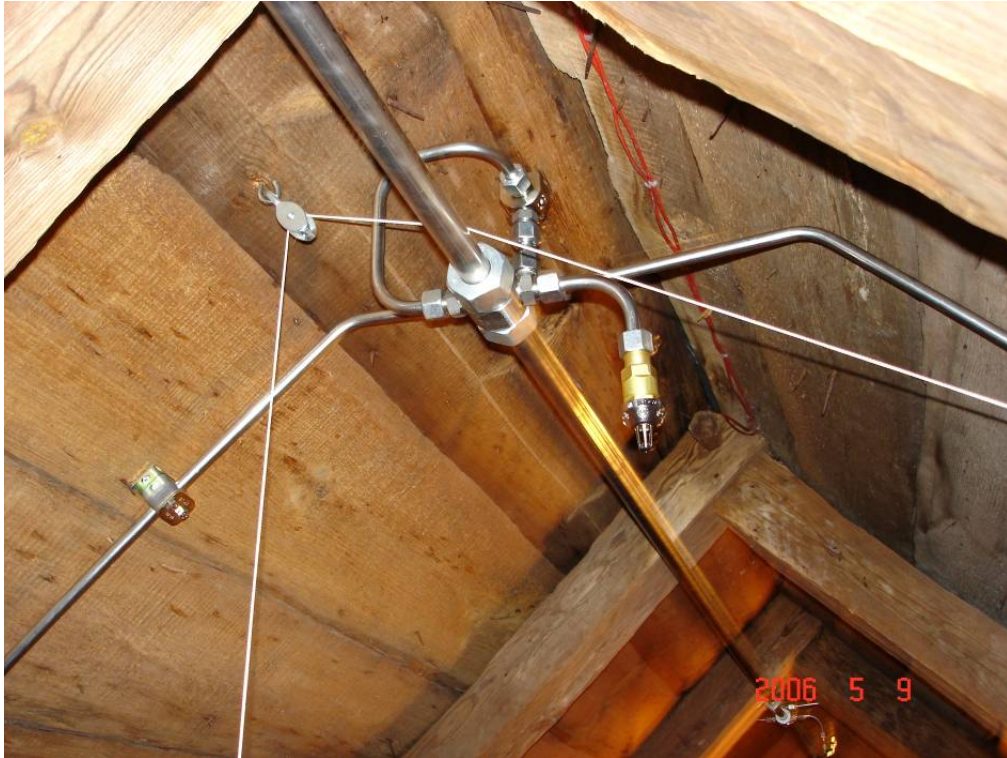
*Installation of the high-pressure system inside the attic of the church. The activation of a group release valve (at the top) activates one nozzle on either of the vertical branch lines. In addition, a separate, automatic, pendent nozzle may activate independent of the group release valve.*

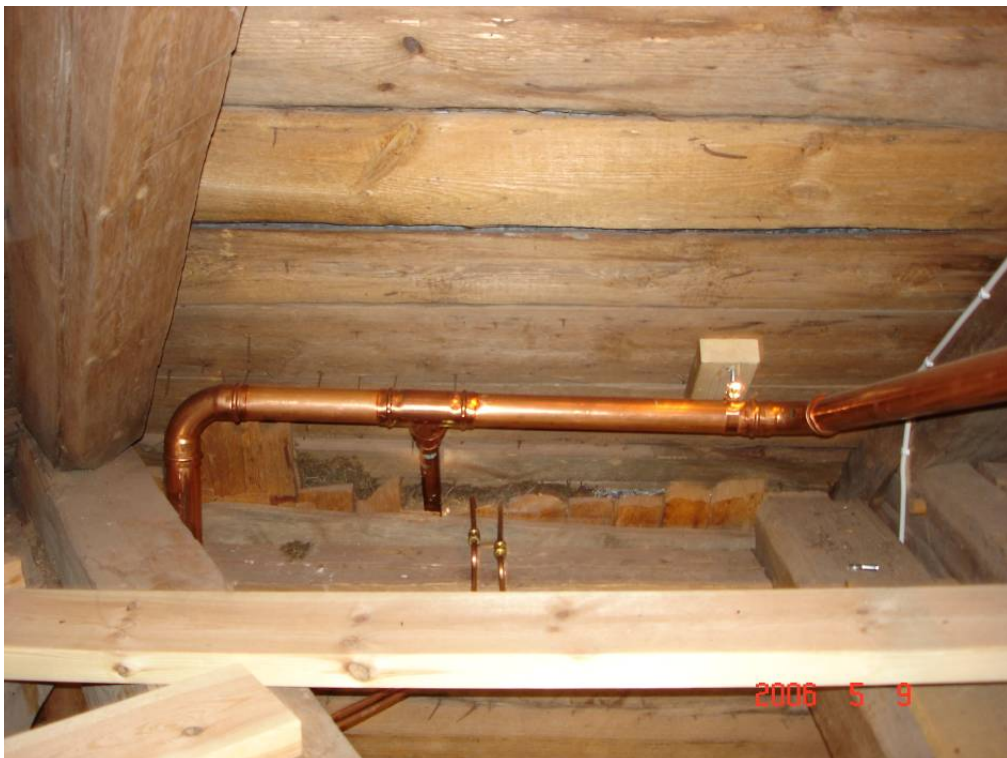
*Photo from inside the attic. The copper piping connects to the pipe-work for the sprinklers protecting the facades. The smaller copper piping connects to the pneumatic linear heat detection system for the facades.*

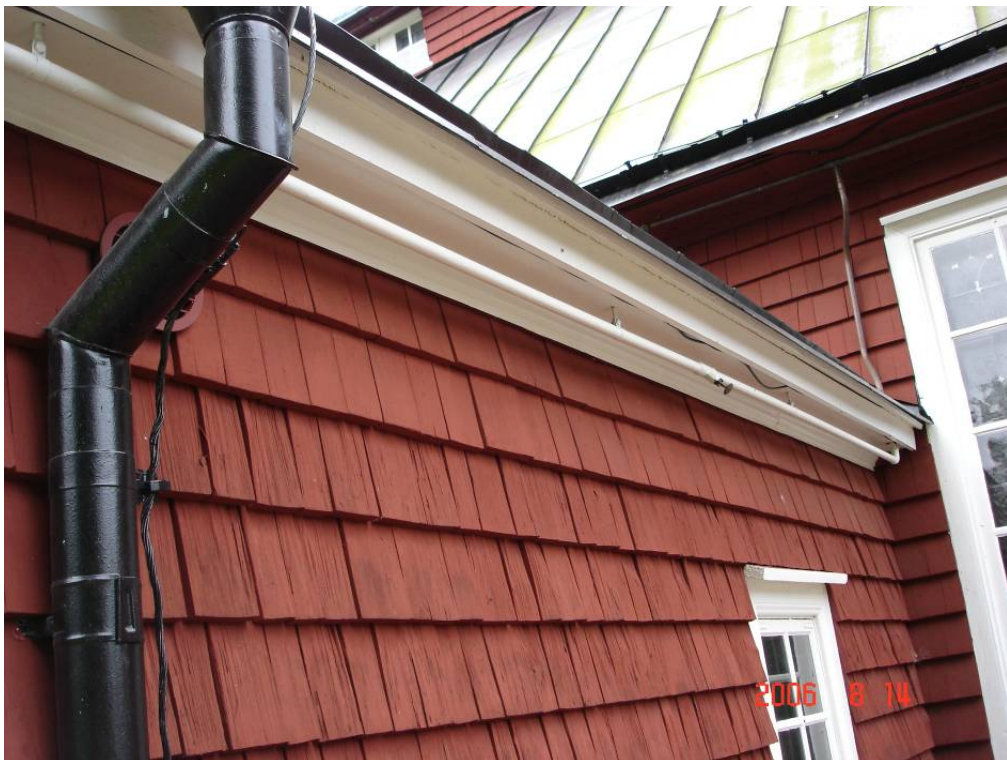
*Sprinkler (open) used to protect the facade, with the pneumatic linear heat detection lines.*

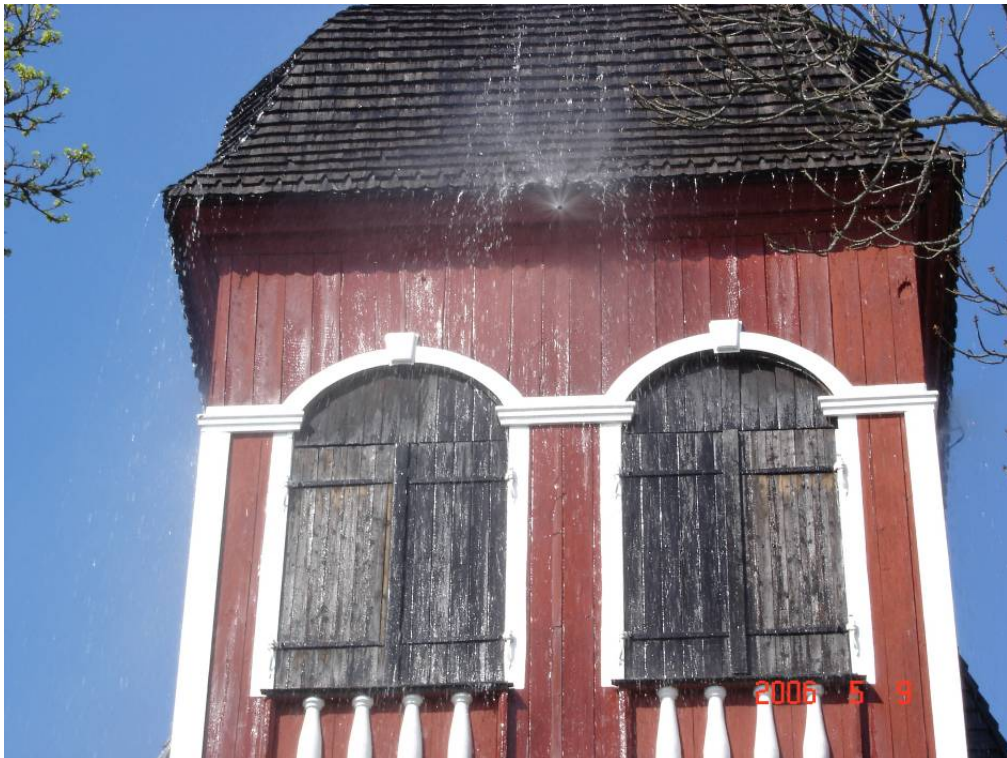
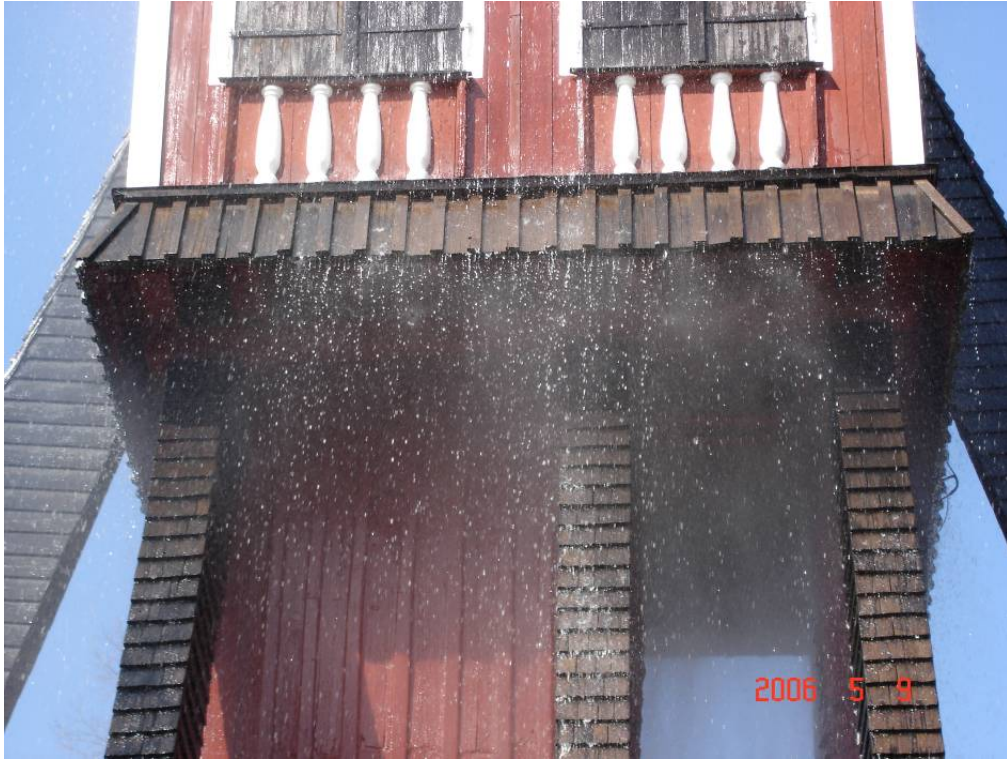
*Functional test of the deluge system that protects the bell tower.*
