# United States Fire Administration

## Technical Report Series

### The East Bay Hills Fire Oakland-Berkeley, California

## United States Fire Administration Fire Investigations Program

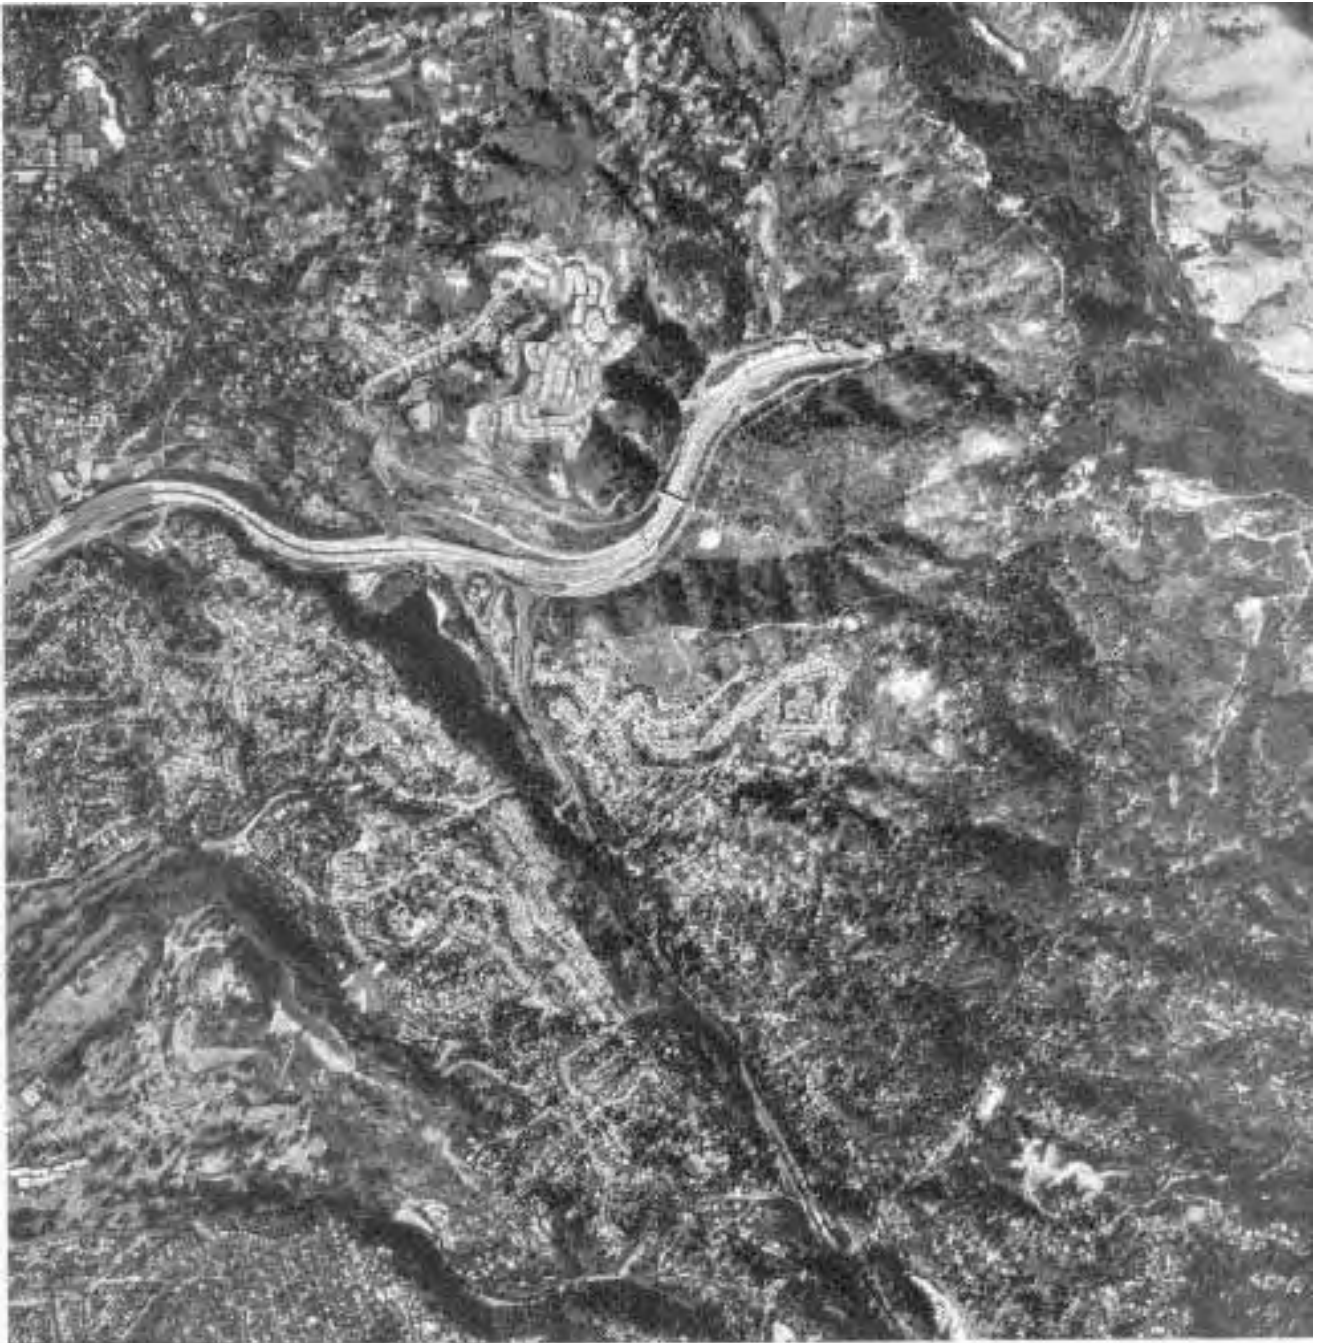
Aerial photograph taken after the fire. Area shown is the same as on page 12.  
In total 3,354 structures were destroyed.

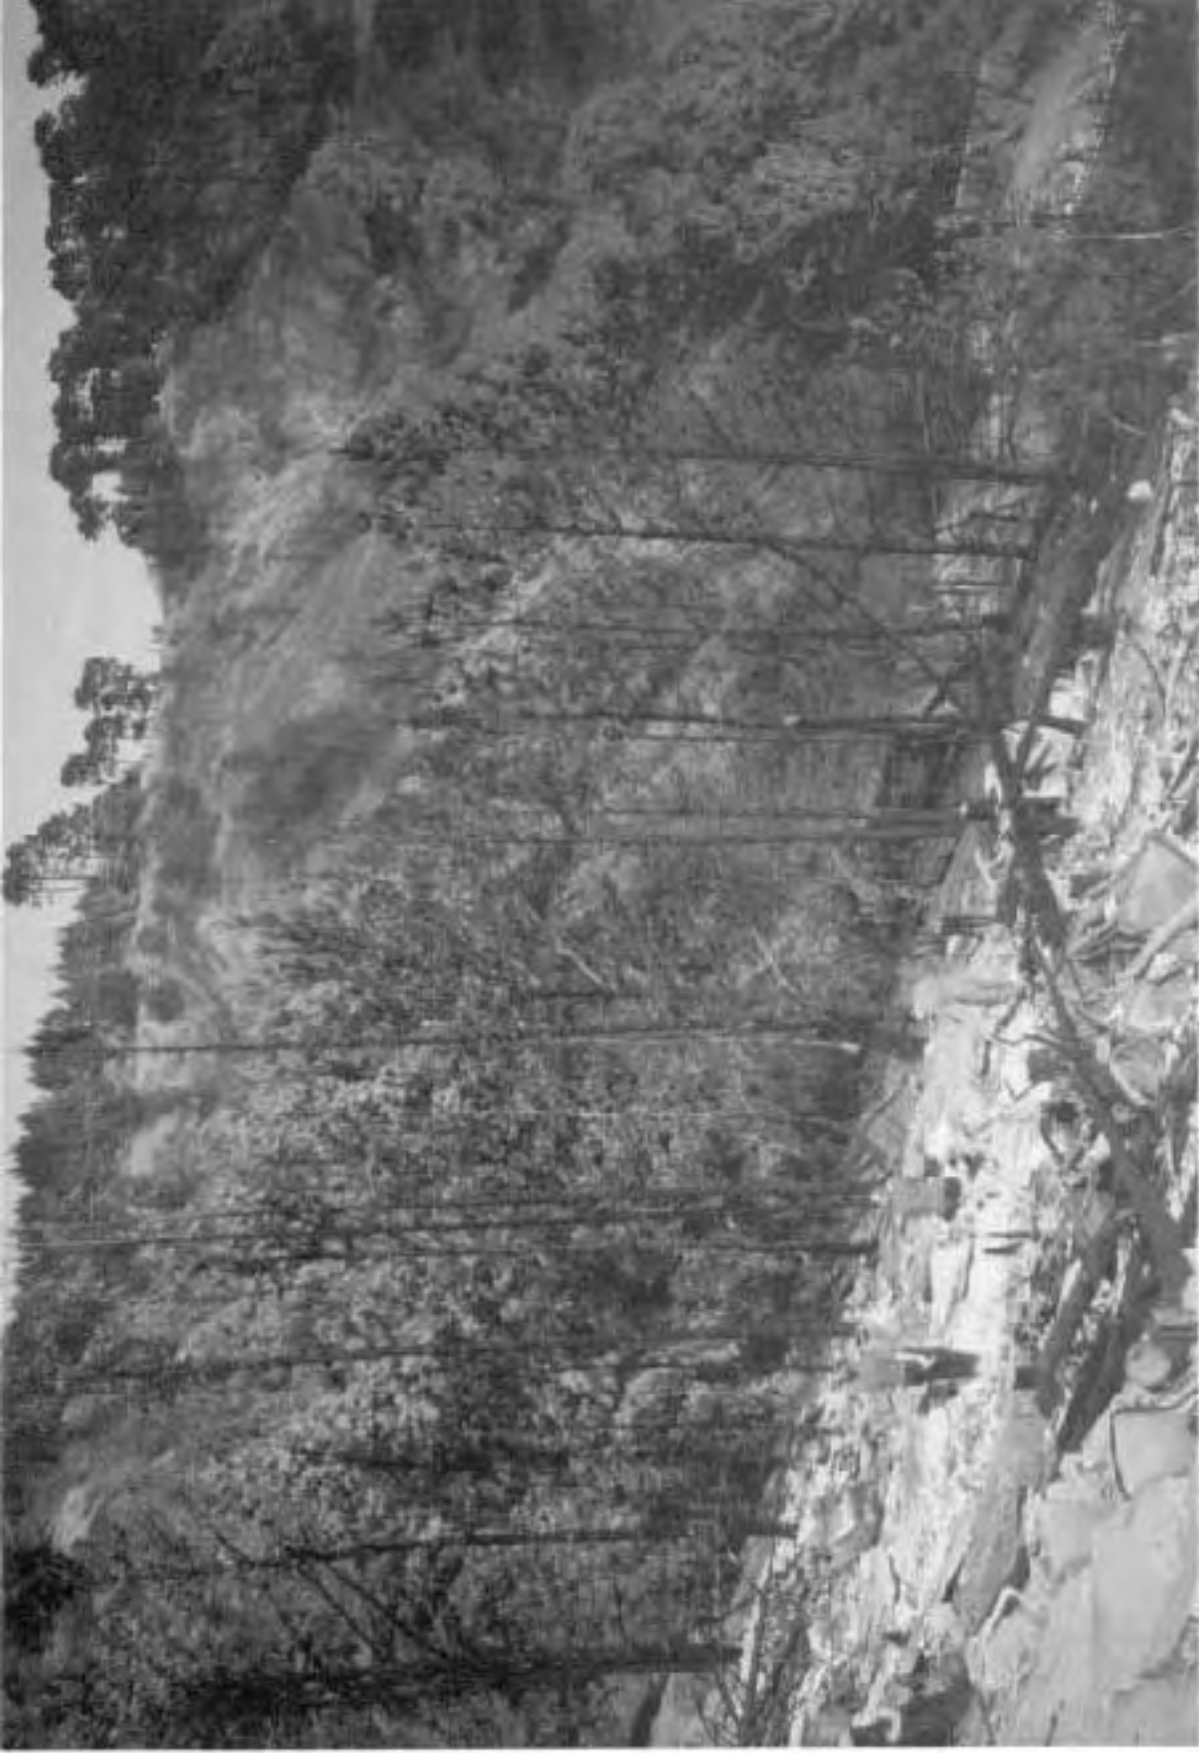
View looking toward the area of fire origin - on the grassy slope in the background. The left flank of the fire spread laterally behind the homes on Buckingham Boulevard and up toward the area in the foreground.

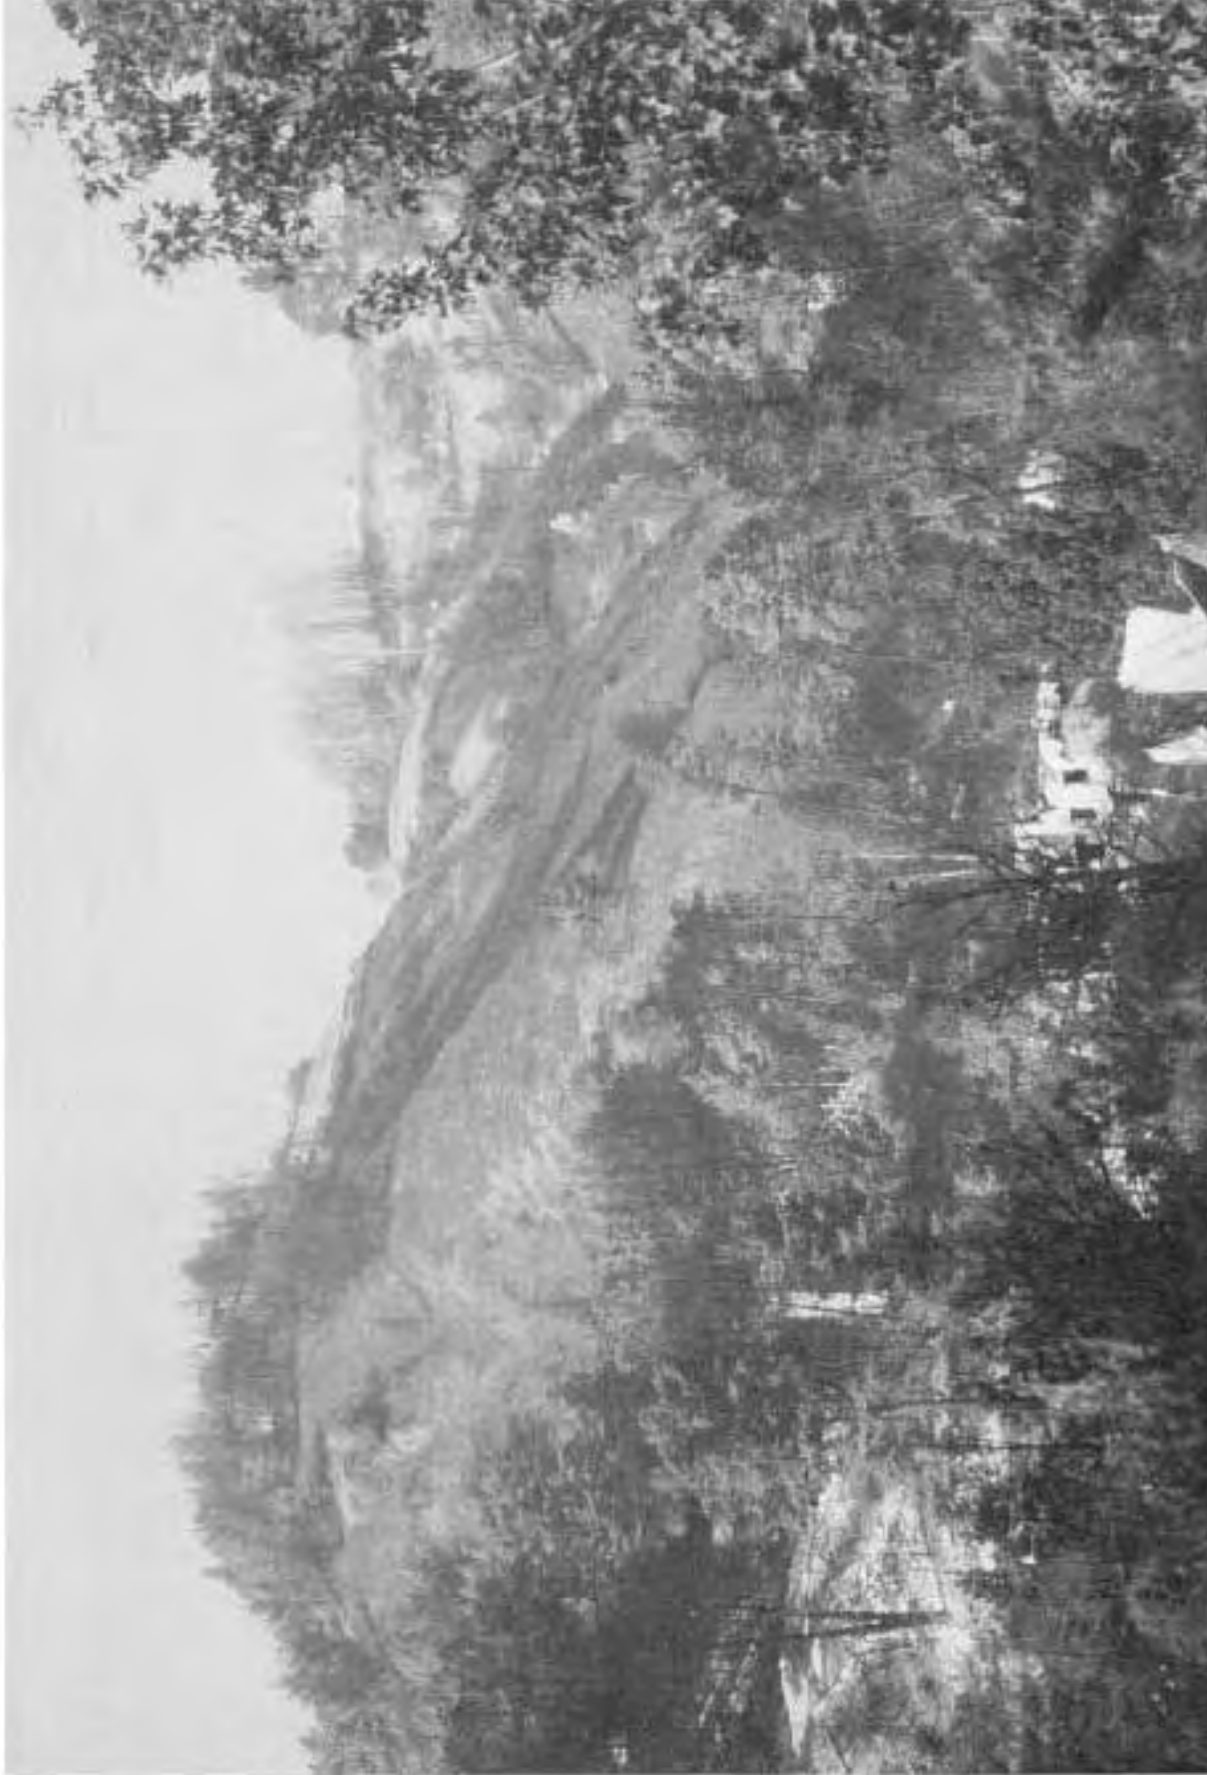
View of the area of fire origin as seen from the Parkwood Apartments. The Saturday fire burned up the grassy slope on the hills toward Marlborough Terrace and the radio tower on Grizzly Peak. The fire on Sunday broke out in the lower part of the original burn area.

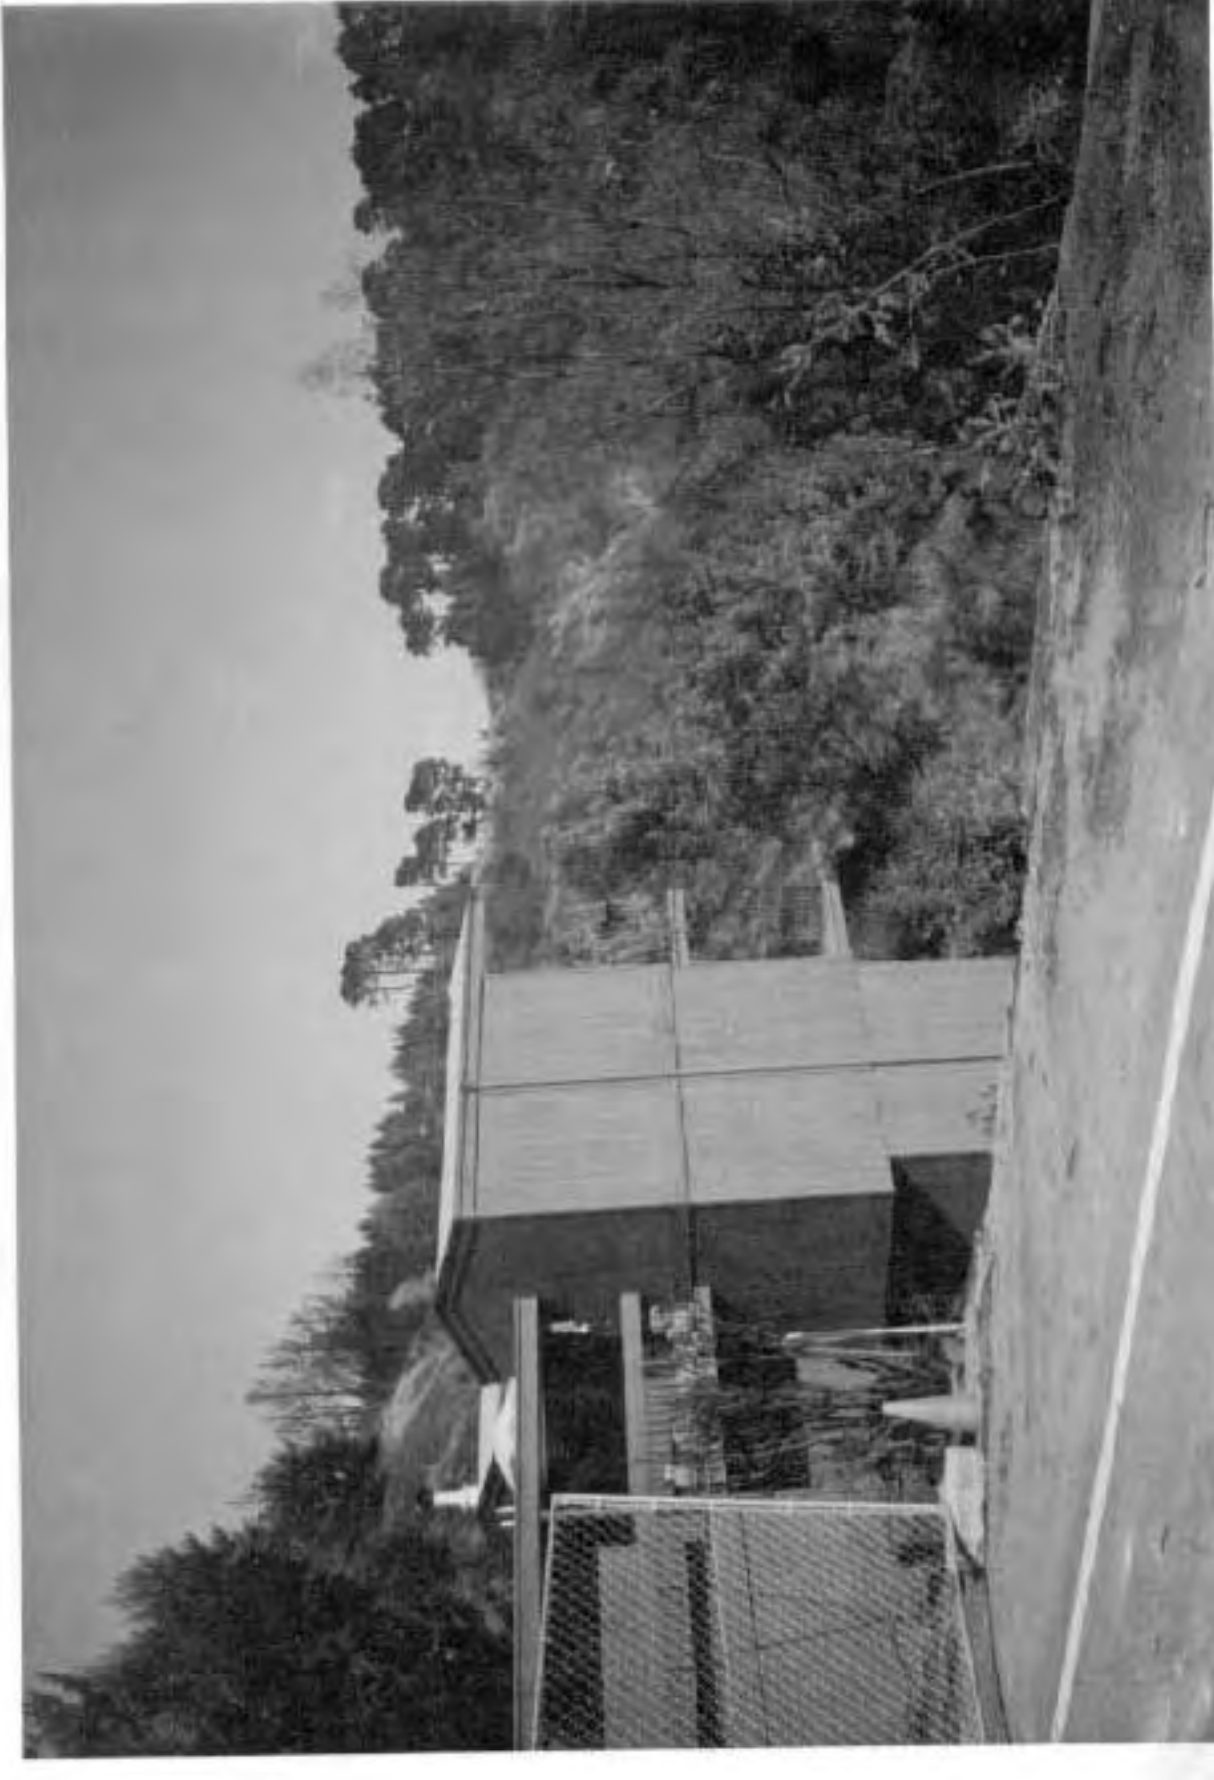
One of the few homes on Marlborough Terrace that was not destroyed by the fire. Houses on both sides burned to the ground.

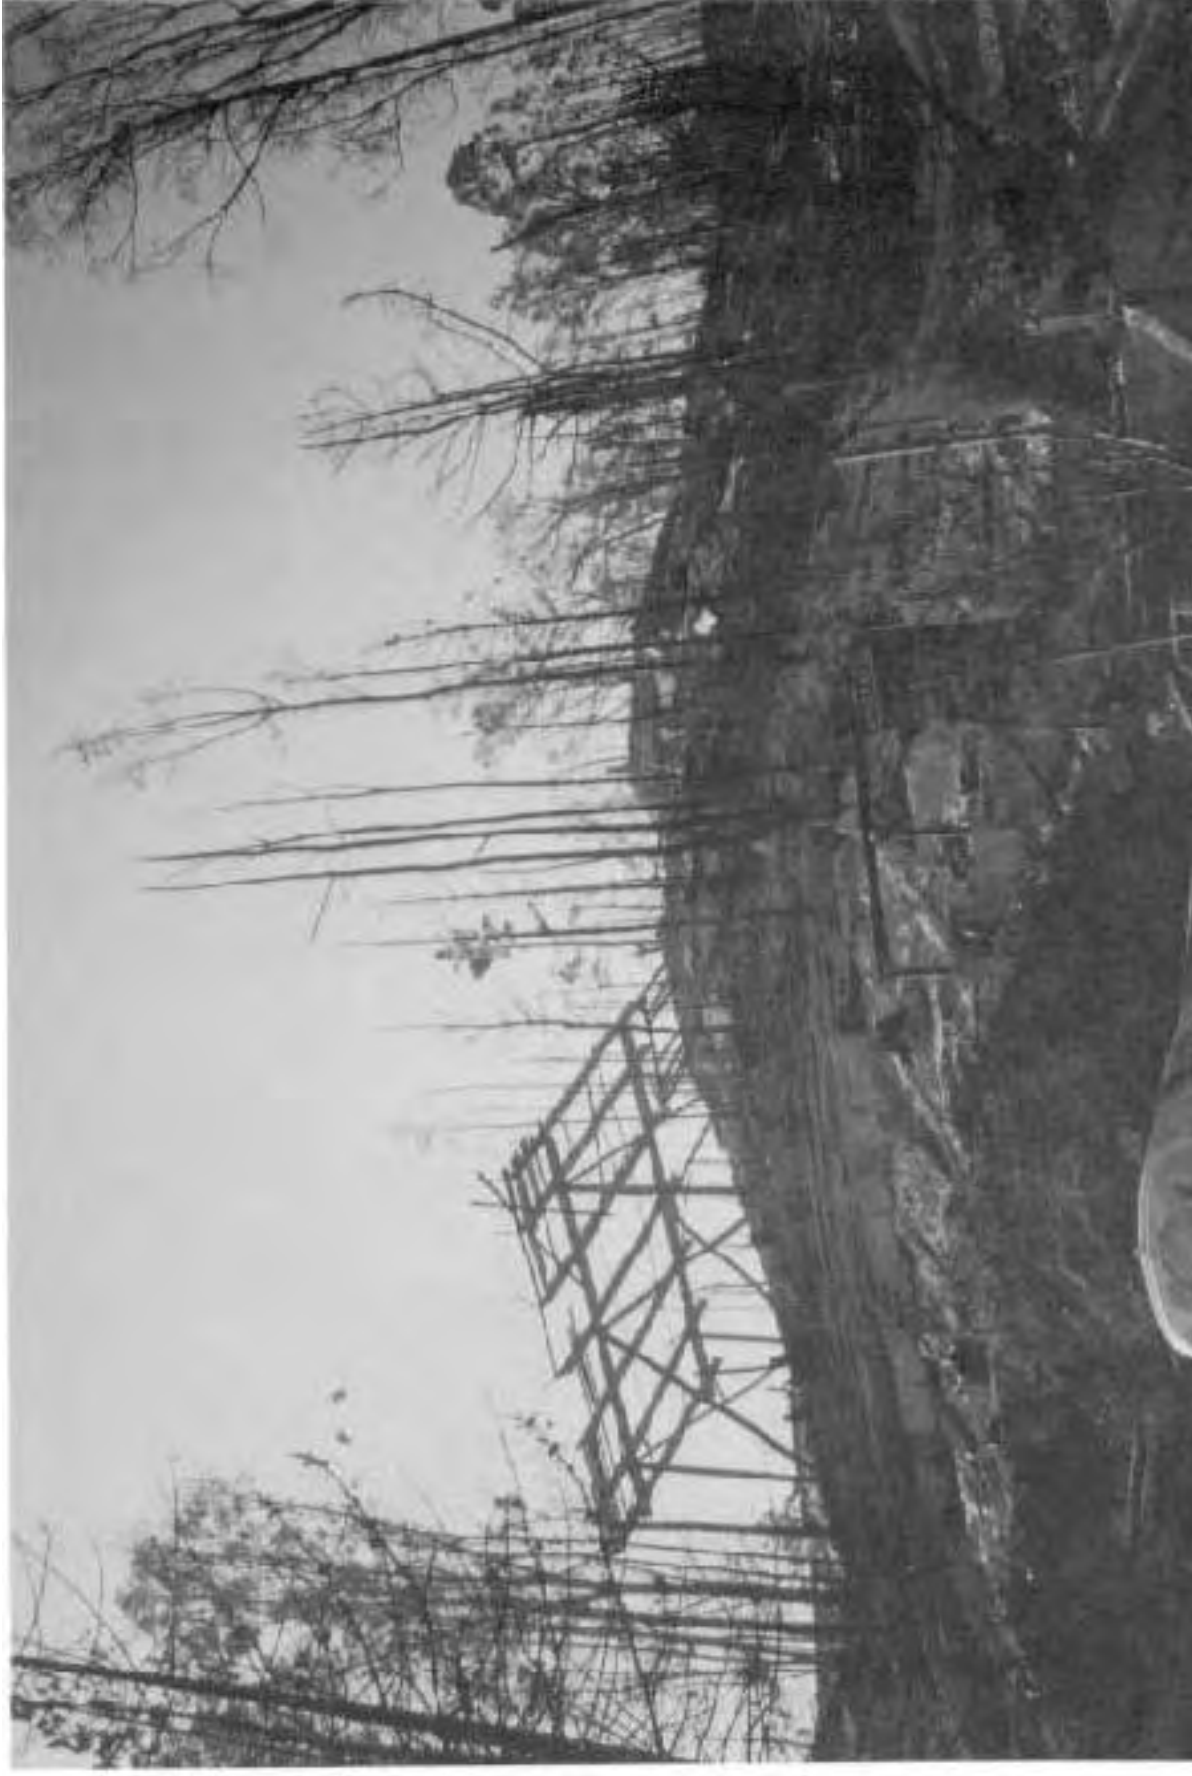
All that remains of one hillside home is the steel supporting structure for the main floor.

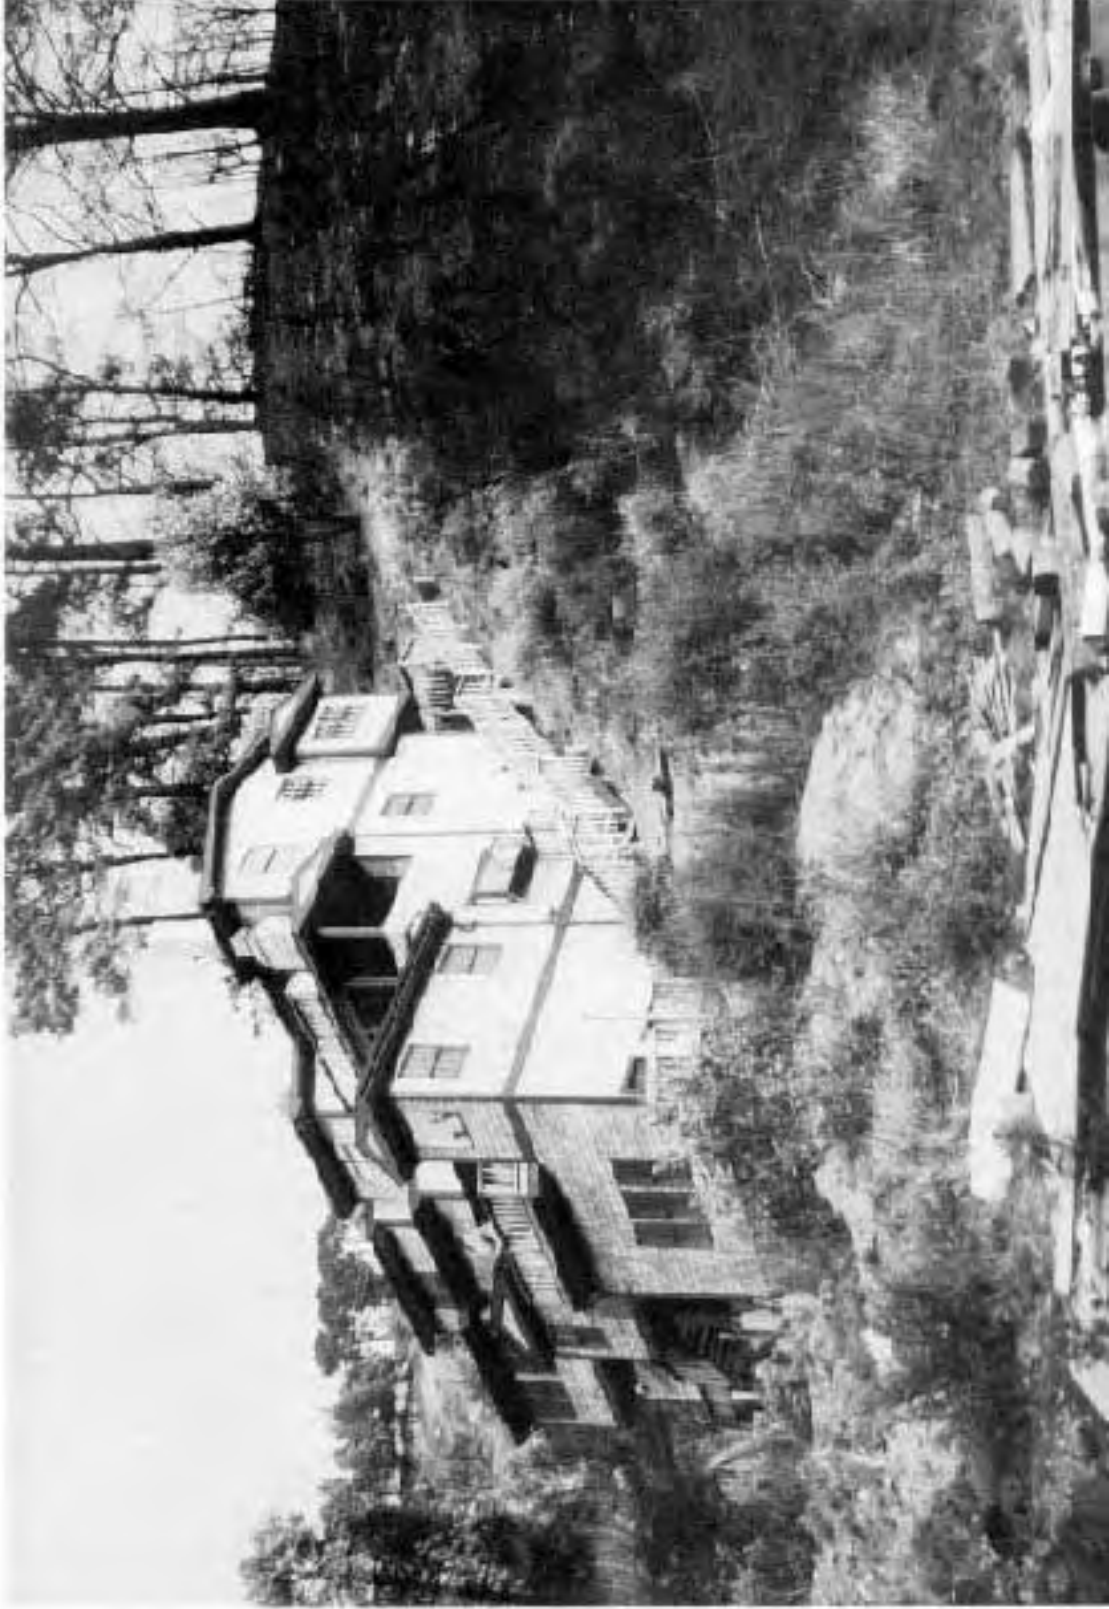
One of the few surviving structures on Buckingham Boulevard, near the area of fire origin. This is the house where firefighters and residents took refuge, using all available water flow to protect the surface as the fire front passed over,

A Lieutenant and a Firefighter had to abandon their Patrol vehicle and took refuge in the swimming pool of a hillside home, along with the homeowner, and spent more than an hour under the pool cover, sticking their heads out just often enough to splash water on the cover to prevent its ignition. The house burned, leaving only the pool, and when the fire

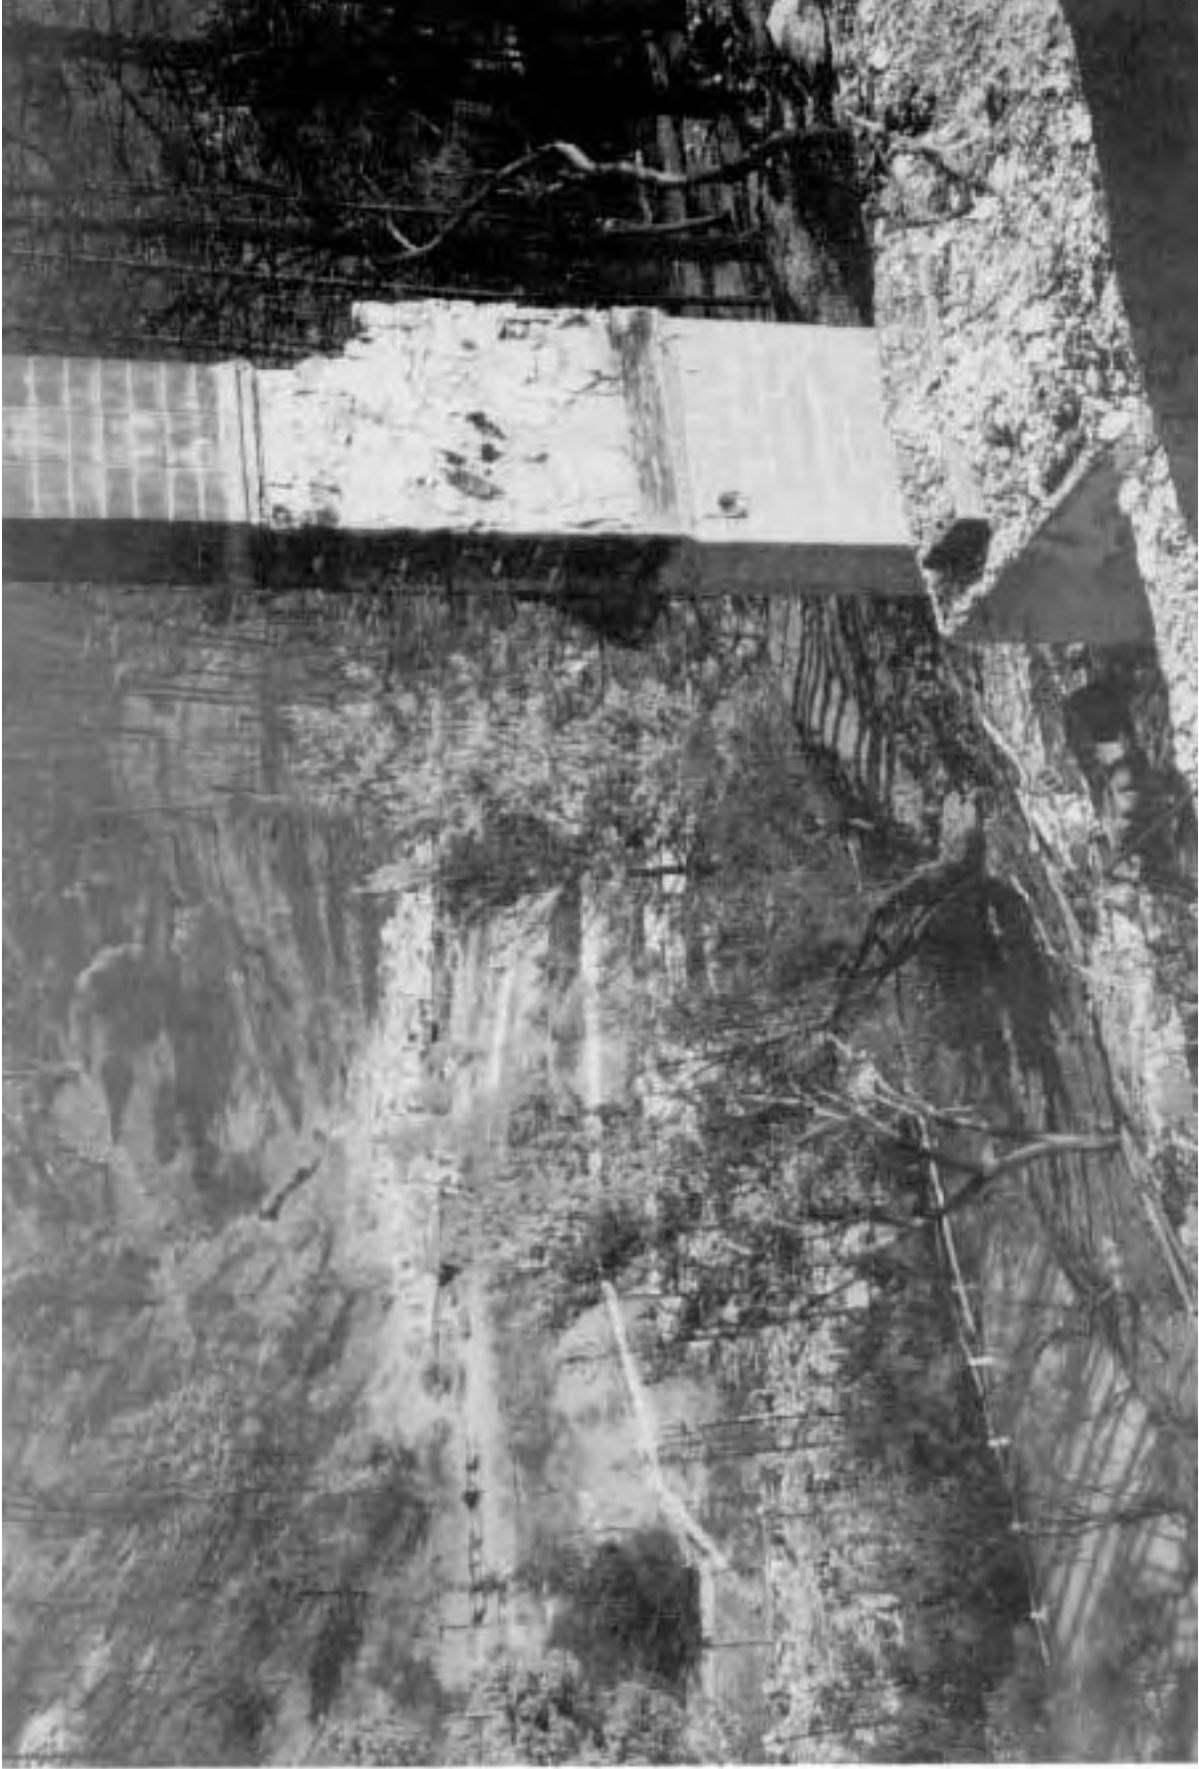
Looking down on the ruins of the Parkwood Apartments from Buckingham Boulevard. Tunnel Road is visible in the lower left corner.

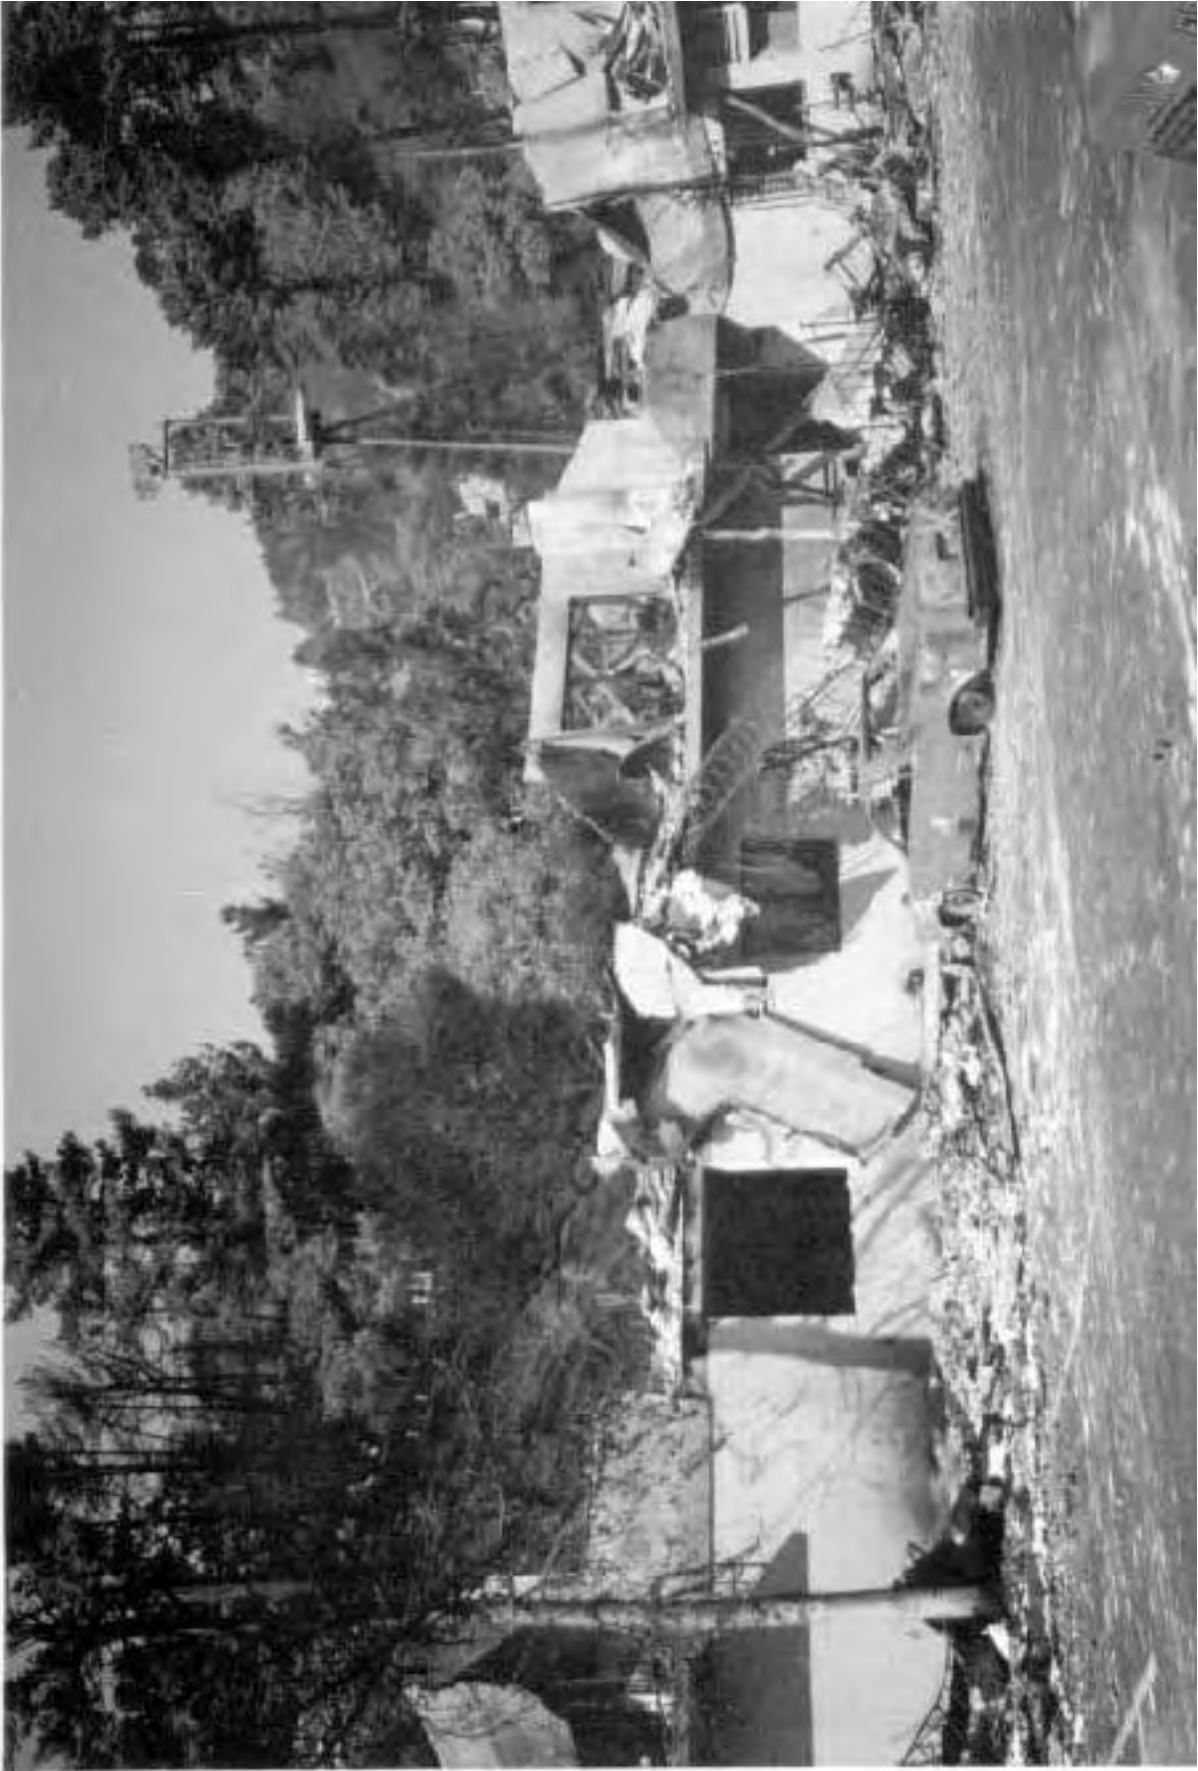
Ruins of the Parkwood Apartments; previously 4-story buildings.

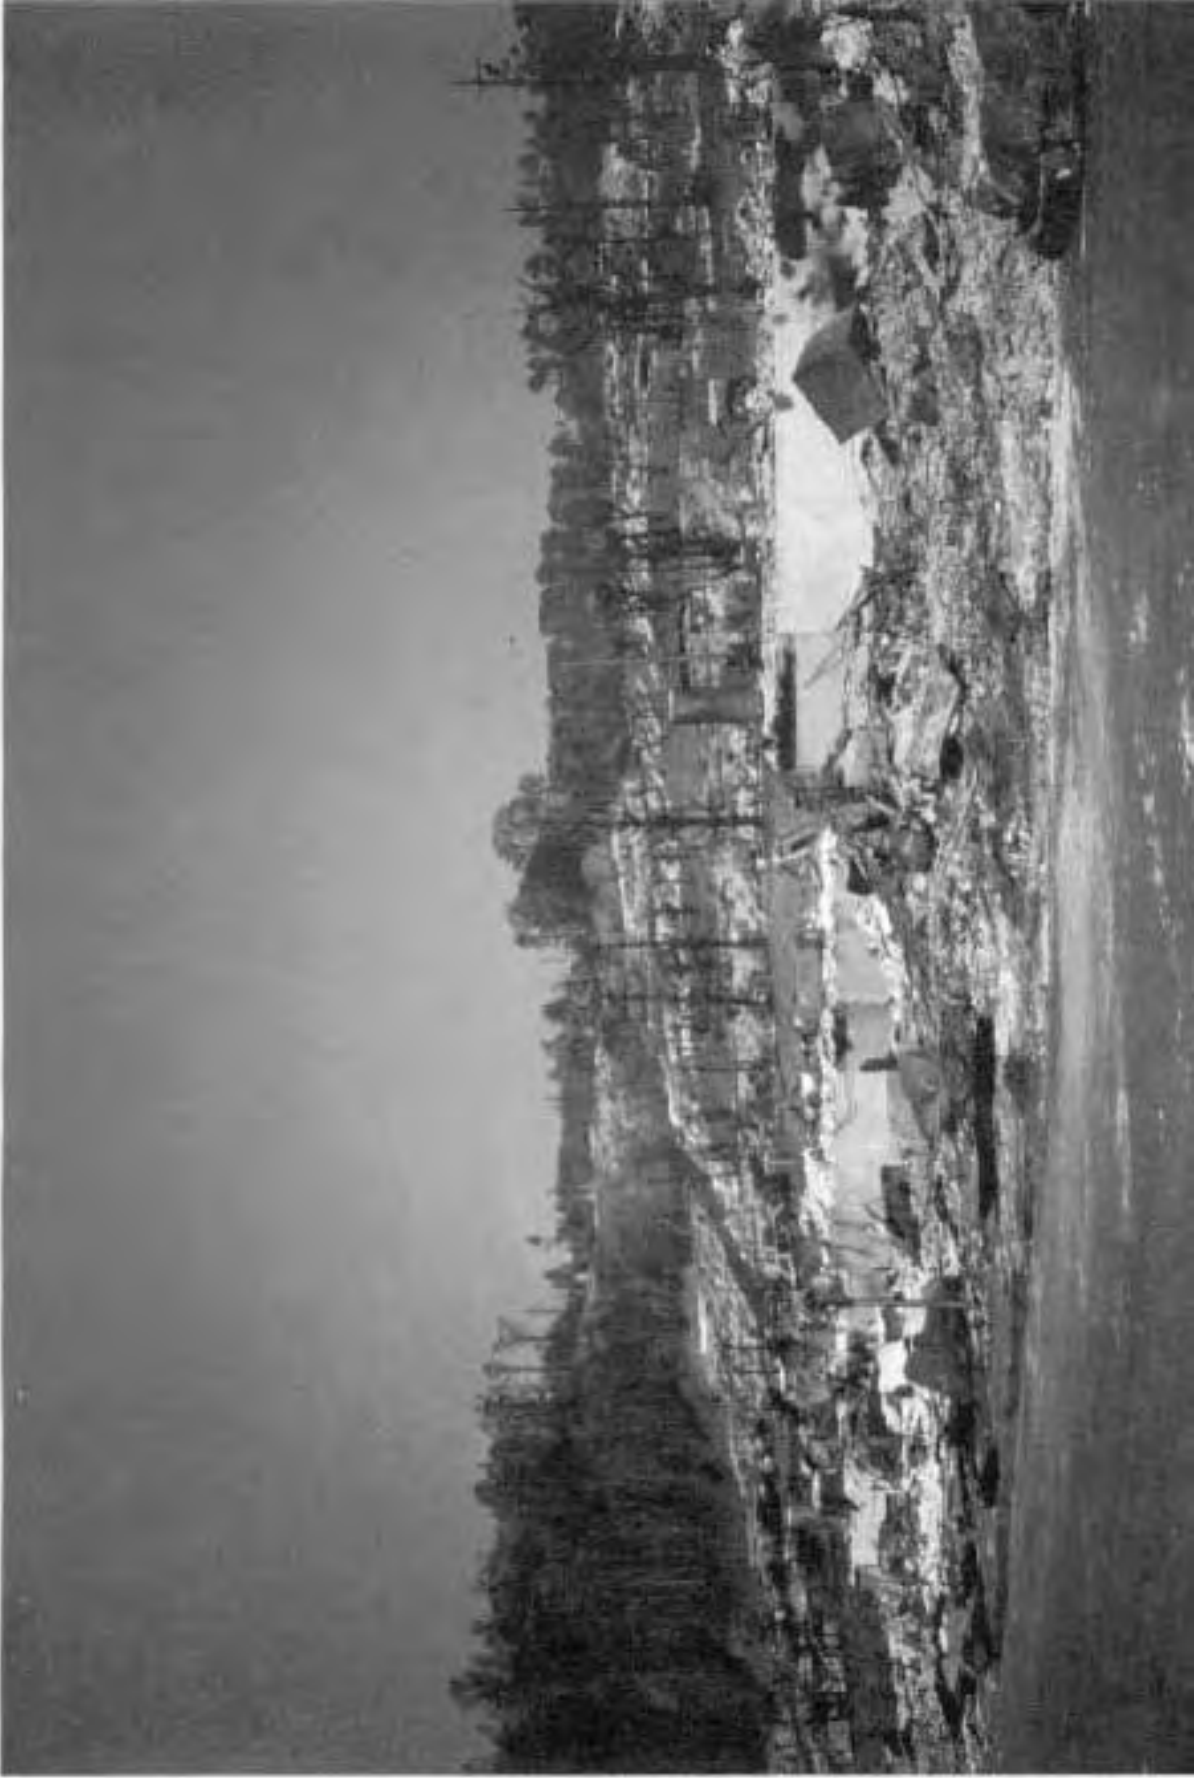
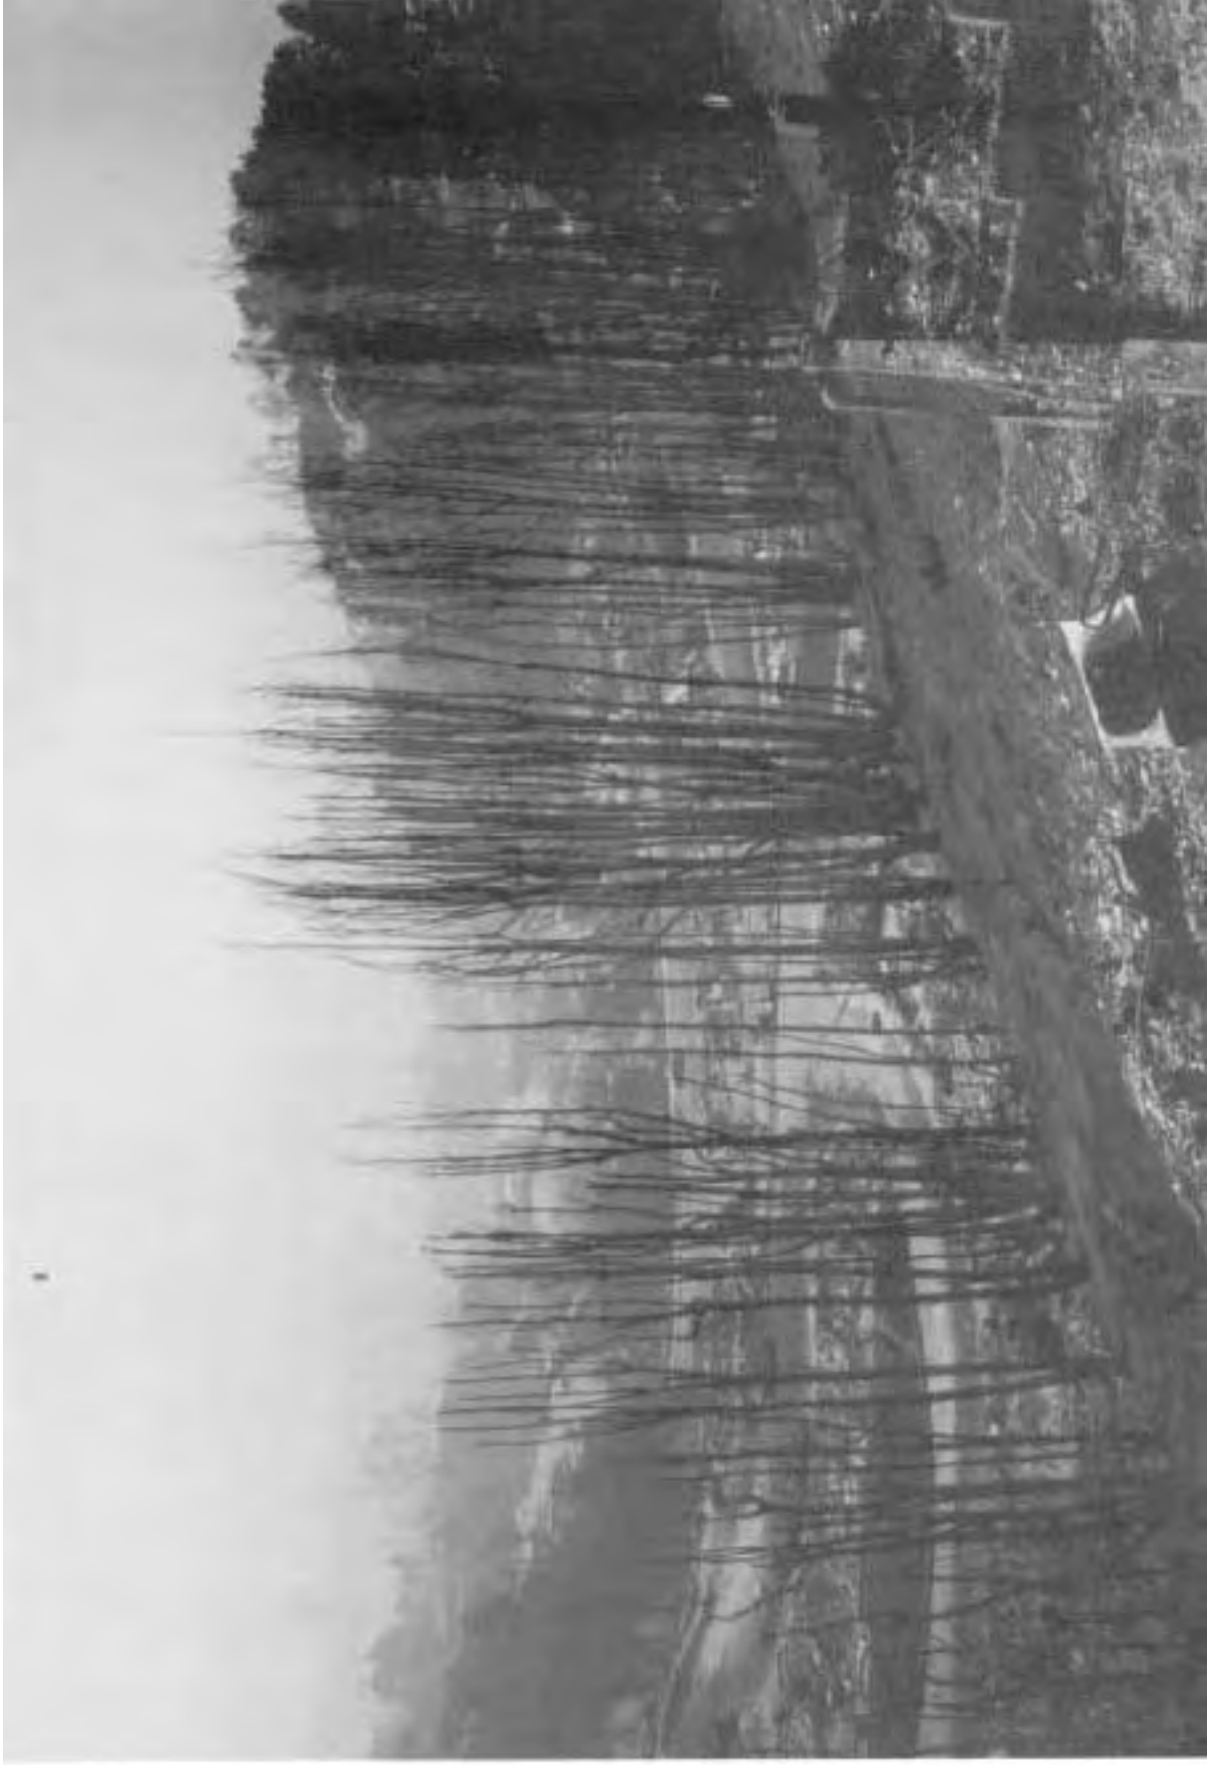
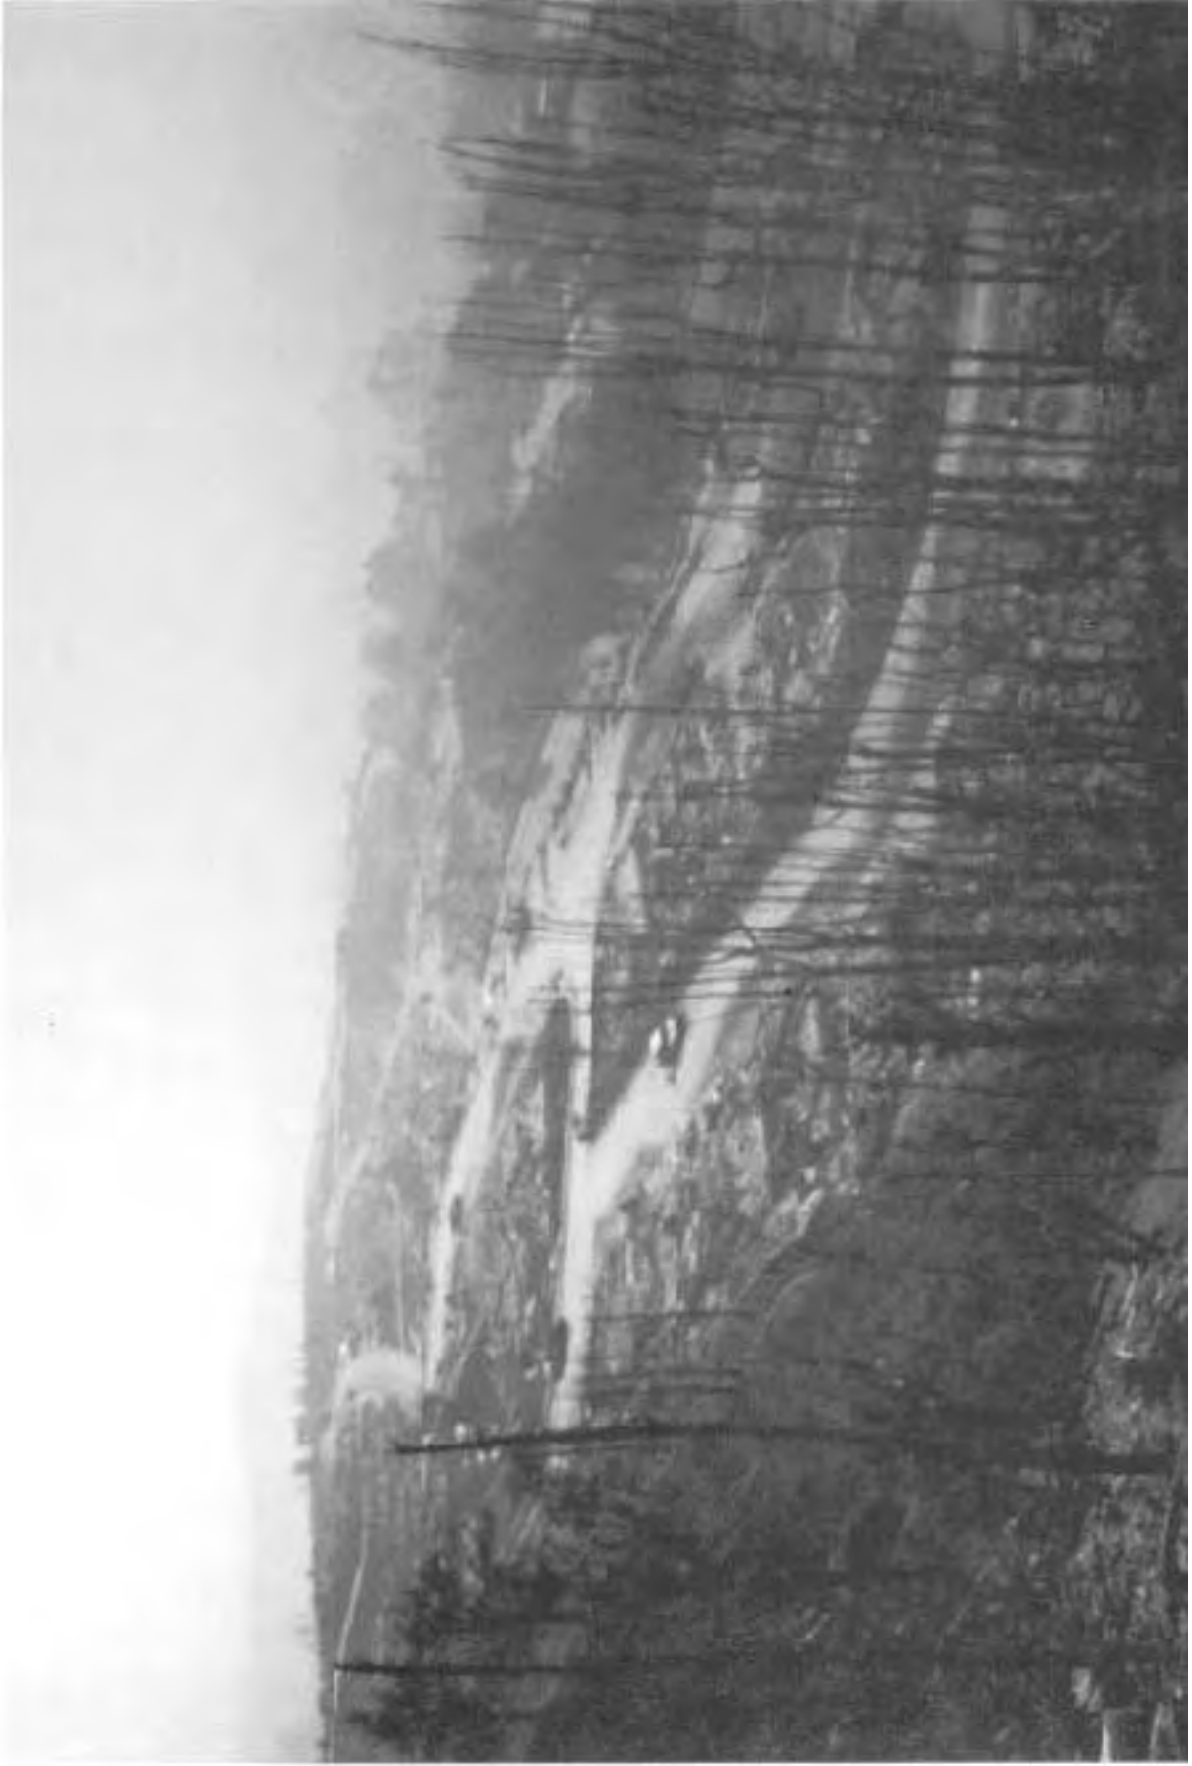
Total destruction of Hiller Highlands complex.
