# United States Fire Administration

## Technical Report Series

### The East Bay Hills Fire Oakland-Berkeley, California

## United States Fire Administration Fire Investigations Program

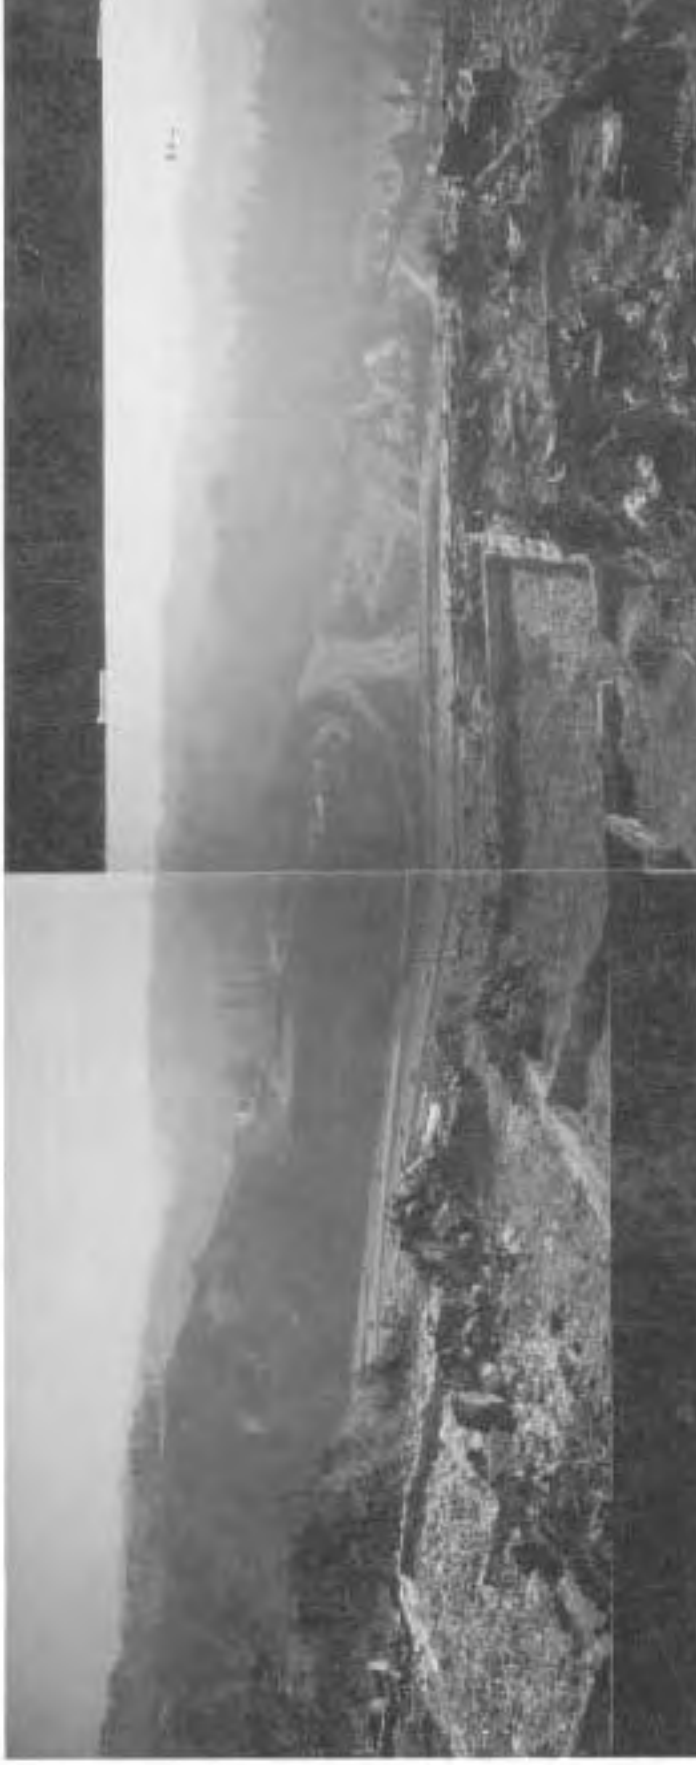
View from Hiller Highlands, looking down on interchange of Highway 24 and Highway 13. Entrance to Caldecott Tunnel is to the left. Lake Temescal and Rockridge District in the background. Fire jumped from Hiller Highlands to the trees beyond Lake Temescal, a distance of approximately 2,000 feet.

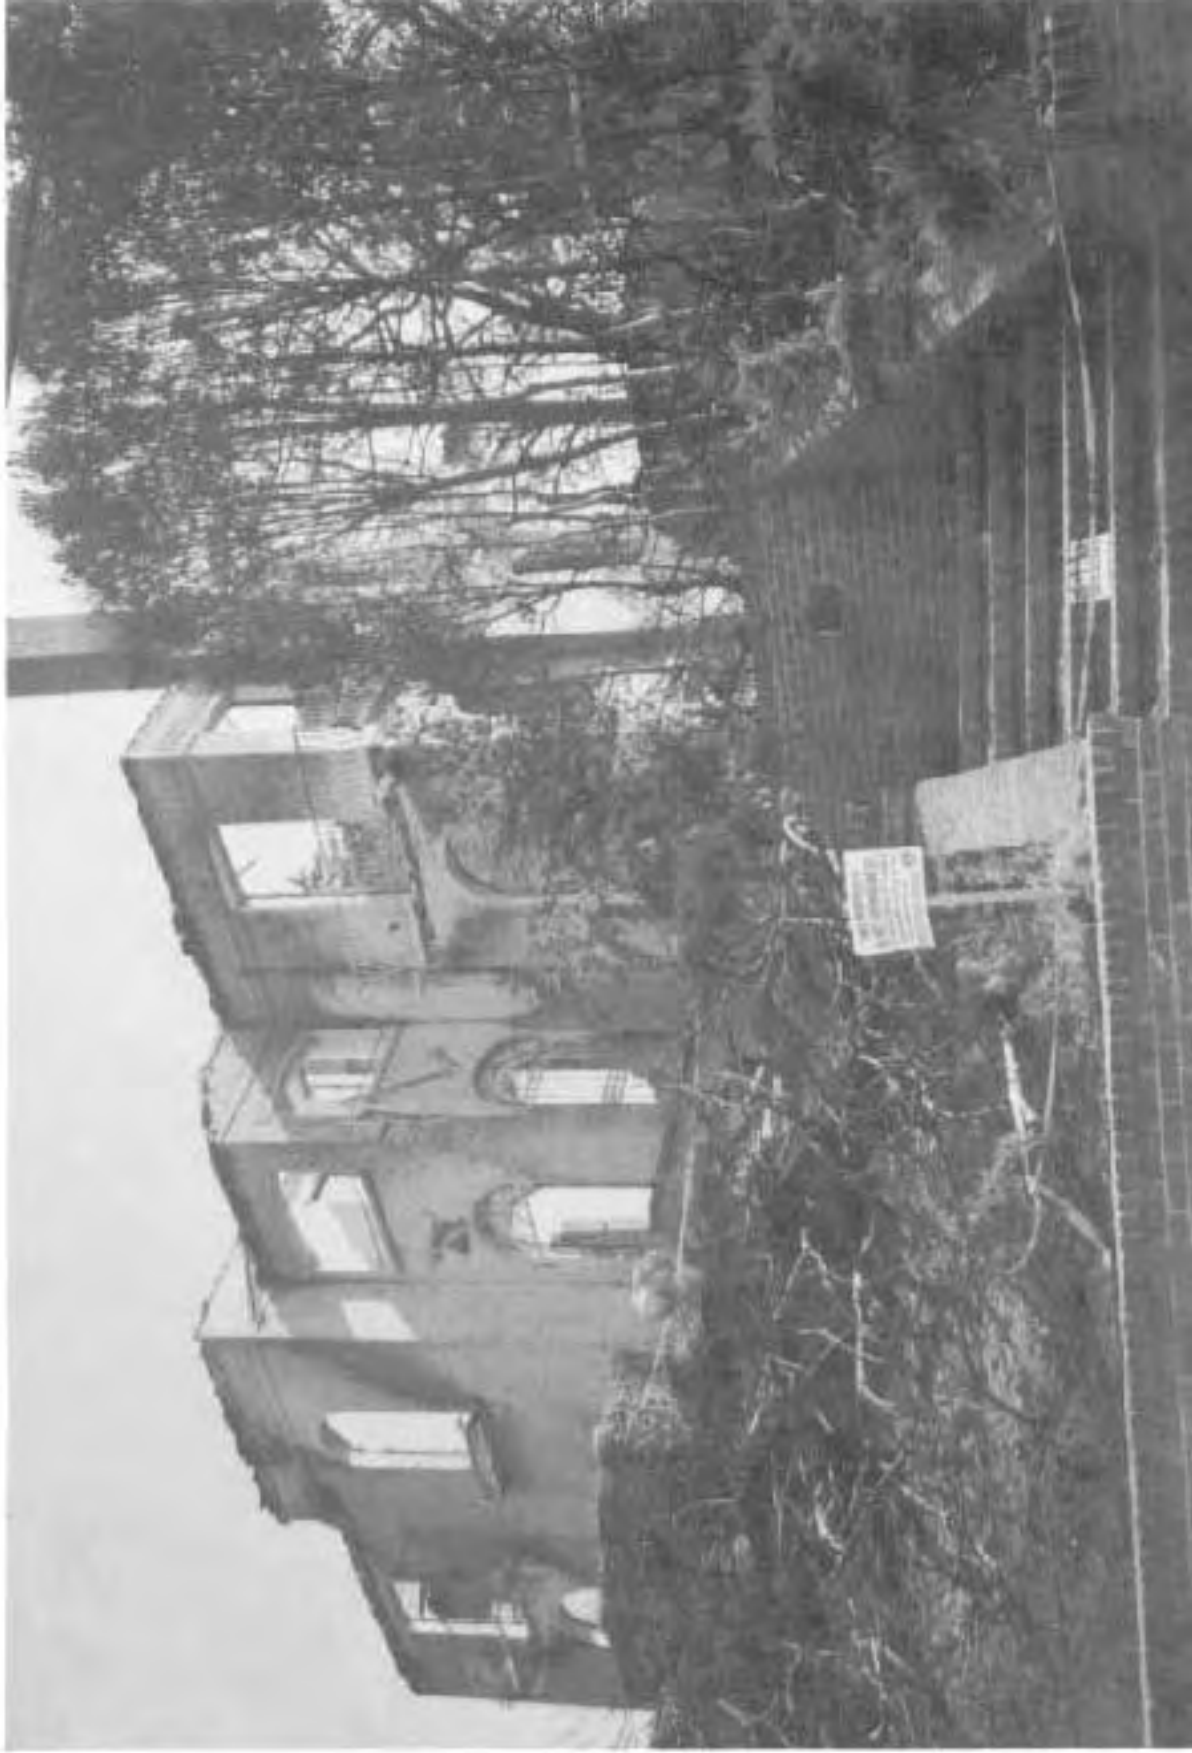
Ruins of large 2-story home in Rockridge district.

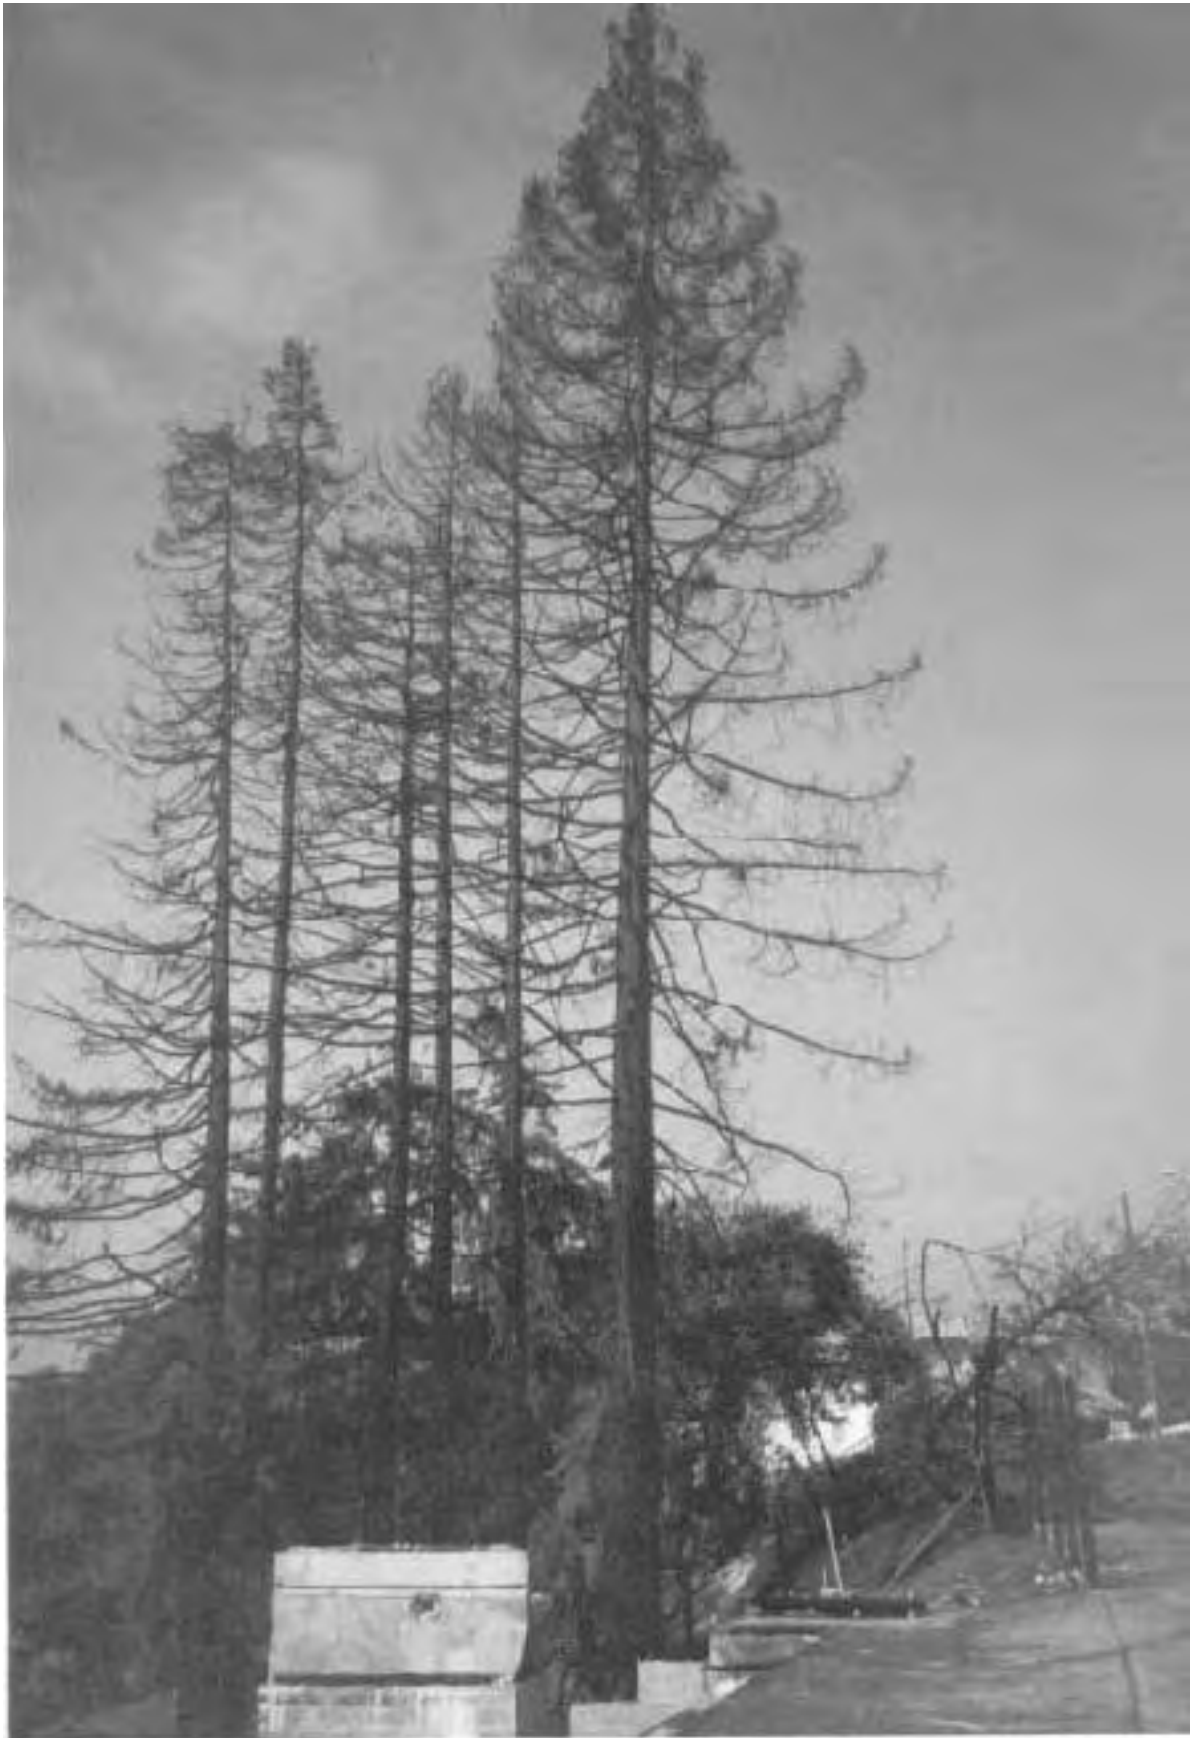
Huge pine trees in the Rockridge district ignited and accelerated the fire spread in this area.

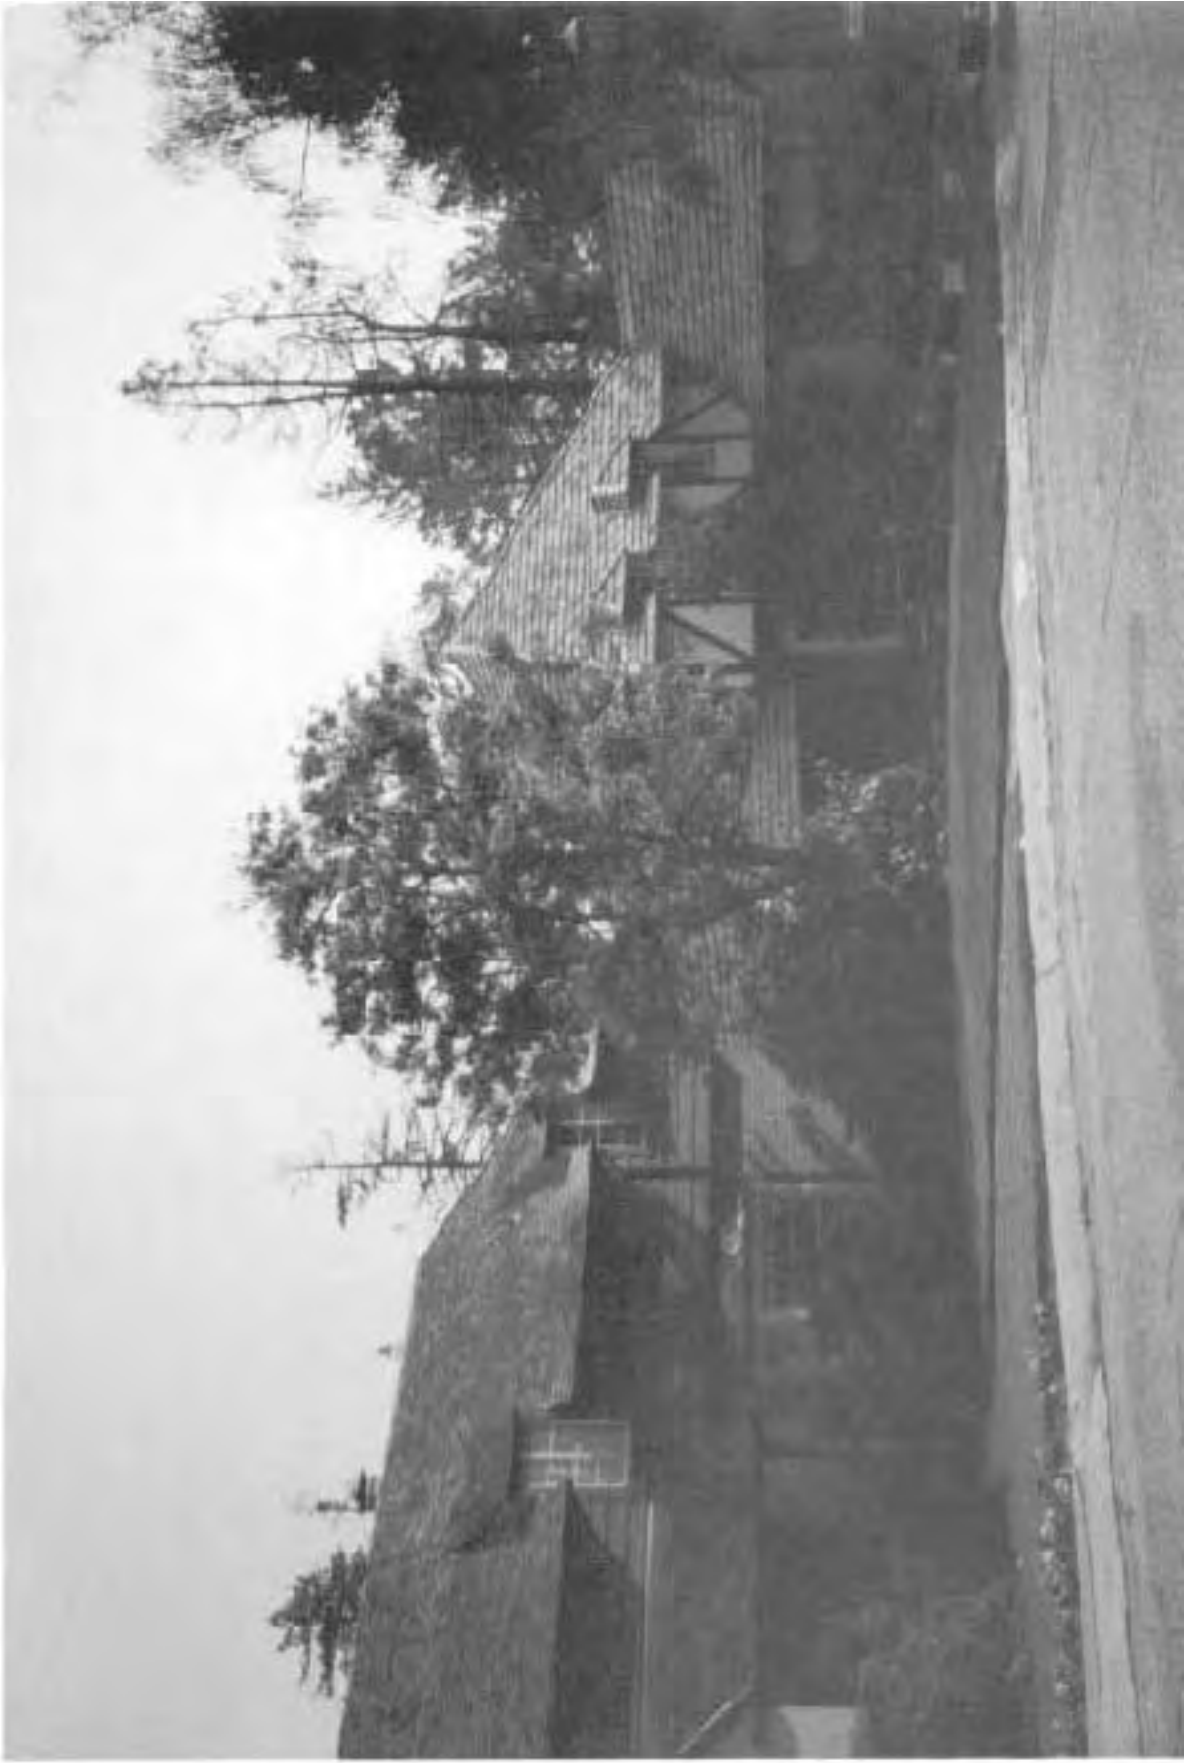
Examples of development in the fire area - wood shingle roofs.

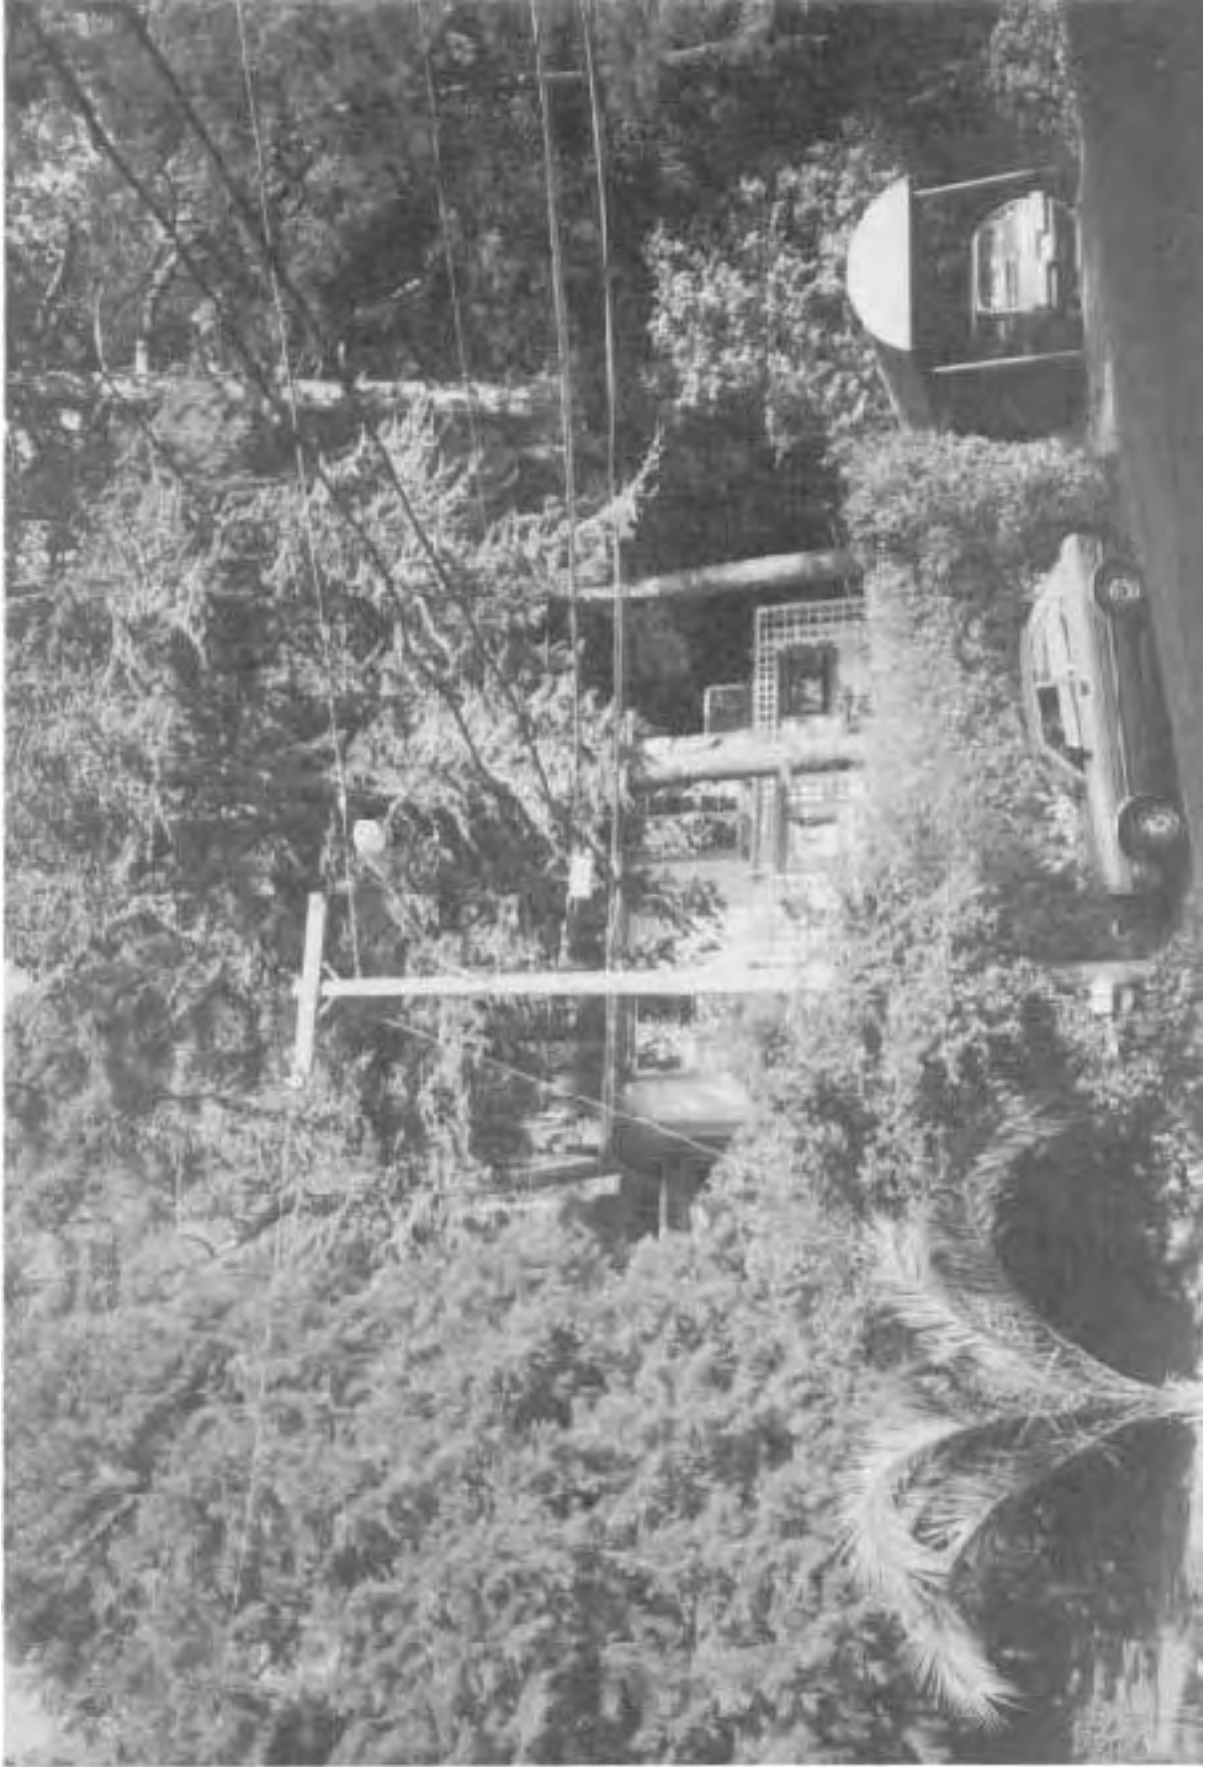
Home enveloped in natural vegetation.

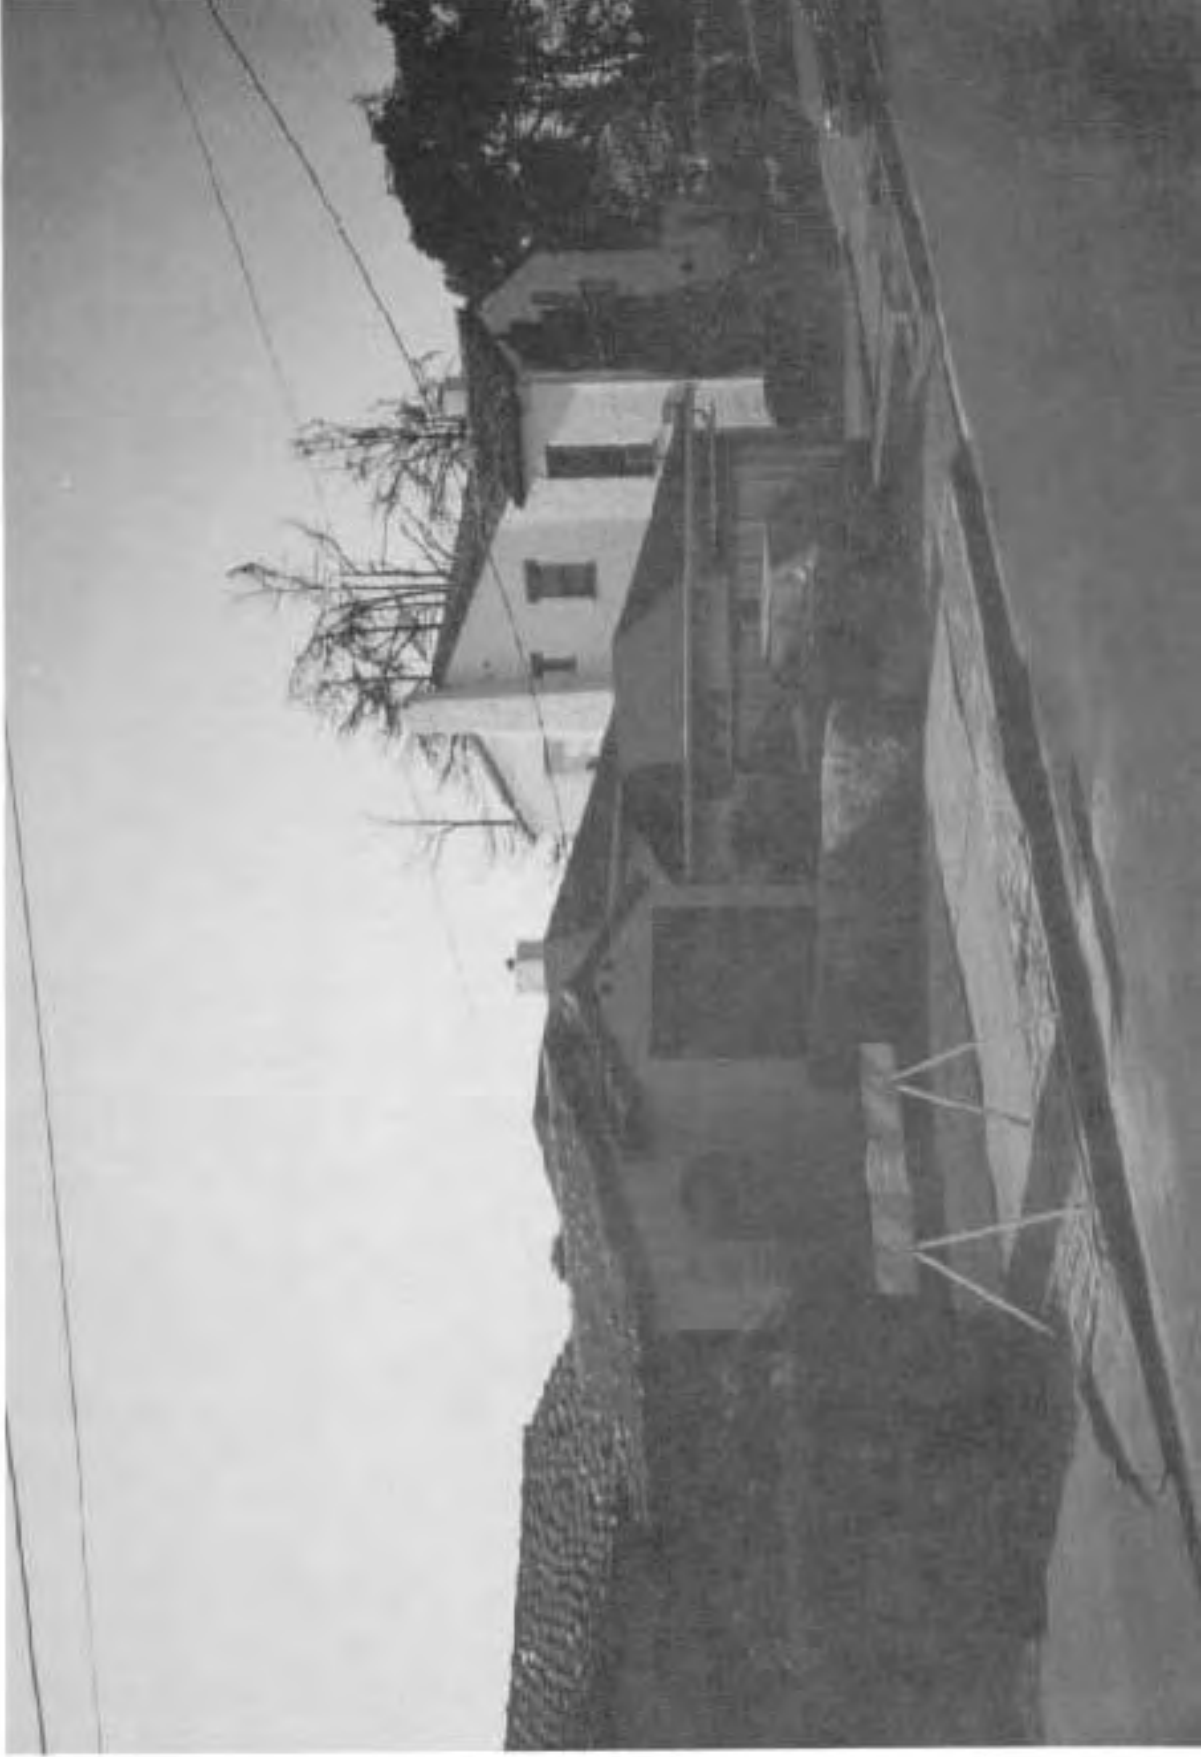
Homes saved within fire area - note non-combustible roofs.

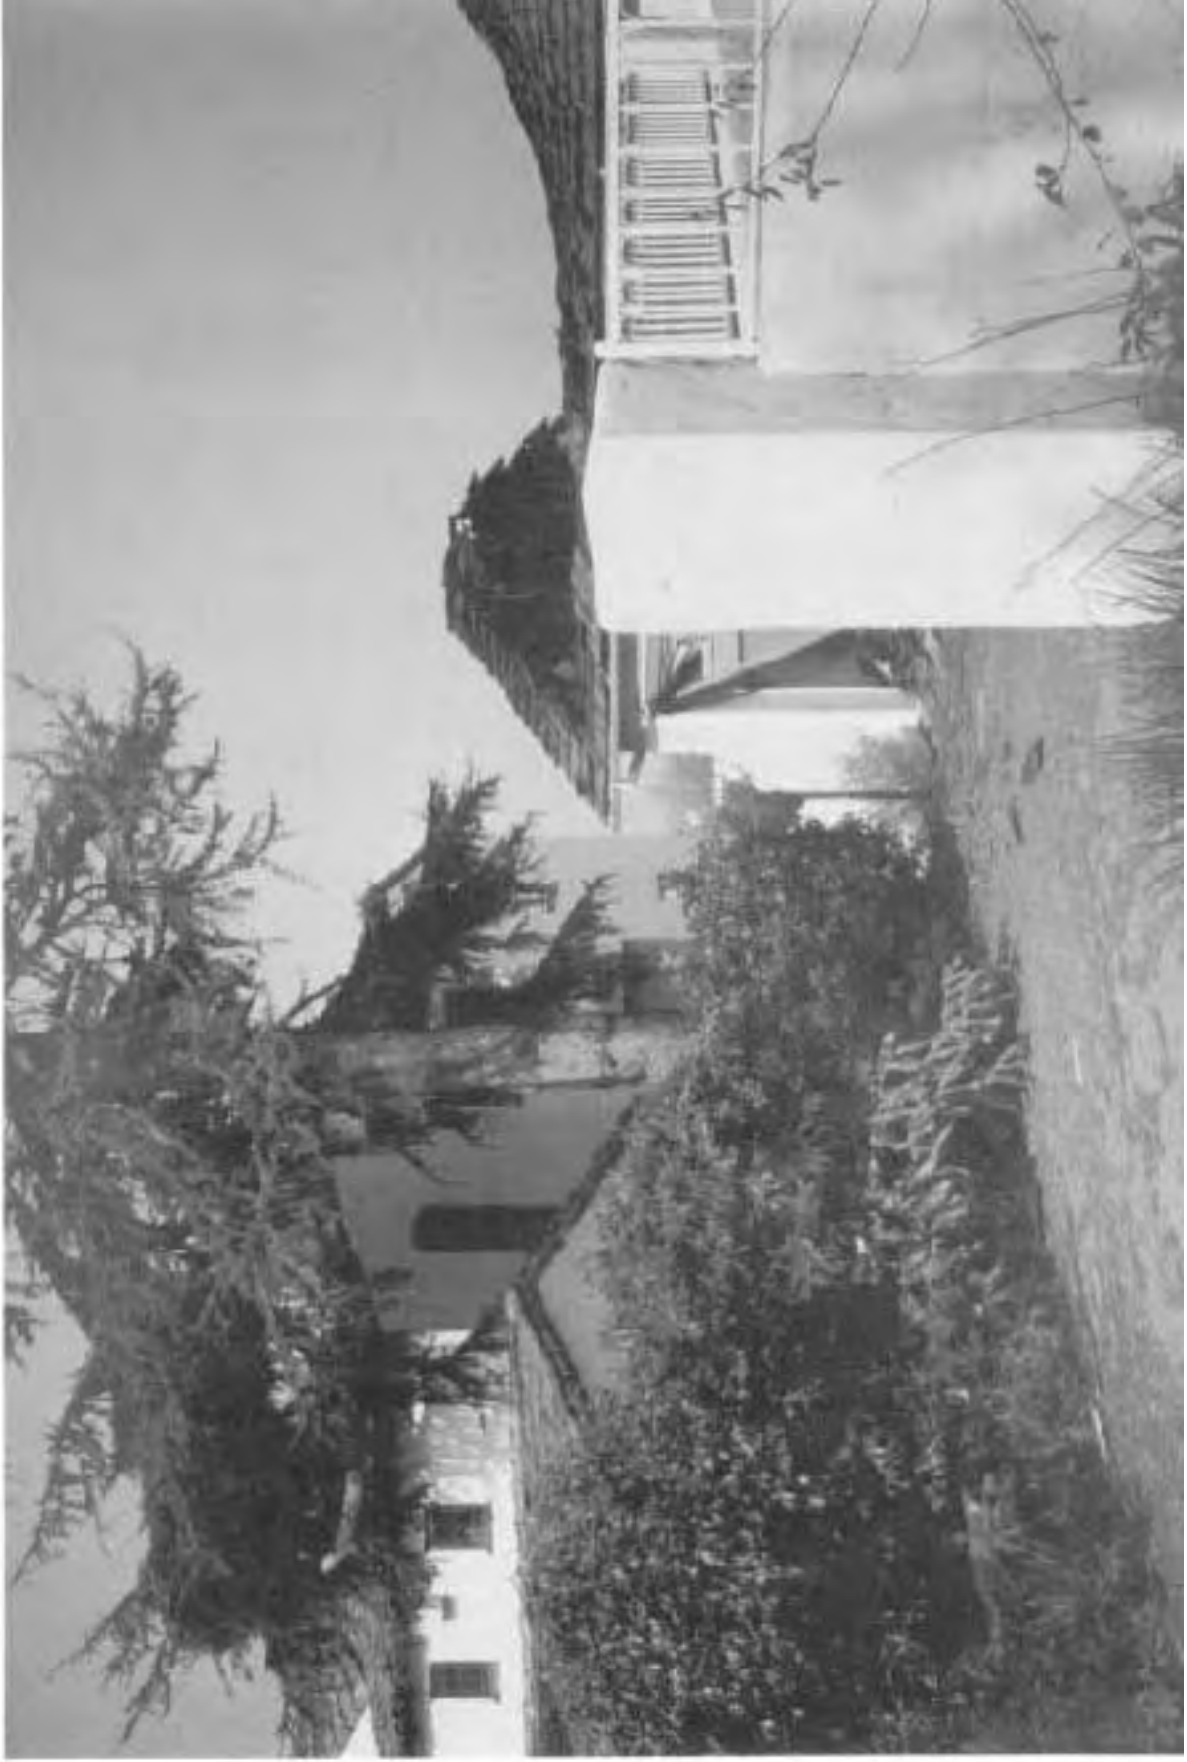
Home with wood shingle roof destroyed. Neighboring home with tile roof saved.

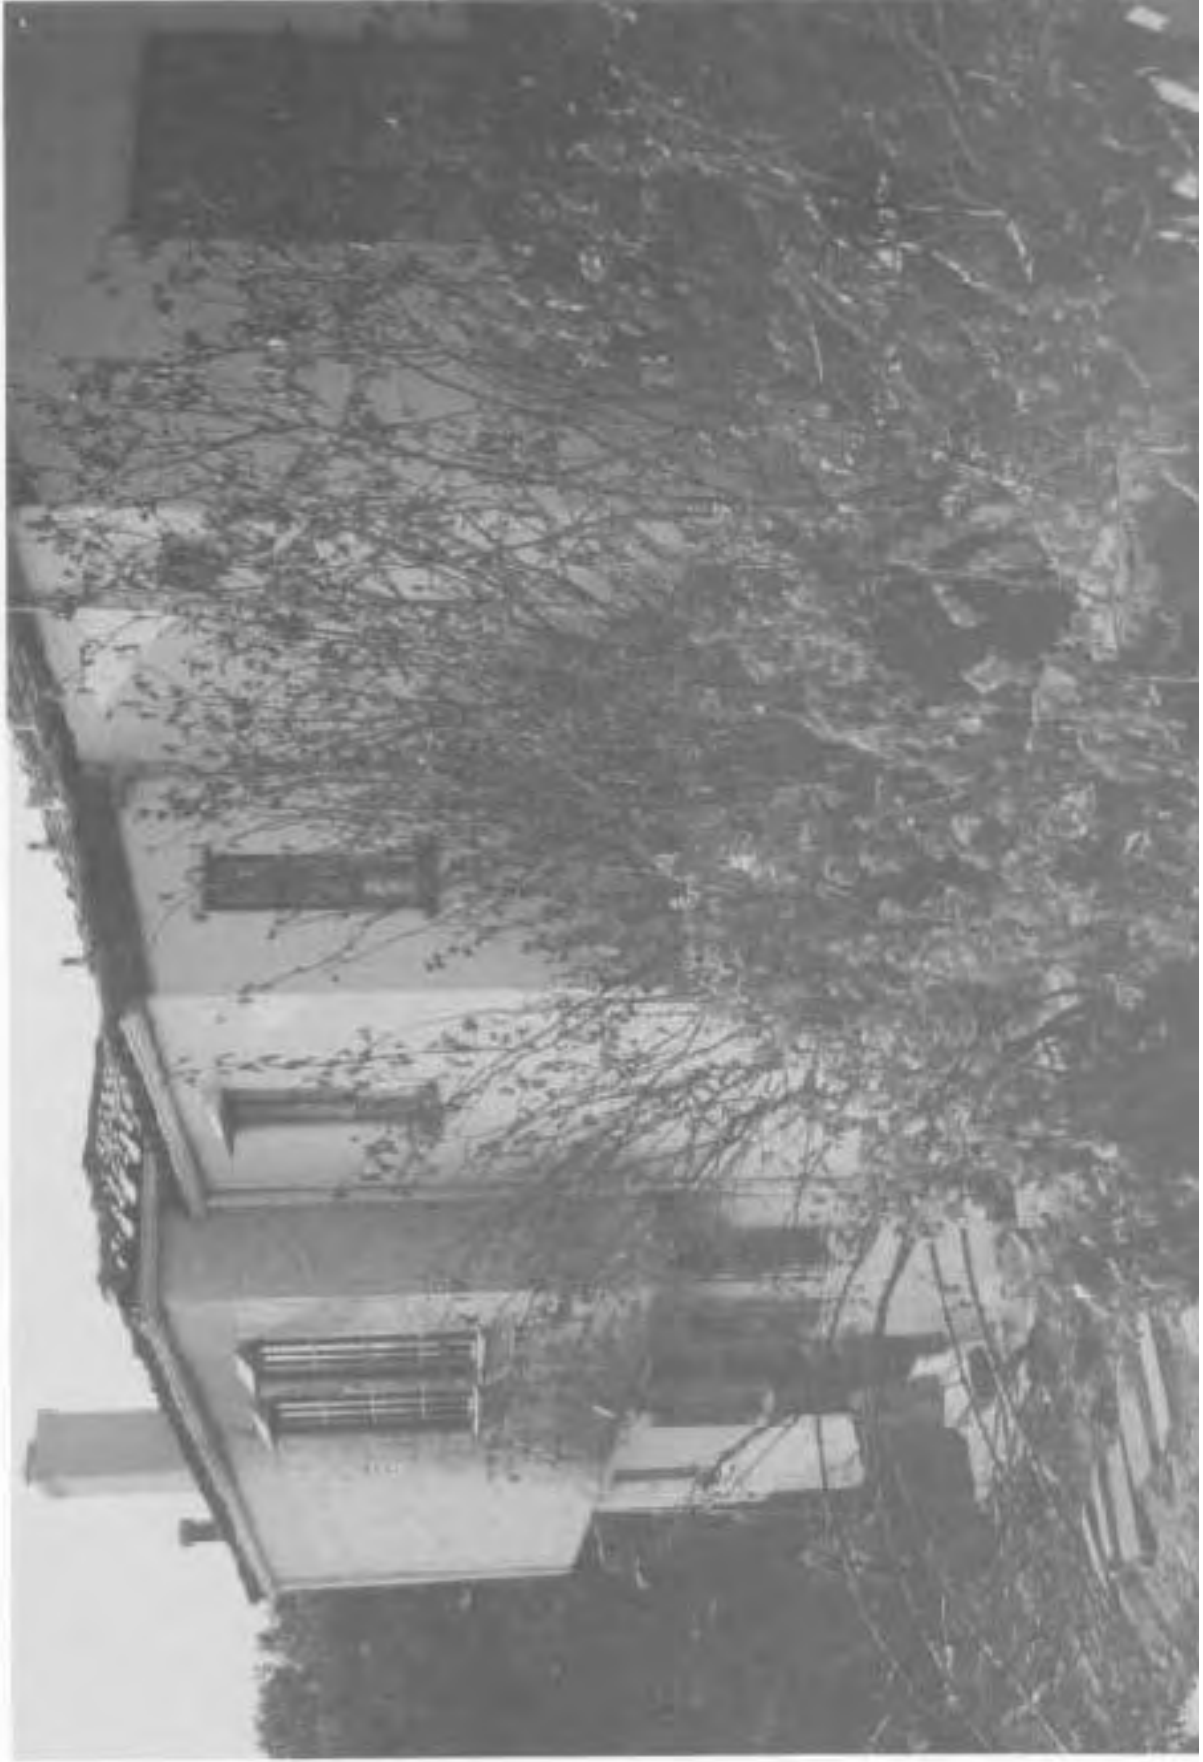
Large home saved by firefighters after vegetation became involved.

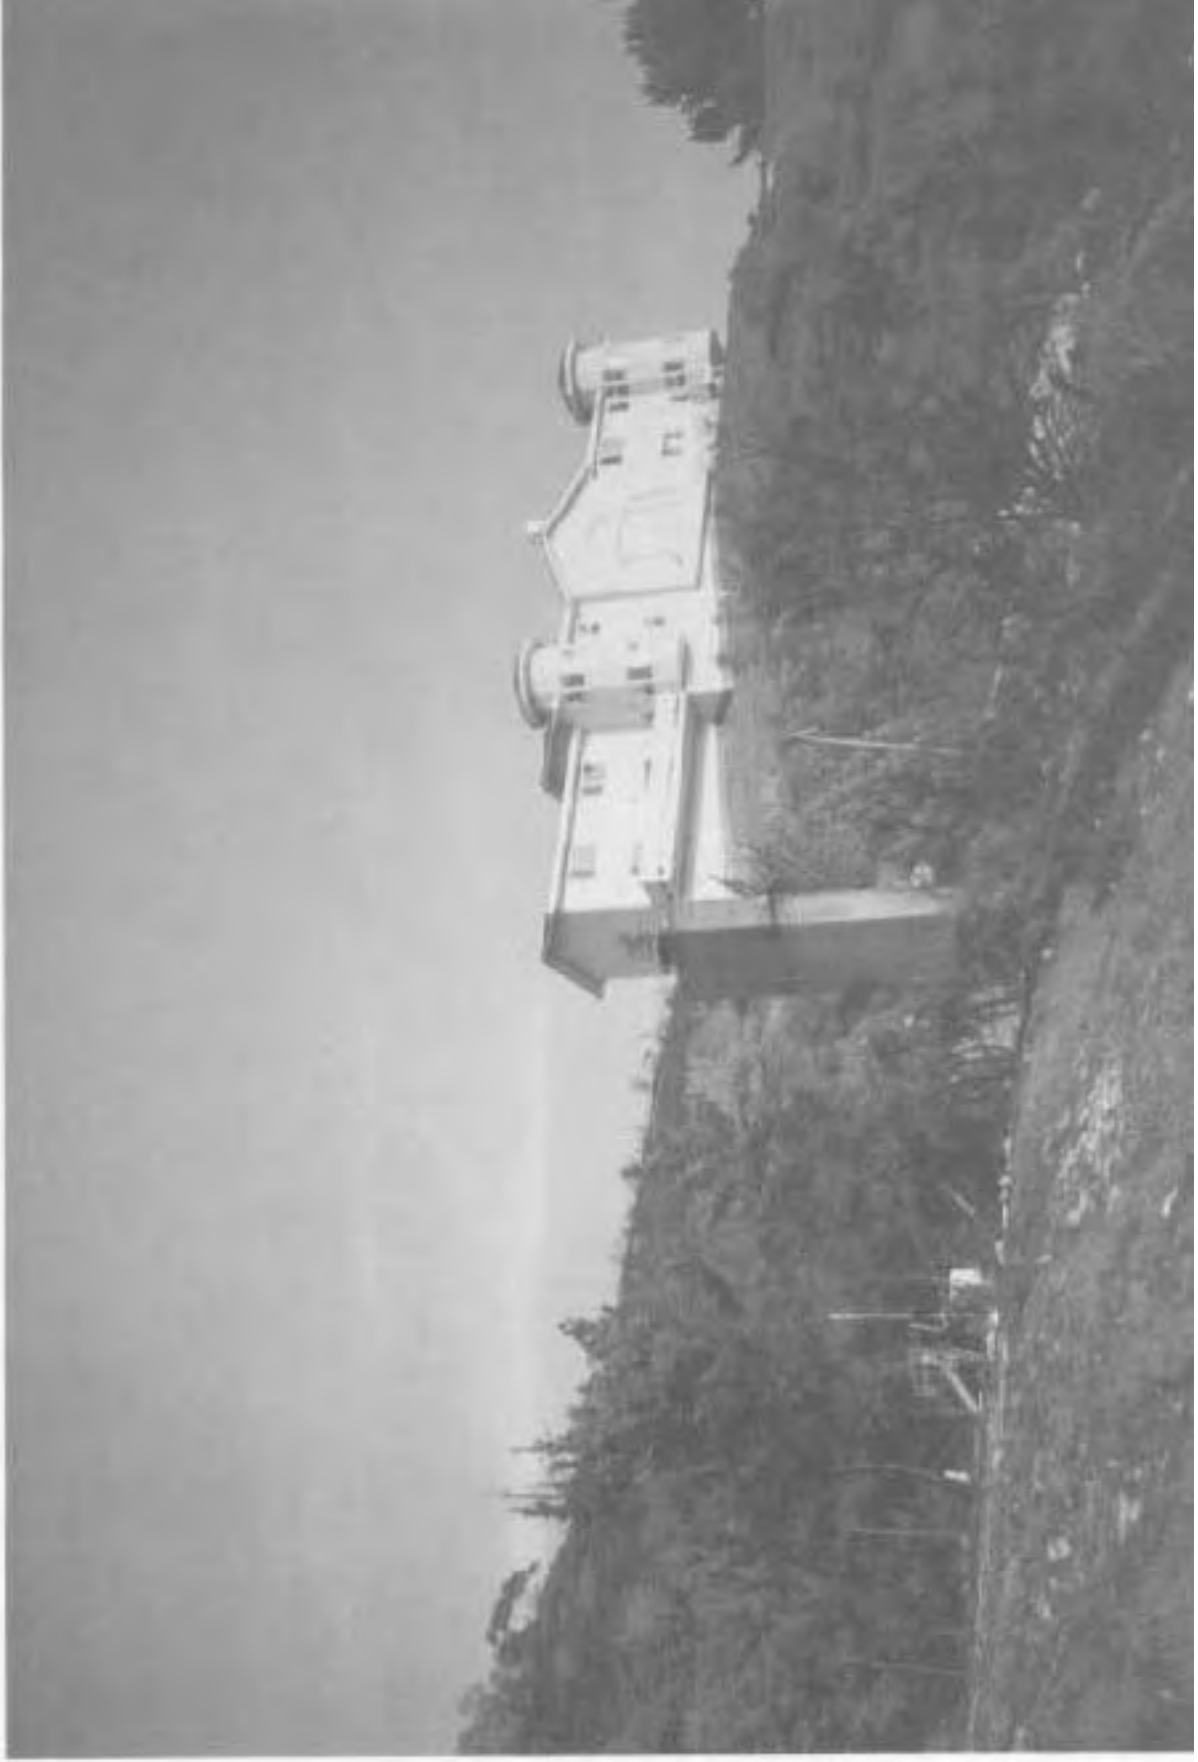
Large home saved by clear area around structure.

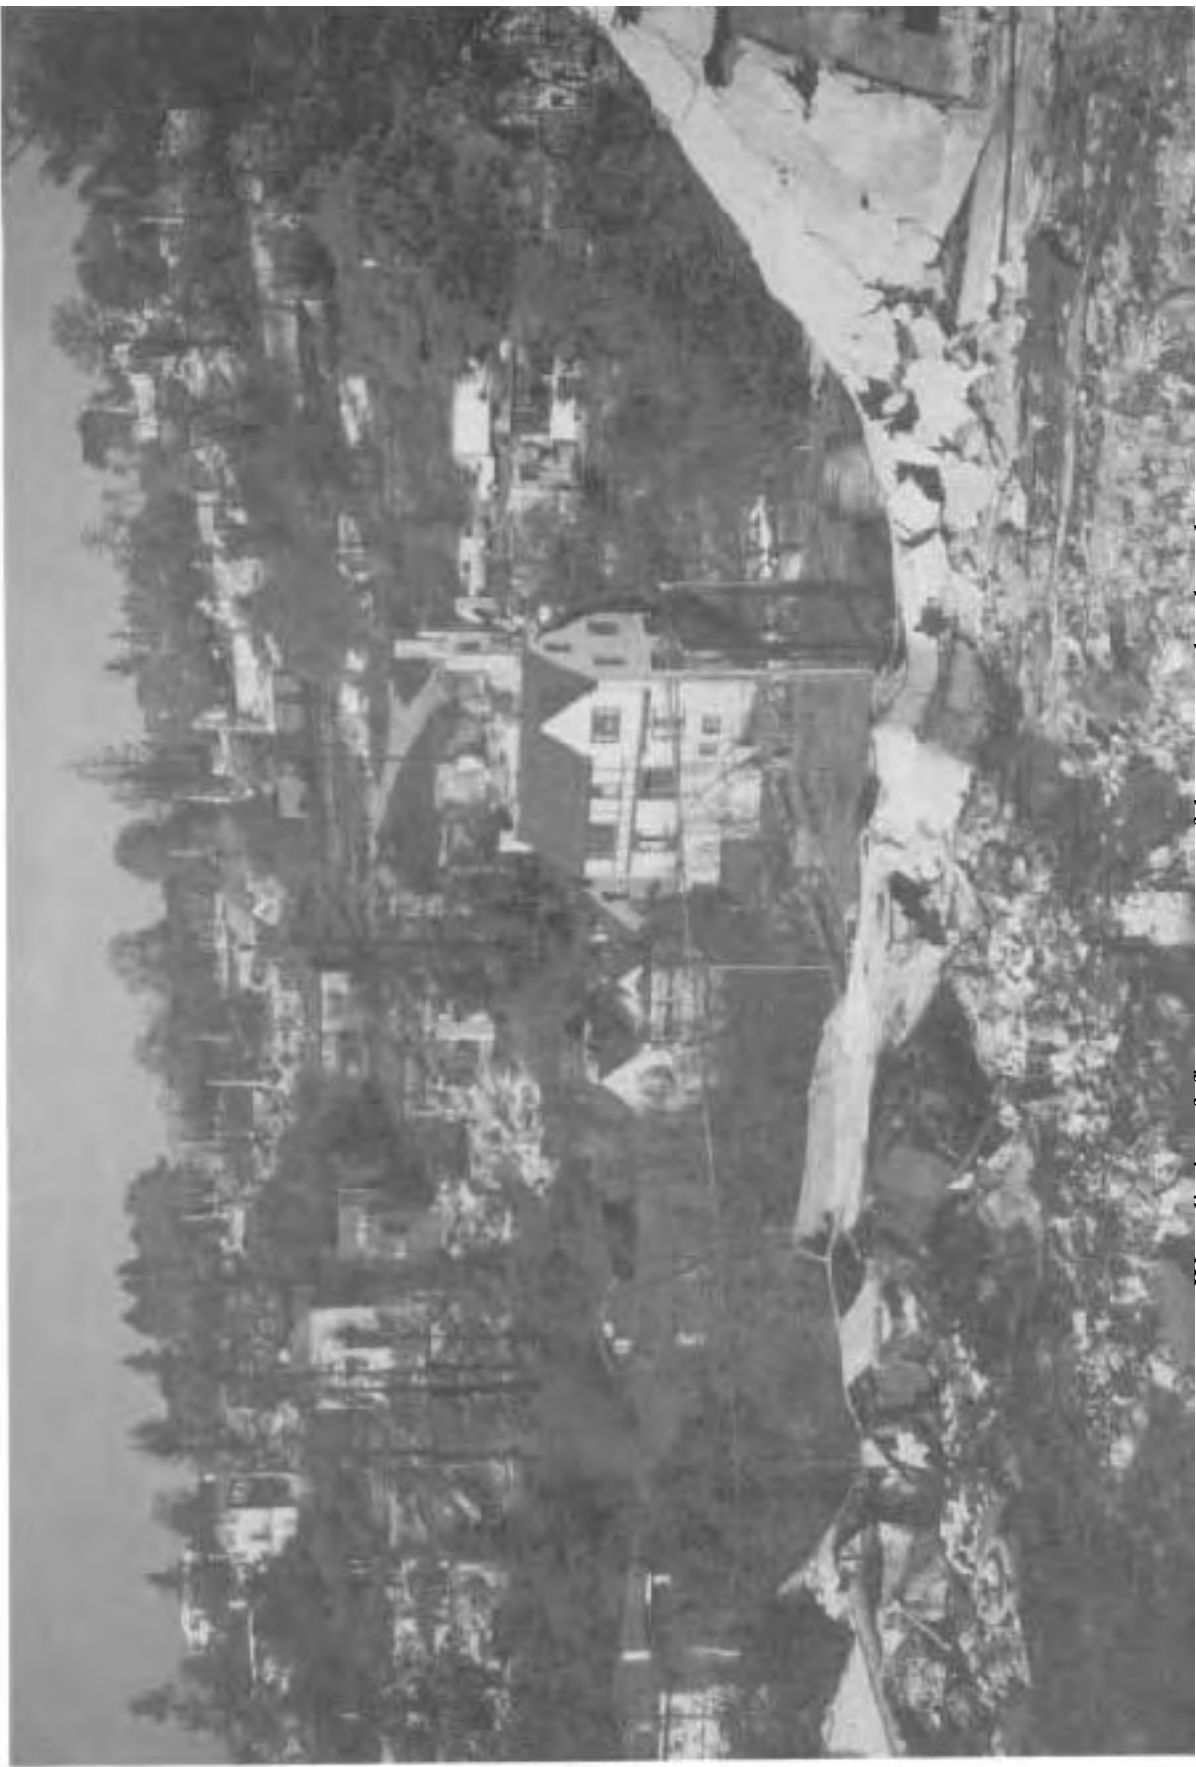
West limits of fire area - groups of homes saved, others lost.

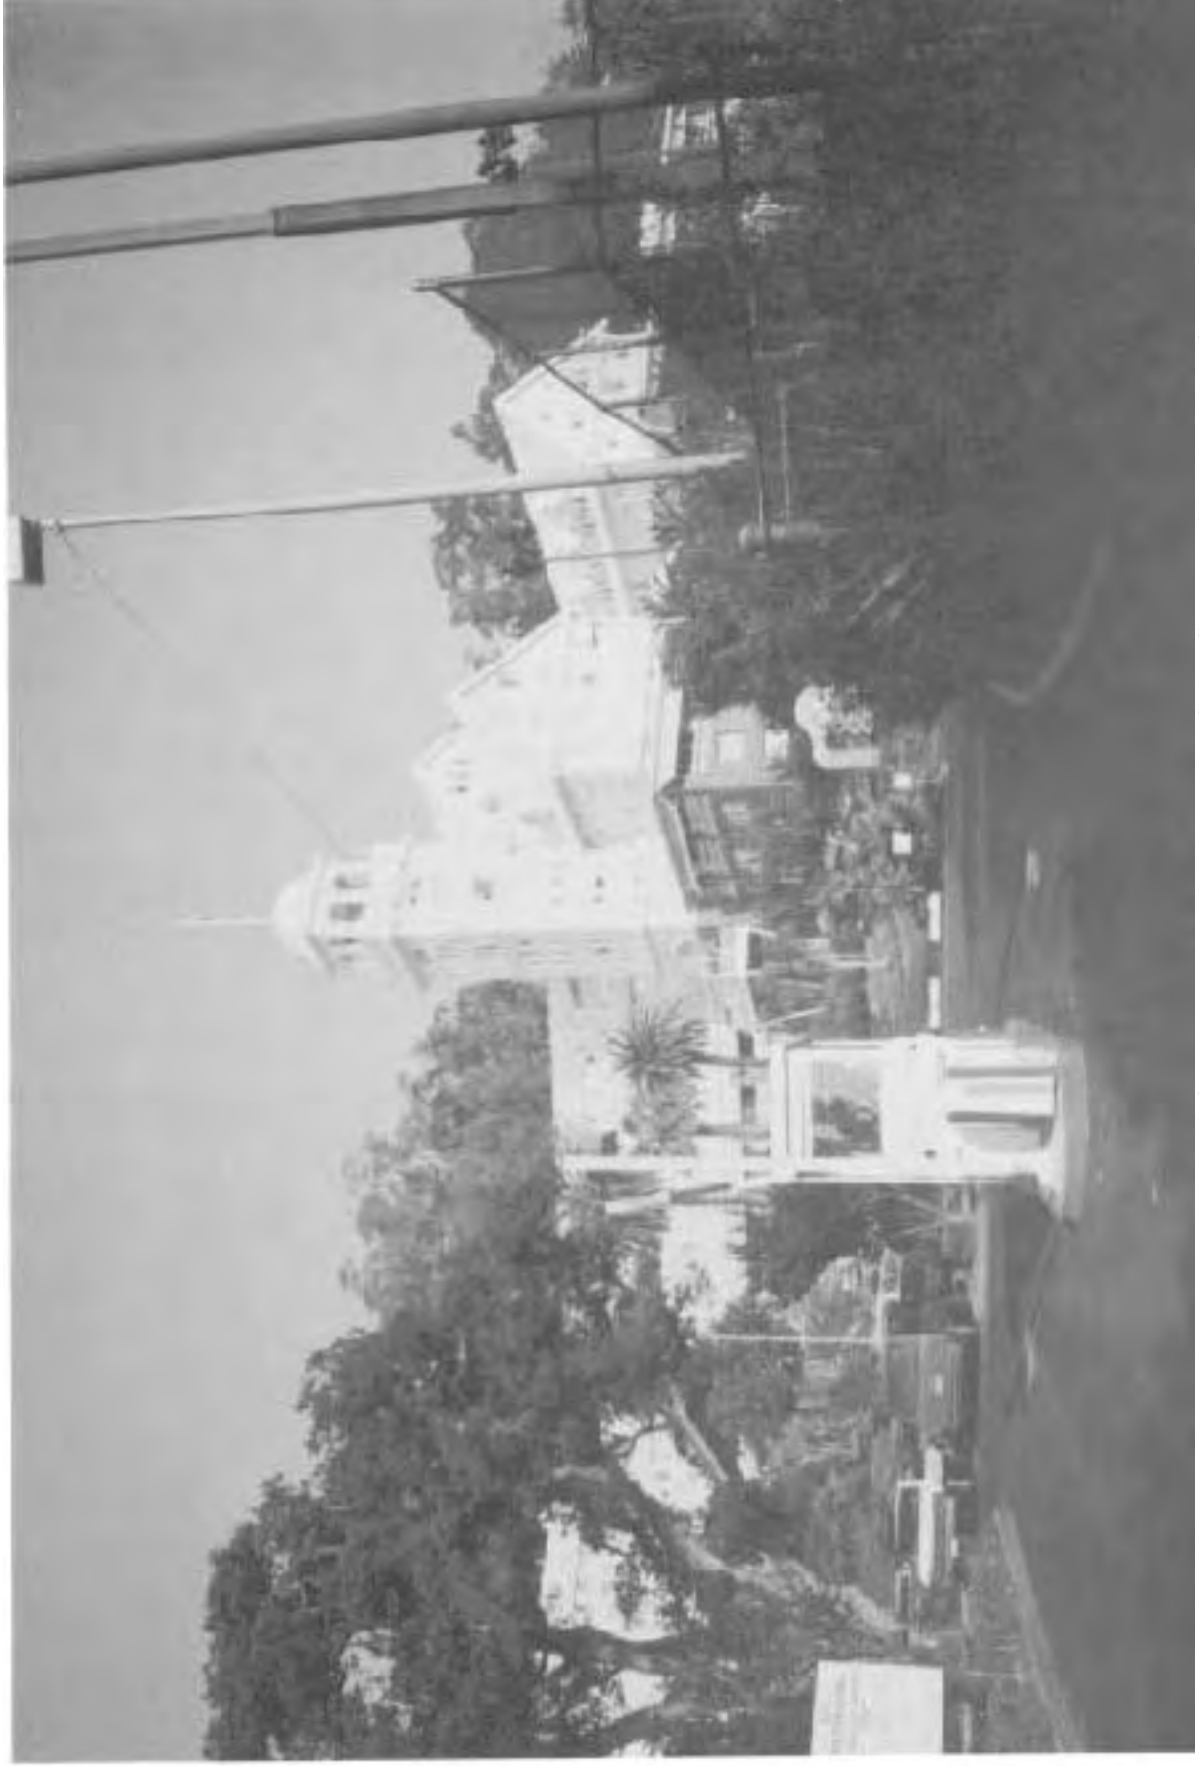
The Claremont Hotel - 5 - story wood frame structure in the path of the fire, considered a "conflagration breeder."
