# United States Fire Administration

## Technical Report Series

### The East Bay Hills Fire Oakland-Berkeley, California

## United States Fire Administration Fire Investigations Program

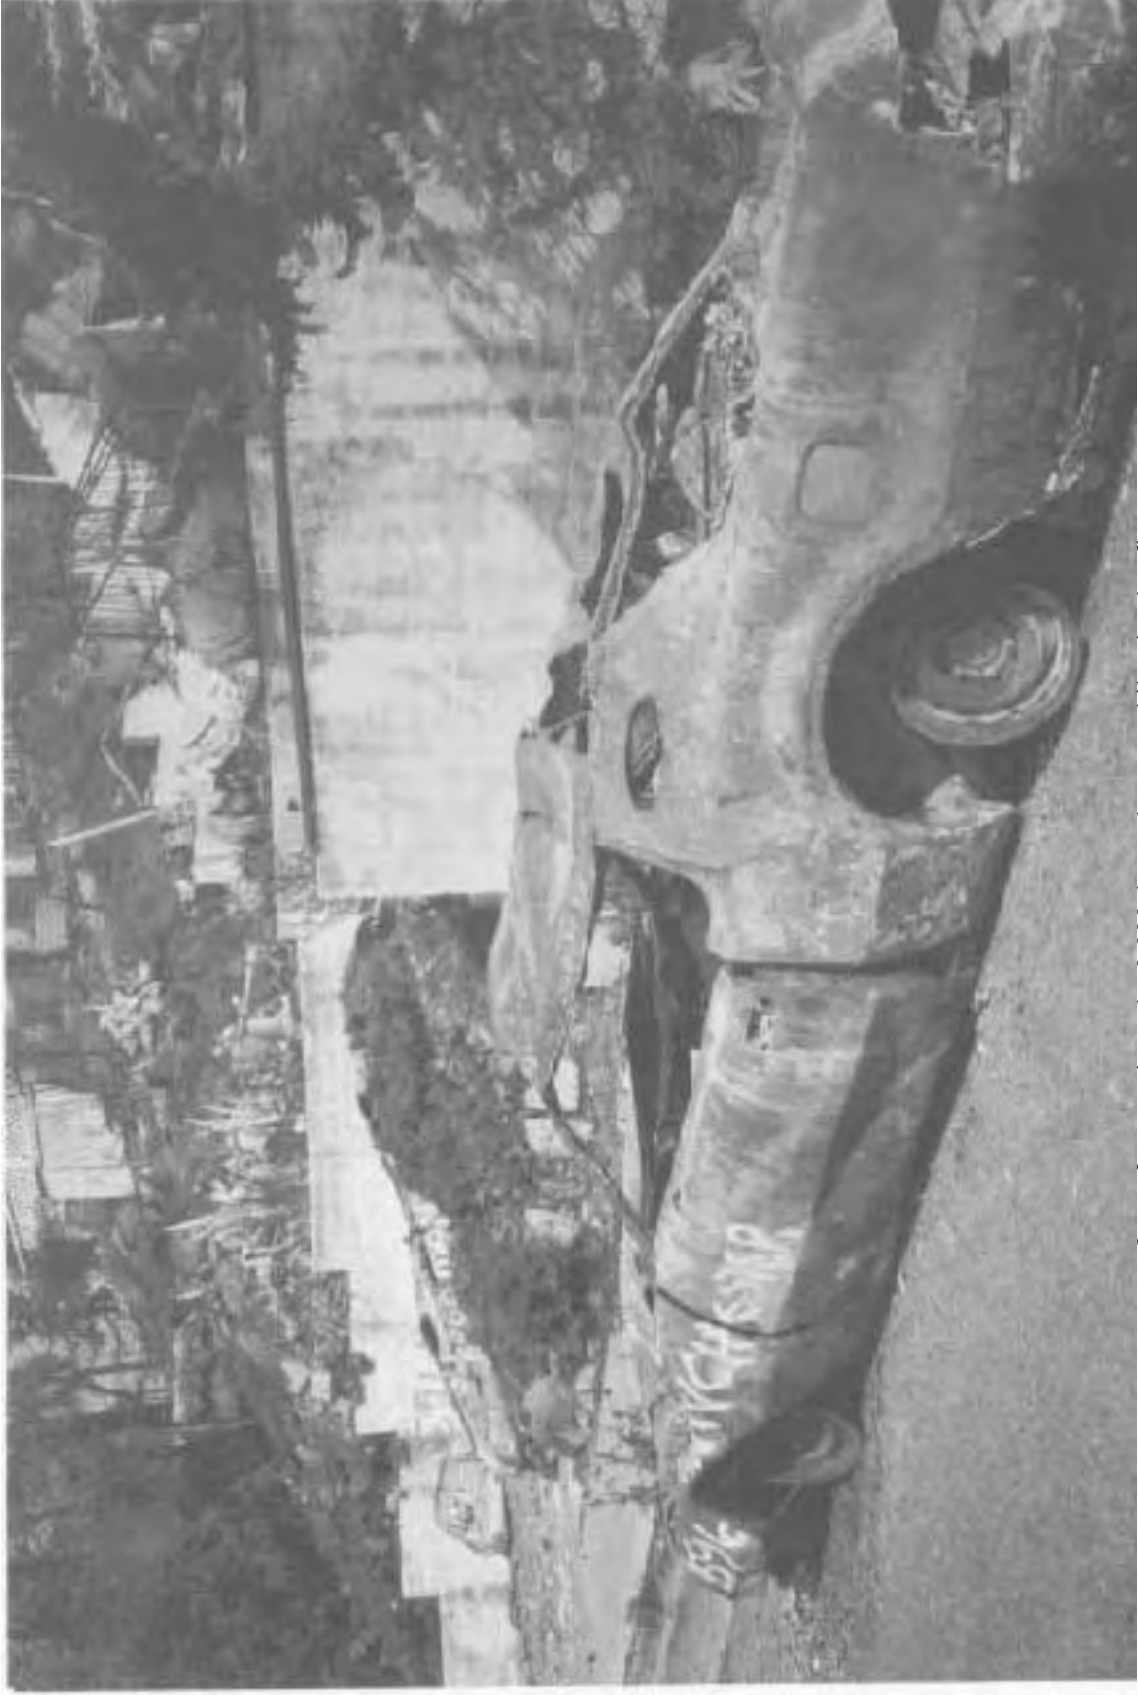
One of approximately 2,000 burned automobiles in the fire area.
