BASF-Industrial Fire Brigade:

TUIS Operation, Level III, 20.11.1997 Elsterwerda Train Station

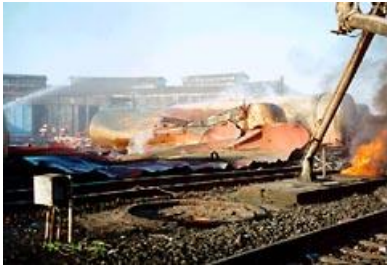
A freight train with 22 rail tankers containing around 1800 m³ of petrol derailed. The electrical locomotive was torn away from the rail tankers whilst crossing points and came to rest a few hundred meters away from the actual scene of the accident. One tanker exploded immediately and 12 other tank wagons were so badly damaged from the crash that a considerable amount of petrol was released and caught fire immediately. A second tanker exploded about 15 min. after the first explosion. Spurting petrol and the immense radiation heat from the flames ignited the station premises. The force of the explosion ripped a large part of the train station building away and cars on the station car park ignited. During scene assessment a fireman fatally injured through collapsing debris, a further 9 people suffered server burns. The Elsterwerda's Voluntary Fire Brigade along with other alerted fire brigades and the BASF Industrial Fire Brigade Schwarzeide began fire fighting and cooling the burning rail tankers.

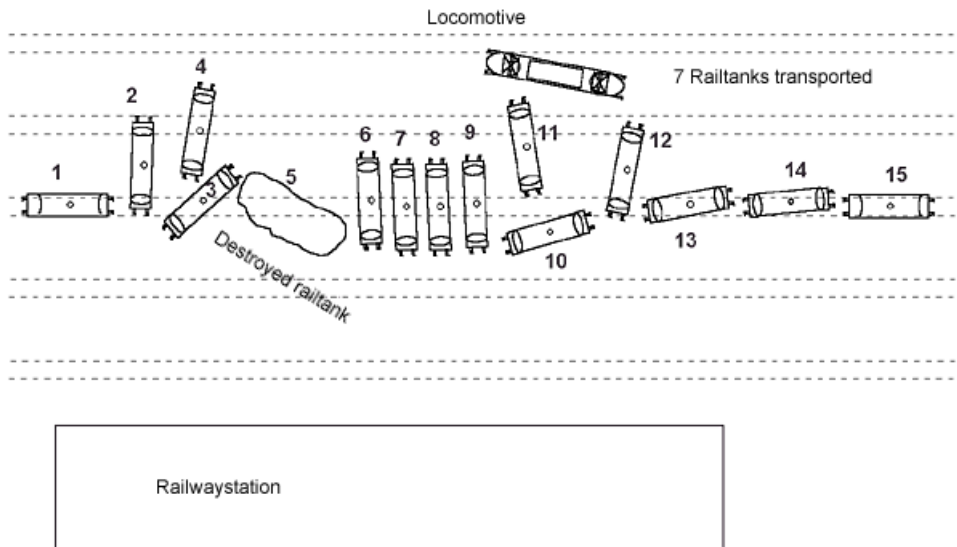
The BASF Industrial Fire Brigade from Ludwigshafen arrived at the train station in Elsterwerda at 13:00 hrs. with a command vehicle. The following situation was given: Under rail tanker Nr. 1 and in particular under the rail tankers Nr. 6 - 12 (shown as a sketch) ground fires still existed and deflagrations were occurring within short intervals. Many drains around the tracks were on fire.

The rail tankers were cooled with water from the municipal fire brigades. The BASF Industrial Fire Brigade decided on applying medium and low-expansion foam to extinguish the fires within the rail and drains area. The ruptured rail tankers were internally covered with low-expansion foam. This was applied through the leakage wholes.
